*The A5/A49 Shrewsbury By-pass:
An Archaeological Evaluation*

THE A5/A49 SHREWSBURY BY-PASS: AN ARCHAEOLOGICAL EVALUATION

**The A5/A49 Shrewsbury Bypass:
 Recommendations, January 1989**

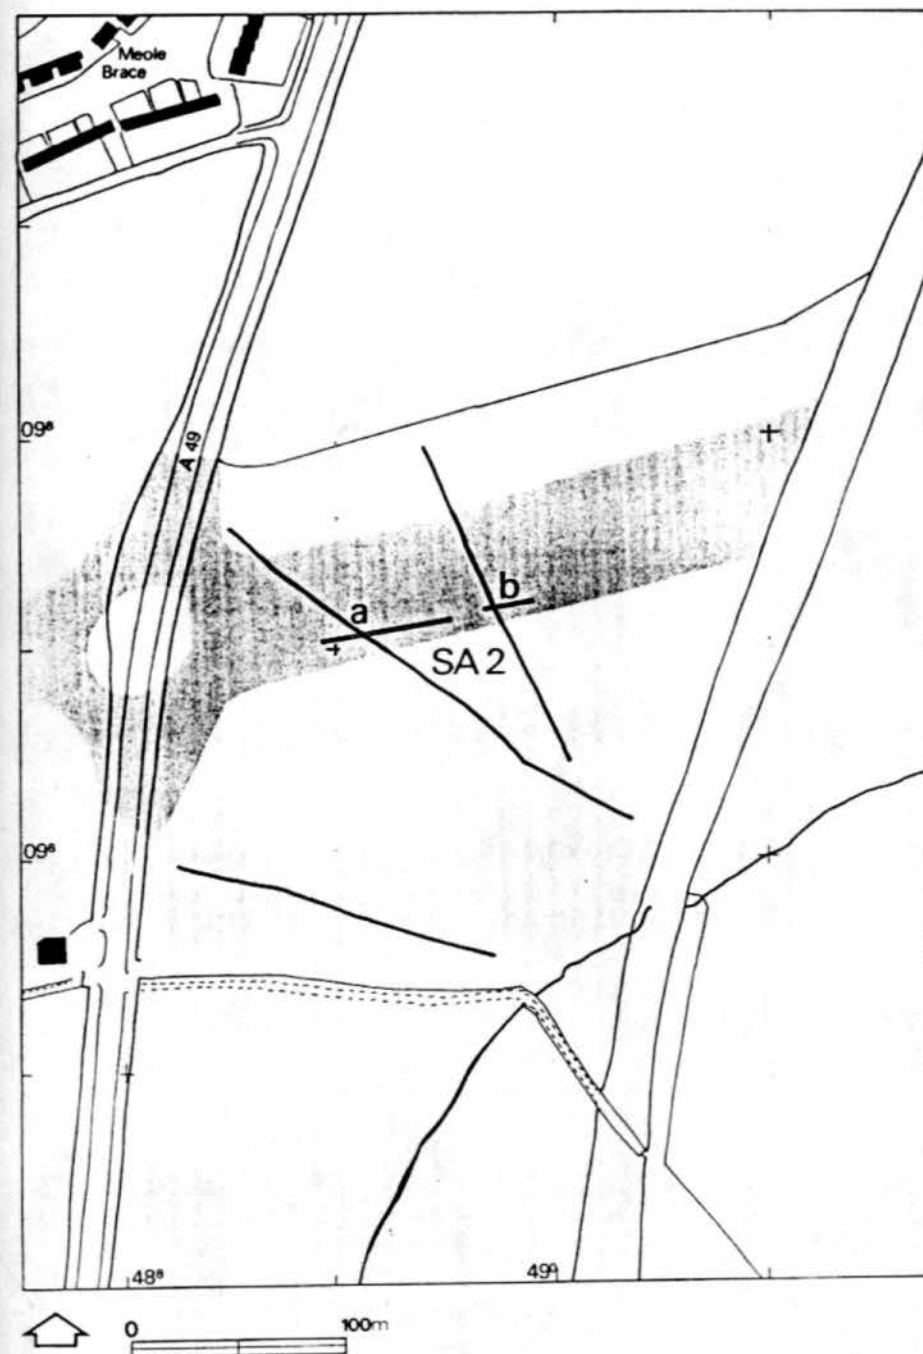
Figure 2 SA.2 location map

The site lies to the east of the A.49, just to the south of Meule Brace, and is threatened by the A5 road enhancement which is planned to join the A49 at a proposed roundabout to the west.

The site was identified on an aerial photograph as three linear crop-marks. None of these are parallel but all run in a roughly NW-SE direction. Although quantities of Romano-British material had been recovered from the field, notably by local amateurs, the cropmarks themselves were neither diagnostic nor very promising.

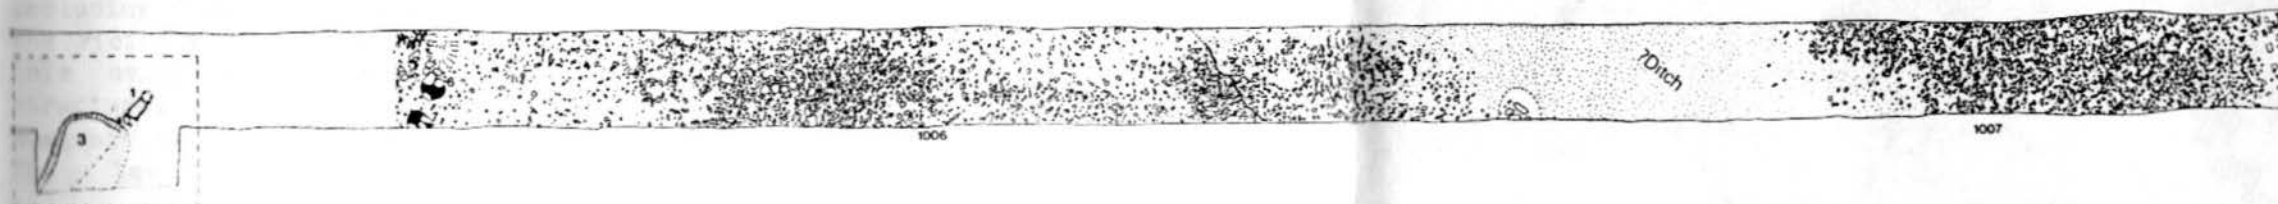
Figure 3 SA.2 trench plan

As part of the A5 evaluation, two 1.5 metre wide trenches were excavated along the proposed line of the road where it crossed the two northernmost linear features. Intensive cleaning of trench A revealed a complex sequence of deposits and features (Fig 3). At the eastern end of trench A a series of well preserved laid surfaces was recorded. These were made of compacted

and worn pebbles with small quantities of Romano-British pottery and tile trodden into their surfaces. At least two periods of surfacing were evident, and the earlier surfaces [1007] were either cut by, or respected an unexcavated linear feature which may have been a ditch. Further to the west, there was some evidence that building traces may have survived on top of the later surface [1006].

Cleaning of trench B revealed a zone of the natural which had been worn, with possible wheel ruts still definable, and patched with cobbling. No negative features were identified. In trench A, to the west of these surfaces a series of substantial post-holes cut into the gravelly clay natural. Two of these [F.6/7] probably formed part of a building and were well preserved, with sandstone post-packing in situ. F.6 had a large pad stone in the bottom. Various ill-defined scoops and patches of clay in the area may have belonged to the same structure. The two remaining post-holes were very large, deep and circular features, one with a massive post pad in the bottom. Although very widely spaced, these features were so similar both in shape and depth, that it seems likely that they also belong to a large structure. Between them was a spread of very worn pebbles and sandstone rubble, with a small fragment of plaster in situ.

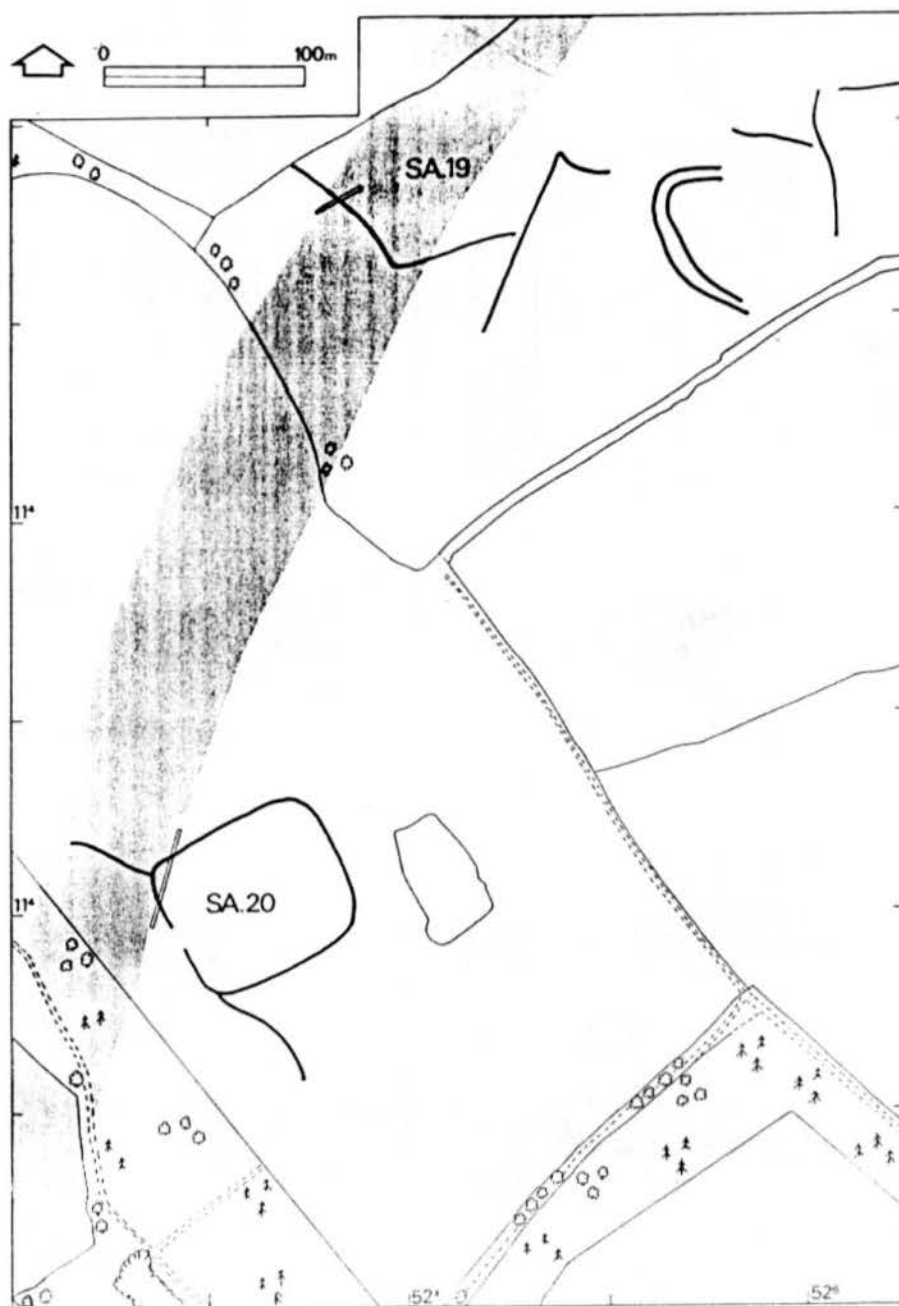
Figure 4 SA.19 and
 SA.20 location map

A series of cropmarks in the field to the west of Preston Fm. The only threatened feature is a linear outlier, presumably part of a field system.

Cropmark of a large rectilinear, round-cornered enclosure with an entrance on the SW side and two intersecting 'wing' ditches. Only the northern edge of the enclosure is threatened by the road scheme.

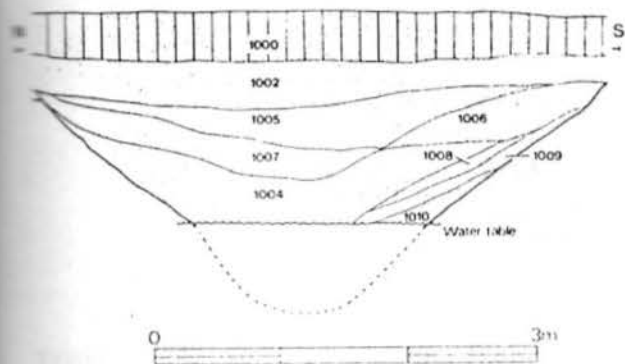
Figure 6 SA.20 ditch F.2 north-facing section.

Several sherds of prehistoric pottery were recovered from the fills of the enclosure ditch, as well as fragments of slag (Table 2). The identification of the single, very small fragment of Romano-British pottery from the ditch is uncertain.

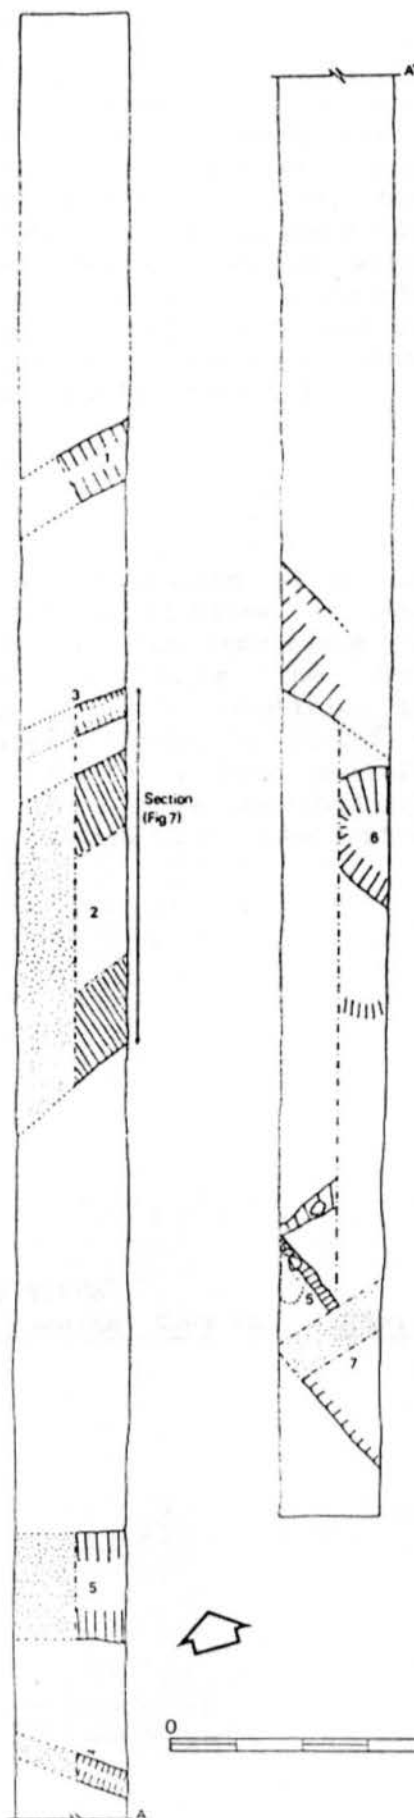
Figure 5 SA.20 trench plan (stipple represents unexcavated features)

A machine was used to remove the topsoil from a 50 metre long trench positioned across the northern corner of the enclosure. The natural was a bright orange sandy gravel and feature definition was reasonable. The enclosure ditch [F.2] was successfully identified and partly excavated on the eastern side. This feature was c.4m wide and at least 2m deep with a complex sequence of silty gravel fills (Fig.6). Two shallow gullies ran parallel to its outside (N) edge. The nearest [F.3] may have been cut by the enclosure ditch. Further small linear features were excavated within the enclosure but no structural evidence was recovered. The definition of the southern enclosure ditch was more difficult and not satisfactorily resolved. There were linear features and hints of edges at the southern end of the trench but none resembled the excavated ditch to the north.

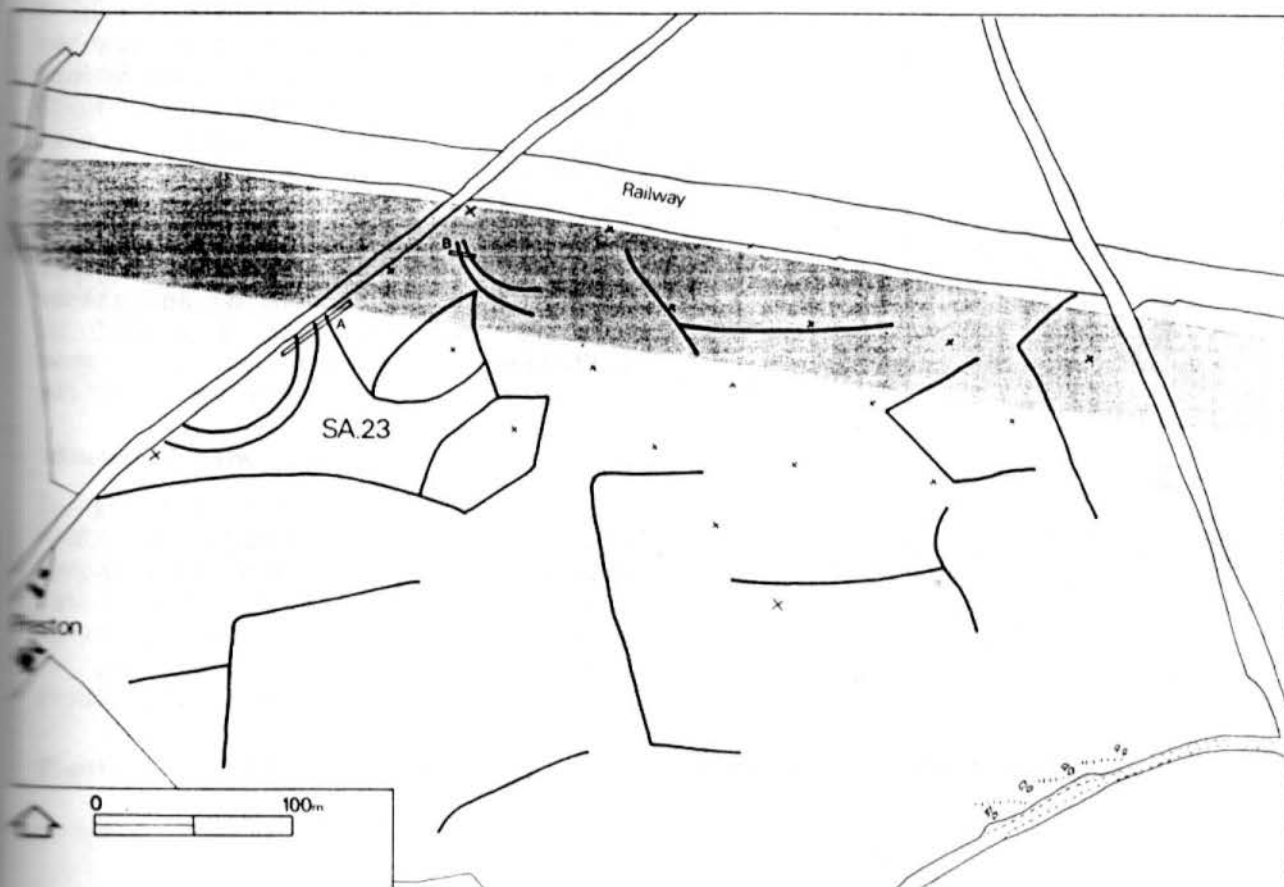
Figure 7 SA.23a/b location map

A complex and extensive group of cropmarks in a field to the east of Preston Farm. Most are fragmentary linear features, possibly field boundaries. Some are irregular enough to suggest a geological origin. The proposed line of the A5 enhancement runs parallel to the railway at this point, and in fact misses the most coherent feature, a double ring-ditch. However, the ring-ditch is bisected by the road to Preston Farm and presumably continues into the field to the north, where it may be disturbed by the roadworks.

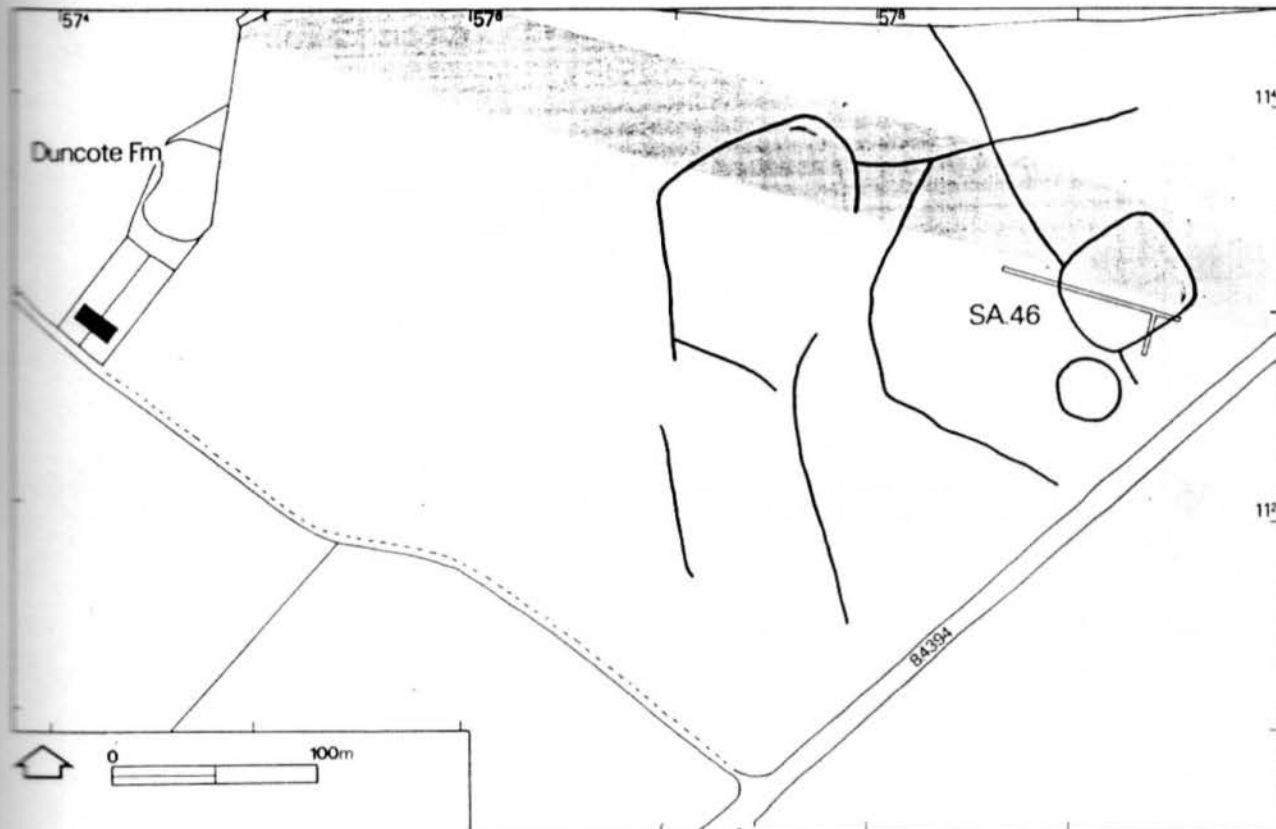
Figure 10 SA.46 location map

A complex series of cropmarks lying in a field to the west of Duncote Fm. They comprise a large rounded rectilinear enclosure, an associated possible field system to the west and a small ring-ditch to the south. The site lies on gently undulating ground levelling out to the south, the enclosure occupying the side and top of an area of slightly higher ground. About half the enclosure and a large area of field system is threatened by the A5 enhancement. The ring-ditch is not directly threatened.

Magnetometer survey revealed the enclosure ditch and the ditch which crosses it. No distinction was obvious between the interior and exterior of the enclosure and no strong evidence for internal features was apparent. The survey revealed that the site is actually c.10 metres to the north of its aerial photograph plot.

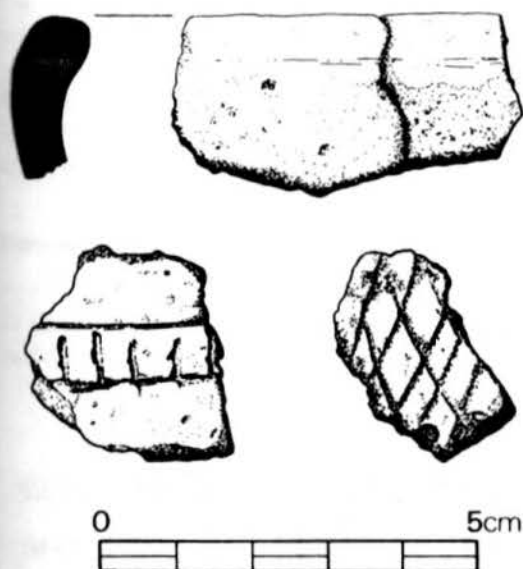
Figure 12 SA.46 Prehistoric pottery (F.4)

Two sherds of decorated prehistoric pottery were recovered from a shallow gully (F.4, Fig 12). A total of 7.799Kg of pottery was recovered from the site as a whole (Table 3). Most assemblages were unremarkable groups of Romano-British wares. However, those assemblages recovered from the ditch sections were not only fairly large but also contained waster material.

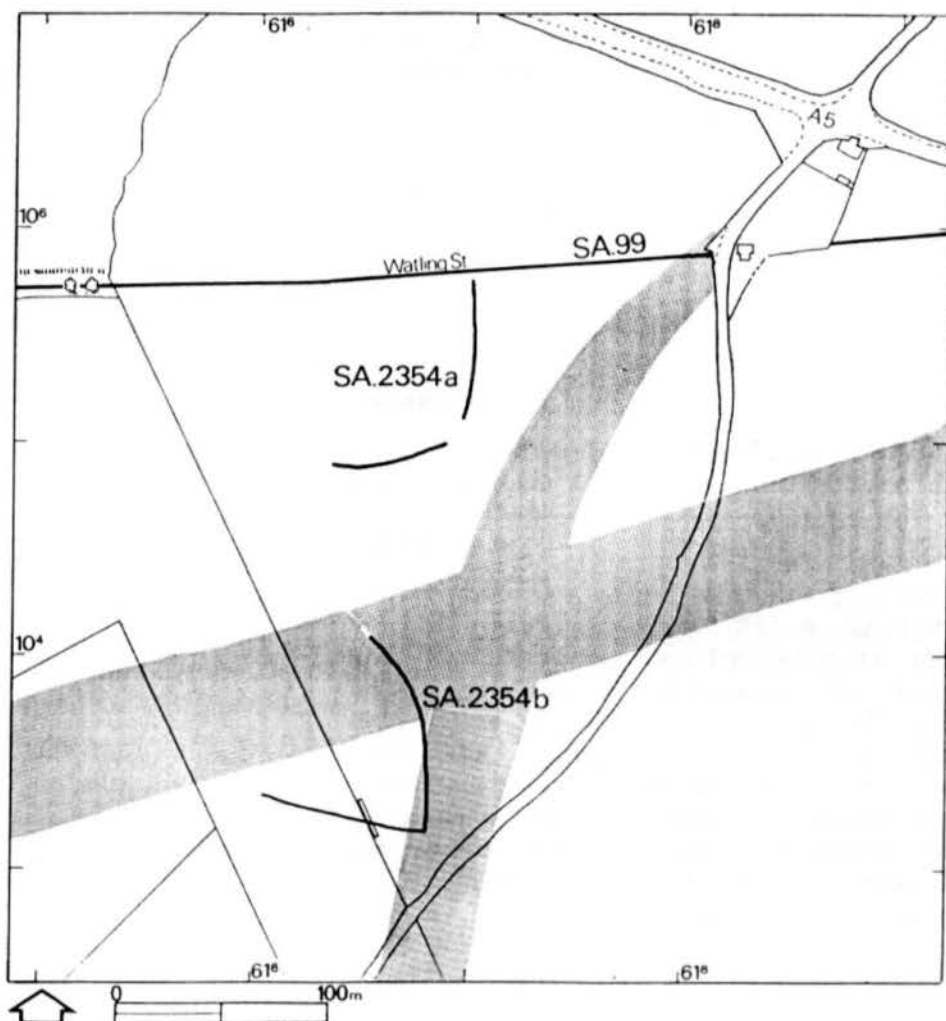
Figure 13
 SA.2354 location map

A series of cropmarks to the south of the present A5. Watling Street (SA 99) runs east-west across the field, apparently cutting a possible enclosure (SA.2354a). Further to the south, on the field boundary is another possible enclosure ditch. The plotting of both cropmarks from aerial photographs is of uncertain value. The shape of the southern 'enclosure' is not convincing and it is possible that undulation shadows were plotted.

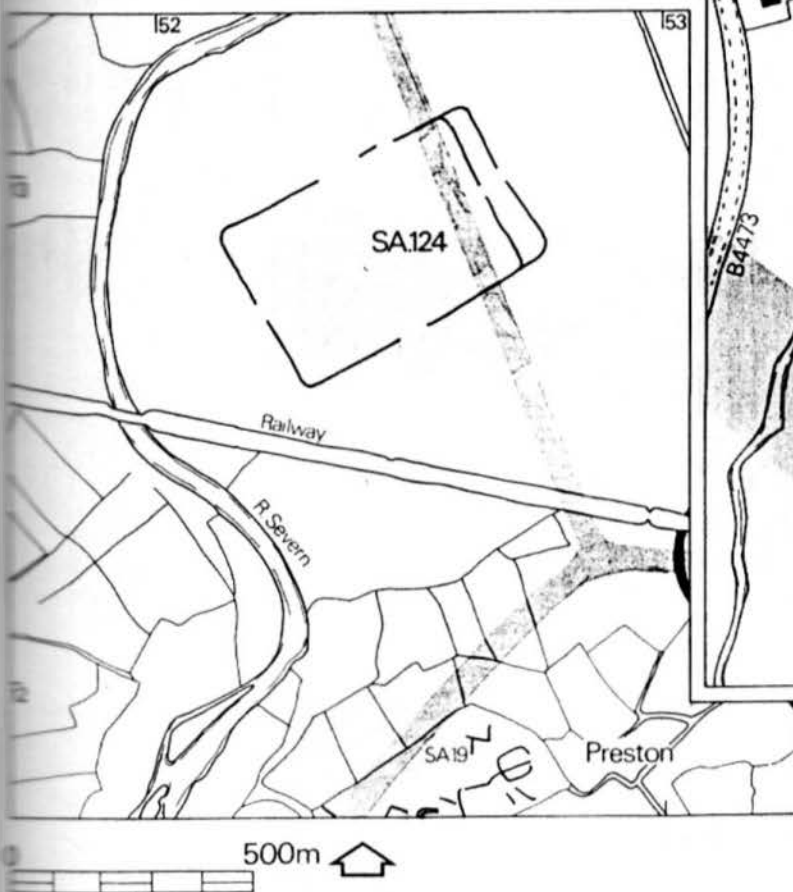
Figure 14 SA.124 location plan

Cropmarks of a large single-ditched Roman marching camp with an annexe on its east side. The whole encloses some 50 acres. The proposed by-pass route will cut a 30 x 350m swathe through the camp, including sections of its north-west and south-east defences.

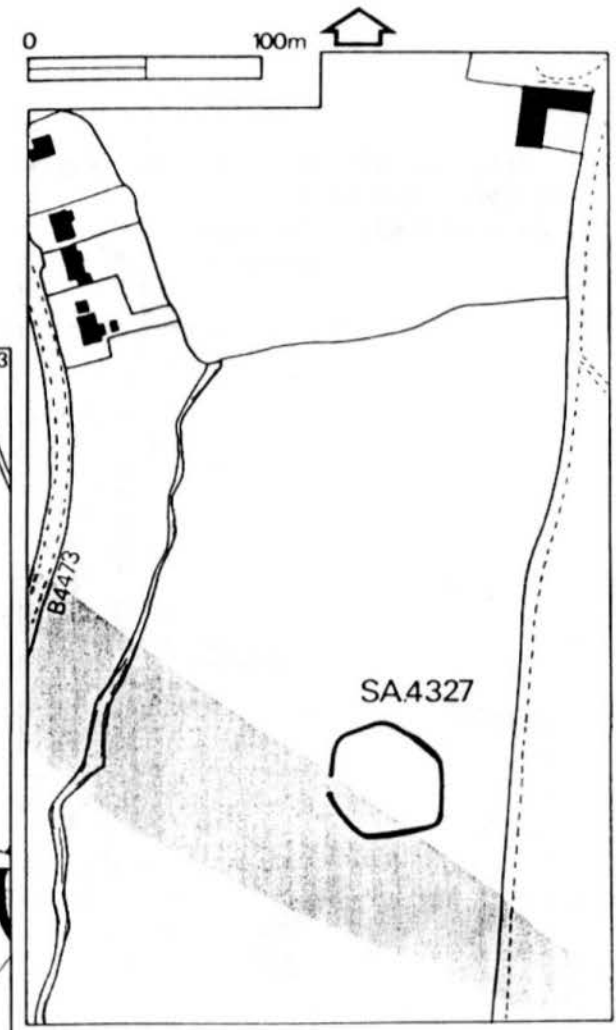
Figure 15 SA.4237 location map

An irregular single-ditched enclosure cropmark, with a possible entrance on its west side. the southern half of the site will be affected by the by-pass route.

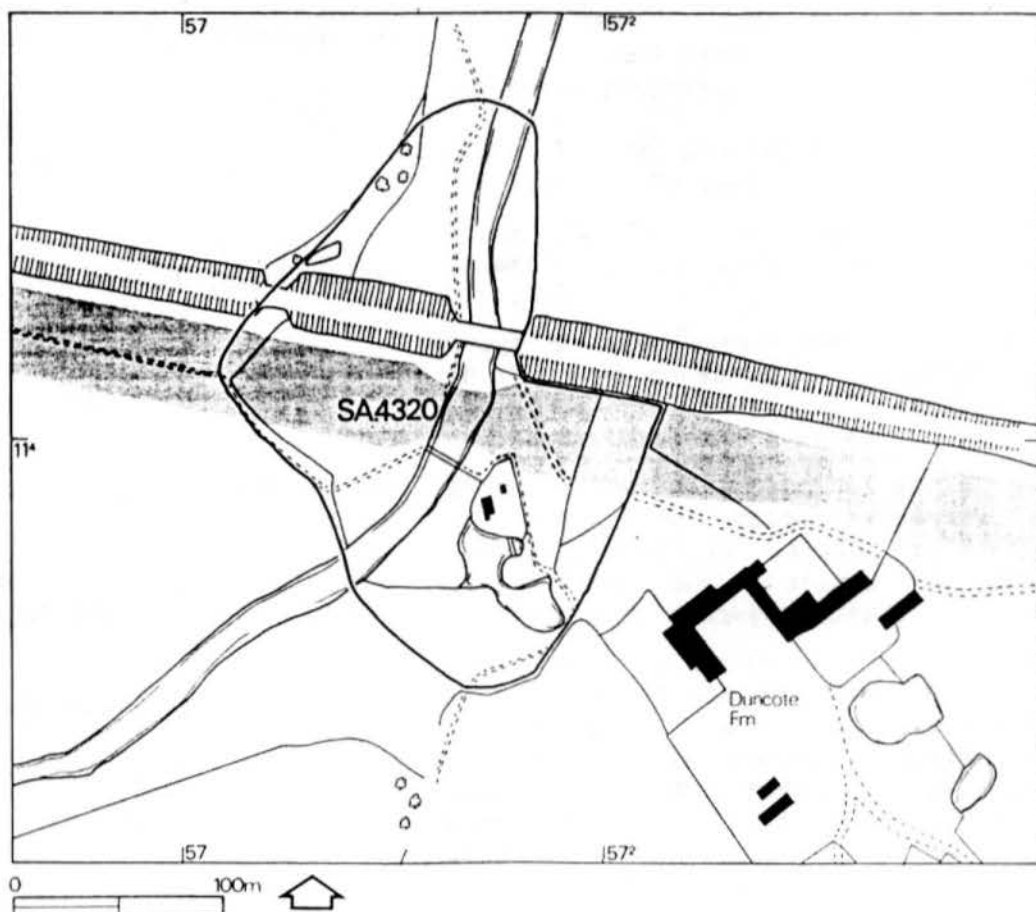
A postulated 17th/18th century iron working site. Substantial amounts of bloomery waste have been dredged from the R. Tern at Duncote Fm, suggesting the former existence of an iron working site, either on the site of, or in the immediate vicinity of, Duncote Mill.

Figure 16 SA.4320 location plan. The solid line surrounds the area of archaeological interest
