WALL TOWN
CAMP
Shropshire

Monument Survey 1989

WALLTOWN ROMAN FORT, CLEOBURY MORTIMER, SHROPSHIRE
(N.G.R. O.S. 69257830)

Monument Survey Report 1989

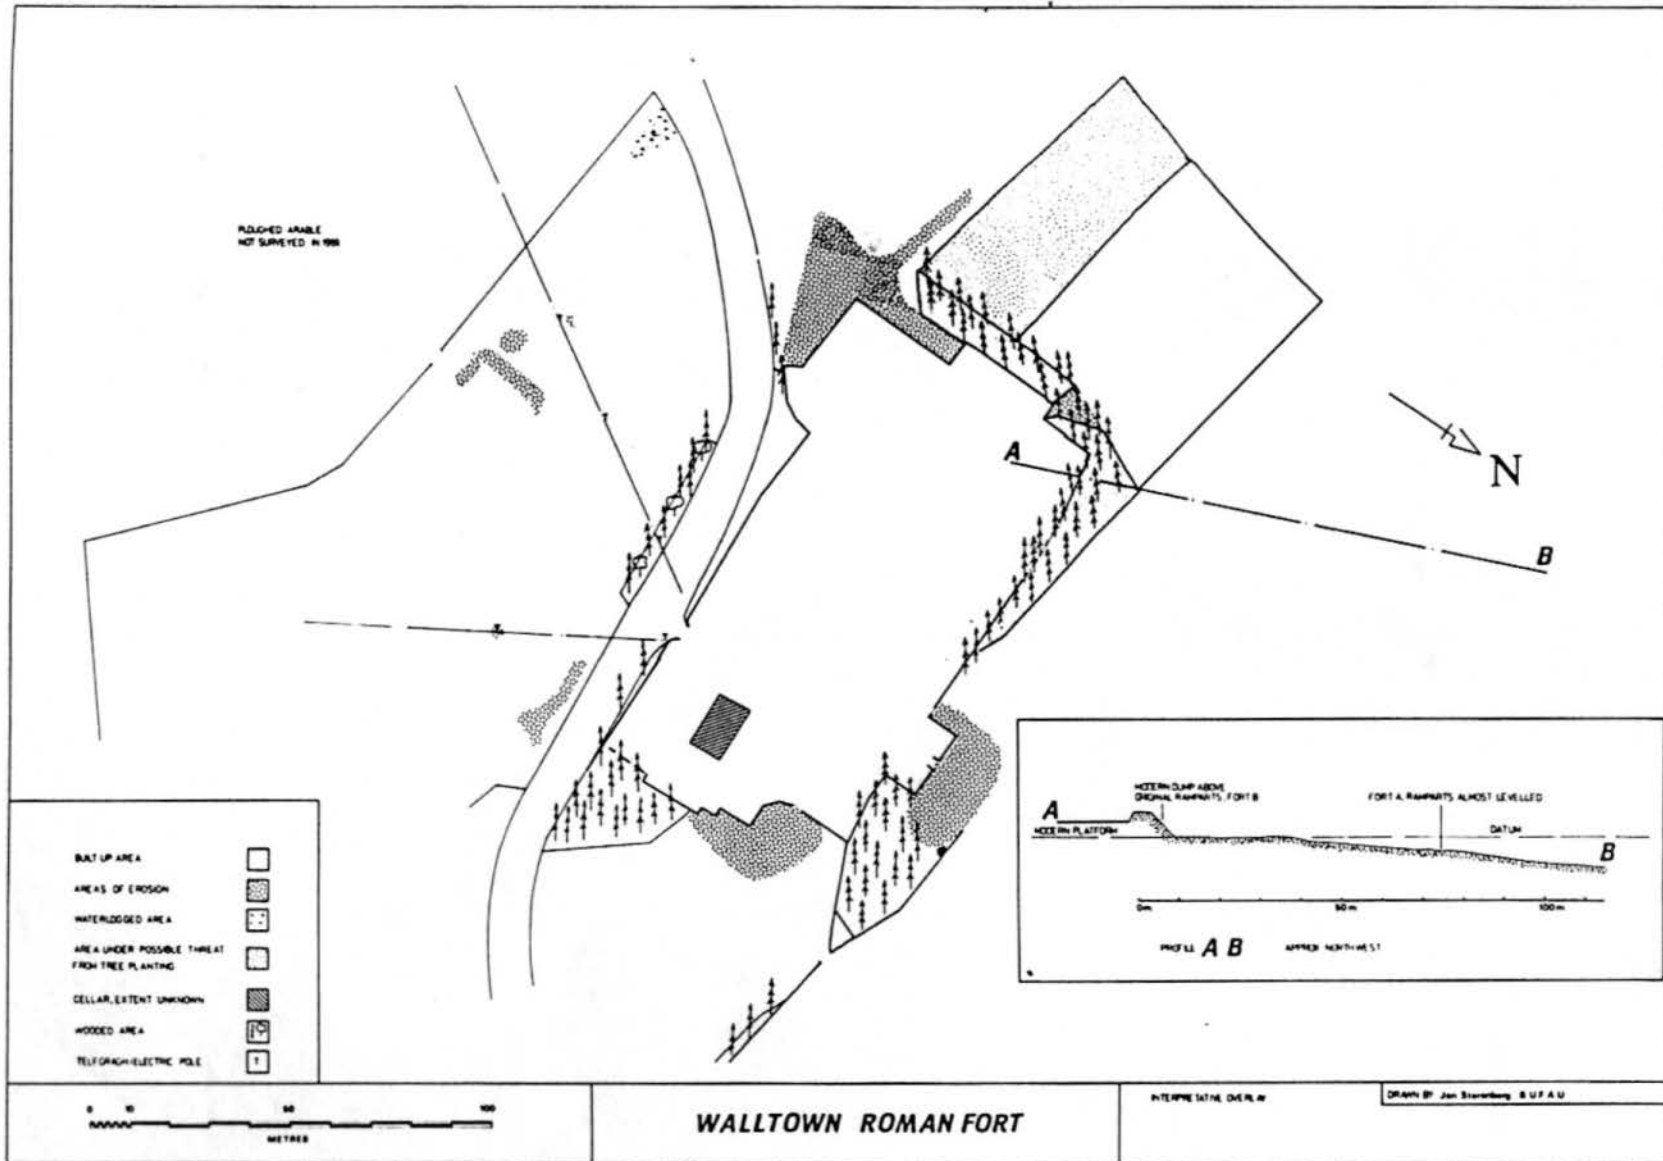
MODERN STAKING STRUCTURES
SCHEDULED AREA BOUNDARY (APPROX)

SURVEY STATIONS SHOWN AS \triangle STN

SPOT HEIGHTS SHOWN AS \square

SITE BENCHMARK SITUATED WEST OF STATION 16 ON EASTERN EDGE OF BARN WALL
