Project No. 94/04

June 1997

BANBURY TOWN CENTRE REDEVELOPMENT

**An investigative appraisal of the standing buildings
in the Bridge Street and Mill Lane (Zone 2)
urban landscape**

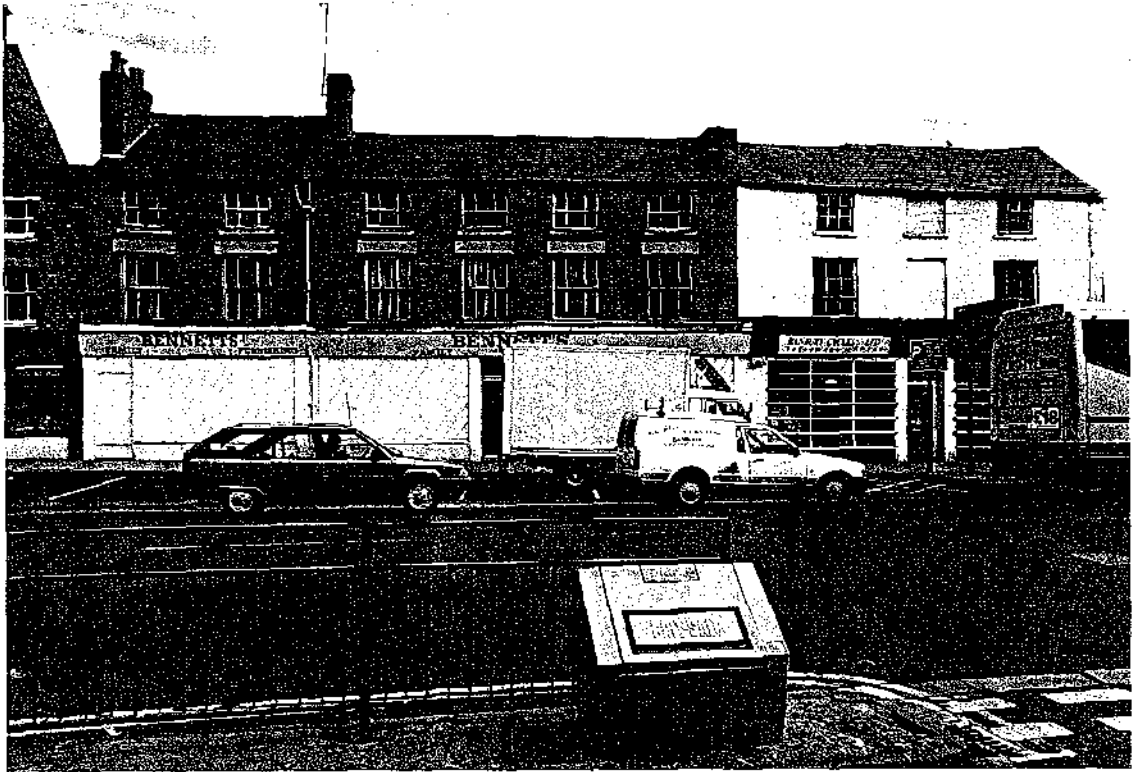
Plate 8

Two bay, three-storey building of Flemish bond clamped brick with slate saddleback roof. Modern shopfront obscures 1st floor window sills, heavy flat stone heads, six-light recessed sashes on each floor, projecting stone sill to squat 2nd floor attic windows. Stylistically similar to Structure G1 to east, but taller and clearly later, the construction break hidden behind a drain pipe between both properties. Two-room-deep plan, three storeys to rear in English Garden Wall bond of four stretcher courses. Victorian sash windows, those lighting the rear staircase with semi-circular arched heads and blue engineering brick sills, 2nd floor arched window has stained glass.

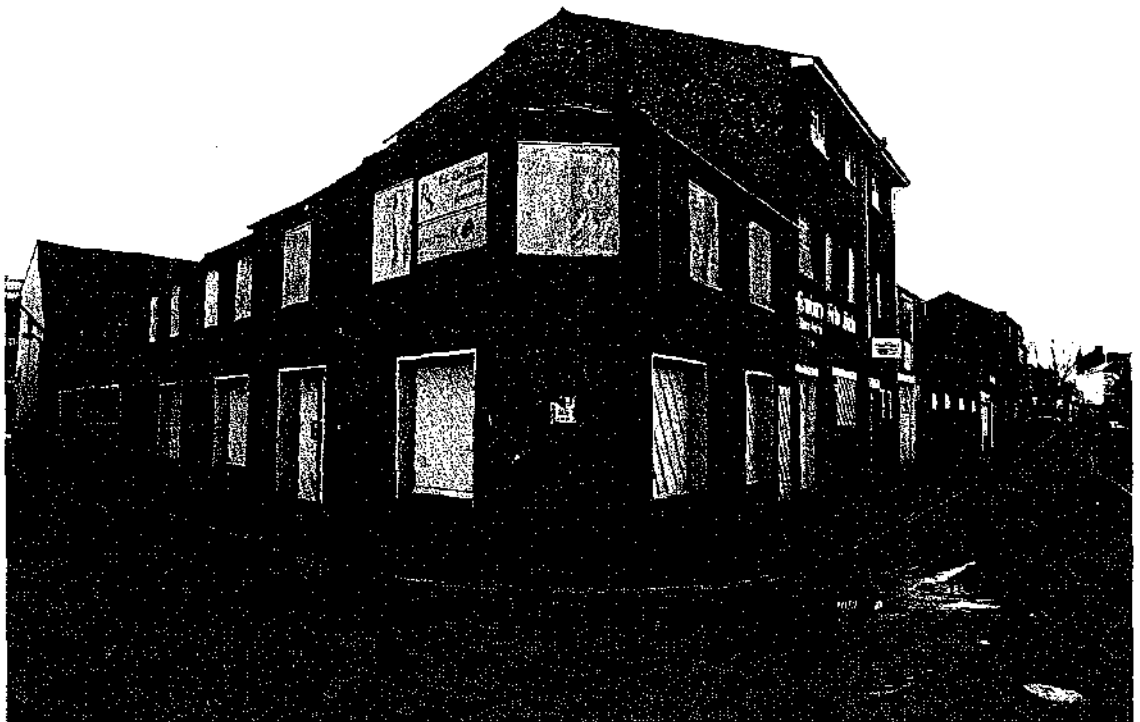
Plate 9

Structure J: 3 Mill Lane, the former 'Struggler' inn, built c.1837 (Plates 9 and 10).

The building at the corner of Mill Lane and Mill Street was once the notorious 'Struggler' canal-side inn. The building was extensively refurbished in the late-1970s after being derelict for a number of years, therefore only a limited amount of information was retrievable from an inspection of the fabric alone. All ground floor openings are later additions through the original clamped brick (8.5" by 4" by 2.5") in English Garden Wall bond. A number of former doorways and windows can be made out particularly at ground floor level by areas of less polluted brickwork, these can be seen on a photograph of the derelict building taken in 1975 (Plate 10; OCL 75/4316). There was an angled corner entrance, with further entrances in each side possibly into a series of snug rooms. The 1st floor storey window heads are flat with cut soldier brick voussoirs, although originally of five flat voussoir stones modelled in stucco. A test-pit excavated inside the corner of the building found evidence of the infilled cellar. The extension on Mill Street can be clearly seen by the change in roofline. This extension is built in machine-cut brick and dates from between c. 1850 and 1882.

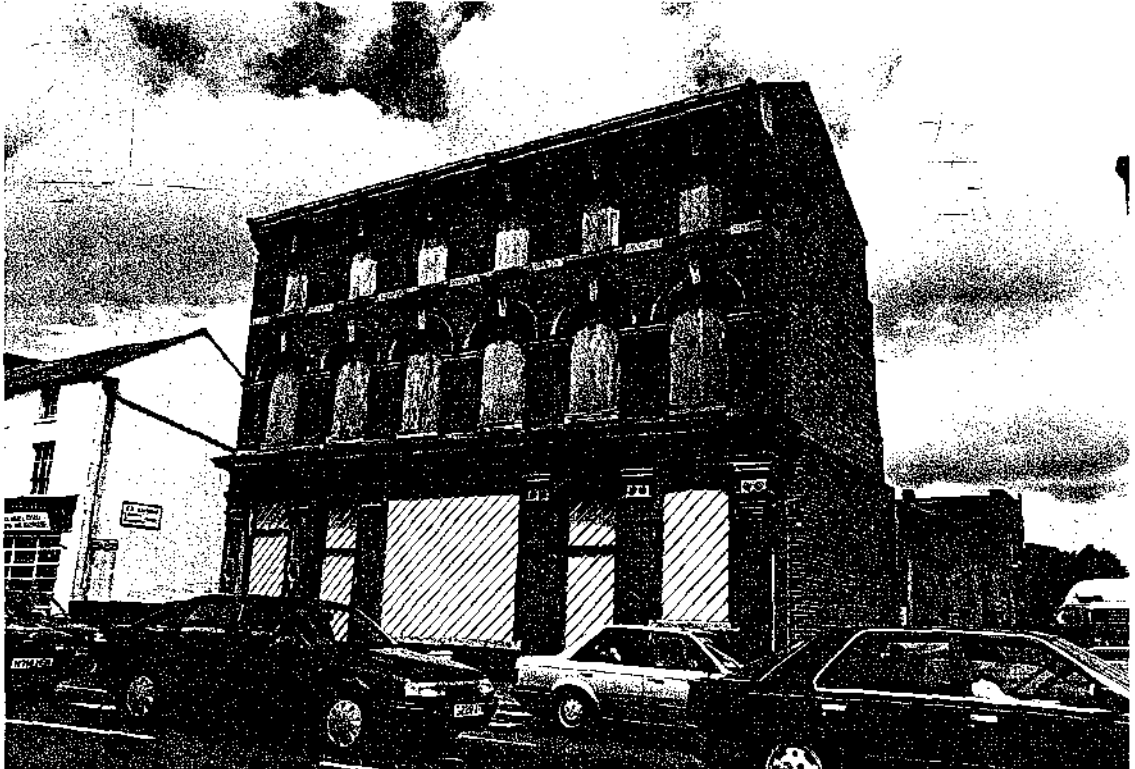
Plate 11

Structure I: 56 Bridge Street, the former Temperance Hall (Plates 11 and 12).

*Tall three-storey structure with slate saddleback roof and six bay frontage constructed in finely finished buff red machine-cut bricks (9" by 4.25" by 3.25") in Flemish bond. Other elevations use cheaper machine-bricks (8.75" by 4.25" by 2.75") mainly in English bond. Ground-floor frontage largely intact, four course high black brick plinth with chamfered upper course, two door entrance on west side with large two-bay wide central window, possibly a later addition and single doorway and window to east. Westernmost doorway most highly decorated with stone pillars on each side with simple plinth, rebated panels to column, simple architrave, and three rose motif on frieze. Stone plinth, architrave, frieze with projecting brick columns around other ground-floor openings which have segmental heads of finely decorated gauged brick voussoirs. Massive continuous cornice to first floor with series of semi-circular arched deeply recessed windows with stone keystone and moulding above decorated gauged brick voussoirs. Each arch is sprung from a brick column with projecting decoration in brick and stone detail. The 2nd floor windows are simpler and smaller with double recessed segmented arches and openings in brick above a continuous stone stringcourse, the window picked out by projecting stone sills and keystones. Heavy moulded stone pediment and moulded gutter above supported on seven sets of three moulded braces which further define the bays of the building. Blind gables to each side with longer fall to rear roof. Roof-line scar belonging to a demolished building on eastern gable, western gable to Mill Lane has an advert for Hot and Cold Baths painted on to the brickwork and a course of dog-tooth decoration between two slightly projecting courses of brick which define the floor levels of the building. At ground level, and set back slightly from the street frontage, is a carved Ordnance Survey datum. To the rear of the main building is a large centrally positioned chimney stack which would have served all floors of the main building and parts of demolished rear wing. Again the scar of this wing can be discerned together with access points between each building. Closer inspection of the building was not possible at this stage because of severe pigeon infestation and the gutting of the staircases and some of the floors inside. A former tenant reported that the baths and boiler advertised on the gable end of the building were still *in situ* in a flooded cellar under the main building; however, no trace of an entrance could be found at this stage. The flat-roofed former Cadbury Hall extension behind Structure I was also unavailable for inspection.*

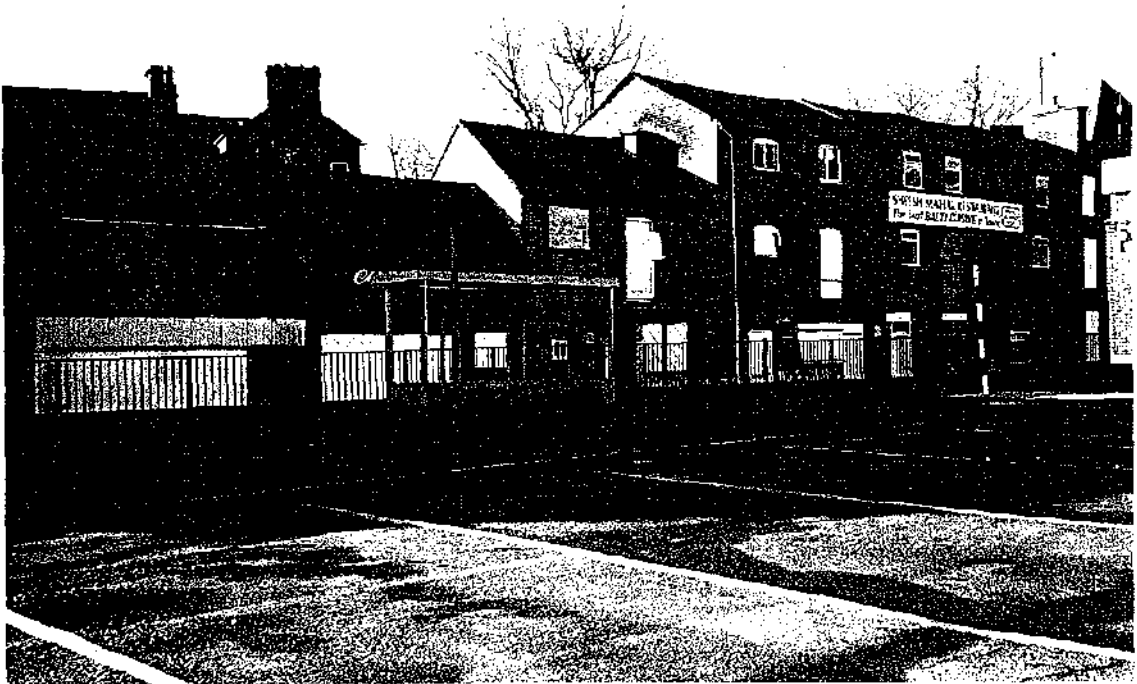
Plate 14

Structure L, behind 46/47 Bridge Street (Plate 14).

Three storey warehouse of two bay width with slate saddleback roof. Cart entrance on west side with lintel over and 1st floor loading door. Inserted ground floor door to east of cart entrance with original small window above on 1st and 2nd floors. Slightly longer window above 1st floor loading door. Windows and doorways of similar style to that described for building above. Internally, the building has been converted into a flat on the 1st and 2nd floors with narrow inserted staircase giving access to/off Mill Lane. The alterations are consistent with the conversion of Structures D1 and D2 into the winebar.

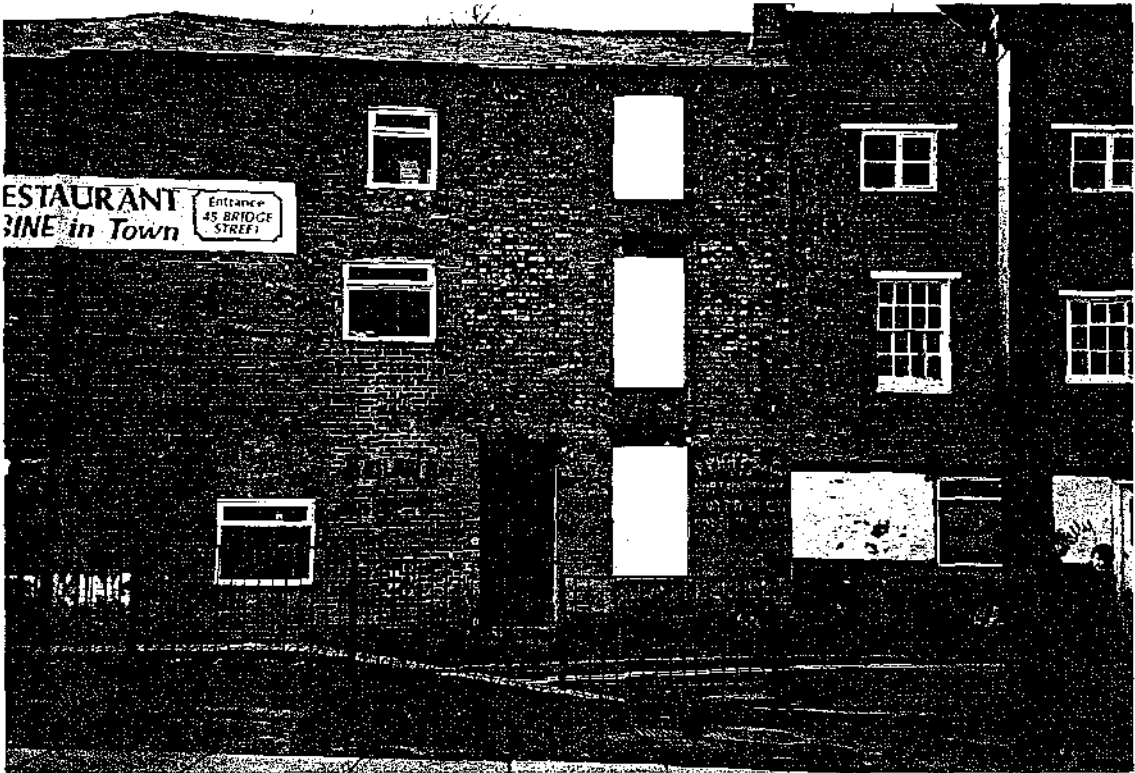
Plate 16

Structure M: including 5 Mill Lane, probably the former 'Jolly Waterman' inn (Plate 16).

Three storey building with a long frontage of c.10m and continuous slate saddleback roof. The building has been subdivided and knocked through with the rear of the Indian restaurant on one side, and a single bay domestic house, 5 Mill Lane, the other. However, the roof and continuous build of the frontage in Flemish bond clamped red brick attest to the singular construction of this building, as does a blocked doorway between both properties inside the front door to 5 Mill Lane. Externally, the frontage of 5 Mill Lane is best preserved, the original windows and doorway intact. The ground floor entrance and window together with the 1st floor window have flat heads of Roman cement divided into five voussoirs with a raised keystone. Two painted adverts for Northampton ale flank the ground floor window. The exterior of the east side of the building has been altered, but the arrangement of openings is similar to that of 5 Mill Lane. Internally, the east side of the building was still occupied and severe pigeon infestation limited inspection of 5 Mill Lane. In plan 5 Mill Lane had two rooms to each floor with access from a straight-flighted staircase built against the east wall of the building. The front rooms on each floor were larger and heated. The rear of the building is very cramped overlooking the back of 44 Bridge St. with a small passageway between. There is a cellar under the front room with a large opening off the street which would accommodate a barrel. This cellar entrance, together with the painted hoarding, the absence of a cart entrance and an undated documentary reference to the 'Jolly Waterman' being converted into a slaughter-house and dwelling occupied by William Trolley (Ms.prop.deeds, Raglan) at this end of Mill Lane, point to Structure M once having been the said inn.

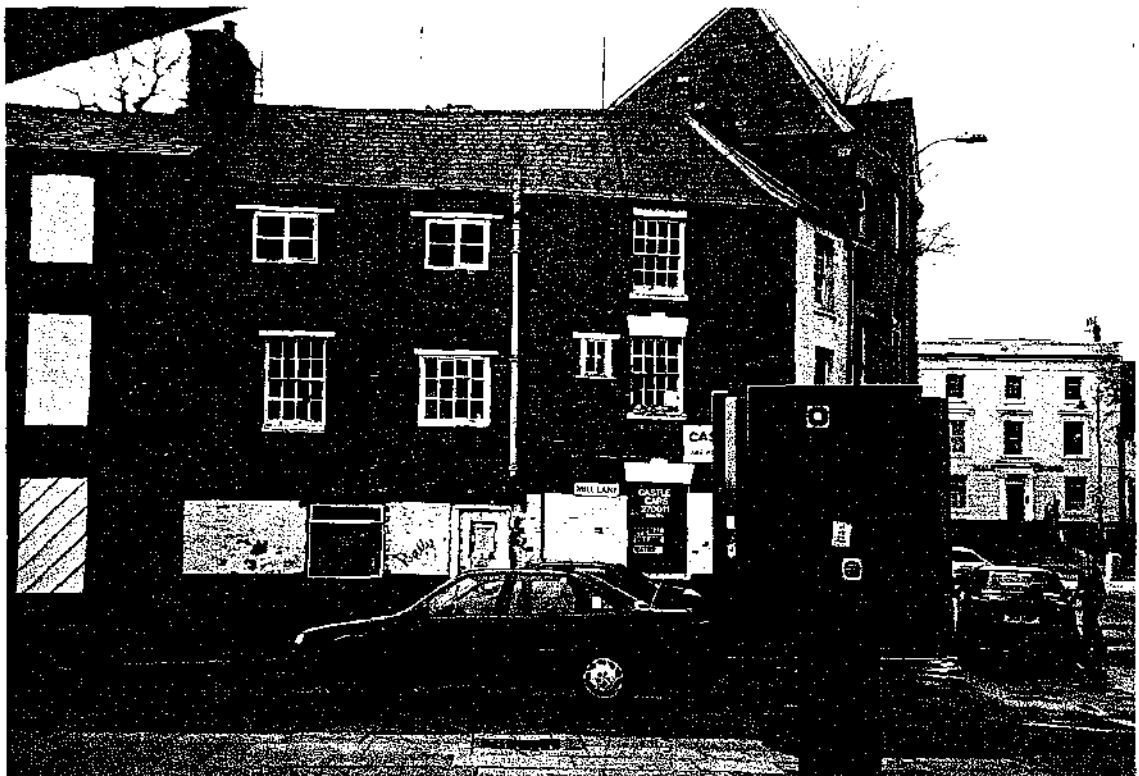
Plate 17

Structure N: 6 Mill Lane, early-19th century industrial building (Plate 17).

Two bay, three-storey structure with slate saddleback roof. Constructed in a variant of Flemish stretcher bond - consisting of a course of alternate double headers and stretchers with five stretcher courses between. The ground floor is relatively low compared to the 1st and 2nd floors which are normal height. There is a continuous lintel at first-floor level, indicative of the former presence of a cart entrance here, possibly with loading door above. The cart entrance has been replaced with a modern centrally-placed window, there is a simple planked-door entrance to the west with a blocked coal chute between, and a small blocked window to the east. The 1st floor windows have small rectangular panes and relatively heavy glazing bars. The east window is larger with 16-lights in a recessed sash. The west window has 12-lights, the central upper pair opening, and the frame is not recessed. There is evidence of blocking above and below the window, which may be the former location of a 1st floor loading door. The 2nd floor windows are shorter with 4-light casements. All windows have wooden lintels and sills. There is a dentilated eaves cornice in brick above.

Structure O: 7 Mill Lane, former Castle Cars taxi company (Plate 17).

Corner building situated at the junction of Mill Lane and Castle Street. Constructed in Flemish bond clamped-brick, three-storey with trapezoid plan. Mill Lane elevation has a Victorian doorway, central 2-light sash and stucco false five voussoir flat head with larger keystone. First and 2nd floor windows have 16-light sashes which resemble the windows in Structure N. First floor central window has stucco head and stone sill. There is a smaller four-light window inserted beside the main window which lights a toilet. The stucco head of the 2nd floor window is partly obscured behind the roof which indicates that the roof has been altered. The Castle Street elevation is narrow (c. 2m in length). There is a Victorian shop front of ceramic brick with a wide window. The 1st floor window has a stucco head and 2-light sash, the 2nd floor window is similar to the 16-light sashes in the Mill Lane elevation.
