A Survey of Lilleshall Abbey, Shropshire

Third Interim Report

Birmingham University Field Archaeology Unit 1990

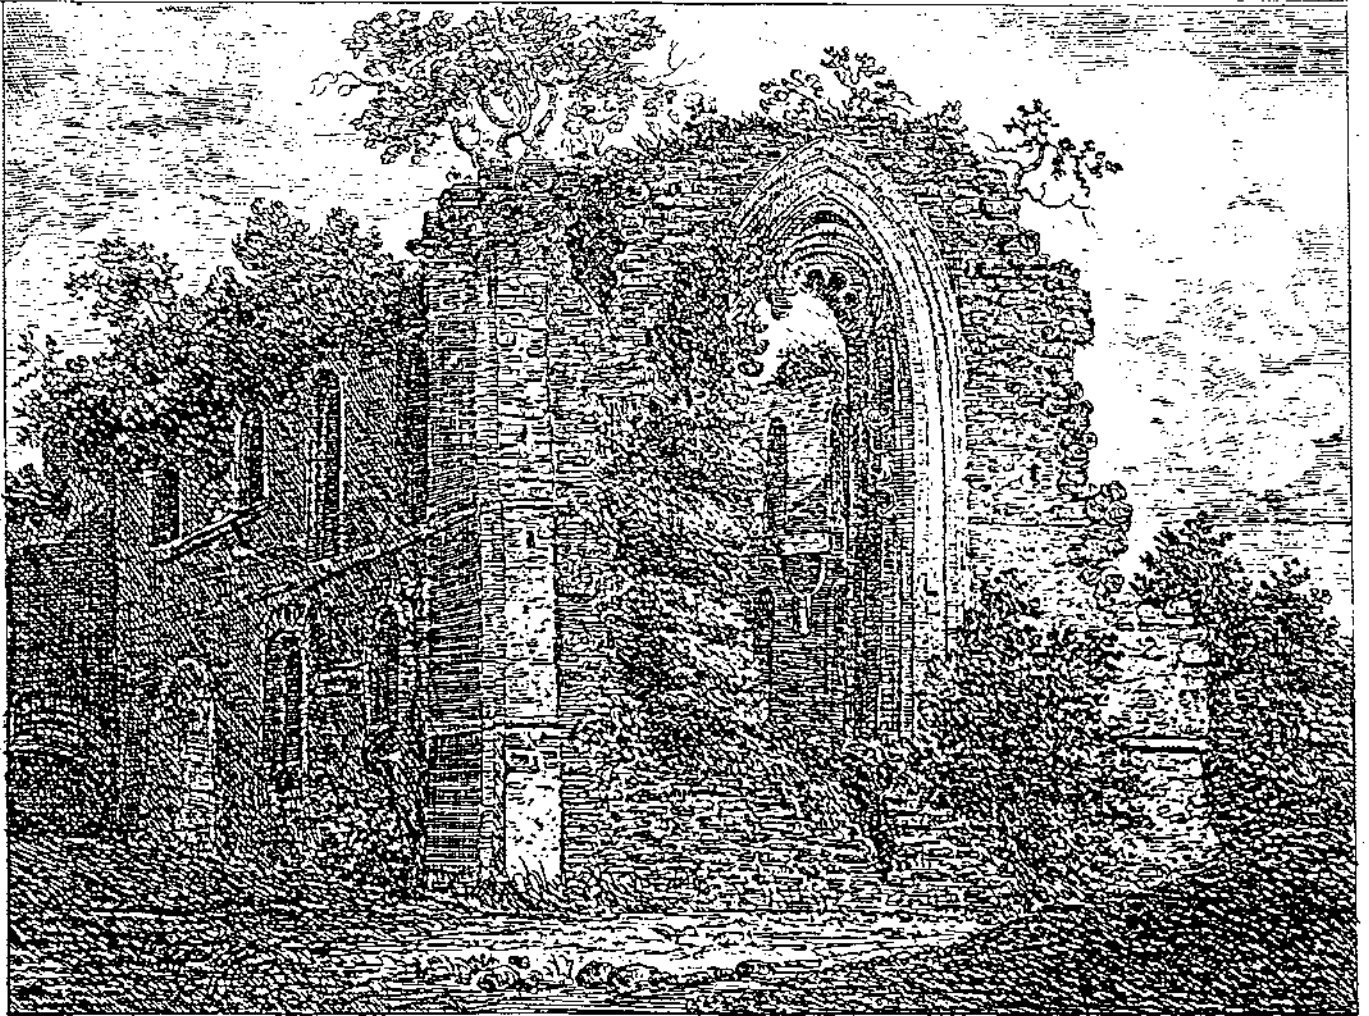
Figure 14 W. Pearson (1807 or 1824)

Figure 14 Another etching by W.Pearson (1807 or 1824). This shows the east window of the church with substantial fragments of the tracery of the great window still in situ.

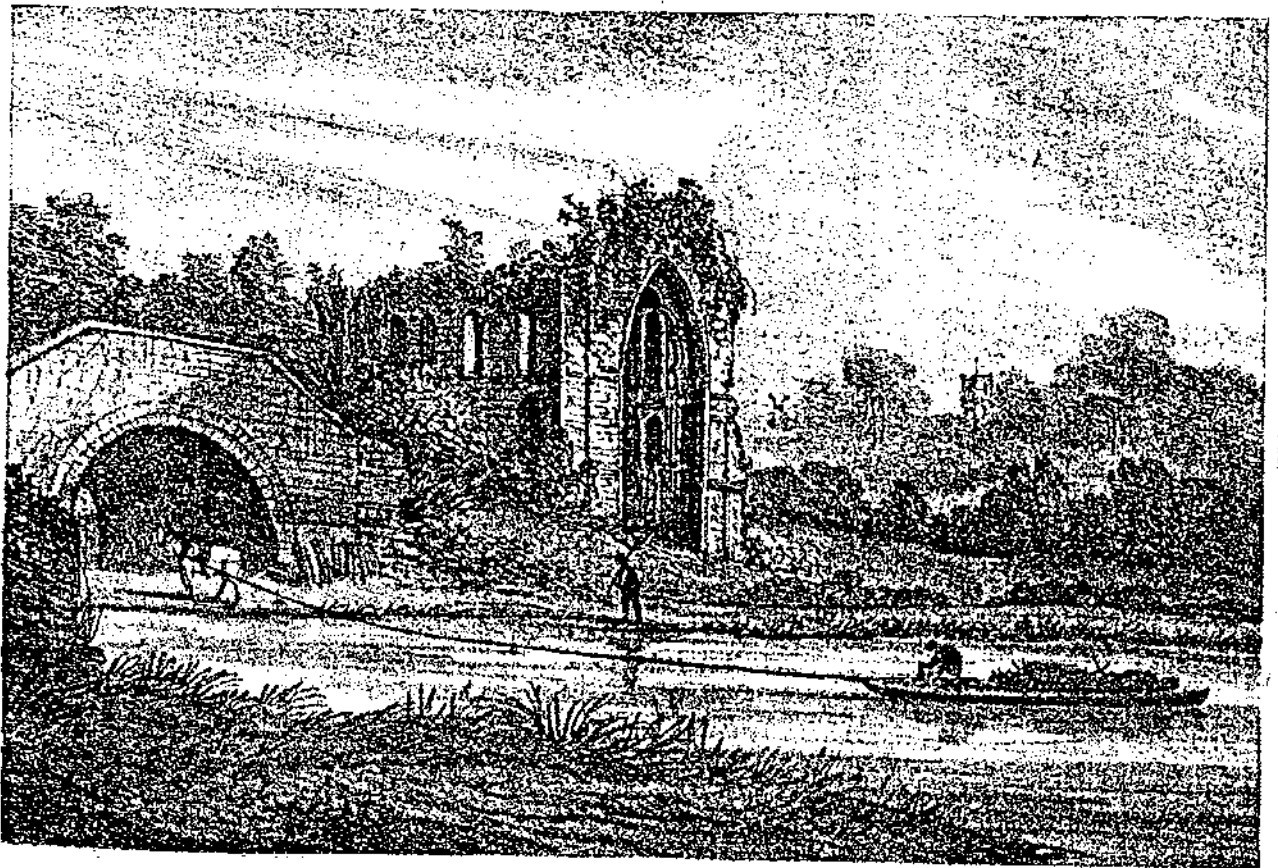
Figure 16 F. Calvert (1822)

Figure 16 Drawn by F.Calvert (1822). This print shows the canal close by the abbey church, with the east window looming in the background. Although the tow-path of the canal appears to be immediately adjacent, the bridge obviously indicates the presence of a road, with which the track through the church may here have converged.

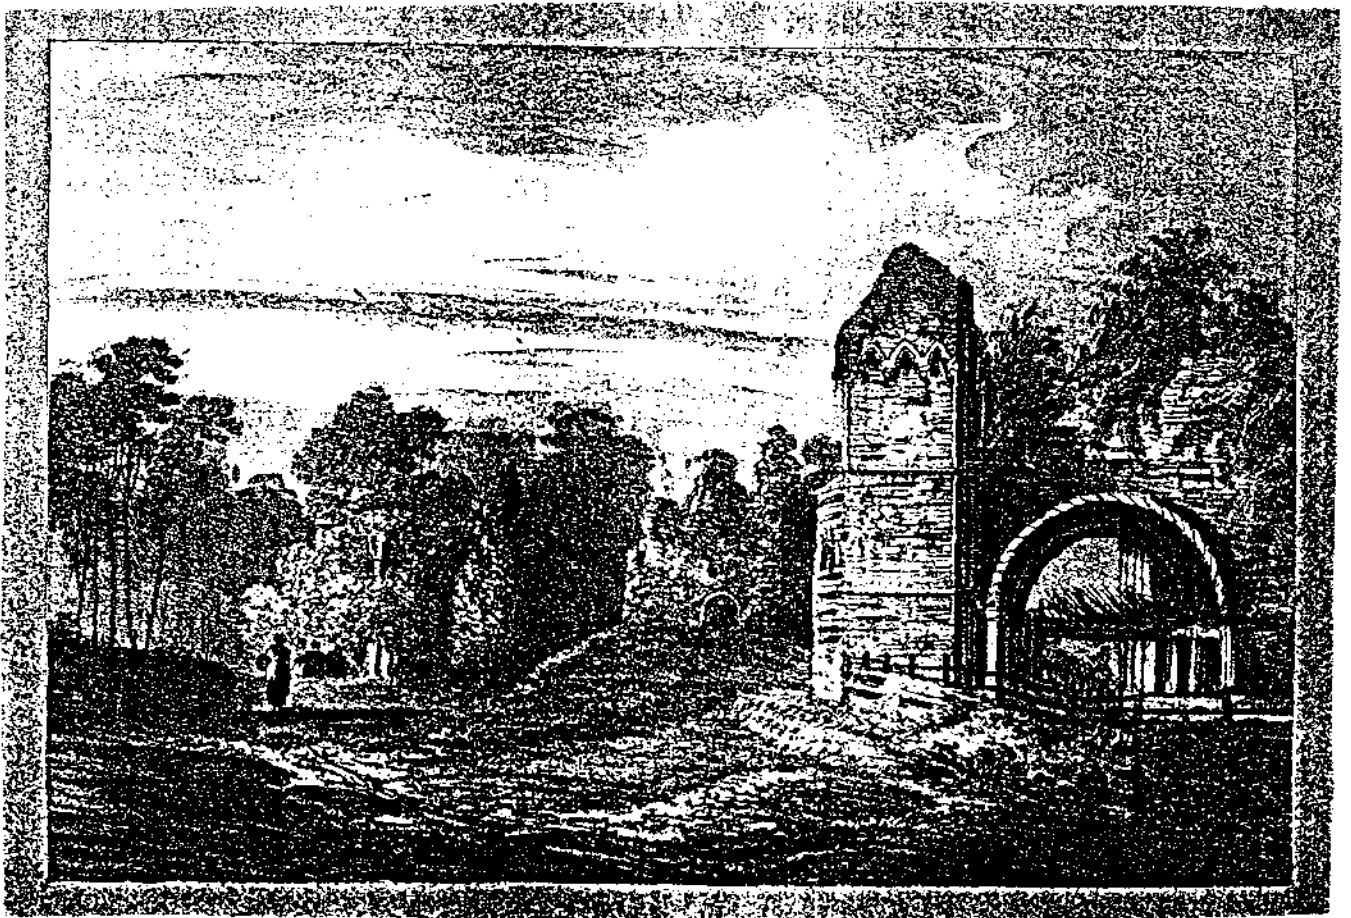
Figure 19 Anon. (no date)

Figure 19 Again not attributable to any artist. This shows the track to the north of the church and the west entrance.
