Birmingham University Field Archaeology Unit

**Report No. 171**

July 1991

**Archaeological Work at Ercall Hall,  
High Ercall, Shropshire in 1991**

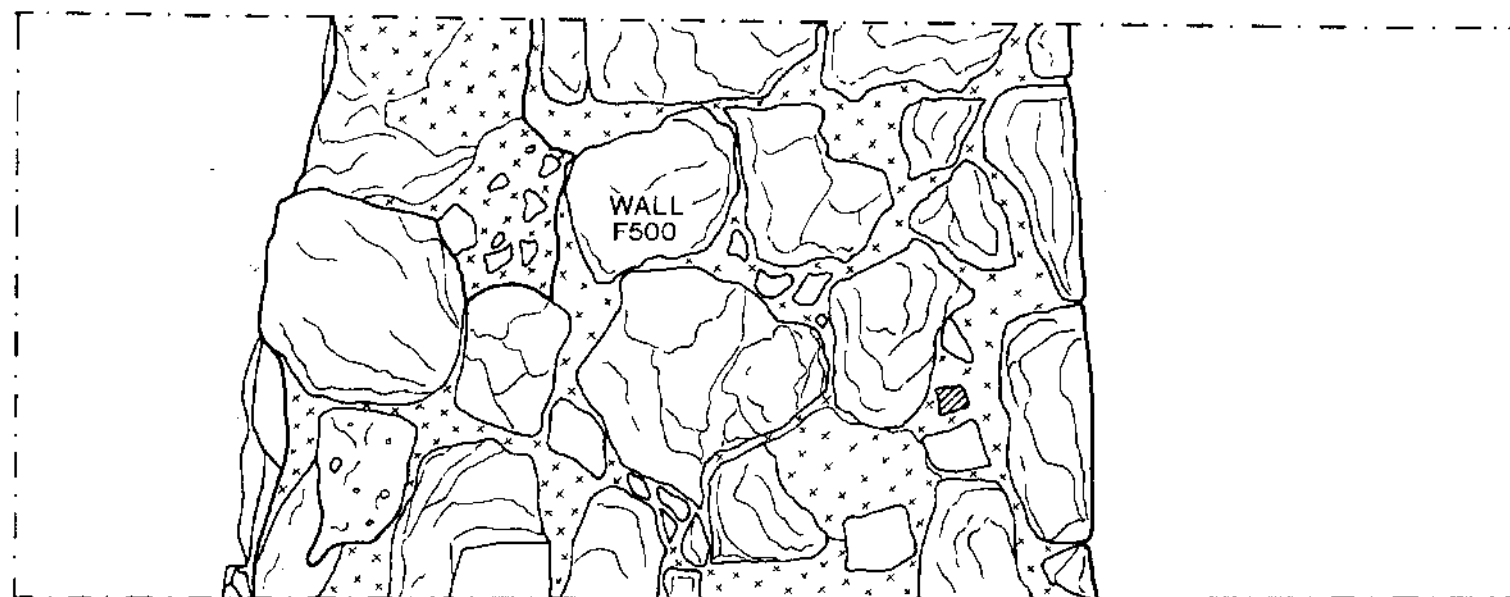
## Trench 5 Plan

#### **Trench 5 (Figure 6)**

Aligned northeast-southwest and measuring 4m x 1.60m, this trench was opened by machine. The topsoil (5000), was c. 0.20m thick and, in the centre of the trench, overlay a 0.30m deep spread of rubble (5001) directly over a c. 2.20m wide wall foundation (F500) constructed of blocks of red sandstone with a mortar bonding (5004). This wall had a good straight face along its northern edge while the southern edge was more irregular, with there being some suggestion that the wall had been widened from an original width of c. 1.40m. To the north of the wall was a spread of builders rubble (5001), very similar to layers 4001 and 4003 in Trench 4, which was removed to a depth of 0.30m, but not bottomed, to expose the wall face. To the south of wall F500, and butting up against the wall face, was a layer of brown silty sand with charcoal and mortar flecks (5002), containing a sherd of later medieval pottery; again, this deposit was not fully excavated but lowered c. 0.25–0.30m to expose the southern wall face.
