Birmingham University Field Archaeology Unit

Project No. 272.1

May 1995

Chester Castle West Range
A description of the demolished buildings

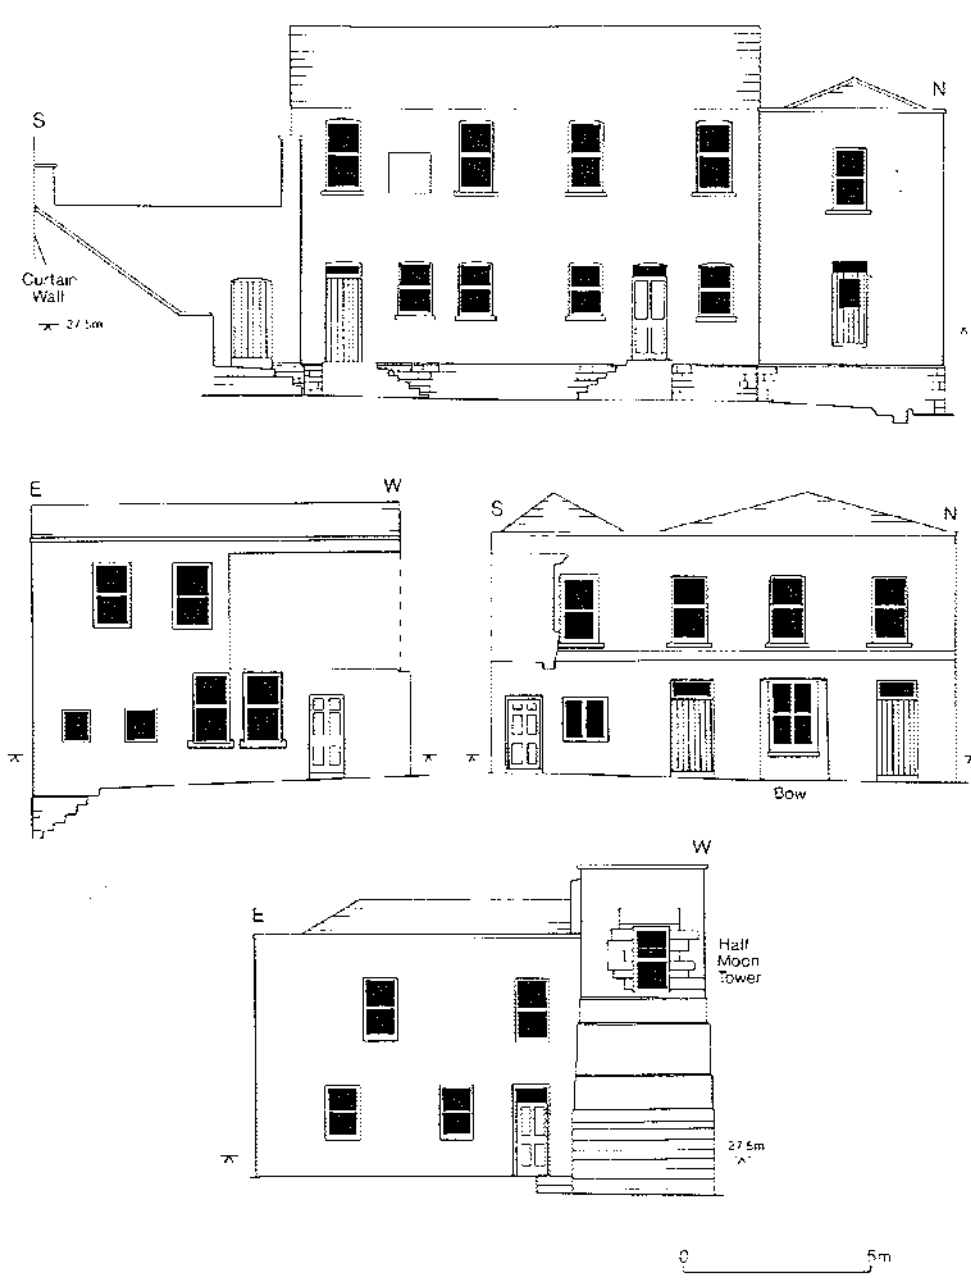
Figure 4

4.3 The plaster face of the east-facing facade of the southern block (Fig 4; Plate 3) was incised to give the effect of painted stone blocks. The central north-south building was set back 1.2m from the east face of the southern and northern additions. The facade was set on a sandstone offset plinth rising 1m above ground level and which still survives. Cuts into either end of the plinth were to accommodate drainpipes. Three flights of steps led to the three entries on the east side. The 12-paned upper and 16-paned lower sash windows of the central block were set beneath slight arches, as were the doors and the door of the southern addition. The window bases were marked by projecting stone sills, and they were protected with bars. A clock face had formerly been set at first floor level. The walls were carried up as parapets above the roof pitch.

4.4 The north-facing facade, similarly of mortar with incised stonework painted white, connected with the central block and with the Old Mint (Plate 4). At first floor level a corridor connected the two blocks. Steps at the east end of the facade brought the ground level above that of the offset plinth. The windows and door lintels were flat. One of the windows was a blocked doorway. The upper windows were sash. The wall rendering showed there had formerly been a lean-to set against it. The wall had an upper stone parapet.

5.1 A 3.5m length of the east facing facade of the northern range was demolished (Fig 4; Plate 1). The plaster and white-painted facade continued northwards as the east face of the retained building - the Old Mint. A horizontal band at first floor level was carried across the facade. The 4-paned sash window rested on a stone sill.

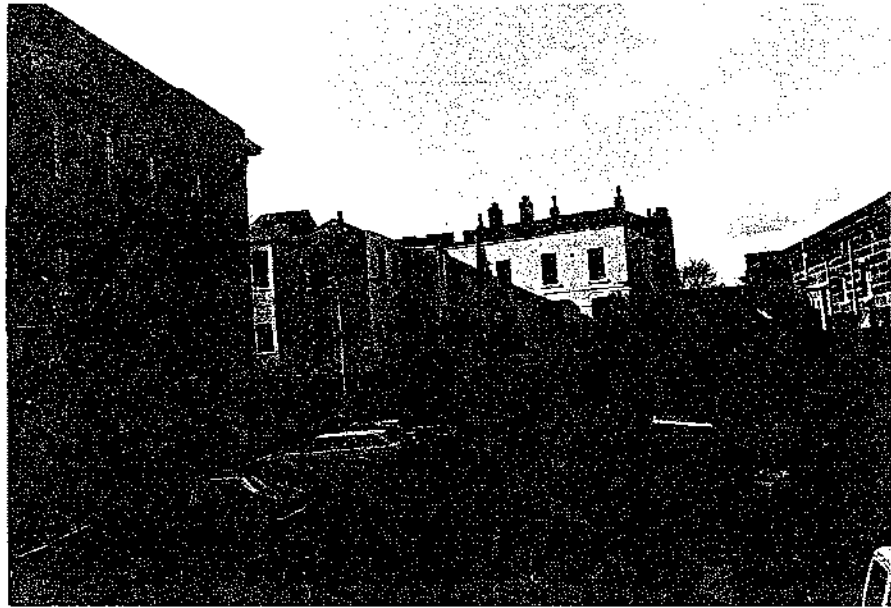
Plate 1
The demolished buildings and retained Mint, view west

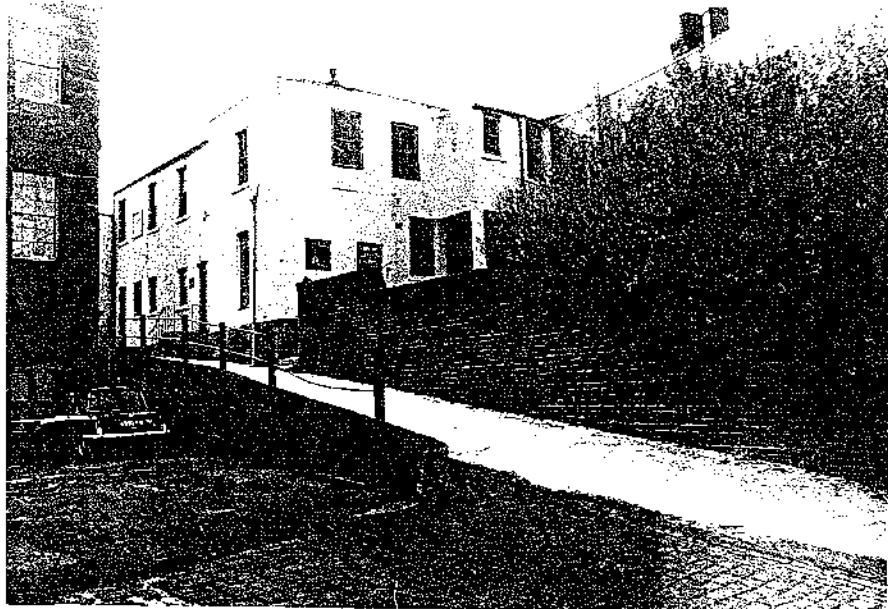
Plate 2
The demolished buildings, view south

4.2 The buildings were of brick covered on the exterior with a whitewashed plaster render (Plates 1-4). Col 17, 18, 36-8, 40, 41, 46. B&W 4.29-37.

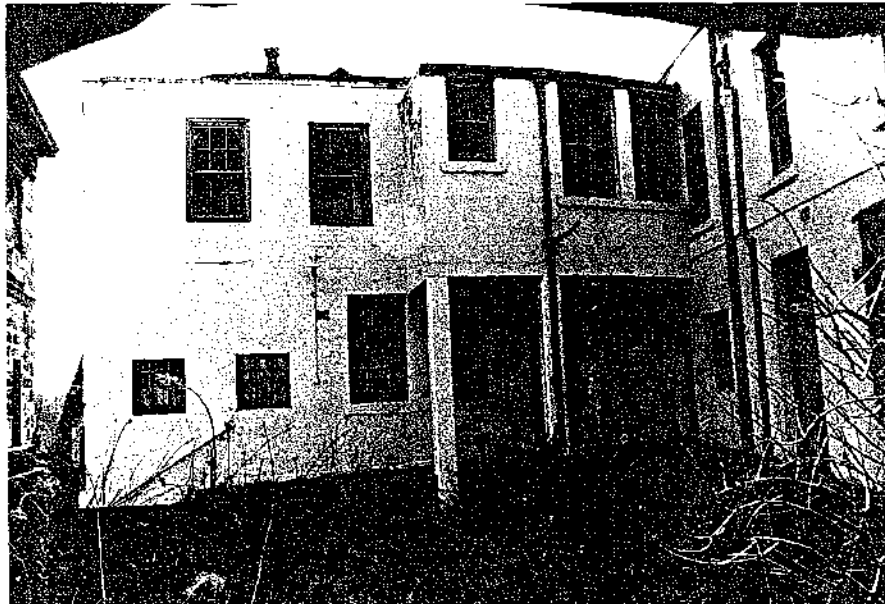
Plate 4
North front of armoury block, view south
