Project No. 378

December 1995

**Archaeological Investigations
at 12-14 Park Street, Walsall**

Archaeological Investigations at 12-14 Park Street, Walsall

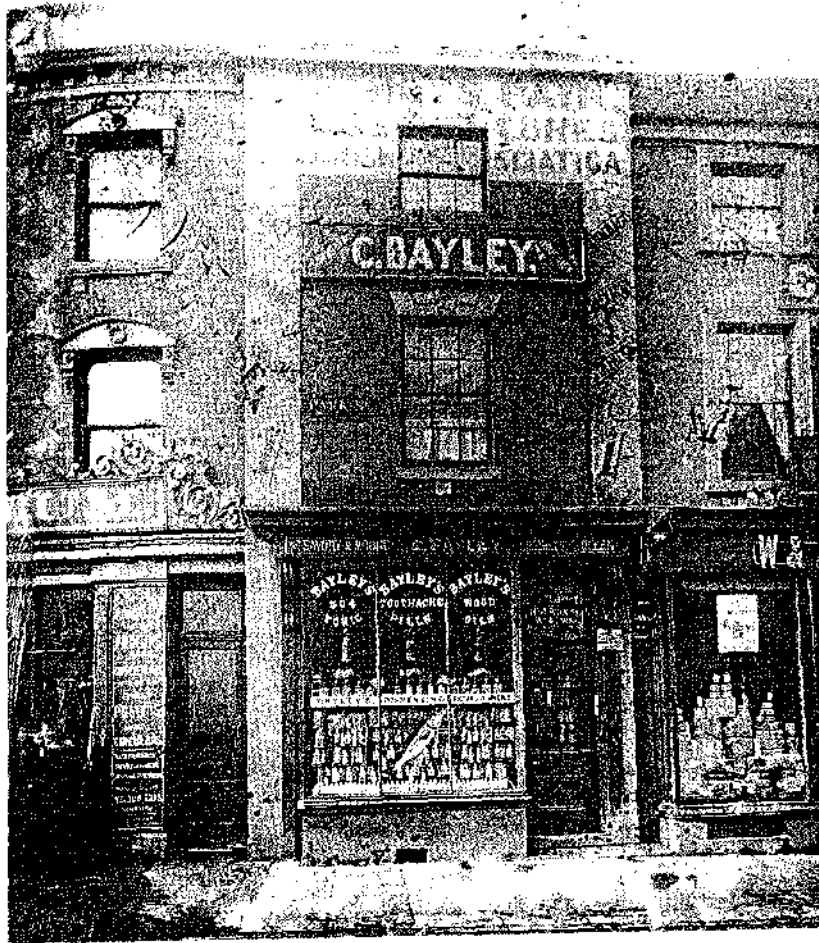
plates 5 and 6

Viewed from Park Street numbers 12/14 appear to form two parts of a row of three squat three-storey terraced properties. The third component of the row, which is currently occupied by Dorothy Perkins, differs slightly from 12/14, being narrower, with single rather than double windows to each of the upper stories (plates 7 and 8). The ground storeys of each property have modern shop fronts, but above these many original features have survived. The frontages are built in flemish-bond 2½ inch-thick brick, the coursing running uninterrupted between each property. A projecting moulded eaves cornice runs along the entire length of the row, and a squat parapet masks the roof from the street. The cornice of 14 Park Street has clearly been replaced recently; indeed, behind the facade most of the property has been extensively rebuilt. Number 14 Park Street has a matching set of balanced sash windows, the frames recessed from the wall front. The first-floor pair have 6 lights to each sash, whereas the squatter second-floor windows have three lights to each sash. The glazing bars are light, and it is probable that these are the original windows. The first-floor windows of 12 Park Street have been replaced with typical Victorian sashes. The second-storey windows have projecting stone sills, but the arrangement of the first-floor sills has been obscured by the modern shop fronts. The heads of each window are square, the decorative detail consisting of finely-rubbed bricks arranged as angled soldier-coursed voussoirs. These are best seen on the old photograph of the Danish Diary Company (plate 6).

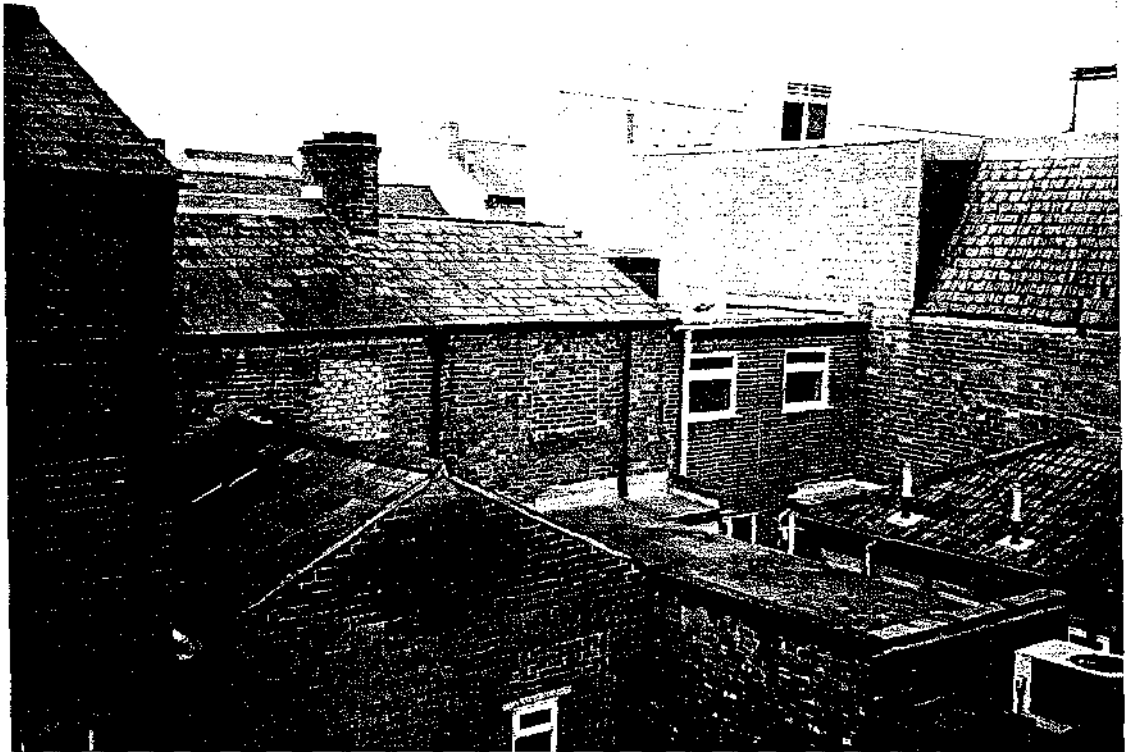
plates 9 and 10

From the rear, the extent of later alterations and repair to each property can clearly be seen. The long narrow Victorian service wings are clearly later, built from larger machine-cut brick. Numbers 10/12 Park Street retain ridge slate roofs, 14 having a modern flat roof (plates 9-12). The front cellar of 14 Park Street had been extensively rebuilt to overcome problems of flooding. The only early feature to survive is a blocked coal-chute from the street front. The rear cellar was part of the Victorian service wing, and is all of this date. However, above the Victorian brickwork of the cellar the party wall between 14 and 16 Park Street is built of 2½ inch-thick brick, and is part of the original build. The cellar of 12 Park Street was original, although the ground floor inside the shop was lowered when a modern concrete and breeze block floor was inserted (plates 13-16). The cellar was divided into three bays. The front bay is much wider, because of the dog-leg extension.
