Birmingham University Field Archaeology Unit
Project No. 408
December 1996

**Archaeological Work at the
Town Wharf, Walsall,
West Midlands (SMR 5894)**

by
S.J. LITHERLAND

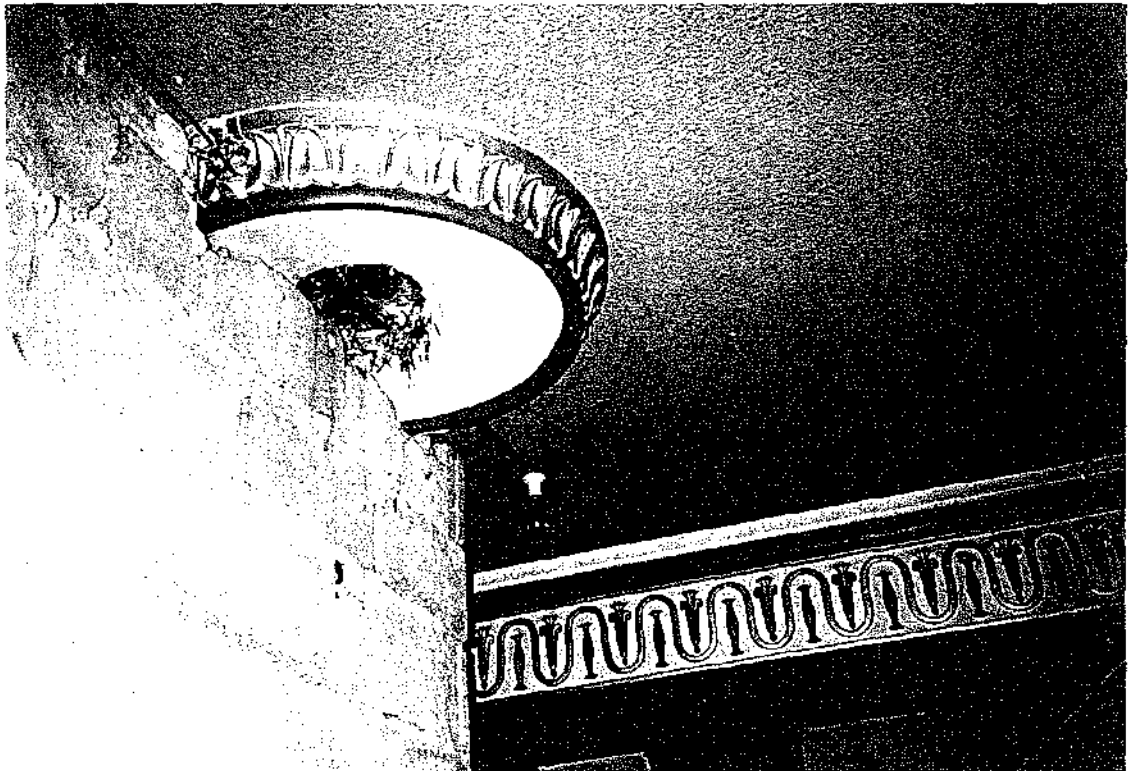
Plate 24 Struc. M

Limited soft-stripping in the foyer area and circle discovered most of the original decor was intact, but hidden from view by false ceilings and later casing. The foyer area would have been very impressive, with a terrazzo floor and bronze painted decorated pillars, and a central chandelier. Originally, there were two staircases, one on each side of the foyer giving access to the circle. Against the deep blue decor of the staircase walls there were several Art Deco friezes depicting musical instruments (plate 24). These were picked out in gold paint upon a light beige background, and placed within a white surround with bronze coloured edges. The left-hand side staircase had been blocked off in the 1970s, and the alternating stripes of cream, bronze and gold paint on the walls may have been original (plate 25).

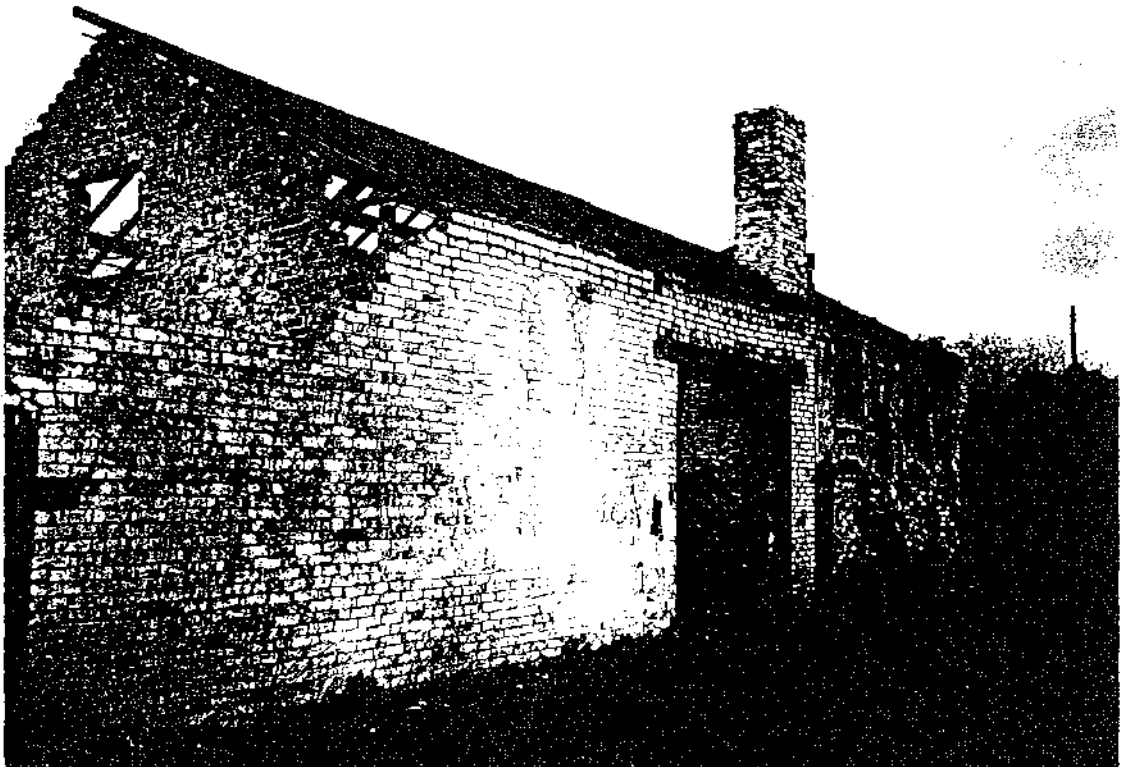
Plate 28 Struc. N

The central bay of the building was dominated by two large access doors, situated directly opposite each other. The north door opened directly onto the canal and still retained its sliding door mechanism. Goods were protected from the weather during loading by an overhanging projection of the roof here (plate 28). The south entrance was for loading to and from carts (plate 29). Remains of a raised timber floor sloping down from the cart access to the canal-side opening were still *in situ*. Both the southern door and the sloping floor were clearly later modifications to the building, these changes being intended to ease the loading of cart-borne goods onto, rather than off, the canal boats.
