Archaeological Recording
at
Aldersley Junction, Wolverhampton,
West Midlands
1997

(SMR 8629)

Birmingham University Field Archaeology Unit
Project No. 420.01
November 1997

by
Steve Litherland and Catharine Mould

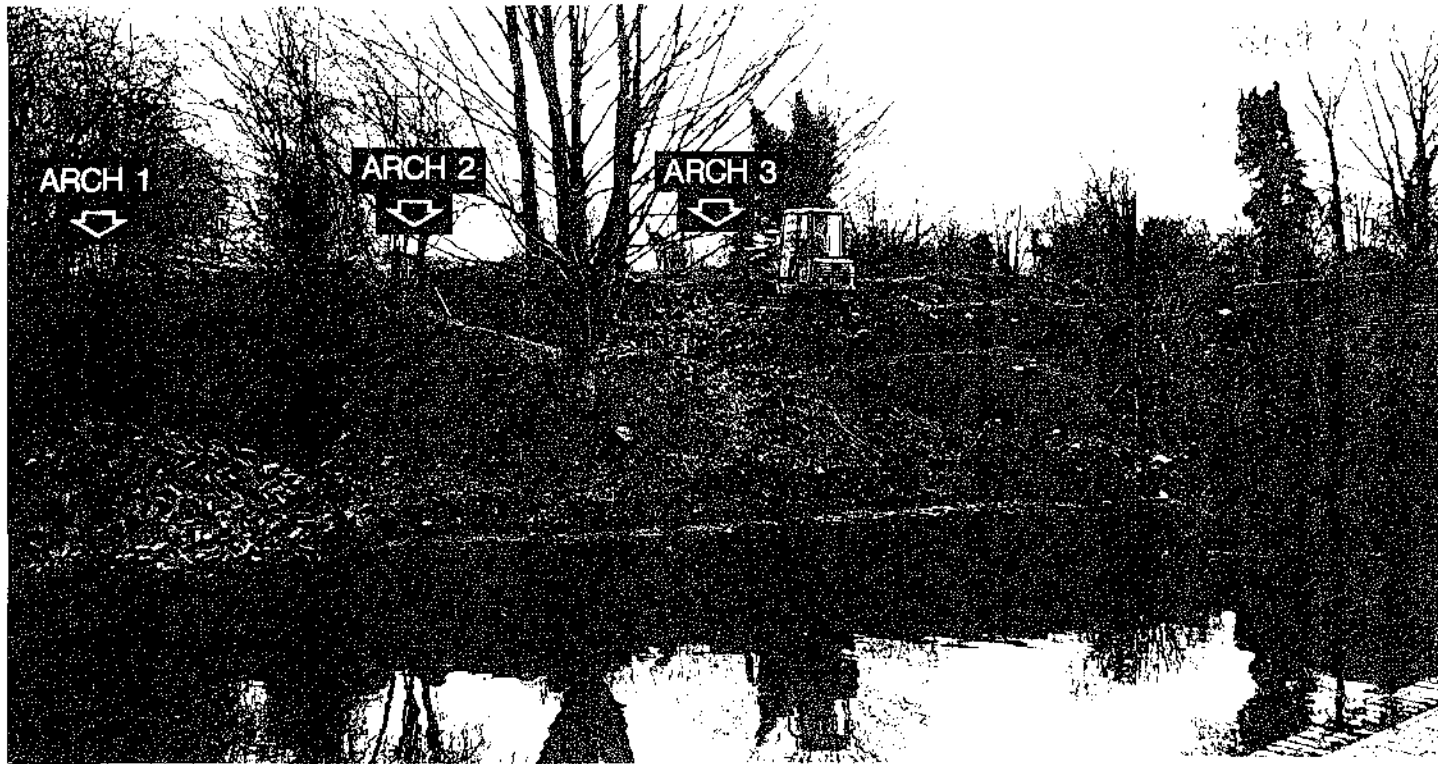
Plate 1

The partial remains of three clamped brick-built arches were exposed. These arches formed the vaulted ceilings of a series of ground-floor rooms. The northernmost arch (Arch 1) was set back further from the canal than Arches 2 and 3. The front sections of Arches 2 and 3, nearest the canal, had been demolished. This, combined with the presence of demolition material, and with the unstable nature of the surviving sections of arching, meant that it was not possible to reconstruct the floorplan beneath all three arches.

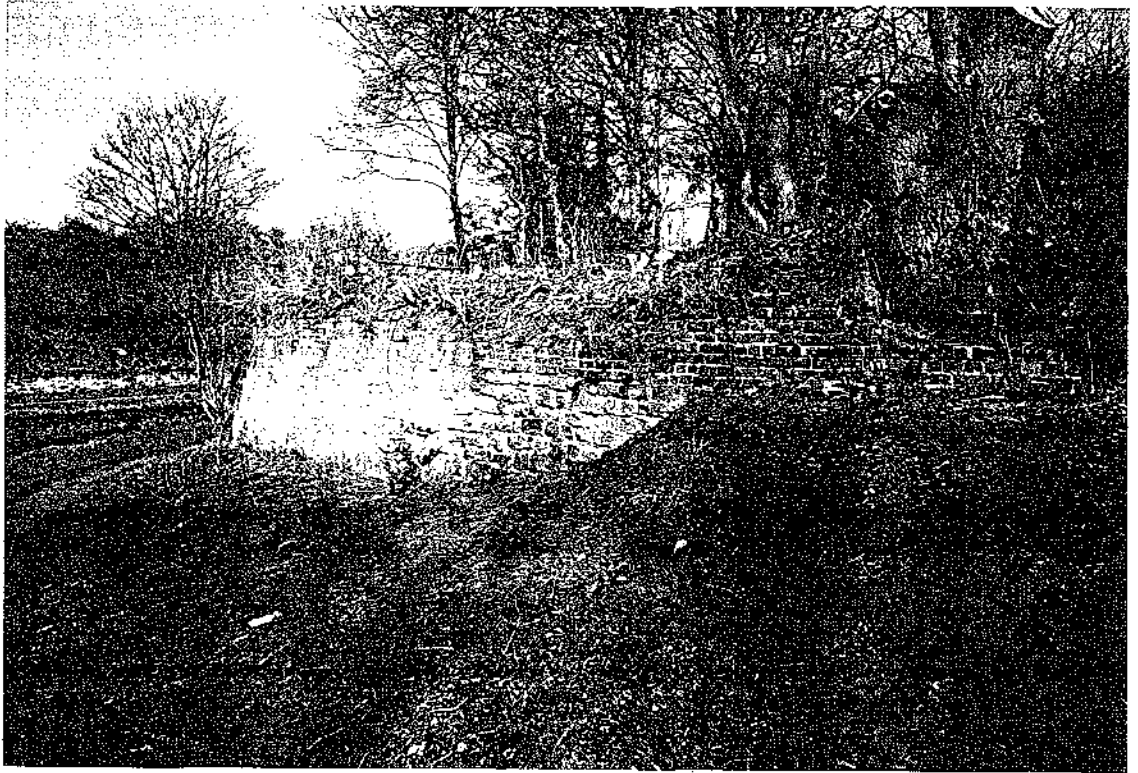
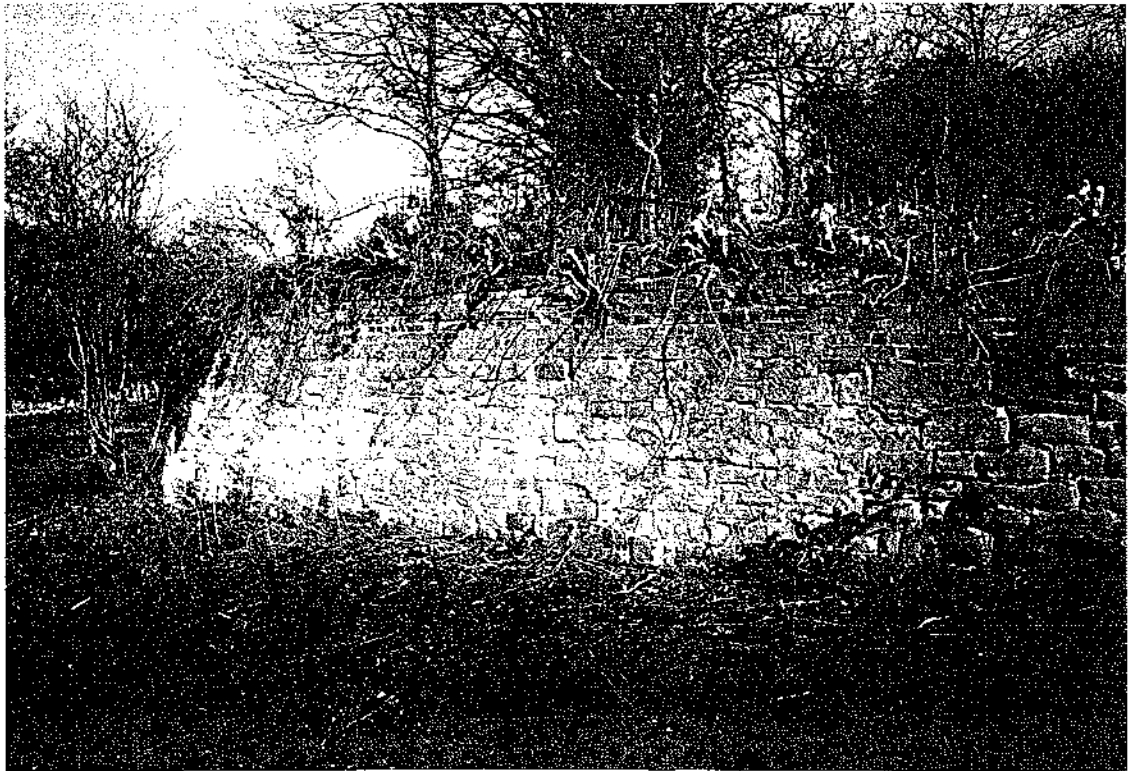
Plate 2

The site, which corresponds with Area Ia of an earlier archaeological assessment report (Litherland 1996), comprised a tall, stone retaining-wall with damaged iron railings facing the towpath of the Birmingham Main Line Canal (Plates 2 and 3), a horse arch under the Aldersley Roving Bridge (Plate 4) which gave access to a complex of buildings, designated as Group B in the earlier assessment (Litherland 1996, figure 5). These buildings comprised several barrel-vaulted brick ground floor rooms, which were partially sealed by a substantial bank of spoil and building debris from the demolition of the buildings and subsequent dredging of the canal.

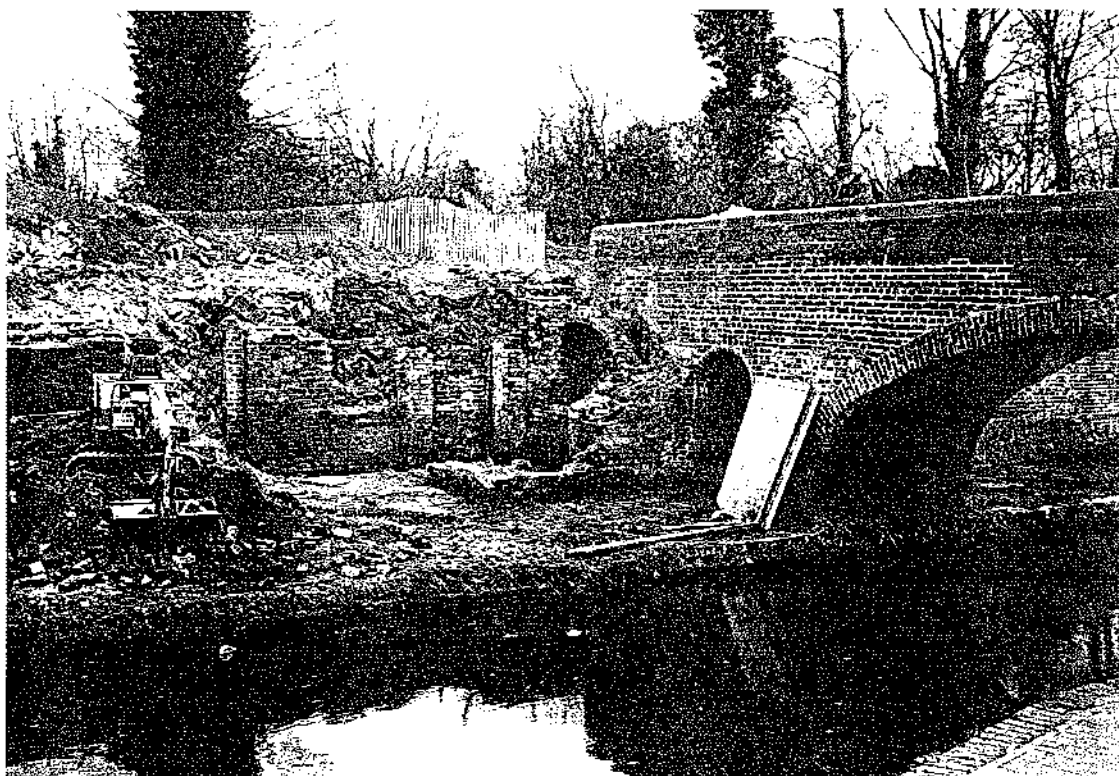
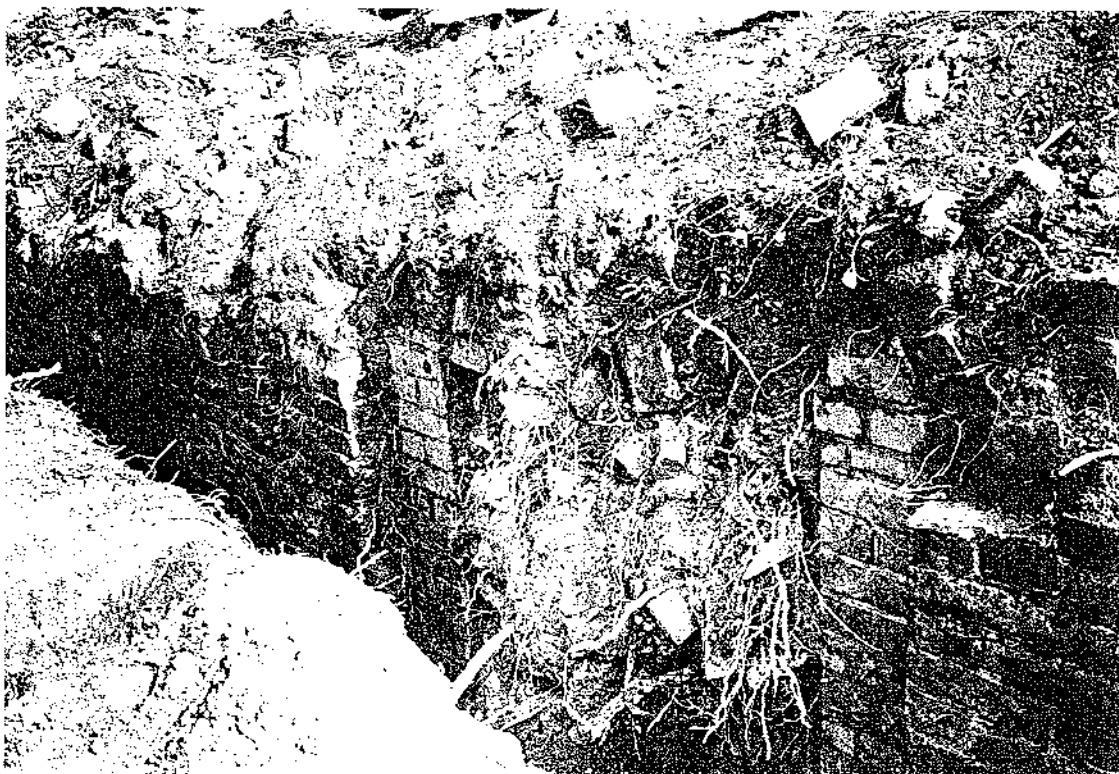
Plate 5

The main western elevation was set back approximately 3m from the canal-side (Plate 5). It survived as a single-storey ruin, constructed from clamped orange-red brick in irregular bonding, which abutted Aldersley Bridge. Two semi-circular arched entrances would have provided access to the building from the canal-side. The southernmost entrance had been blocked-in with machine-brick, whilst the northernmost one was filled with loose bricks which had been used to backfill the arches (Plate 6). A later modification of this entrance was represented by the insertion of machine-cut, blue-grey, engineering-brick. A window opening was located inbetween the entrances - the shape of its upper half was not preserved. An orange-red brick paviour extended from the main elevation to the canal edge.

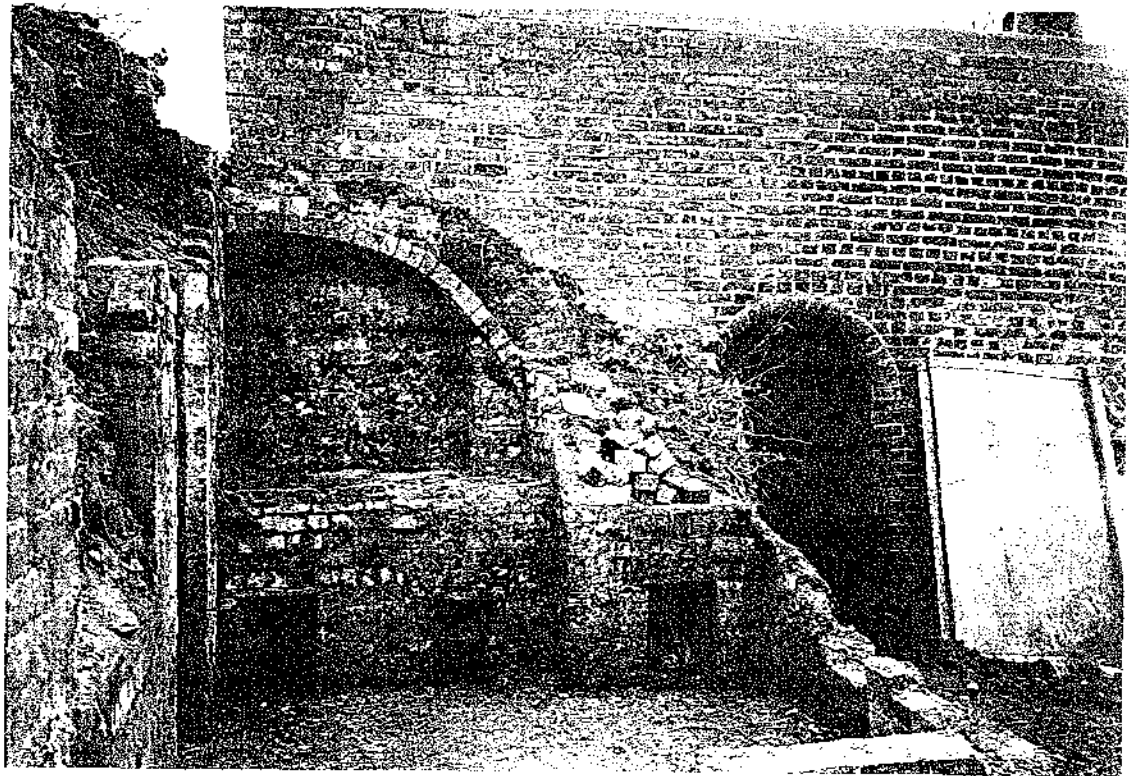
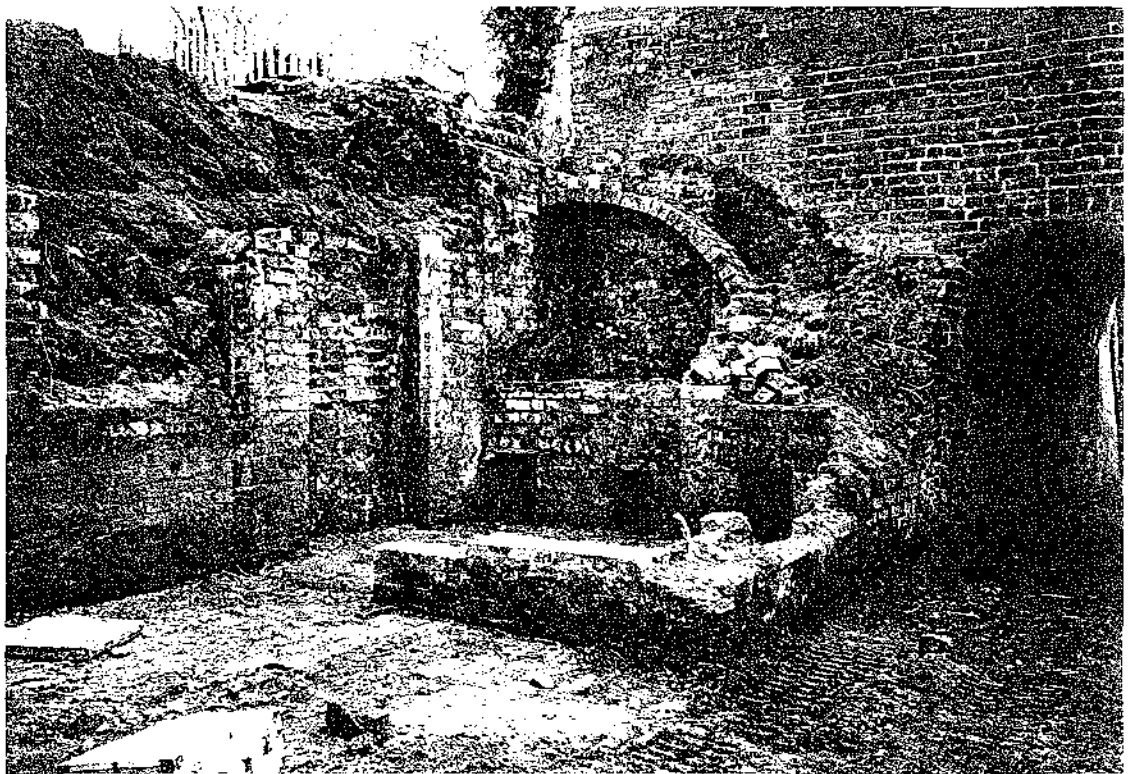
Plate 7

A single-storey clamped red-brick extension had been added to the building some time between 1845 and 1887. The extension abutted both the southern end of the western elevation and the northern side of Aldersley Bridge.

Exterior: Little of the exterior walls of the extension survives. The main access would have been through a doorway in the northern elevation, now represented by a gap. Although no roof-structure survived, a photograph in Wolverhampton Archives (D8/ALD/4) does show that the extension had a pitched roof, now visible as a line of moss against the northern face of Aldersley Bridge.

Interior: The only features within the extension survived against the northern side of Aldersley Bridge. They comprised a brick-built range with two hearths, each with an iron fire-grate *in situ*. Two iron bowls had been built into the brick-range, above the hearths. The main flue was set slightly forward from the range, and a third opening may have represented an additional hearth or some form of ventilation control for the range. A single-brick half-arch survived above the back of the range, abutting the bridge and main western elevation. The function of the arch, which was vandalised during the consolidation project, is unclear, but it is probably a later alteration. Access to the southernmost entrance to the main building was now via the extension.

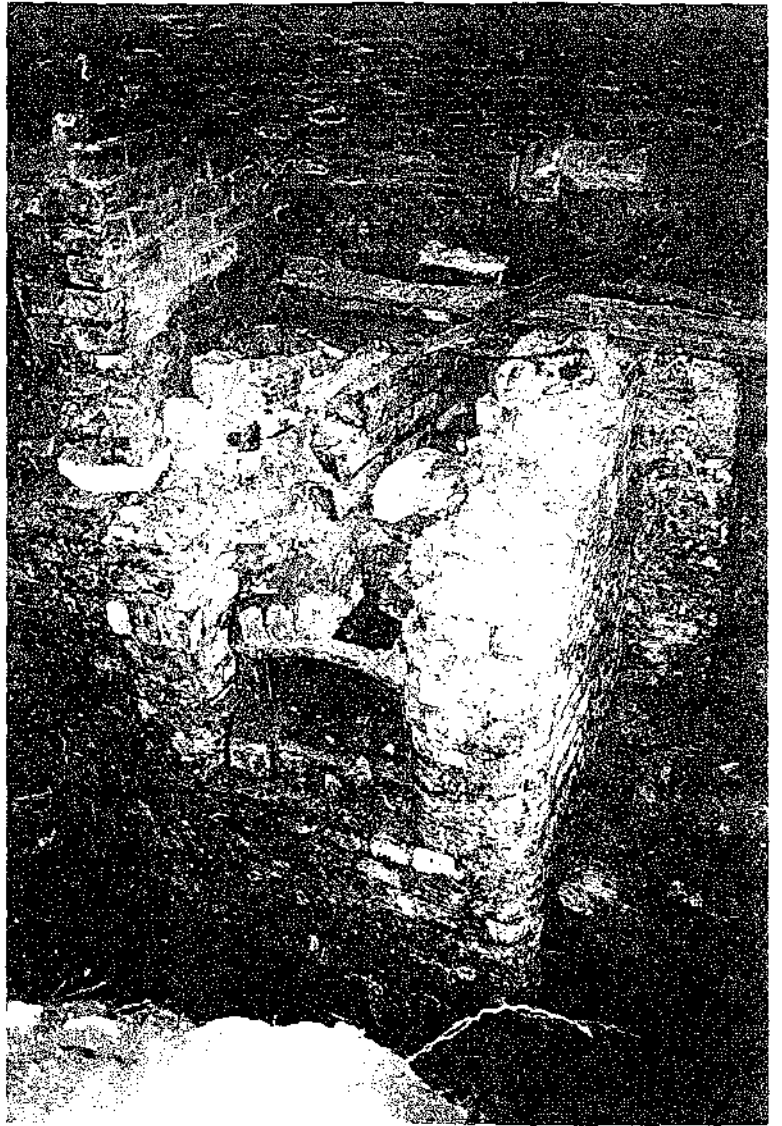
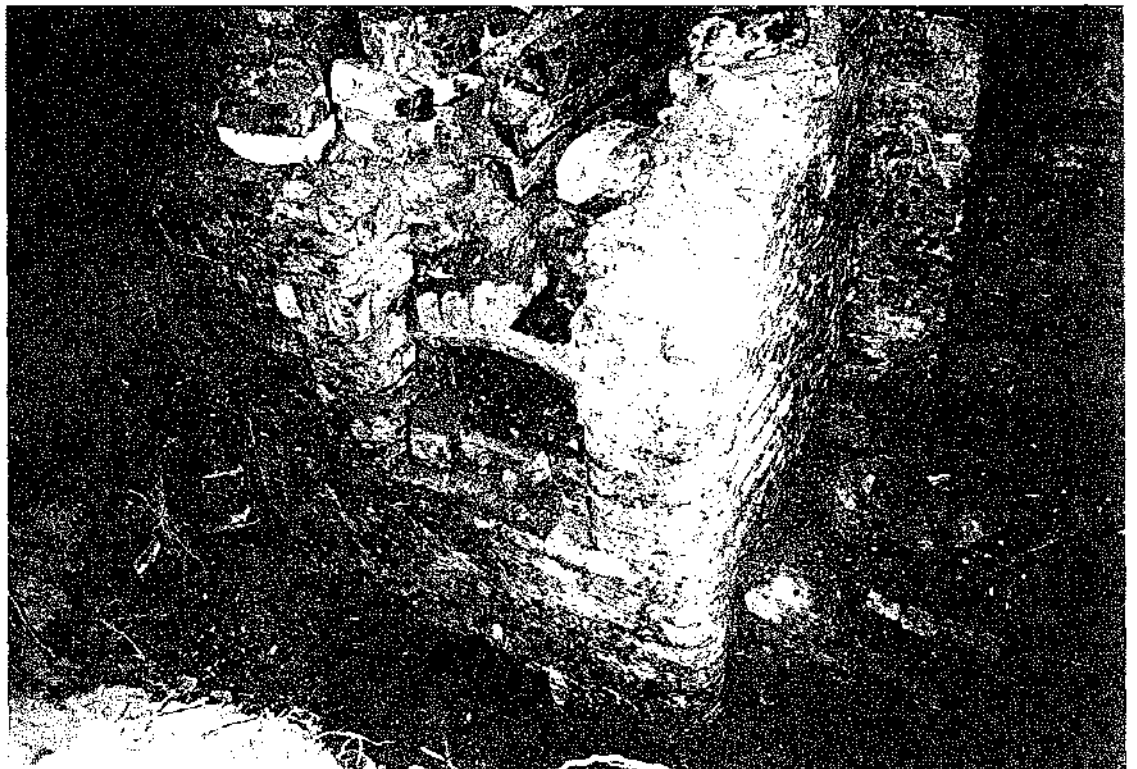
Plate 9

The remains of this northernmost arch were set back further from the canal-side than the main building which contained Arches 2 and 3.

Exterior: The canal-side elevation of Arch 1 was not exposed as part of the consolidation and enhancement scheme. However, the top of a doorway could just be seen.

Interior: The full extent of the floorplan was masked by rubble infill. A brick oven or furnace was built up against the southern wall. An upper and lower small, semi-circular arched vent fed from the furnace/oven through the northern wall of the main building housing Arches 2 and 3. The upper vent was angled through the vault of Arch 1, coming out above the vault of Arch 2.

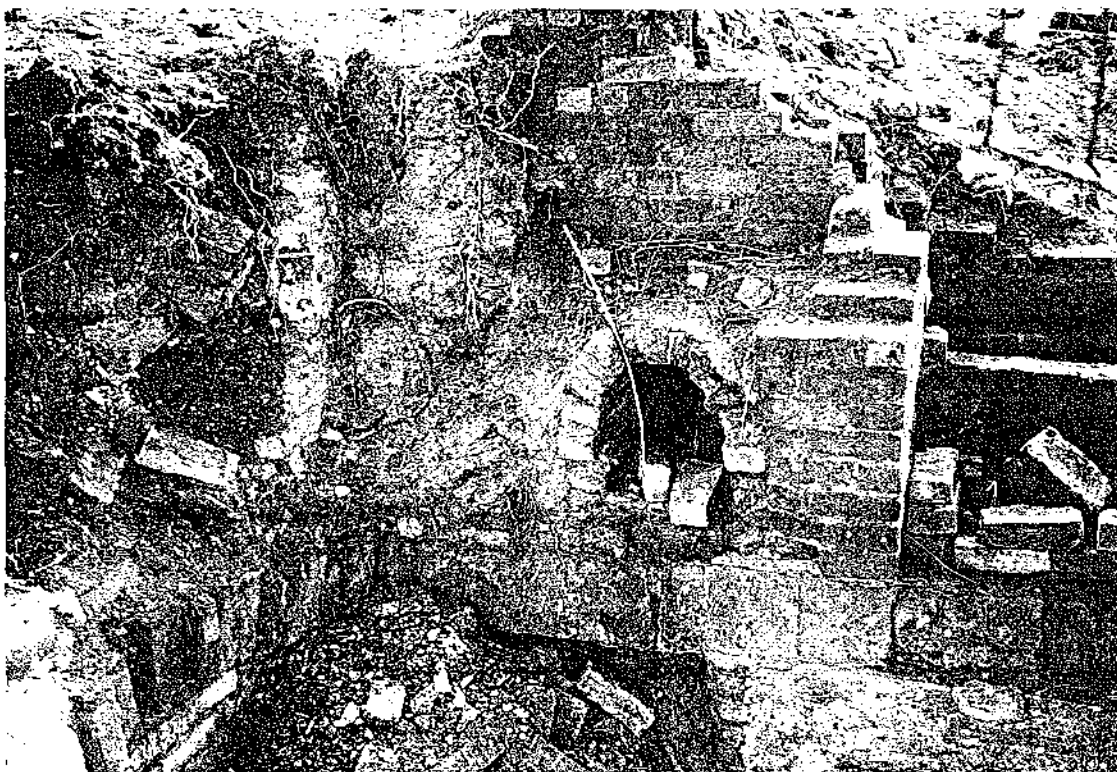
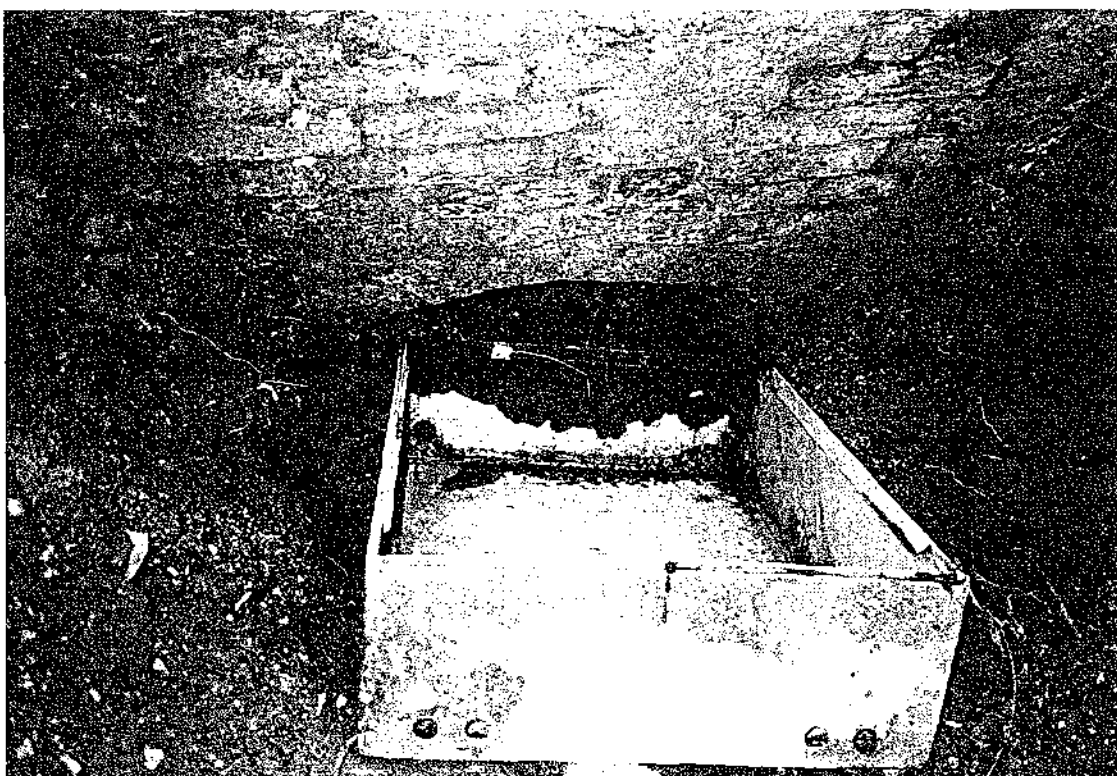
Plate 11

Exterior: The only feature to survive in the reduced canal-side elevation in front of Arch 2 was the northernmost entrance. Photographic evidence indicates that originally there were two windows to the north of this entrance, one being at the corner of the building.

Interior: This arch was partially filled with demolition material. It was divided into two rooms by a single brick interior wall which ran parallel to the canal. The front and back rooms were not inter-connected. A staircase built against the eastern wall of the back room provided access to the first floor. There may also have been access at ground floor level into Arch 3, but this was not exposed.

The upper and lower vents from the furnace/oven in Arch 1 were also recorded in the northern wall of the room closest to the canal-side. In addition, another chimney flue and large, lower vent were recorded in the southern wall of this room (Plates 11 and 12).

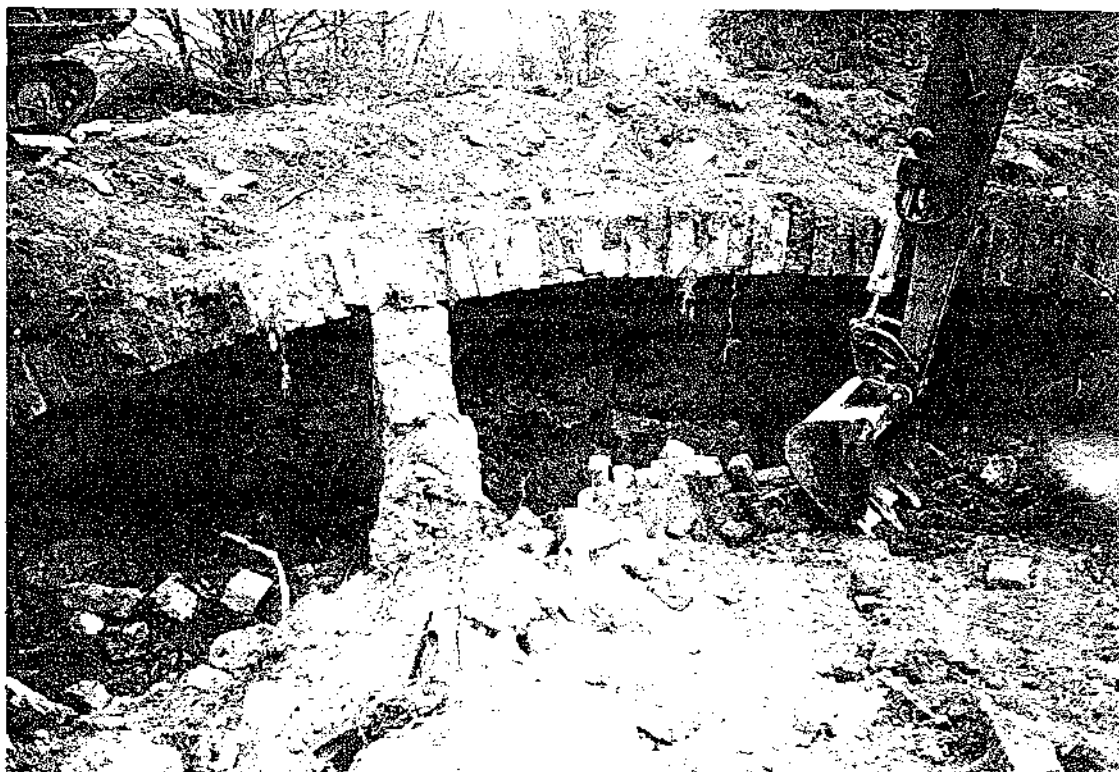
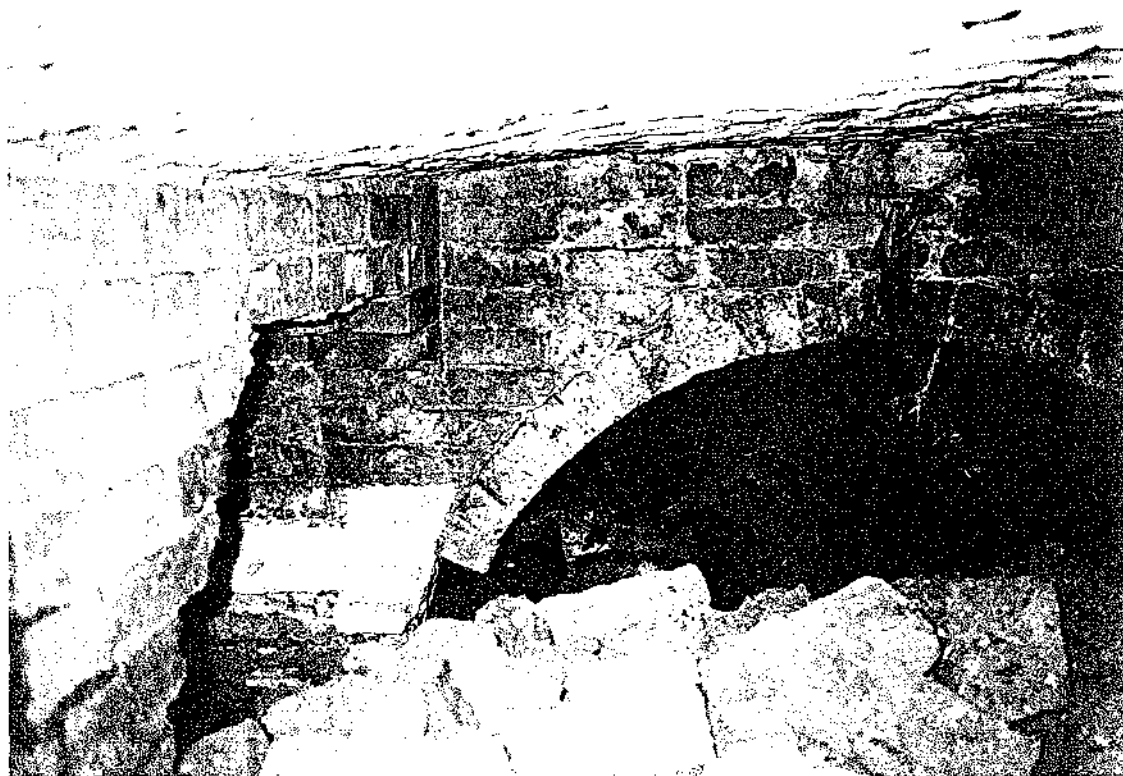
Plate 13

The remains of Arch 3 were set-back approximately 4.7m from the main western elevation.

Exterior: A doorway and window associated with Arch 3 were recorded in the western canal-side elevation.

Interior: A clamped-brick wall, running at a right-angle to the canal, sub-divided Arch 3 into a narrow northern passage and a larger southern area. The southern area was divided into two rooms by a second brick wall, running parallel to the canal, with a semi-circular arched entrance (Plates 13 and 14). No other features were identified.

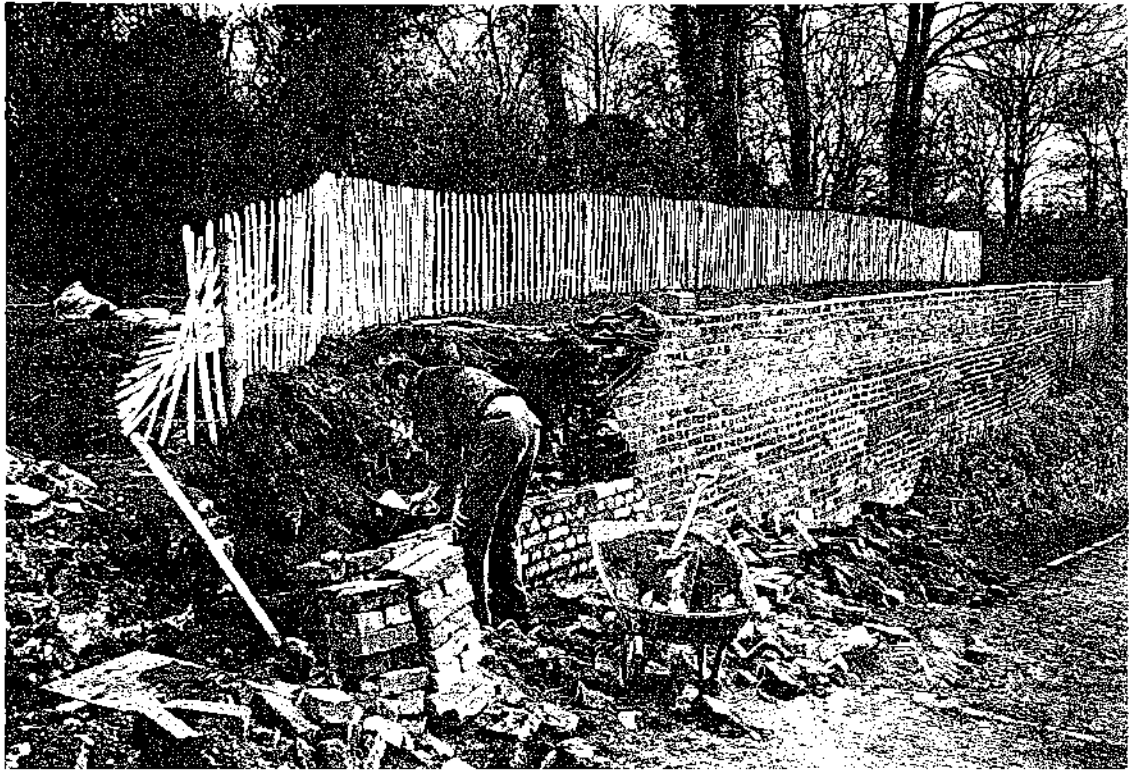
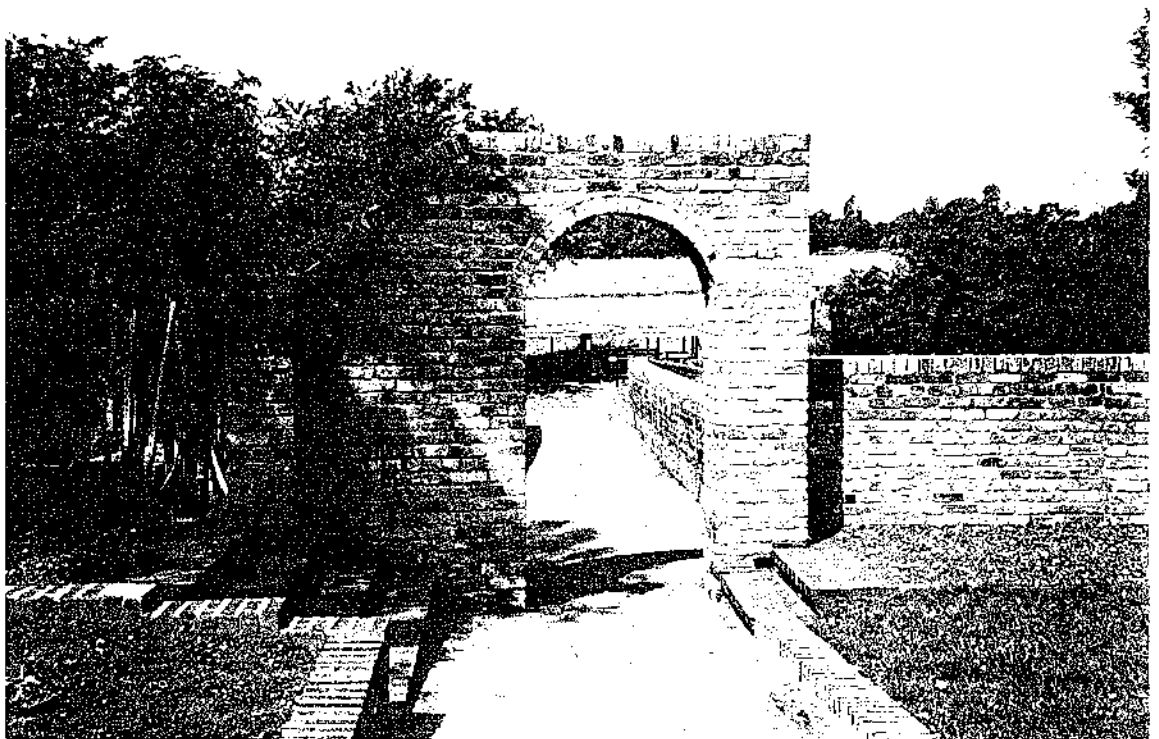
Plate 15

In addition to consolidation of the three arches, part of a tall, stone retaining-wall was reduced in height to create a uniform level (Plate 15), and an arch was built at the eastern end of Aldersley Roving Bridge (Plate 16). The wall and arch were built and consolidated with bricks salvaged from demolition material which covered the site. A number of panels of damaged iron railings were removed from the site for preservation. They were replaced by a design which is sympathetic to the existing character of the site.

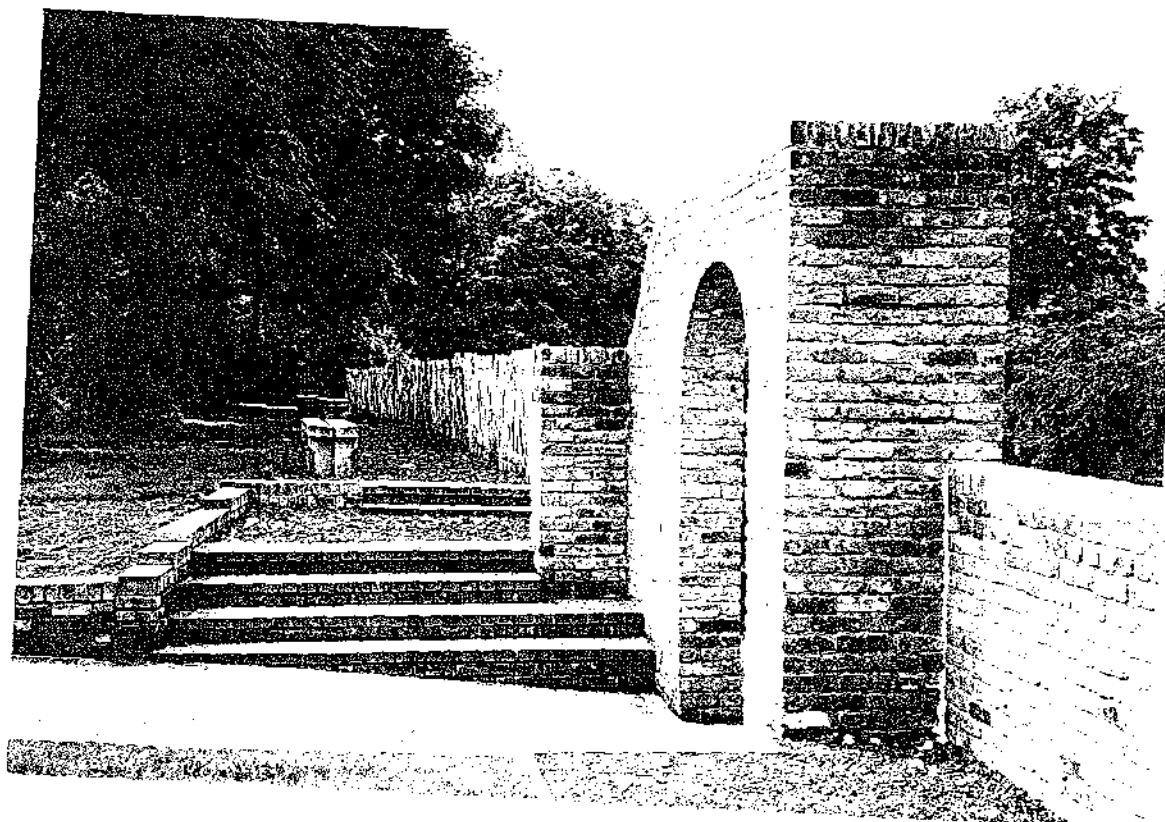
Plate 17

The area over the backfilled arches, and an area immediately to the south, was landscaped, and a number of wooden benches were installed (Plate 17). A viewing point over the canal was created by raising the level of the main western elevation (Plate 18). A second viewing point and seating area was created by the canal-side itself (Plates 18-20).
