# MEDIEVAL TILE PROJECT PHASE 2:

Buildwas Abbey, Shropshire Archive Report 046.02

Archive Report No: 046.02 By L.Bevan & E.Newton With D.Carr

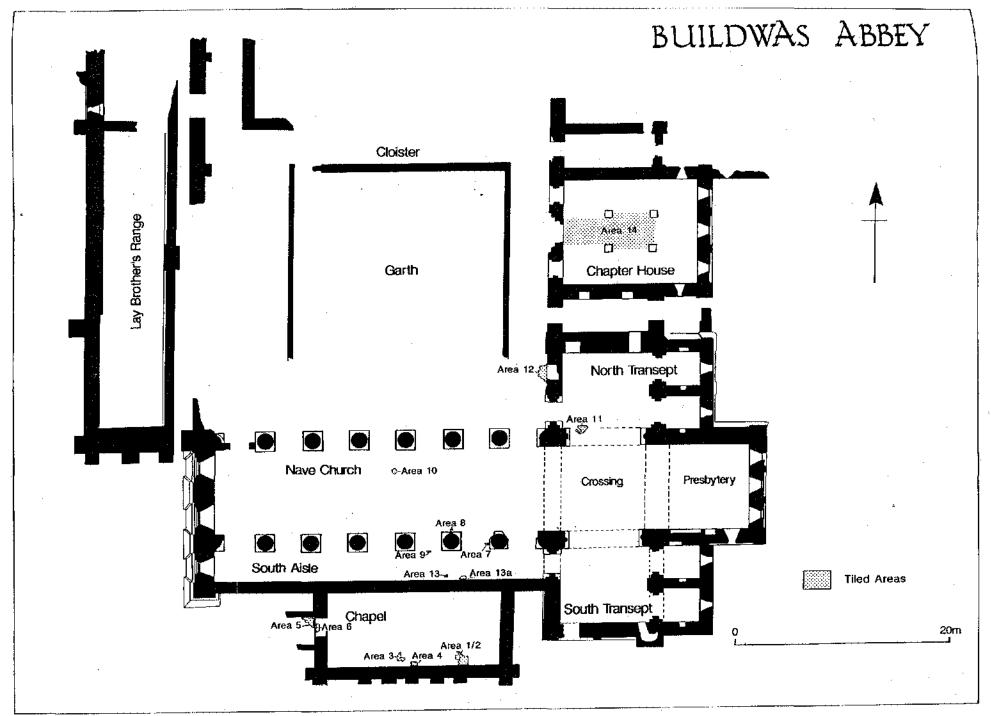
Figure 1.

Tile Areas 1-14 (Figure 1) were recorded by members of Birmingham University Field Archaeology Unit during November 1996. All areas, including a further area identified (Area 13a, Figure 5), were recorded, planned in detail and photographed (Areas 1-13 in black and white, Area 14 in colour). A photomontage of Area 14 was created from a series of prints (see A3 folder, site archive). All tiles with identifiable decoration were allocated a number, (using a separate numerical sequence for each area), traced, and subsequently inked. All inked tile tracings are stored in the site archive on 21 Al sheets of permatrace.

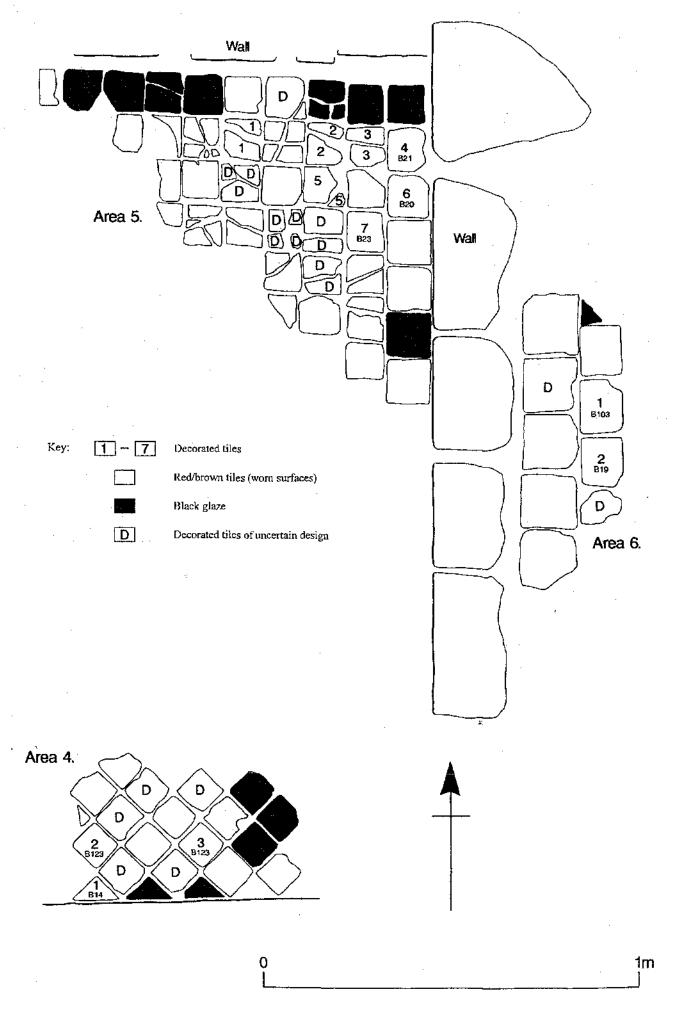
This small area consists of 21 tiles (Figure 3), five of which are a blue-black colour, and three of which were attributed to the following designs: B14(1), B123(2). Tile condition was poor and five further tiles showed surface decoration which was too abraded to identify.

Forty-two tiles remain in situ, but approximately half are shattered and all are in an abraded condition. Decoration remained visible on several tiles, three of which were attributed to the pre-existing Buildwas series: B20, B21 and B23. Four tiles were of a 'chequerboard' design executed in yellow glaze, a tile design previously unrecorded at the site (Figure 3). Six other decorated tiles, which were too abraded to identify, are also indicated in Figure 3.

This small area of ten tiles includes four decorated tiles, two of which are of identifiable designs (B19, B103), and one fragment of tile with a black glaze (Figure 3).

This roughly rectangular area, measuring 0.39m x 0.61m, consists of 21 tiles, three of which had retained sufficient surface decoration for tracing (Figure 3, tile archive sheet 2).

This triangular area, set against the remains of two walls, measures 1.03m x 0.84m and consists of 42 tiles, seven of which had retained sufficient surface decoration for tracing (Figure 3, tile archive sheet 3).

This small rectangular area, measuring 0.77m x 0.27m, is separated from Area 5 by a stone wall, and consists of 10 tiles, of which two decorated tiles were traced (Figure 3, tile archive sheet 3).

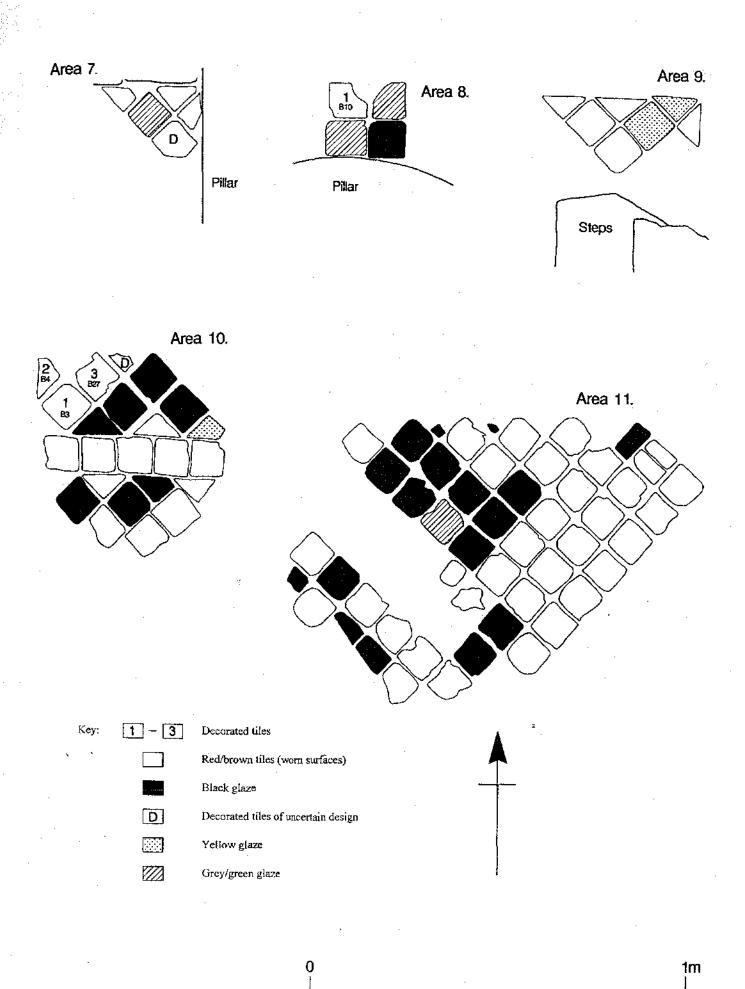
Figure 4.

One tile is a grey-green colour and another has traces of possible decoration in this small area consisting of five tiles (Figure 4).

This area consists of four tiles, of which one is decorated (B10) and in a good condition, two are grey-green and one is black (Figure 4).

There are no decorated tiles among the seven tiles in this small area, two of which have retained total yellow glaze (Figure 4).

This area consists of 23 tiles, three of which have retained recognisible designs (B3,B4, B27), one of which has traces of unidentifiable decoration, and seven of which appear to have been black (Figure 4).

There are no decorated tiles apparent in this worn, damaged area of 51 tiles. One tile is grey/green and approximately 12 appear to have been black (Figure 4).

This area, measuring 0.27m x 0.18m, between a pillar and part of an exposed wall, consists of five tiles, none of which had retained surface decoration (Figure 4).

This four-tile square is next to a pillar and measures 0.21m x 0.20m. Only one tile had retained surface decoration (Figure 4, tile archive sheet 2).

This small area of seven undecorated tiles is situated next to some stone steps and measures  $0.43m \times 0.20m$  (Figure 4).

This area, measuring 0.62m x 0.43m, consists of 23 tiles arranged in two triangles set diagonally against a single linear strip, of which three decorated tiles were traced (Figure 4, tile archive sheet 2).

This area, measuring 1.11m x 0.75m, consists of 51 tiles, none of which had retained surface decoration (Figure 4).

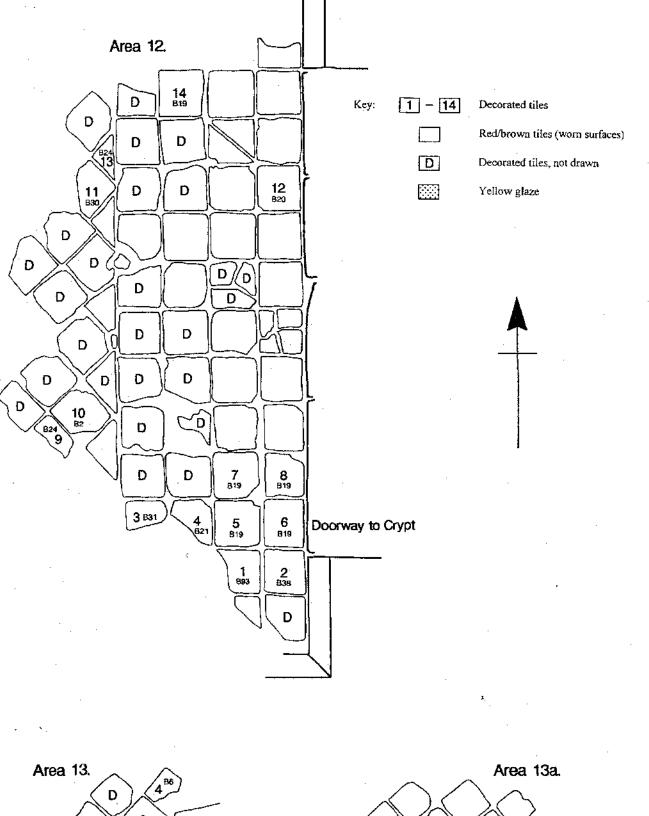
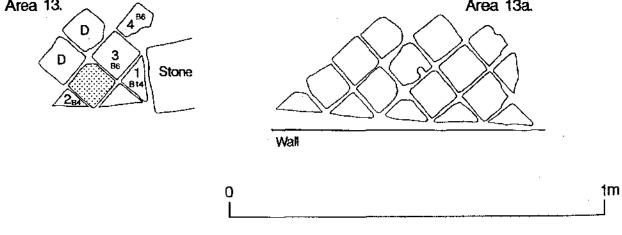
Figure 5.

This area, consisting of 61 tiles, includes at least 25 decorated tiles, many of which are now too degraded for identification (Figure 5). The outer register of diagonally-placed tiles has sustained the worst damage, with substantial surface loss. Fourteen decorated, mainly line-impressed, tiles were related to the pre-existing type series (Lunt 1979): B2(1), B19(5), B20(1), B21(1), B24(2), B30(1), B31(1), B38(1), B93(1).

This small area consists of eight tiles, six of which have retained traces of decoration, and one of which has a plain yellow glaze (Figure 5). Four of the decorated tiles were attributed to the pre-existing Buildwas type series: B4(1), BB6(2), B14(1).

This area consists of 16 badly-degraded tiles from which any traces of surface decoration had been obliterated (Figure 5).

This area, situated in the Crypt doorway, measures 1.59m x 0.82m and consists of 61 tiles, of which 14 decorated tiles were traced (Figure 5, tile archive sheet 3).

This area, measuring 0.21m x 0.31m, consists of eight tiles, of which four decorated tiles were traced (Figure 5, tile archive sheet 2).

This additional area, which was not included in the original survey (Lisk 1991), measures 0.23m x 0.68m and is located next to a wall near to Area 13. It consists of 16 undecorated tiles (Figure 5).

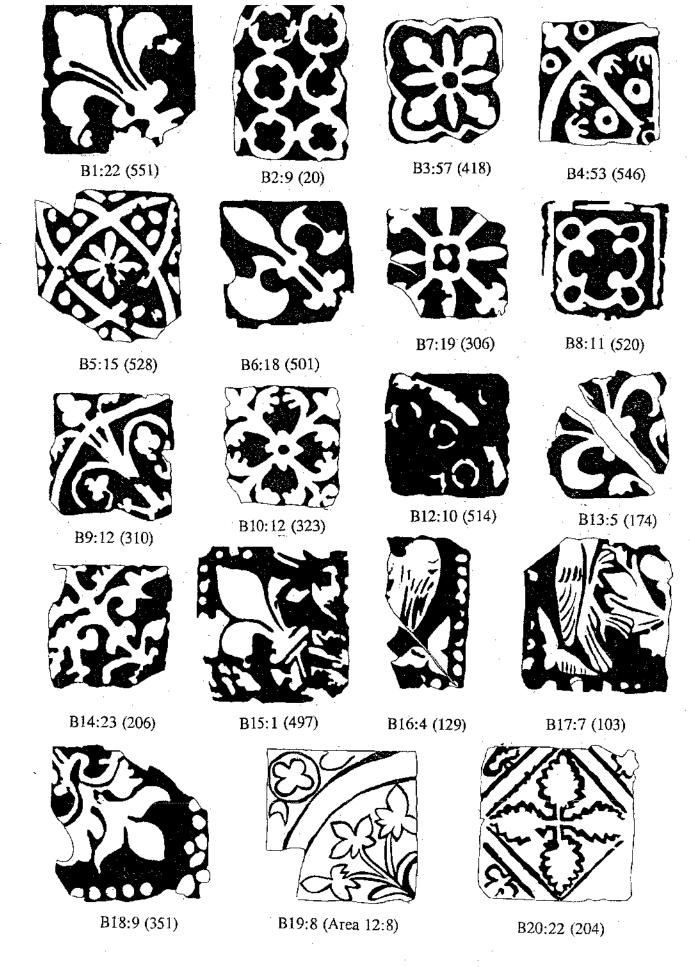
Figure 7

With reference to the large Buildwas type series (although many of the types originally identified did not occur among *in situ* tiles in the Chapter House floor), totals of each tile type are listed beneath the examples in Figures 7-10. The tiles illustrated are the most complete examples of each type recorded. Unless otherwise stated, examples used are from Area 14.

Medieval Tiles in Area 14, Buildwas Chapter House. (Ref. Lunt 1979:Total/Tile No. of Example\*)

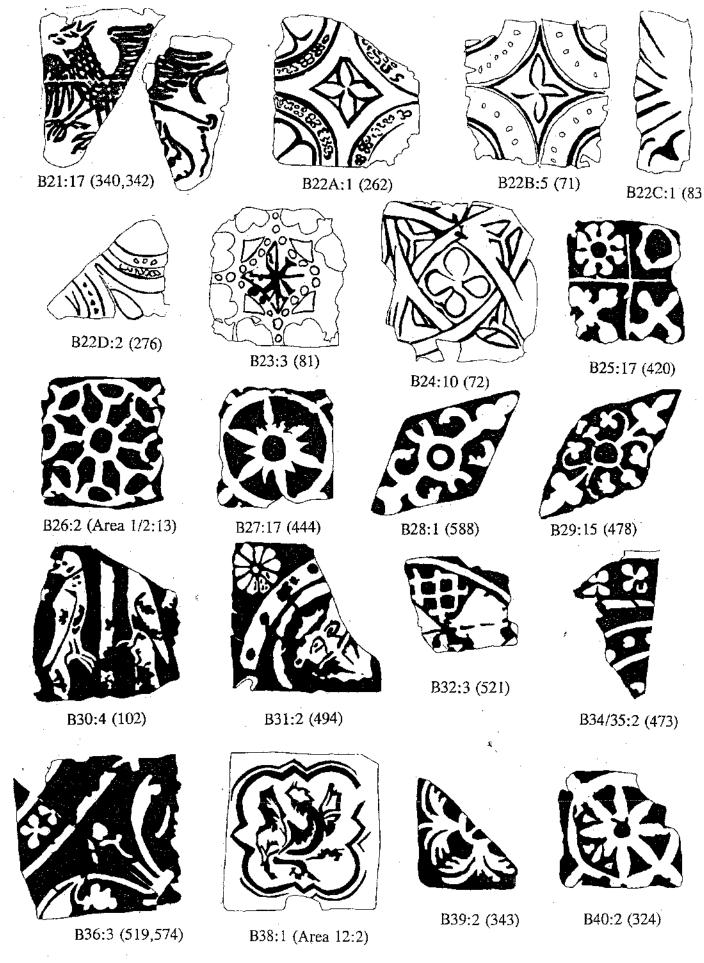
Figure 8

Medieval Tiles in Area 14, Buildwas Chapter House. (Ref. Lunt 1979:Total/Tile No. of Example\*)

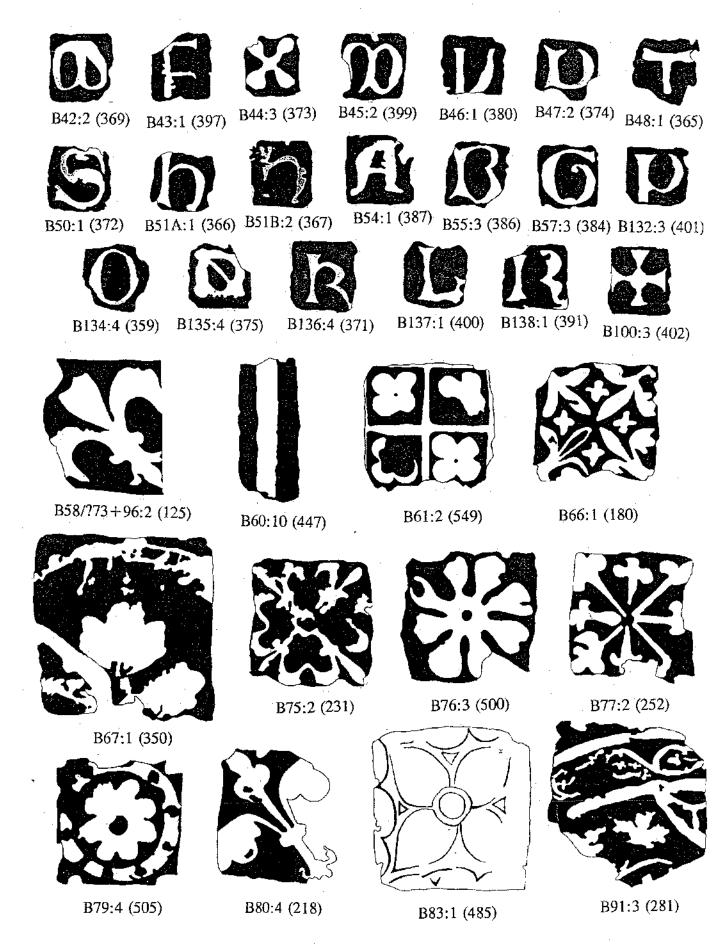
Figure 9

Medieval Tiles in Area 14, Buildwas Chapter House. (Ref. Lunt 1979: Total/Tile No. of Example\*)

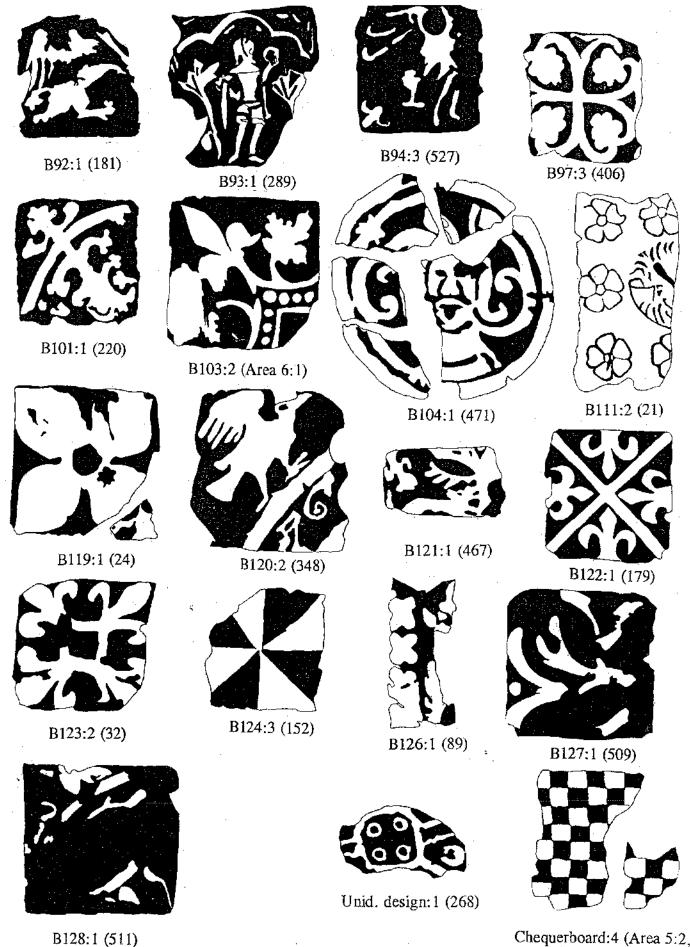
Figure 10

In addition to known Buildwas tile designs, one tile fragment of a previously unidentified design, consisting of four enclosed rings, was discovered in Area 14 (Figures 6 and 10:Tile 268, photomontage), and four examples of a 'chequerboard' design (Eames 1980, design 2020), executed in yellow glaze, in Area 5 (Figures 3 and 10, see also area photograph).

Chequerboard:4 (Area 5:2, not in Area 14)

Medieval Tiles in Area 14, Buildwas Chapter House, except 'chequerboard' tile from Area 5 only. (Ref. Lunt 1979:Total/Tile No. of Example\*)

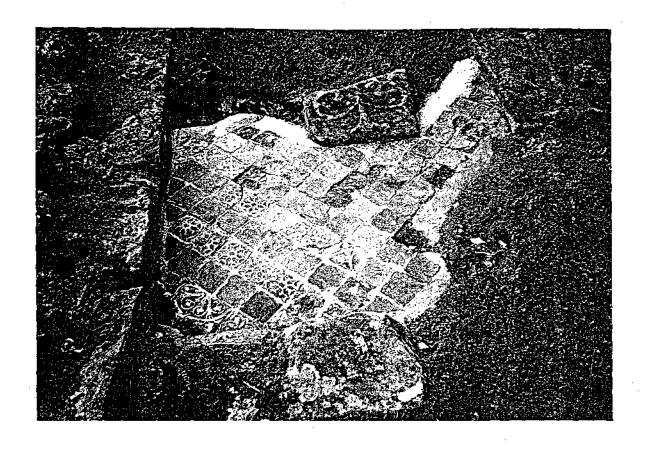
AREA 1/2

Some diagonal patterning could be observed in the placement of rows of decorated tiles interspersed with rows of plain tiles, and four B9 tiles had been placed in a four-square arrangement. Two bulbous wasters, both decorated, were also visible in the pavement.

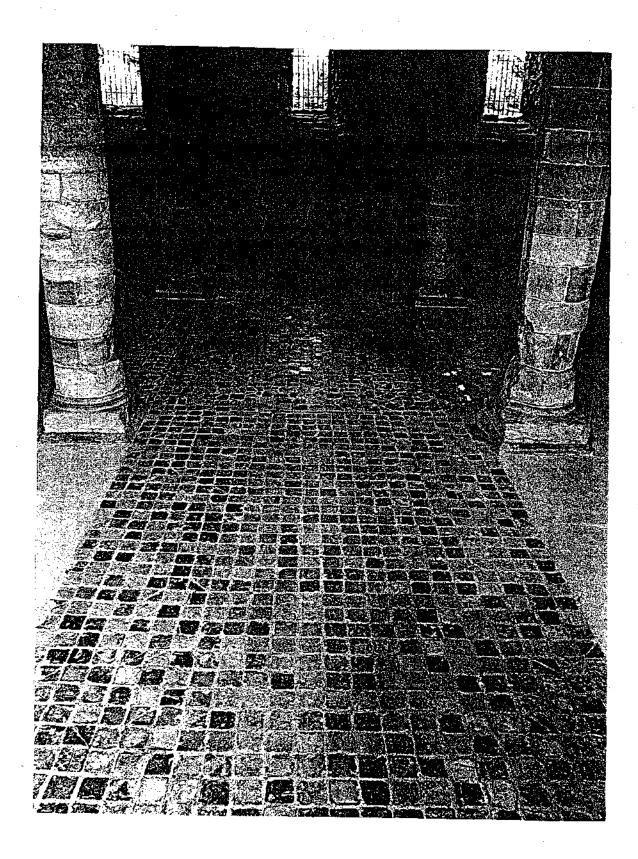
AREA 14

The condition of the tiles in the central area, between the four pillars, was superior to those situated immediately below the entranceway, although the edges of many of the tiles were covered by concrete which obscured some surface detail. The difference in preservation probably results from the greater wear from both visitors' feet and wind-blown material to the tiles nearest the entrance, whereas the tiles in the central area appear to have been roped off to prevent visitor access for some time. It is also possible that the curator responsible for re-laying the tiles in the Chapter House might have selected the better decorated and preserved tiles for the central area, placing the plainer, more worn, tiles nearest to the entranceway.

The tiles in the entranceway below the Chapter House steps, 823 in total, included only fifteen tiles with recognisible designs, several with traces of decoration, and 12 bulbous wasters. The remaining tiles have monochrome glazes. By contrast, the 1222 tiles in the adjoining central area were, with the exception of a border composed of mainly plain tiles, decorated. These included many fragments which were placed in circular 'roundels' (see Figure 6 and photomontage in archive folder). Many half tiles were placed together, some of which were joining pieces, others of which were not. Fragments from the same tile were allocated the same number, and fragments from non-joining tiles were allocated separate numbers.
