MEDIEVAL TILE PROJECT PHASE 2:

Castle Acre Priory, Norfolk
Archive Report 046.03

Medieval Tile Project, Phase 2 Recording: Castle Acre Priory, Norfolk

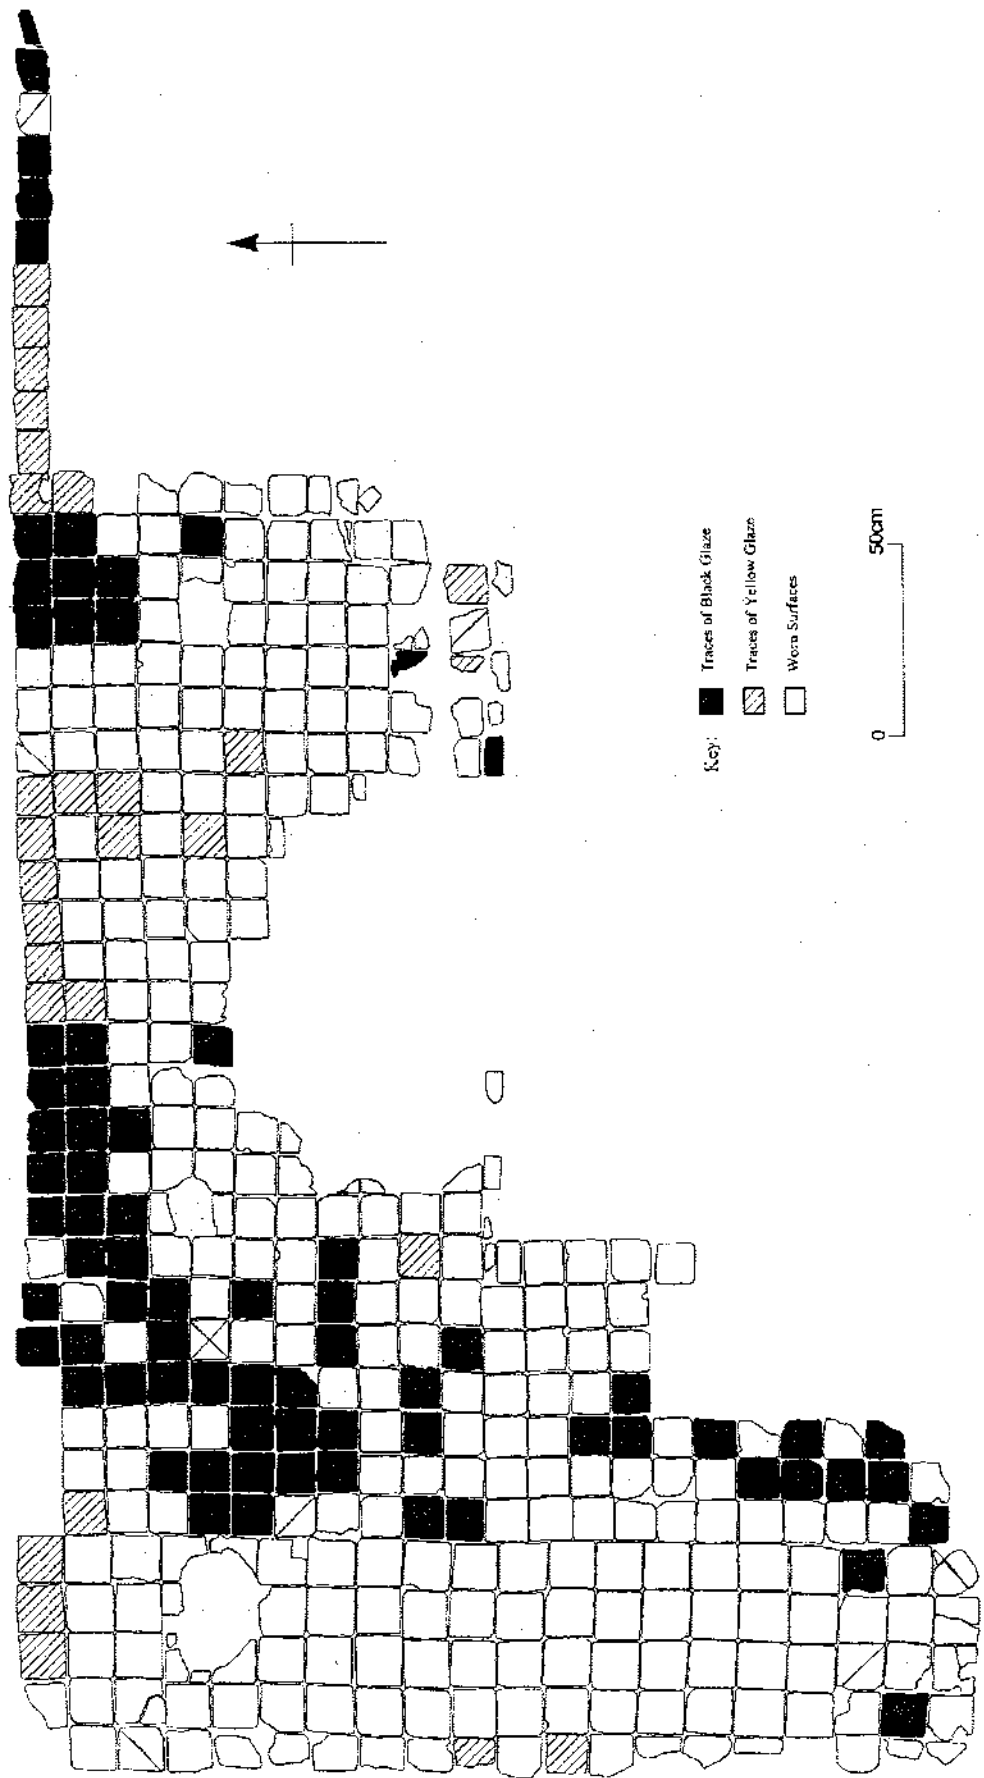
Figure 8. Area 5

Areas 5 and 6 are located in the Lady Chapel on either side of the doorway leading to the North Transept (Figures 8 and 9). Both areas of tiles are 'set square to the walls rather than diagonally, which 'may indicate that they have been re-bedded' (Davison 1995, 2). The tiles are badly eroded but appear to have had plain black and yellow

glazes. Area 5 measures 5.10m by 2.70m and comprises 480 tiles. Area 6 measures 4.60m by 1.80m and comprises 418 tiles.

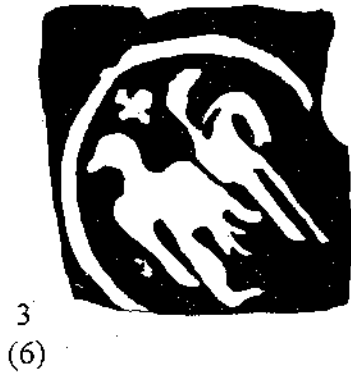
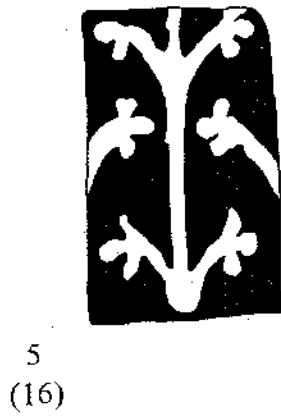
Figure 15: Prior's Chapel
Examples of Tile Designs 1-6
Individual Tile numbers are shown in Brackets

With the exception of the single decorated tile beneath the window in the Prior's Chapel (Figure 5), and some tiles with traces of decoration in the Chapter House (Area 9), none of which could be traced, all decorated tiles discussed here were found on the raised dais/altar recess in the Prior's Solar (Area 1). Eighteen of these were traced and a total of six designs was identified, examples of which are shown in Figure 15:

Design/ Description	Total/Tile Nos./Fig. No.
1. Floriform with border	3 (1,2*,12)/15:1
2. Small diagonal floriform	1 (3*)/15:2
3. Two birds	4 (4,5,6*,7)/15:3
4. Cruciform	2 (13,14*)/15:4
5. Floriform without border	5 (8,9,16*,17,18)/15:5
6. Large diagonal/circles	4 (10,11*,15,19**)/15:6

Despite surface abrasion, some red and black patterning can be observed in the altar dais tiles (Figure 15, Archive Sheet 1), and it appears likely that most of the tiles were part of an original floor. The only obvious 'interlopers' were the largest decorated tiles (Figure 15:6) which, although Medieval, appear to have been a later addition to the floor (Durbin 1996). Some of these tiles which might have originated from the Cloister Walk (Durbin 1996) were recently stolen, recovered by the police, and re-set in the dais by Leslie Durbin (see photographs in archive file).
