**A Desk-based assessment and recording of
industrial buildings at the rear of 9-13
Wolverhampton Road, Bloxwich, West
Midlands (SMR 9456)**

Birmingham University Field Archaeology Unit
Project No. 460
February 1996

by
Steve Litherland

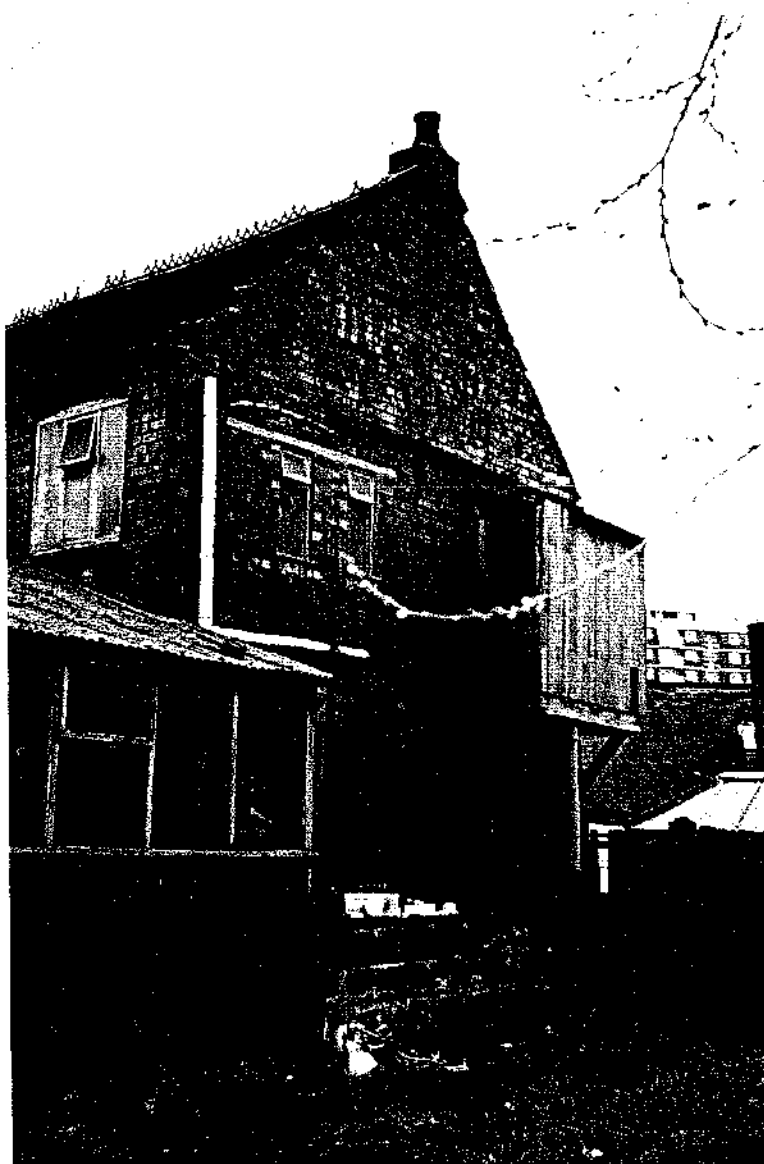
There are narrow windows in the west gable on both floors. Each gable has a central chimney. The flue arrangement on the ground floor has been removed, but may have been for a hearth or stove in the west end and arguably a flue from a steam engine powering the lathe-booms at the east end. Original ground-floor access at the east end of the north facing main elevation, first floor access via external staircase on eastern gable. Ground-floor access in the southern elevation has been inserted through former window openings, although fire-damaged first-floor loading door is probably original.

Structure 1: east elevation

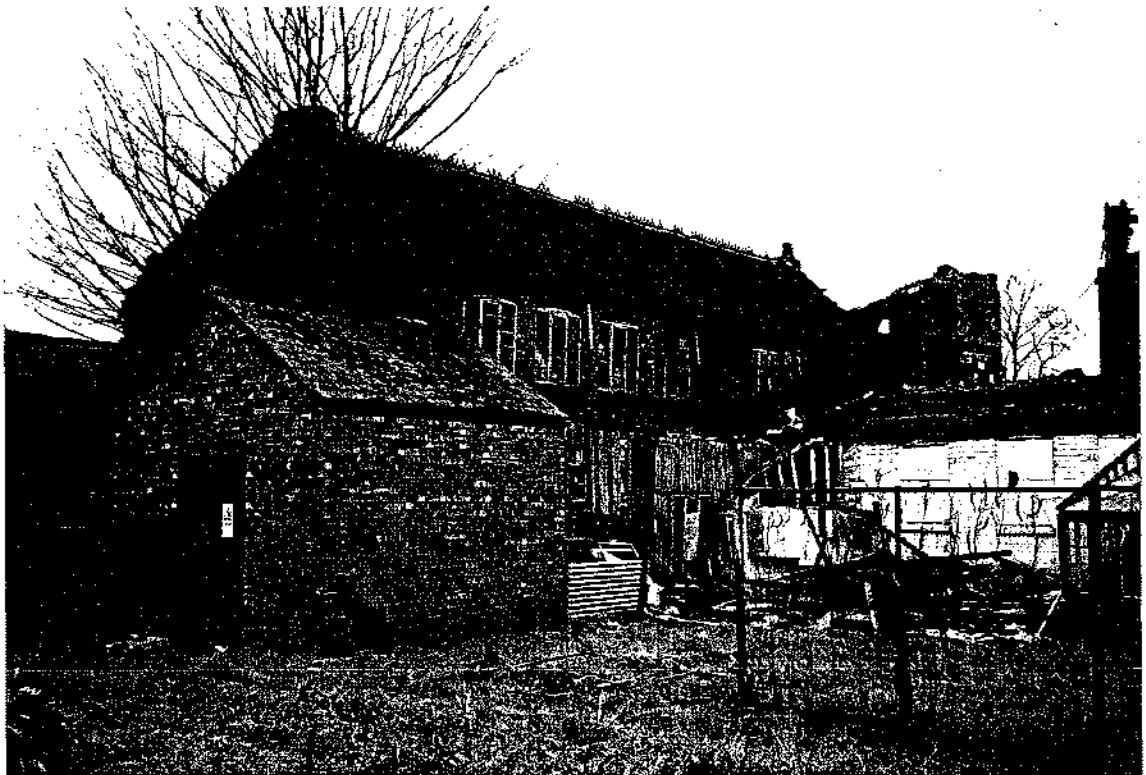
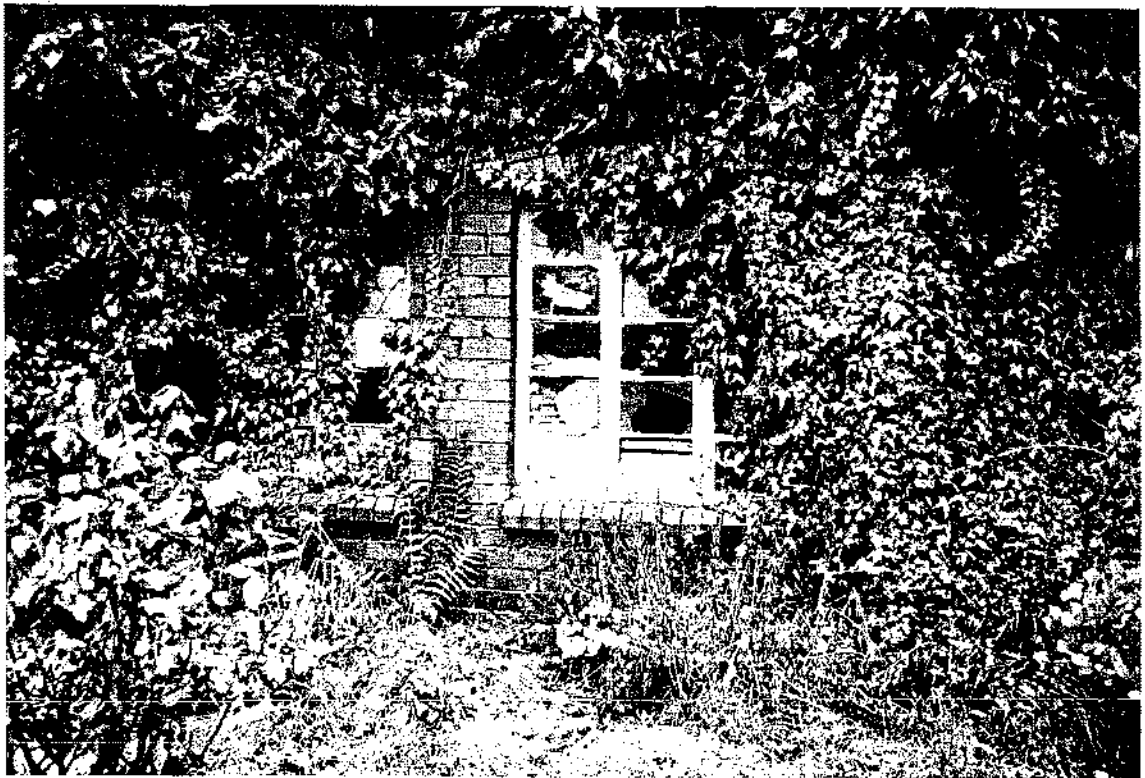
A purpose-built, two-storey, late-Victorian 'industrial vernacular' lock-making factory, originally freestanding within a yard to the rear of the Turf Tavern. Blue brick details around the windows and doors and decorated ridge tiles indicate the building was at the higher end of the quality scale for industrial structures of this type and period. Original open plan on both floors with exterior staircase providing access to the first floor was later sub-divided by wooden panelling and an interior staircase. Dimensions 17m by 6.75m externally (excluding staircase).

Plain tile saddleback roof with decorated ridge tiles with fleur-de-lys and club pattern. Many of the tiles are broken or missing. Roof structure of sawn and nailed timber, thin-section ridge piece and pairs of equidistant purlins supported by simple triangular trusses with diagonal struts from the tie-beam and a central vertical iron tie-bar. Trusses arranged between every two bays of the building with an extra truss at the east end to strengthen and support the lathe-booms located here.

Main elevation 9 bays in length defined by windows and doorways set into three-brick thick walls. Gable ends only double-brick thickness. The bonding of the main elevation is irregular, while that of the gables is of alternate courses of Flemish Bond with three stretcher courses between. Brick of main build is machine-cut red brick, dimensions 9" by 3 1/4" by 4". A large proportion of the main elevation is taken up by glazing, good lighting being an important requirement of lockmaking. The windows have chamfered blue brick sills. The segmental arches are also picked out in blue brick, the ground floor arches are of double blue brick laid on edge, the upper windows have only single-brick arches. There are wooden-framed triple casement windows with five rectangular lights to each window, generally the central window opens for ventilation.

Structure 1: general view and detail

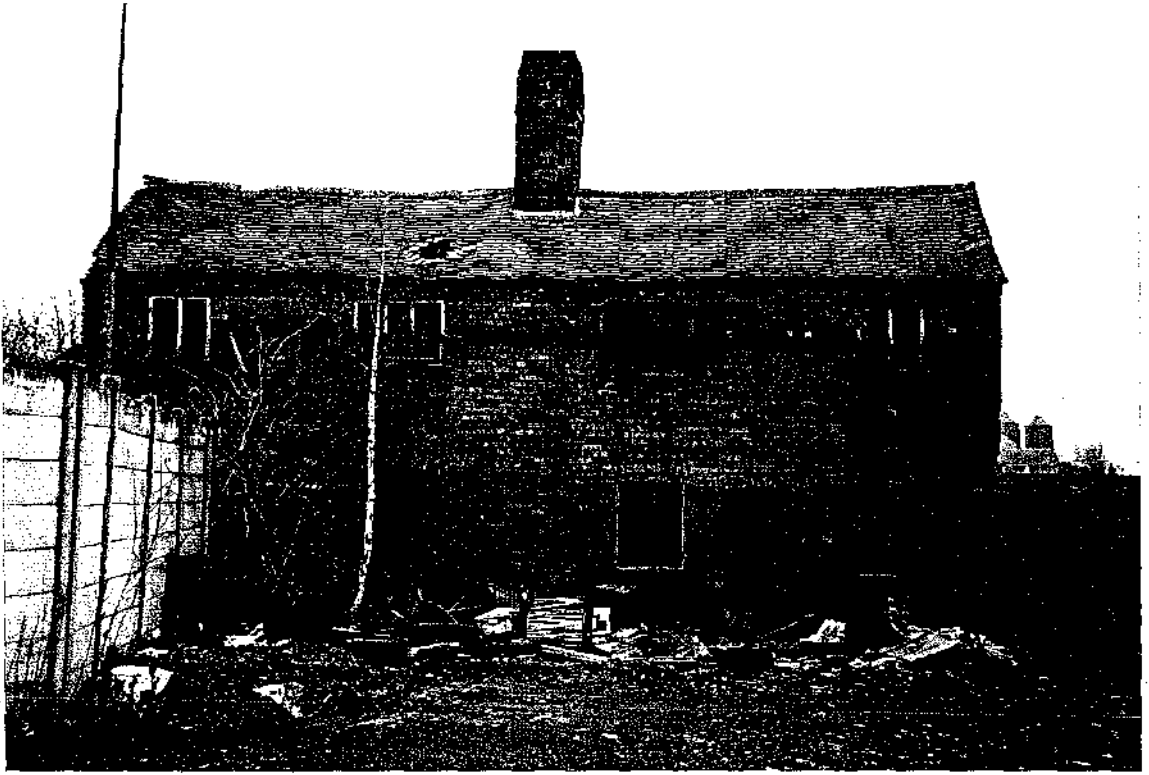
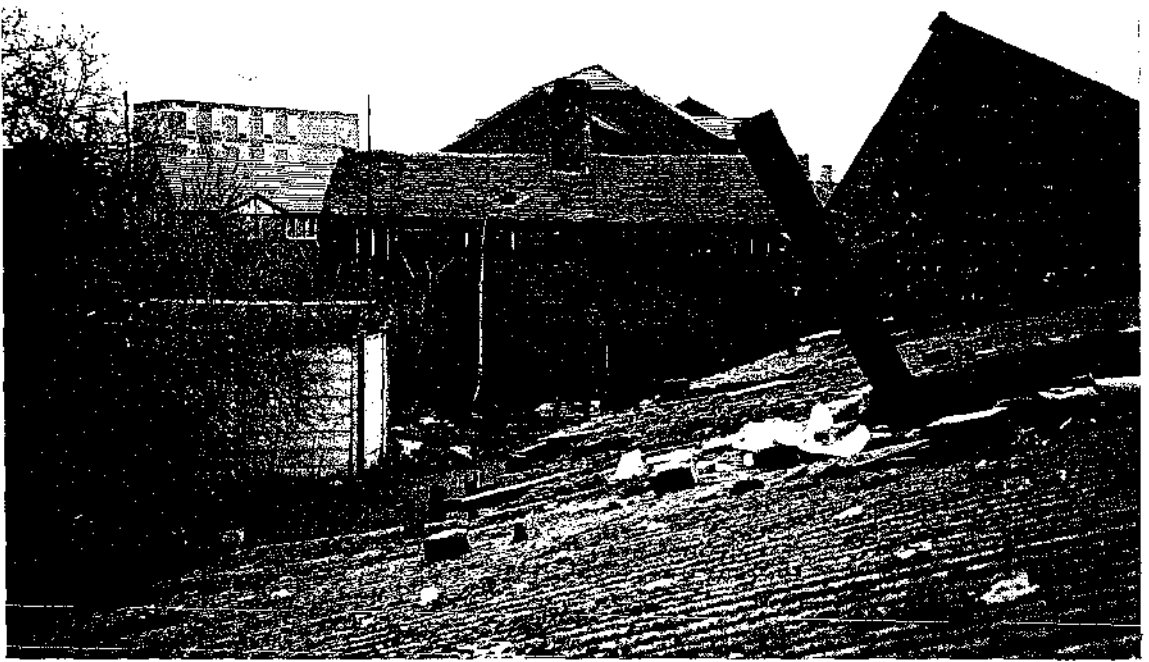
It was not possible to carry out an internal inspection of Structure 4 because of its dangerous fire-damaged condition and insanitary interior created by a roosting pigeon population. The building consists of a pair of two-storey, blind-backed, low status court buildings arranged either side of a central chimney stack serving both properties. The construction of Structure 4 is cheap and simple with a plain tile low saddleback roof and badly-fired locally produced red clamped-bricks (dimensions 9" by 2 7/8" by 4 1/4"). The walls are irregularly bonded. There is an attempt at English Garden Wall Bond on the main elevation with four stretcher courses above ground-floor level, the gables have up to ten stretcher courses between irregular Flemish Bond. The windows

are simple with single edge-laid common brick arches to the ground floor and flat lintels on the first floor. The only decorative feature to break the bleak functional facade is the simple brick dentilation under the eaves of the main elevation

Fragility/vulnerability The building is in a dangerous condition which has been exacerbated by recent fire damage. In addition, the insanitary condition of the inside precludes further investigation without expensive protective precautions.

Structure 4
