Birmingham University Field Archaeology Unit
Project No. 466.01
May 1997

**An Archaeological Watching Brief
at
21-27 High Street, Bilston,
Wolverhampton, West Midlands
1997**

(SMR 9466)

by
Catharine Mould

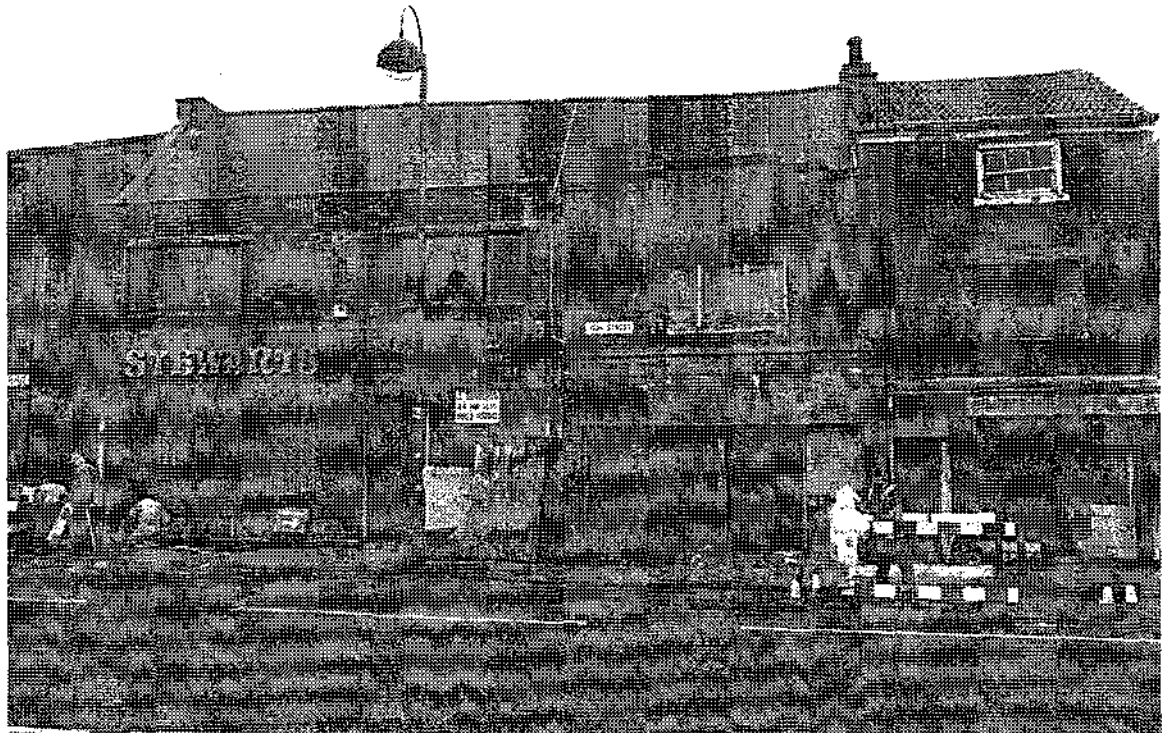
Plate 1

- 1 Numbers 21-27: High Street elevation.
- 2 Numbers 21-27: rear.
- 3 Numbers 21-27: removal of roof timbers.
- 4 Numbers 21-27: rear view of partially demolished structures.

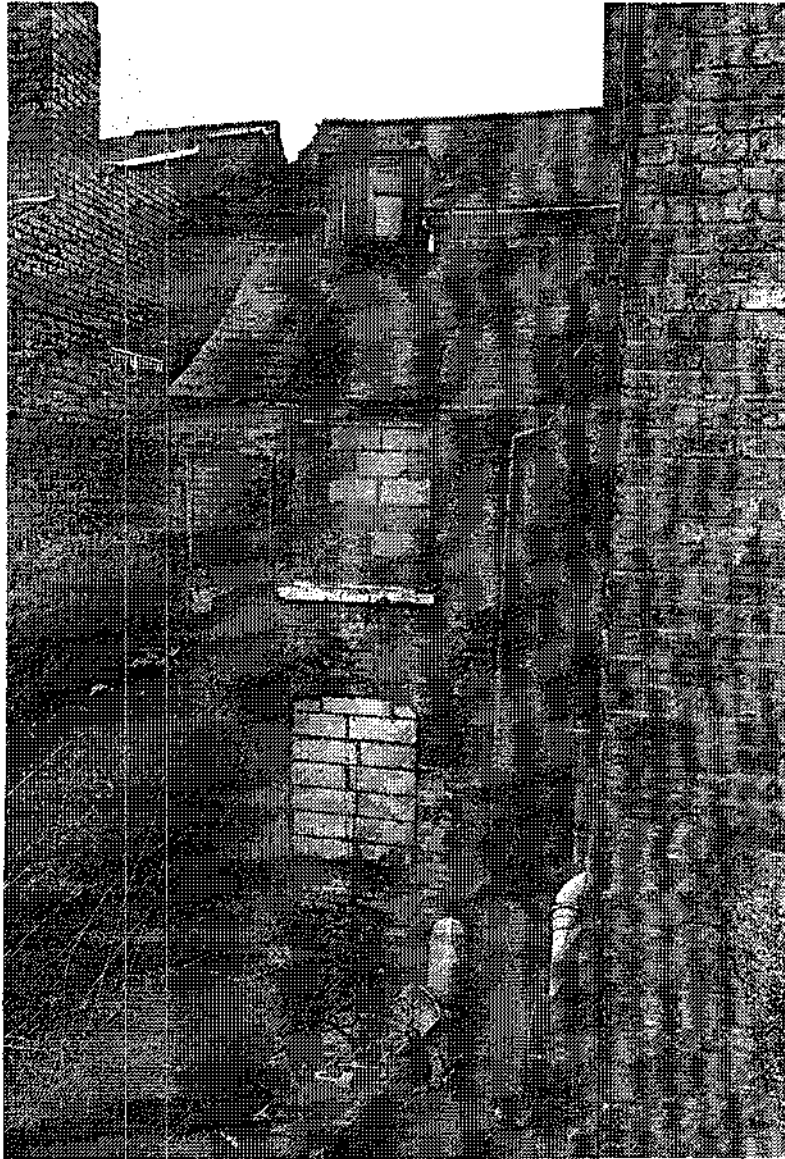
Plate 5

- 5 Number 21: rear view prior to demolition.
- 6 Number 21: rear view, roof tiles removed.
- 7 Numbers 21-23: cellar, taken from Number 23, showing arched entrance to cellar beneath Number 21.

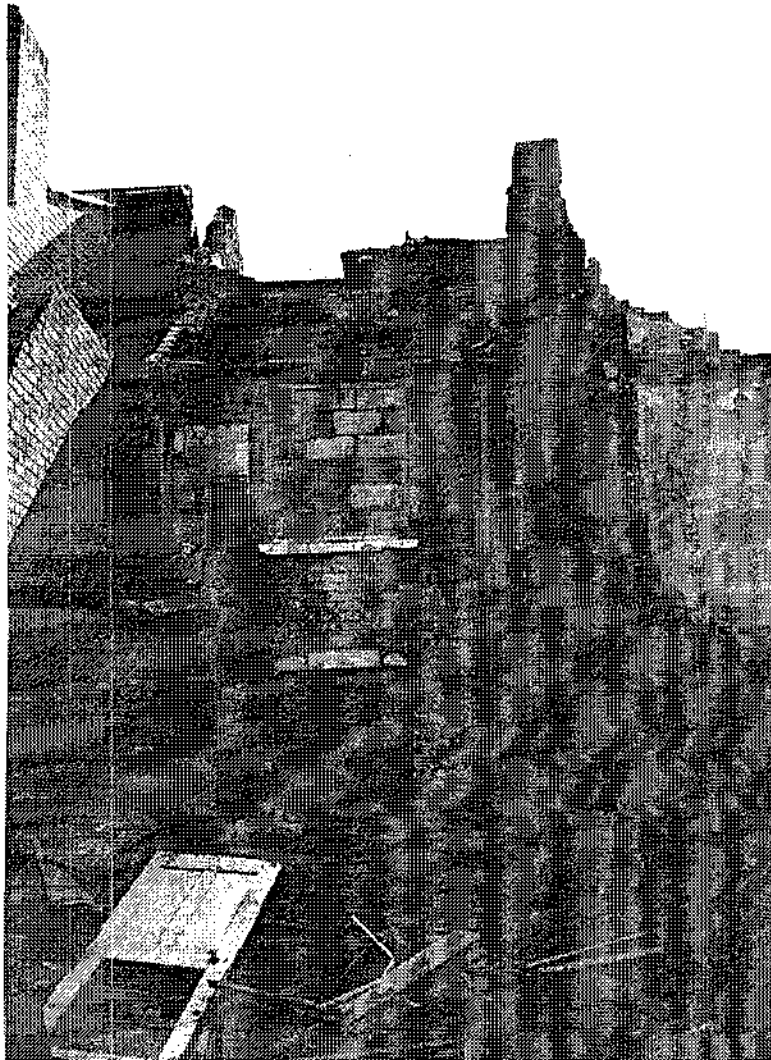
Plate 9

- 8 Number 21: cellar, showing remains of vaulted roof and decorative metal box set into the cellar wall.
- 9 Number 21: scarring on back wall.
- 10 Number 21: scarring on back wall and remains of earlier roof gable.

The removal of the roof over the main building and rear extension allowed further structural investigation (Plates 9 and 10). This indicated that the rear wings of Numbers 21 and 23 were added later in the life of both buildings. Numbers 21 and 23 were connected at the first and second storey levels. However, this was probably a relatively recent alteration, associated with the extension of retail space over virtually the entire ground floors of Numbers 21 and 23.

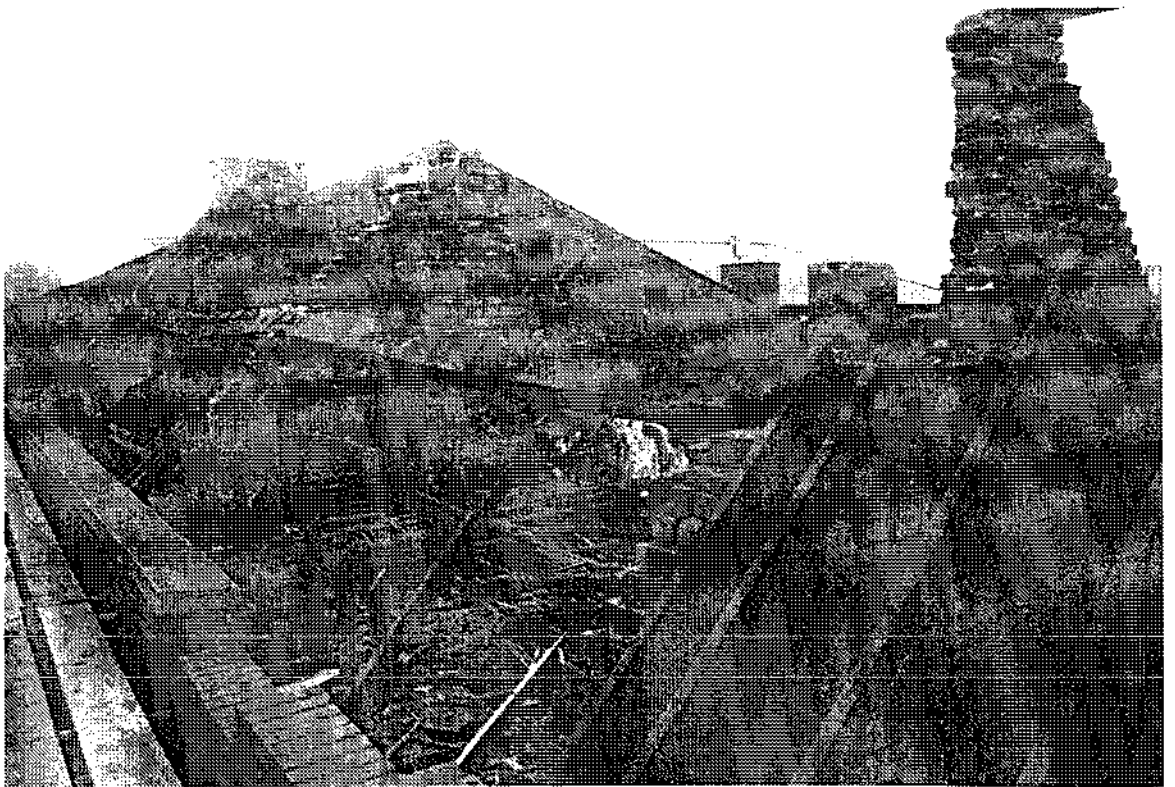
Plate 19

- 16 Number 23: re-used timbers.
- 17 Number 23: re-used timbers.
- 18 Number 23: re-used timbers.
- 19 Numbers 23-27: re-used timbers.
- 20 Numbers 23-25: re-used timbers.

The exposed front purlin of Number 23 was built into the brick party walls of the building and was jointed into a continuation of this arrangement over Numbers 25/27 (Plates 16-19). The purlin of Number 23 was clearly re-used, with regular, redundant, mortices and cuts, and probably originally formed part of the wall-plate of an earlier building. The roof structure at the back of Number 23 was mainly of later construction, associated with the rear wing of the property.

that of Number 23, and would appear to indicate that Numbers 23, 25 and 27 were built as a row of commercial premises (Dingwall 1997, map dated 1832). Again, the purlins were of re-used timber, set into the brick party walls between the properties. The purlin in Number 27 had sagged significantly as the scarf joint in the middle of its span had weakened. The timber appeared to have been a re-used rail from part of the wall-frame of a box-framed building. There was access between the roof spaces above Number 25 and Number 27.
