**A Desk-based Assessment and
Preliminary Recording of Buildings at 21
- 27 High Street, Bilston, Wolverhampton,
West Midlands**

Birmingham University Field Archaeology Unit
Project No. 466
February 1997

by
Lucie Dingwall

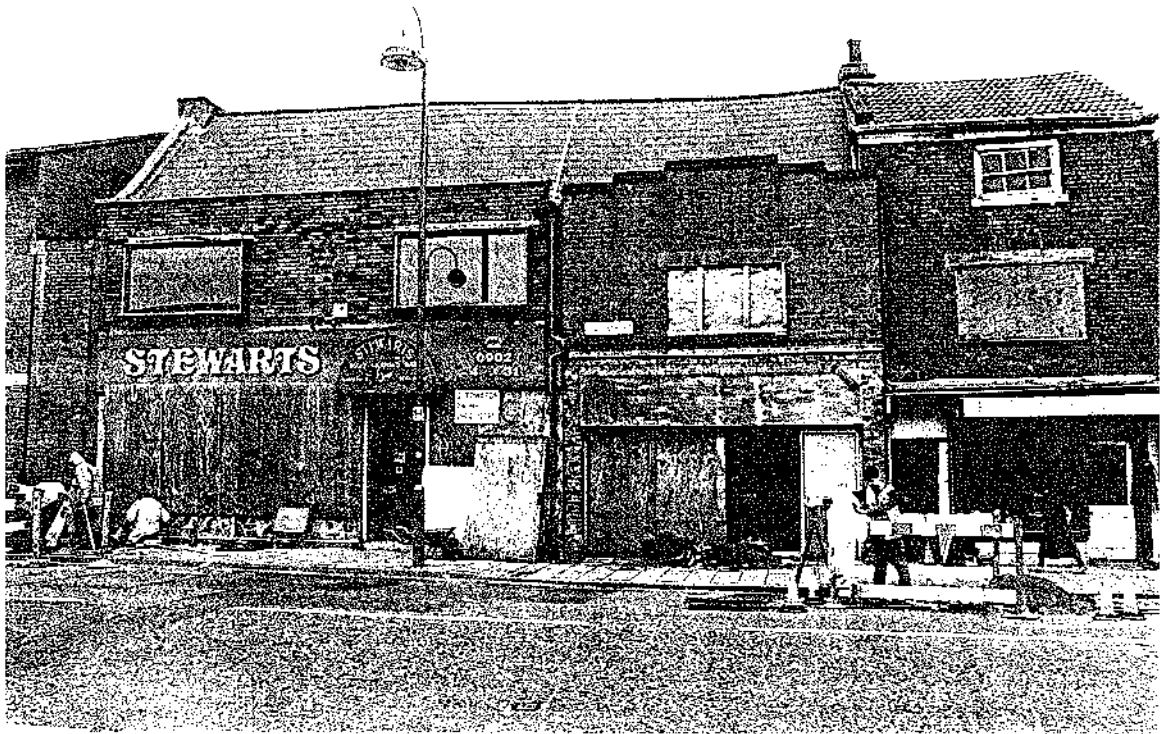
Plate 1

The front elevation of Number 21 is constructed of small hand-made bricks, approximately 9" x 2.5" in size, in Flemish bond. The first floor window is a modern opening with a concrete lintel, inscribed through the remains of an older, narrow, flat headed opening. The second floor window is a small attic window, probably dating from the early 19th-century (Plate 1).

The front elevation appears to be modern, constructed of machine bricks of Flemish bond and has a modern first floor window with a concrete lintel and a modern aluminium shop front (Plate 1).

Number 25/27 High Street is a brick building under a saddle-backed slate roof. The frontage is constructed of modern yellow bricks, with a modern shop front and two modern large paned windows at first floor level (Plate 1). Prior to its vacancy, it was in use as a bar.
