An Archaeological Watching Brief
at
Lower Farm, Aldersley, Wolverhampton,
West Midlands
1998

(SMR 6710/6712)

Birmingham University Field Archaeology Unit
Project No. 477.01
April 1998

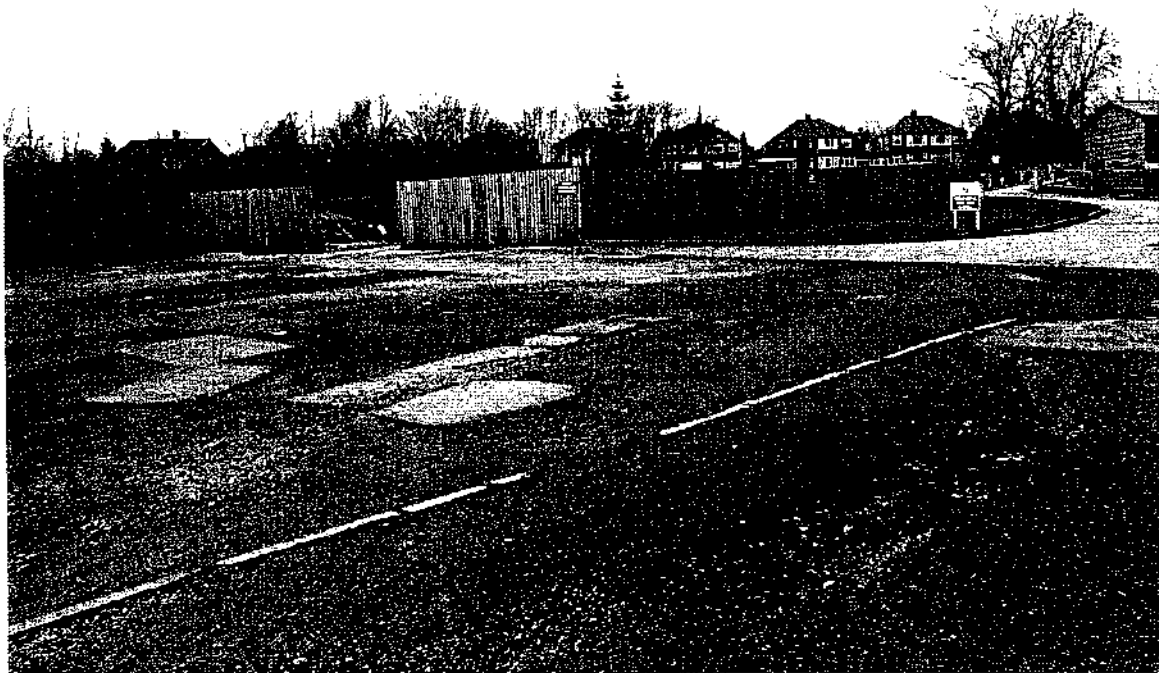
Plate 1: Former Location of Buildings A and B, Lower Farm

Former Location of Buildings A and B, Lower Farm (Plates 1-5)

No other deposits or features were observed within the Lower Farm site, as further enhancement works for creating a village green here comprised landscaping by importing material rather than by reducing the existing ground level.

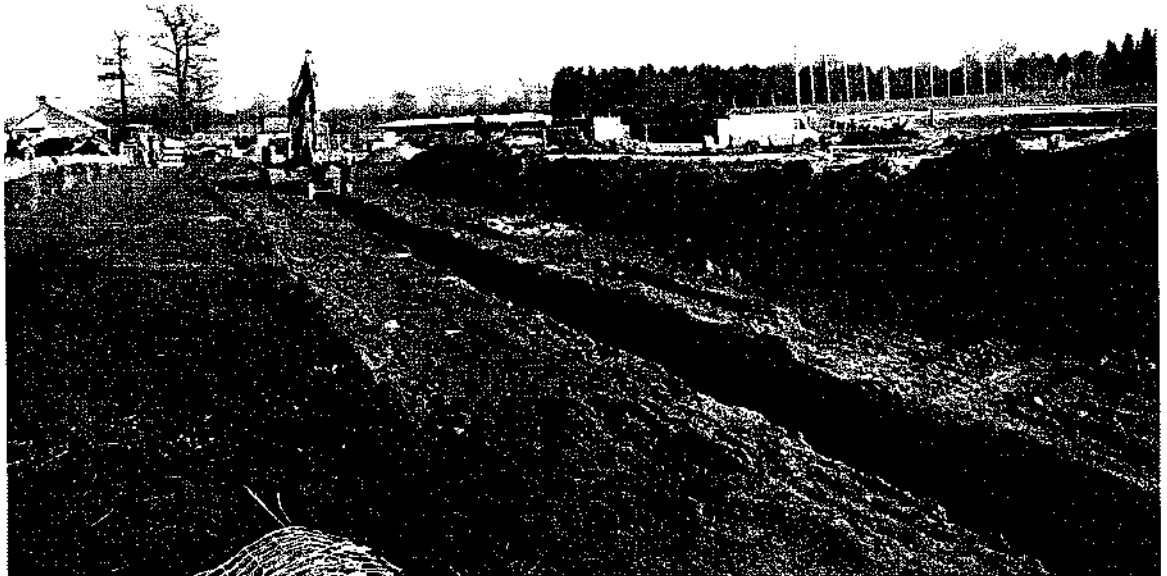
Plate 8: Section 6

The subsoil comprised a red-brown sand-clay with sparse sub-rounded stones, overlaid by a red-brown silty, clay-sand (6001). It was sealed by dark brown topsoil (6000). No archaeological deposits or features were recorded.
