**ST CHAD'S CHURCH, PATTINGHAM,
STAFFORDSHIRE
AN ARCHAEOLOGICAL
EVALUATION 1997**

Birmingham University Field Archaeology Unit
Project No. 492
September 1997

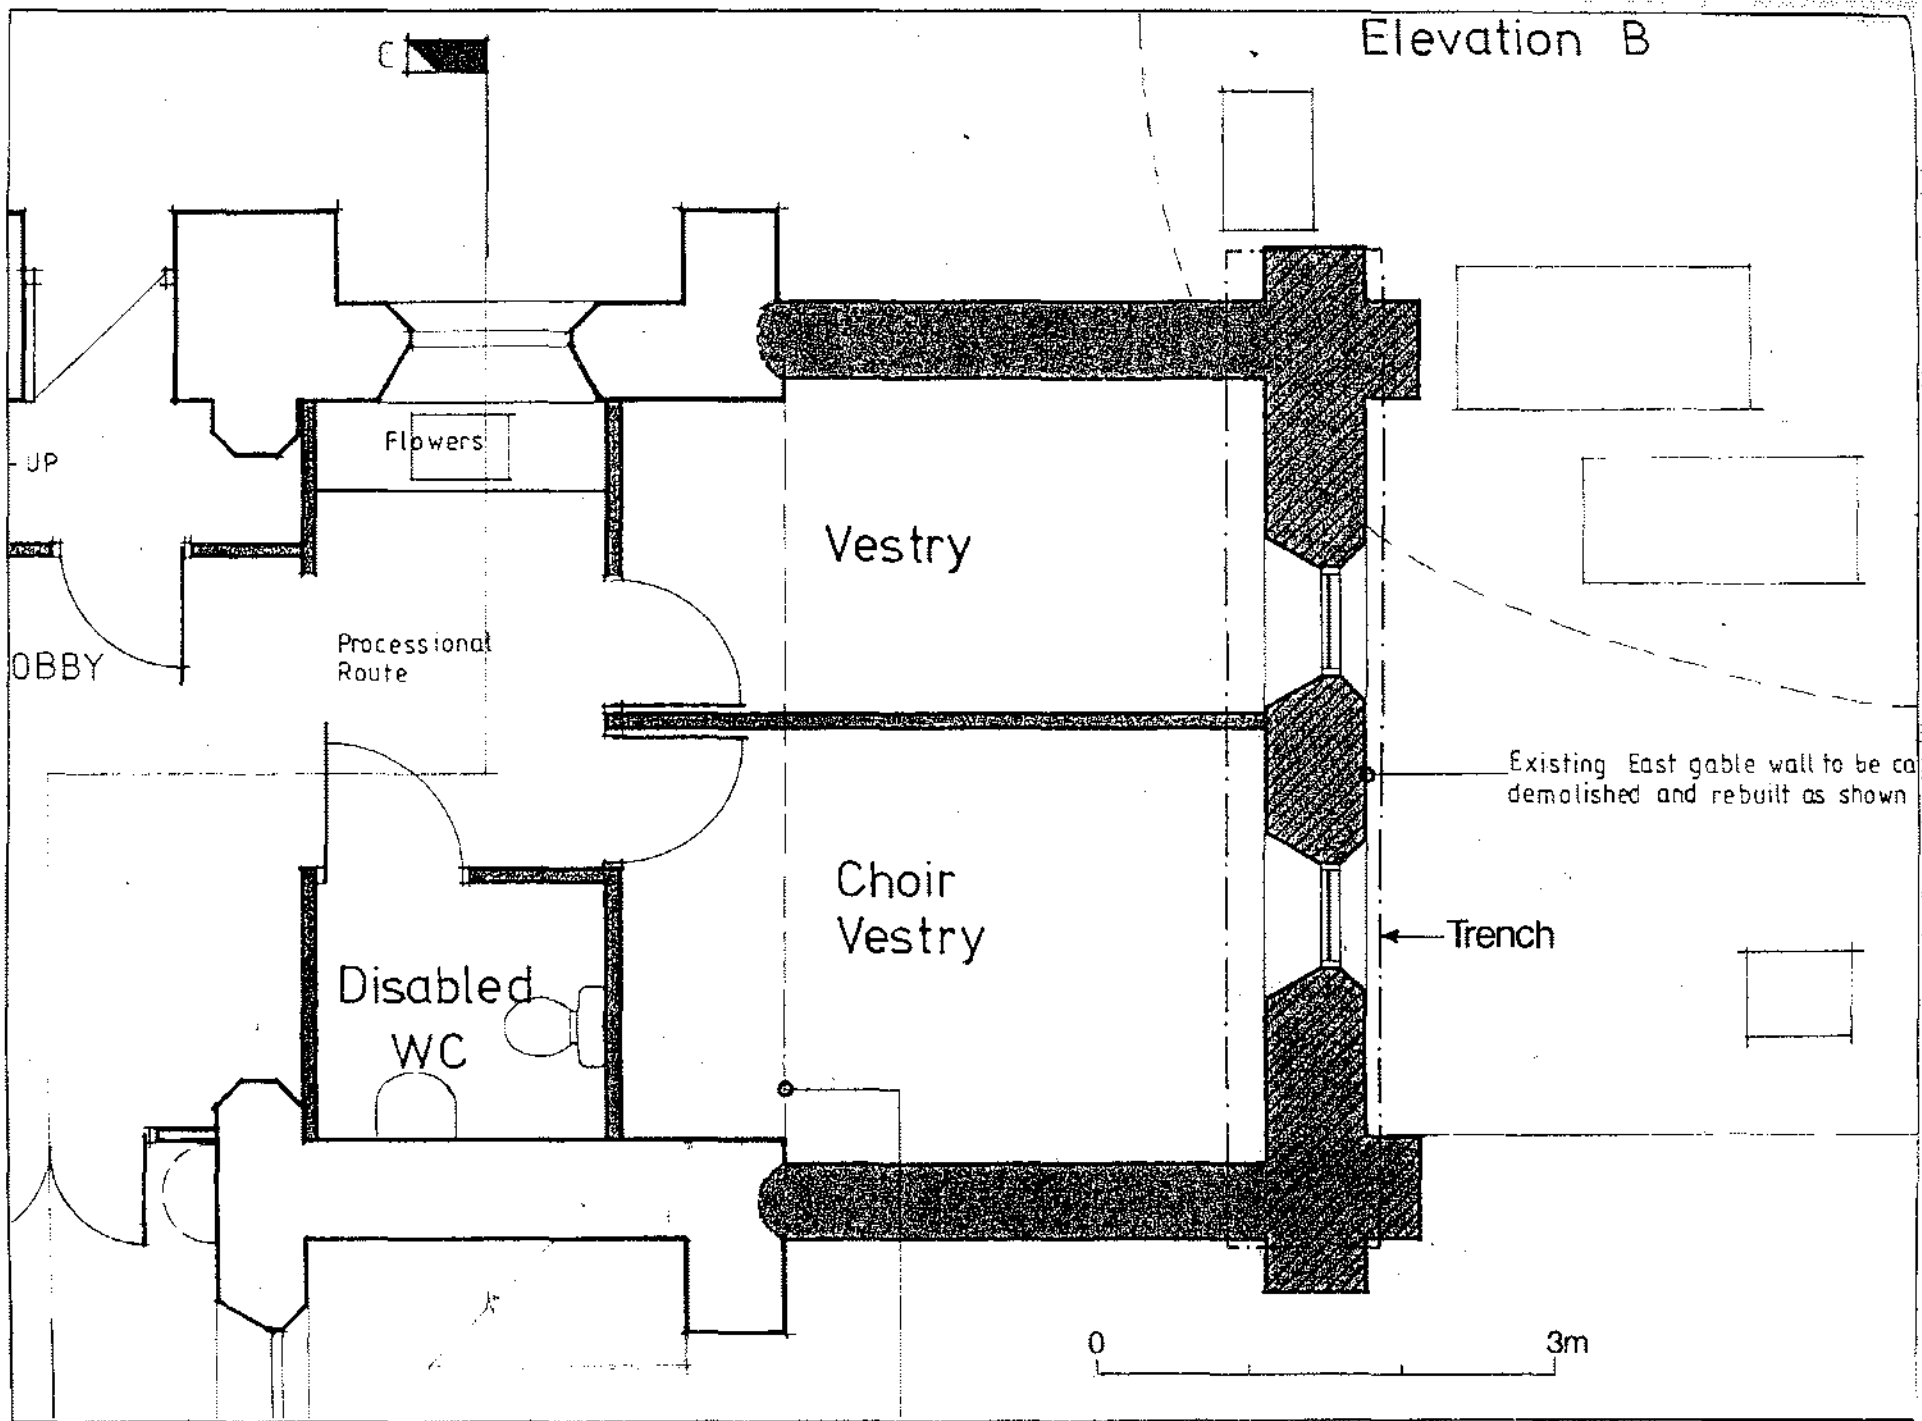
Fig 2

- 1 Location of site
- 2 Location of trial-trench (Based on Wood, Goldstraw and Yorath dwg. 189.5.6)
- 3A Plan of trench
- 3B Section of trench

3.0: METHODOLOGY (Fig. 2)

A single trench, aligned north-south, measuring 6.5m by 1m was excavated. The extreme northern end of the trench extended just into the present churchyard boundary. The trench was located along the line of the eastern wall of the proposed extension. The modern overburden was hand-excavated. The underlying deposits were systematically hand-excavated to a maximum depth of 0.75m below the modern ground surface, a limit specified in the Evaluation Brief and Schedule. Baulks were retained adjoining services during excavation, to prevent collapse or damage to service pipes, all of which were assumed to be still in use. Recording was by means of pre-printed pro-formas for contexts and features, scaled drawn sections and plans, supported by monochrome print and colour slide photography, all held in the archive. It is intended that the archive will be deposited in Stoke-on-Trent Museum.

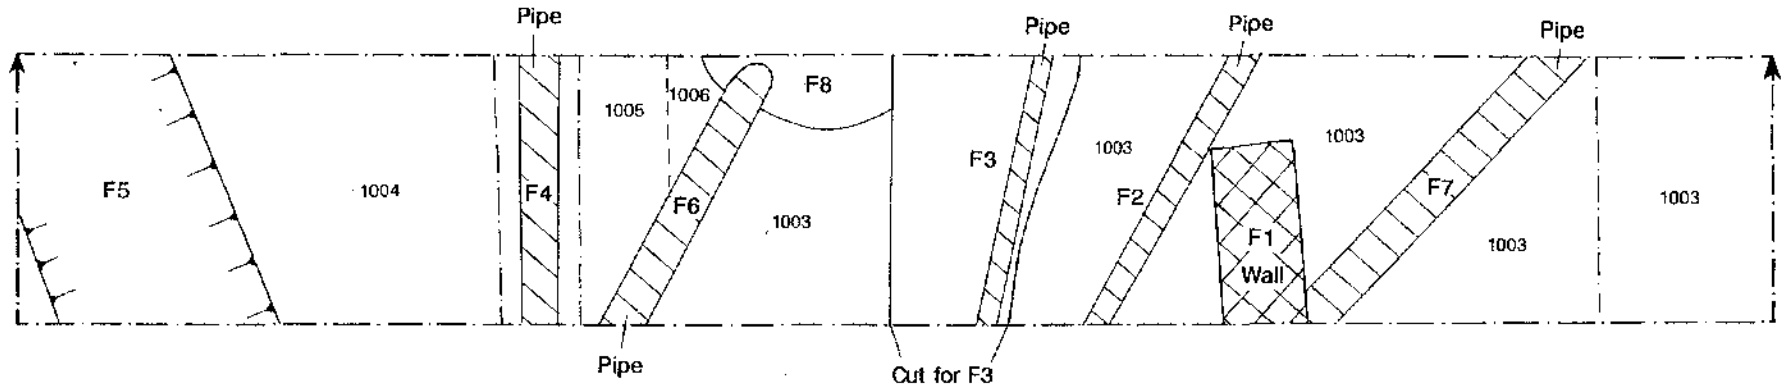
Trench 1 Plan

Due to the limit placed upon the depth of excavation (a maximum depth of 0.75m below the modern surface), the uppermost horizon of the natural subsoil was not located. The earliest deposit encountered in the south of the trench was a layer of dark brown sand-silt (1004), recorded for a depth of 0.4m. The base of this deposit was not reached because of the limits placed upon depth of excavation. Further to the north the earliest deposit recorded was a layer of clean red clay (1005) containing fragments of coal. This layer is interpreted as a make-up horizon. Further to the north was a drain junction (F8). It was sealed by a layer of brown-clay silt (1006).

In the south of the trench layer 1004 was cut by a service trench (F5). This feature was backfilled with a deposit of red sand (1003), containing brick fragments, which also extended to the north, sealing layers 1004, 1005, 1006 and feature F8. Layer 1003 was cut by two drains (F4 to the south, and F7 to the north). Layer 1003, and the backfill of the drains (F4 and F7) were sealed by a layer of mid-brown sand-silt (1002), identified along the whole length of the trench. This layer was cut by a brick wall (F1), aligned approximately west-east, and by two adjacent service trenches (F2 and F3). Layer 1002 was sealed in the south of the trench by a gravel surface (1001), and by shallow topsoil (1000), in the extreme south of the trench.

No features or deposits associated with burials, or earlier builds of the church were identified. The features mainly comprise services, which may remain in use. Feature F1 was the western terminus of an east-west aligned wall. Layers 1003 and 1002 may be levelling-up horizons associated with the excavation of the service trenches.
