St Peter's Church
Barford
Warwickshire

An Archaeological
Watching Brief
1998

Birmingham University Field Archaeology Unit
Project No. 510
November 1998

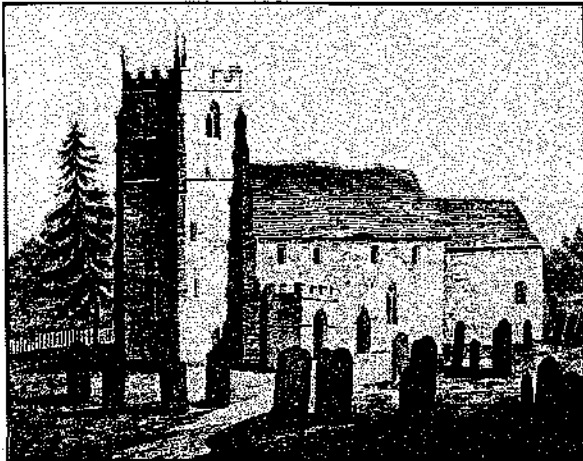
Plate 2. 1820 Water-colour of Barford Church (Southern Face)

A water-colour dating from c.1820 (VCH, 1949, from a drawing in the Aylesford collection, which is held in the Birmingham Reference Library) shows the southern side of the church before it was rebuilt (Plate 2). On this illustration the building does not have a southern aisle, and there are marked graves situated close to the church. The presence of an earlier medieval aisle, possibly occupying the same area as the present aisle, is suggested by the remaining stonework of the three large gothic arches. These are visible within the external fabric of the nave. The size, as well as the close proximity of these features to each other, makes it seem unlikely that they are the remains of former window openings.

The southern facade of the pre-1844 building does not display the same uniformity of build as the present church. Other architectural features suggest that the dimensions of the building have been altered several times, often without any attempt to imitate or complement earlier architectural conventions. These factors may reflect the low importance of St. Peter's as one of the acquisitions of a monastic establishment, as well as possibly mirroring fluctuations in the population and prosperity of Barford.

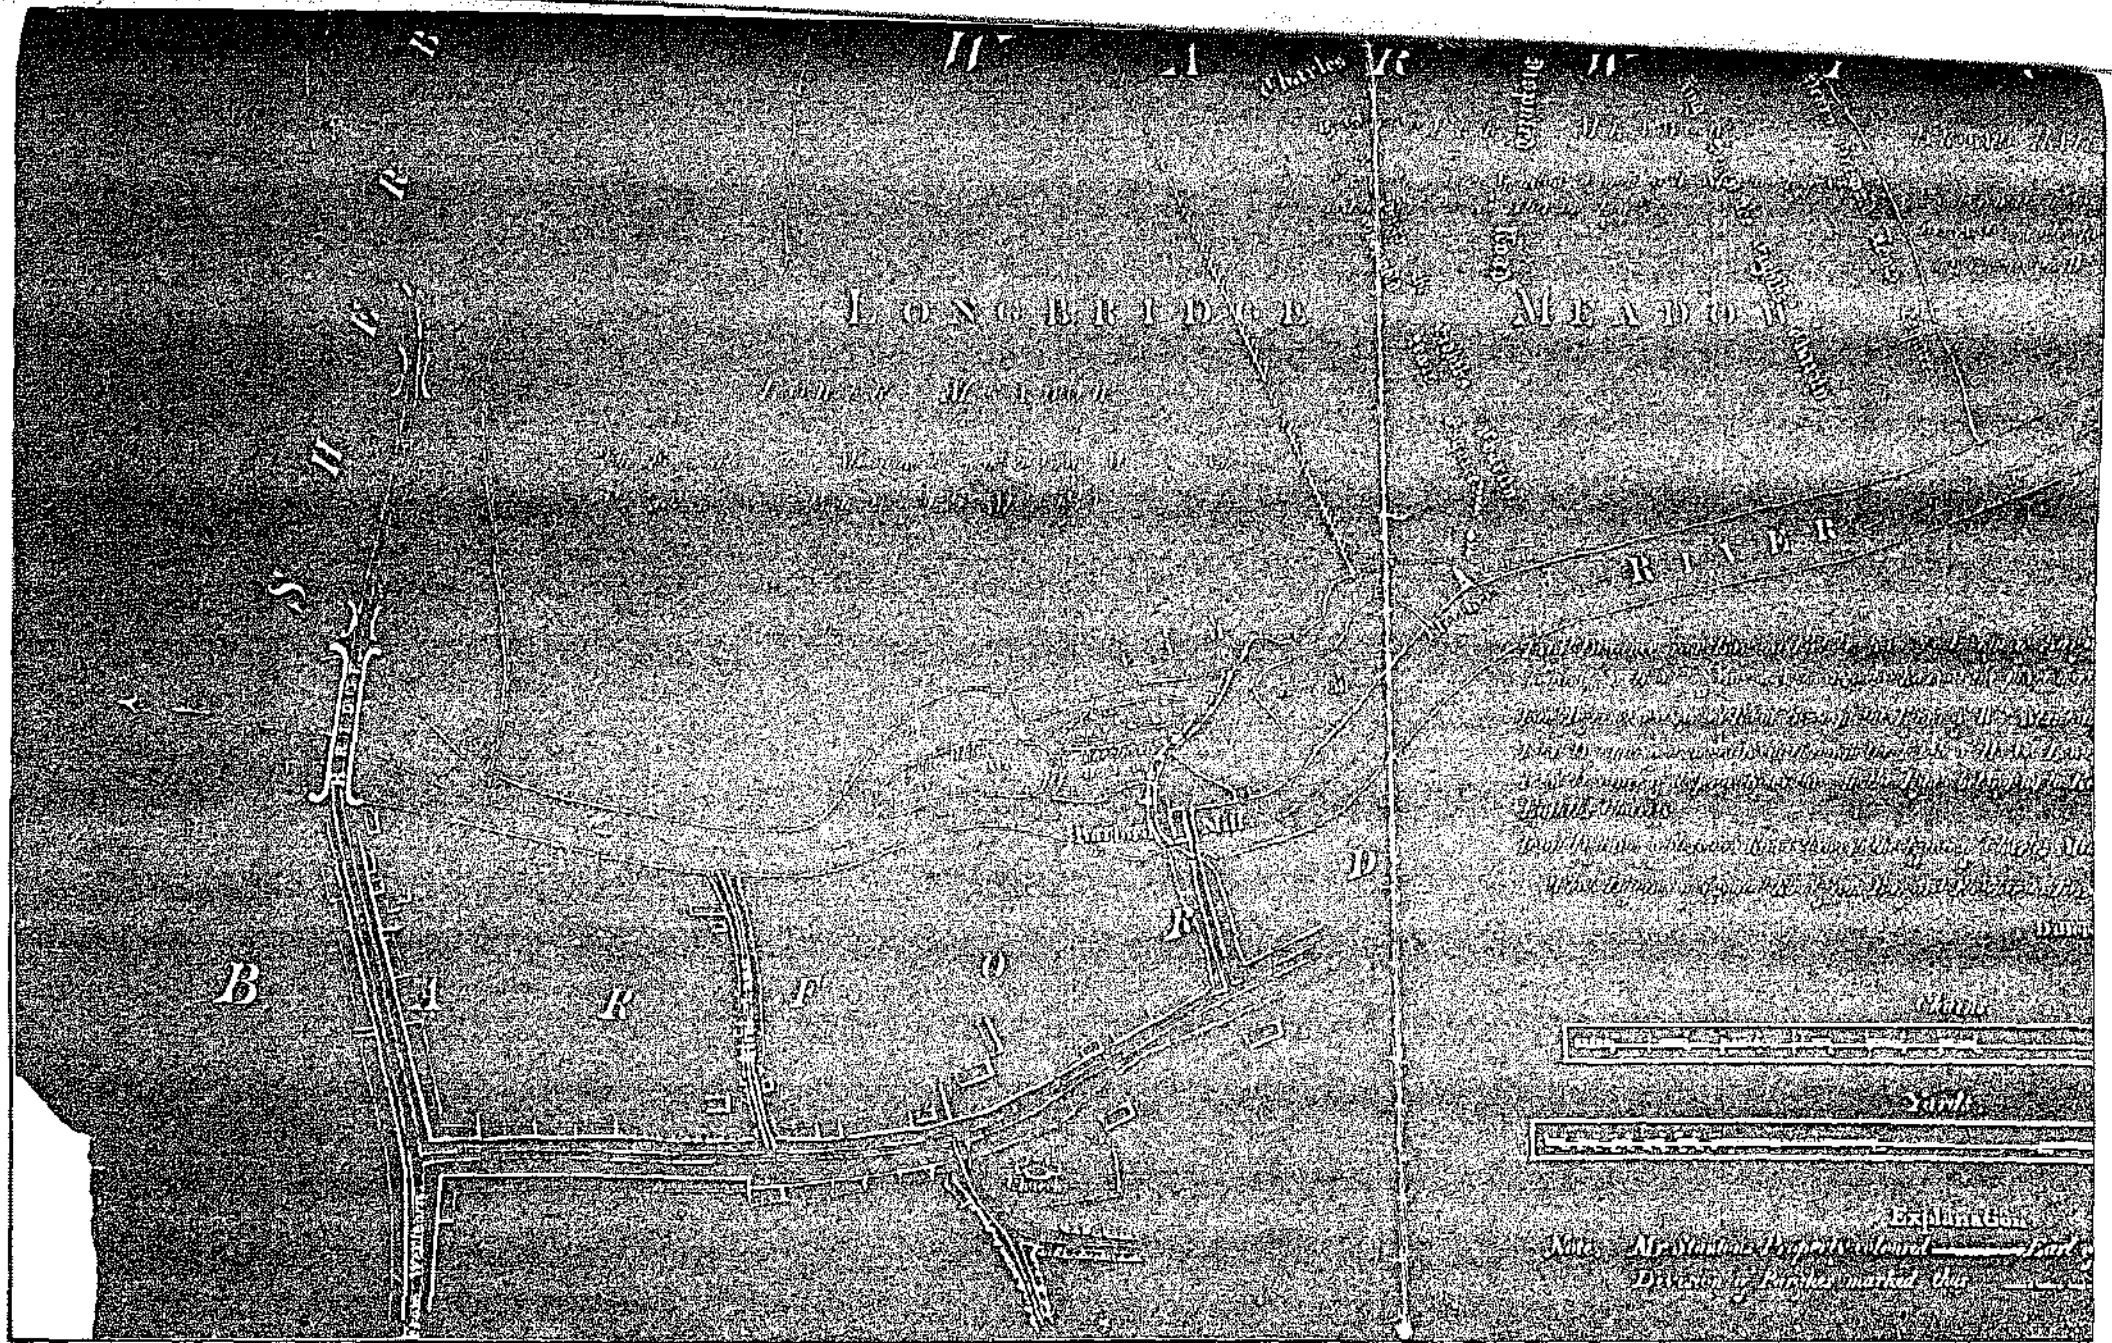
Fig.3

St. Peter's church is situated in the centre of Barford. The name of the village suggests that it originated on the site of an early, possibly Saxon, crossing of the River Avon (Twigger, 1982, 7). The settlement lies on the southern side of the river, between the ancient commercial centres of Warwick and Kington. Early references to mills in Barford (VCH, 1949, 12) attest to the economic importance of the river to the village. A mill is referred to in 1806, and three such establishments were granted to the monks of Bordesley in 1205 (Warwickshire SMR No.WA 702). These appear on the Eden map of 1811 (Fig. 3).

1811 (W.Eden) Parish of St. Mary & Barford & Sherbourne

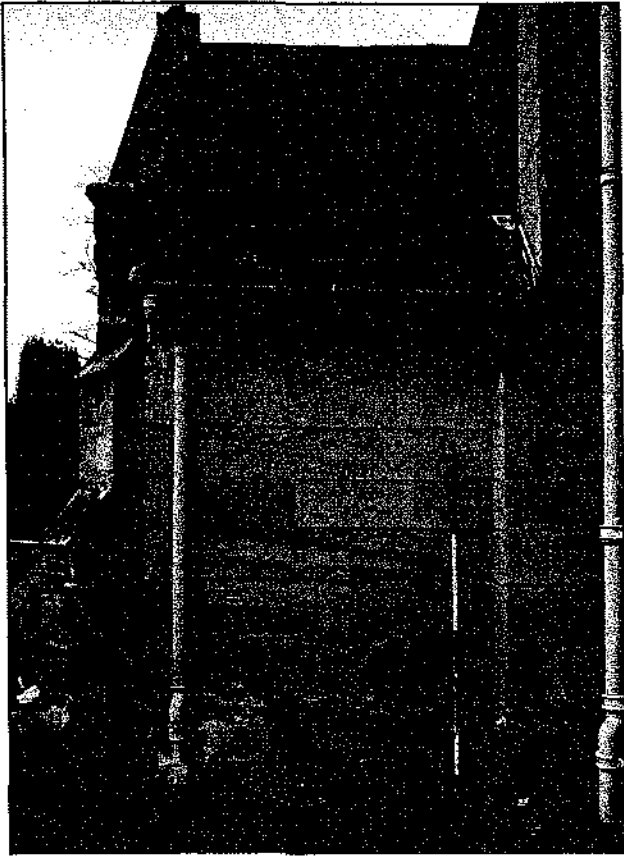
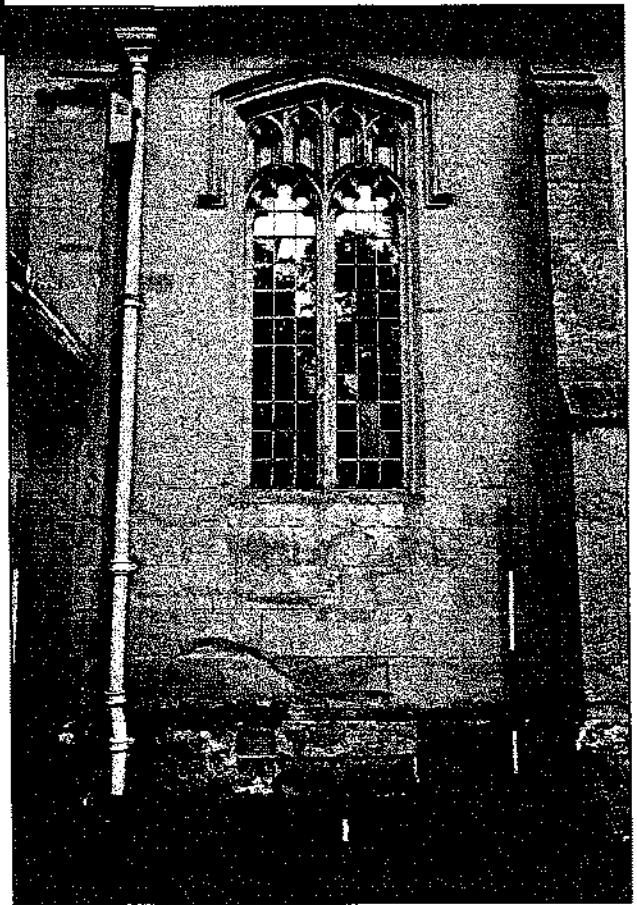
The work also involved alterations to the church porch to allow access to the new extension. This involved the removal of a small window and the subsequent enlargement to allow the inclusion of a doorway into the extension. Prior to this work the east facing wall of the porch was photographically recorded (Plates 10 and 11 at rear of report).
