Birmingham University Field Archaeology Unit  
**Project No. 517**  
March 1998

**49, New Street, Dudley, West Midlands**  
**An Archaeological Evaluation**

by  
S.J.Linnane

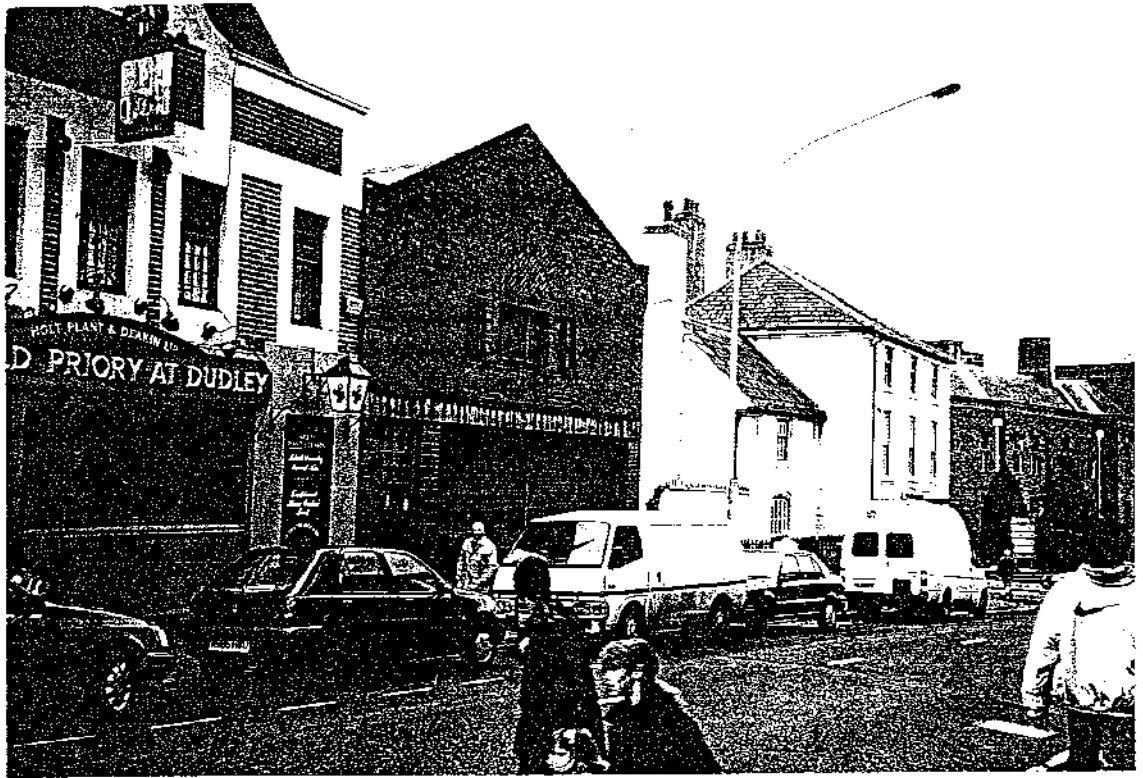
1

- Structure A The main building fronting New Street (Plate 1).
- Structure B A three-quarter width rear range (Plate 2).
- Structure C The modern infill of the yard area between Structure B and the properties fronting Priory Street, only recorded photographically.
