Birmingham University Field Archaeology Unit
Project No. 525
April 1998

**Archaeological Recording at 'The Hovel',
192, Jerry's Lane, Erdington, Birmingham**

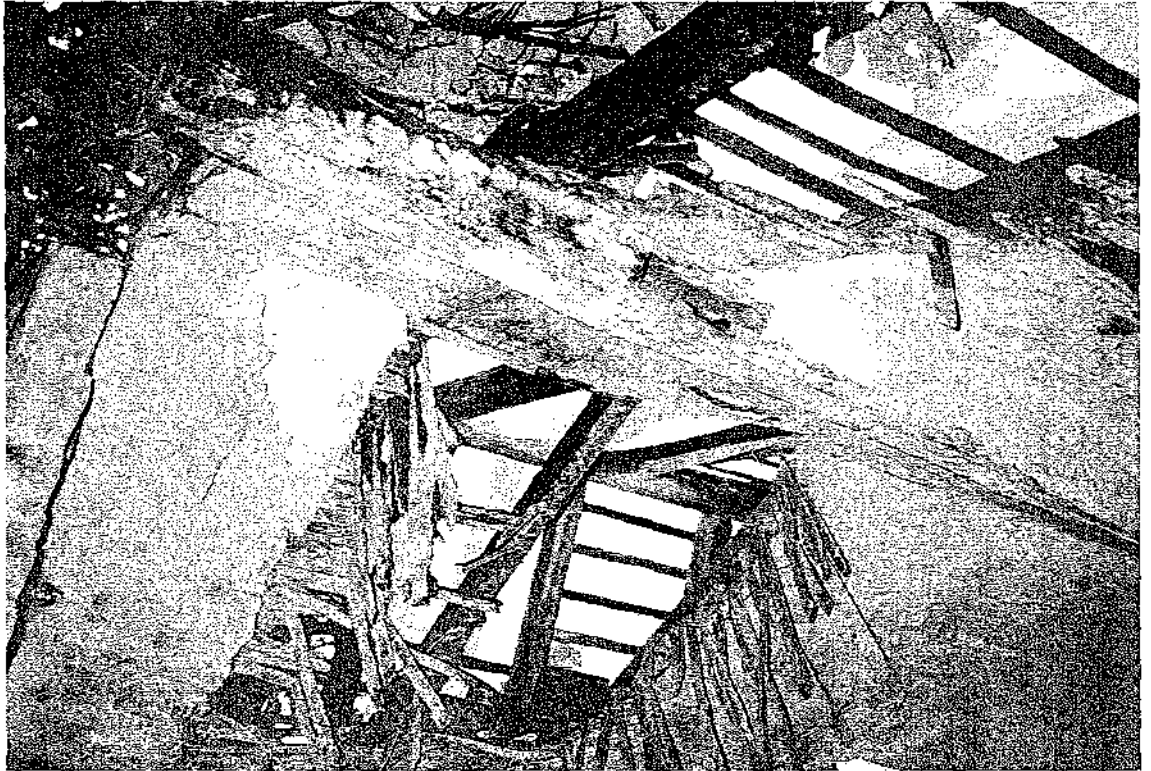
- 1 General view down Jerry's Lane, 'The Hovel' on the left.
- 2 Detail of interior floor beam - ground floor.
- 3 Detail of wall plate and small tie-beam - first floor.
- 4 Northern purlin, detail.
- 5 Southern purlin, note empty mortice.
- 6 Quarry tile floor, wash-house.
- 7 Cast-iron 'copper'.
- 8 Interior of outside toilet.
- 9 South elevation.
- 10 South elevation.
- 11 South elevation.
- 12 South elevation.
- 13 South elevation.
- 14 West gable.
- 15 West gable.
- 16 East gable.
- 17 East gable.
- 18 East gable.
- 19 Detail of eaves, southeast corner.
- 20 Detail, old gas cooker.
- 21, 22 2, Fern Road, Erdington, late-18th century cottage built on the waste.
- 23 Station Road Cottages, Erdington.
- 24 Berwood Cottages, Chester Road, Erdington, 17th century origins.

Inspection of the upper floor was limited to what could be seen through the various holes in the fabric of the building. There were two tiny bedrooms on the first floor. Access must have been via a staircase or ladder into the eastern room. A connecting doorway was cut through the single brick-thick partition wall over the central floor beam. The doorway also cut a thin-sawn tie-beam set into the partition wall which was positioned slightly beneath the existing wall plates (Plate 3). A similar beam was also seen in the east gable wall. The roof utilised a pair of roughly-cut reused purlins, originally set into the gable walls, which acted as trusses. The purlins were not split from the same piece of timber. The north purlin was very curved (Plate 4), the south purlin had a redundant mortice in its western end (Plate 5). Sawn rafters were laid on top of the purlins. A small dormer window was recorded by Demidowicz in the north-facing elevation near the east end of the building, but no trace of this was seen in the present survey.
