**An Archaeological Watching
Brief of Soft Stripping at 24
and 25 Sheepcote Street,
Birmingham
2000**

Project No. 615.02
July 2004

By
Chris Hewitson

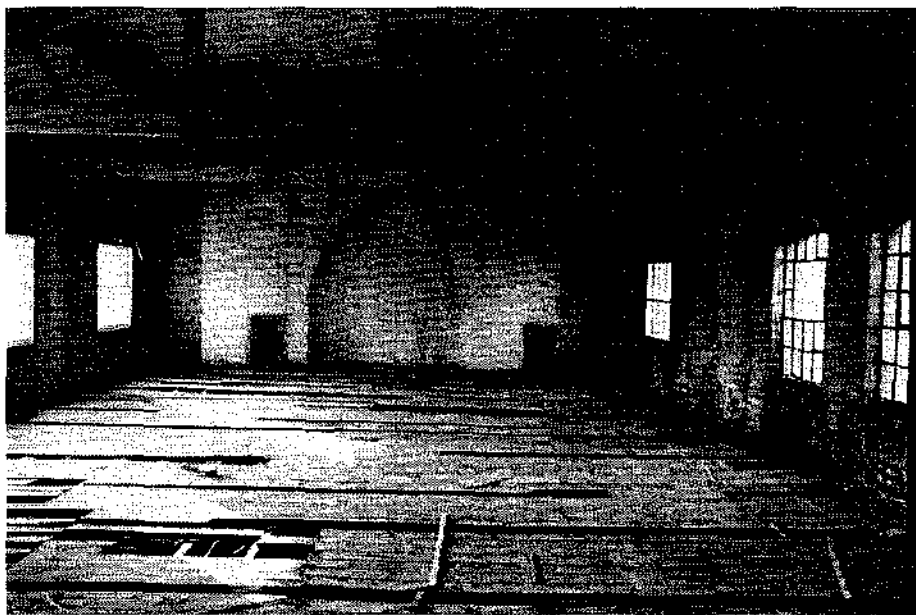
Plate 4

Results: The suspended ceiling was removed revealing a replacement roof with extensive damage to the south end (Plate 4). This was supported by three simple queen-post trusses of typical 19th century design. Iron-framed window with segmental-arched head exposed in north wall adjacent to the chimney (Plate 6 S24). Three fireplaces survived (Plate 5 S24), one in the northern end and two in the

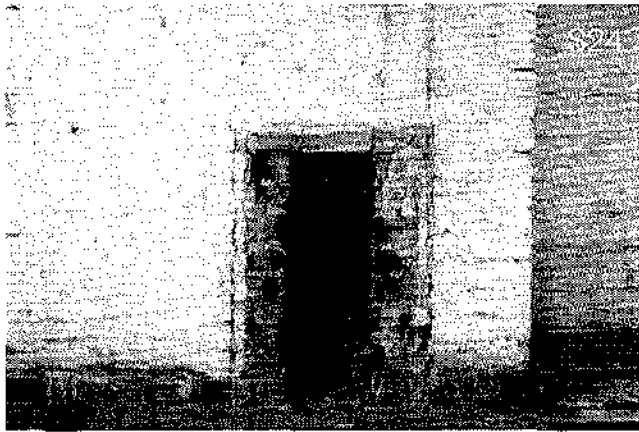
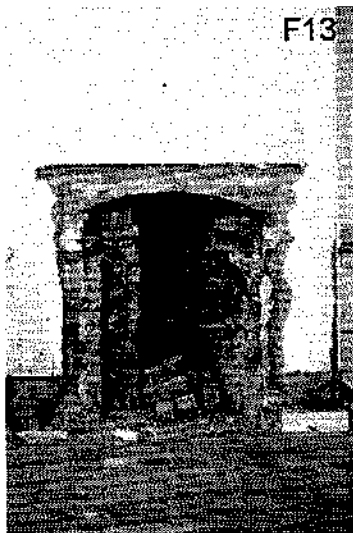
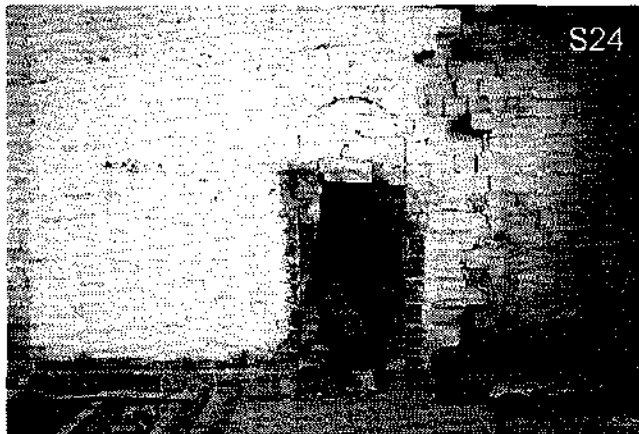
Results: Most architectural features were later replacements, including the skirting boards. No original architectural elements were revealed (Plate 5 F13, Plate 6 F11).

Results: Originally used as a large open counting room. Original skirting survived only between the two doors opposite the fireplace. The remainder of skirting was taller and a later replacement. Architrave and windows surrounds were likewise later replacements. (Plate 5, F16)

S22: Skirting boards of plain design like S19, central gas light, fireplace (Plate 5 S22), similar to S19 but larger, no grate survives, again inverse V profile to fire opening.

southern. They were of simple semi-circular arch design. No evidence of internal partitions and the floor appeared to have seen periodic alteration.

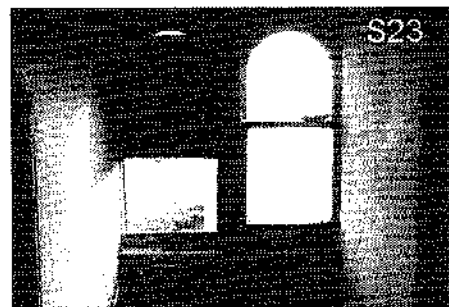
Plate 6

Only the south-western end of the room was plastered which may indicate that this was an office space prior to the removal of the passage. Removal of the plaster revealed an original doorway adjacent to the later cart entrance that was part of 25 Sheepcote Street (Plate 6, G9). The plasterwork was two skins deep and used horse hair, being whitewashed over the top. The southernmost and northernmost windows appeared to have been replaced at the same time as the blocking of the passageway, but originally appeared to have contained larger lights.

S23: Gas light no heating, suggested use as a store room (Plate 6, S23)
