**Land Bordered by Park
Road, Rose Lane and
High Street, Mansfield
Woodhouse,
Nottinghamshire:**

**an archaeological desk-based
assessment**

Birmingham University Field Archaeology Unit
Project No. 678
February 2000

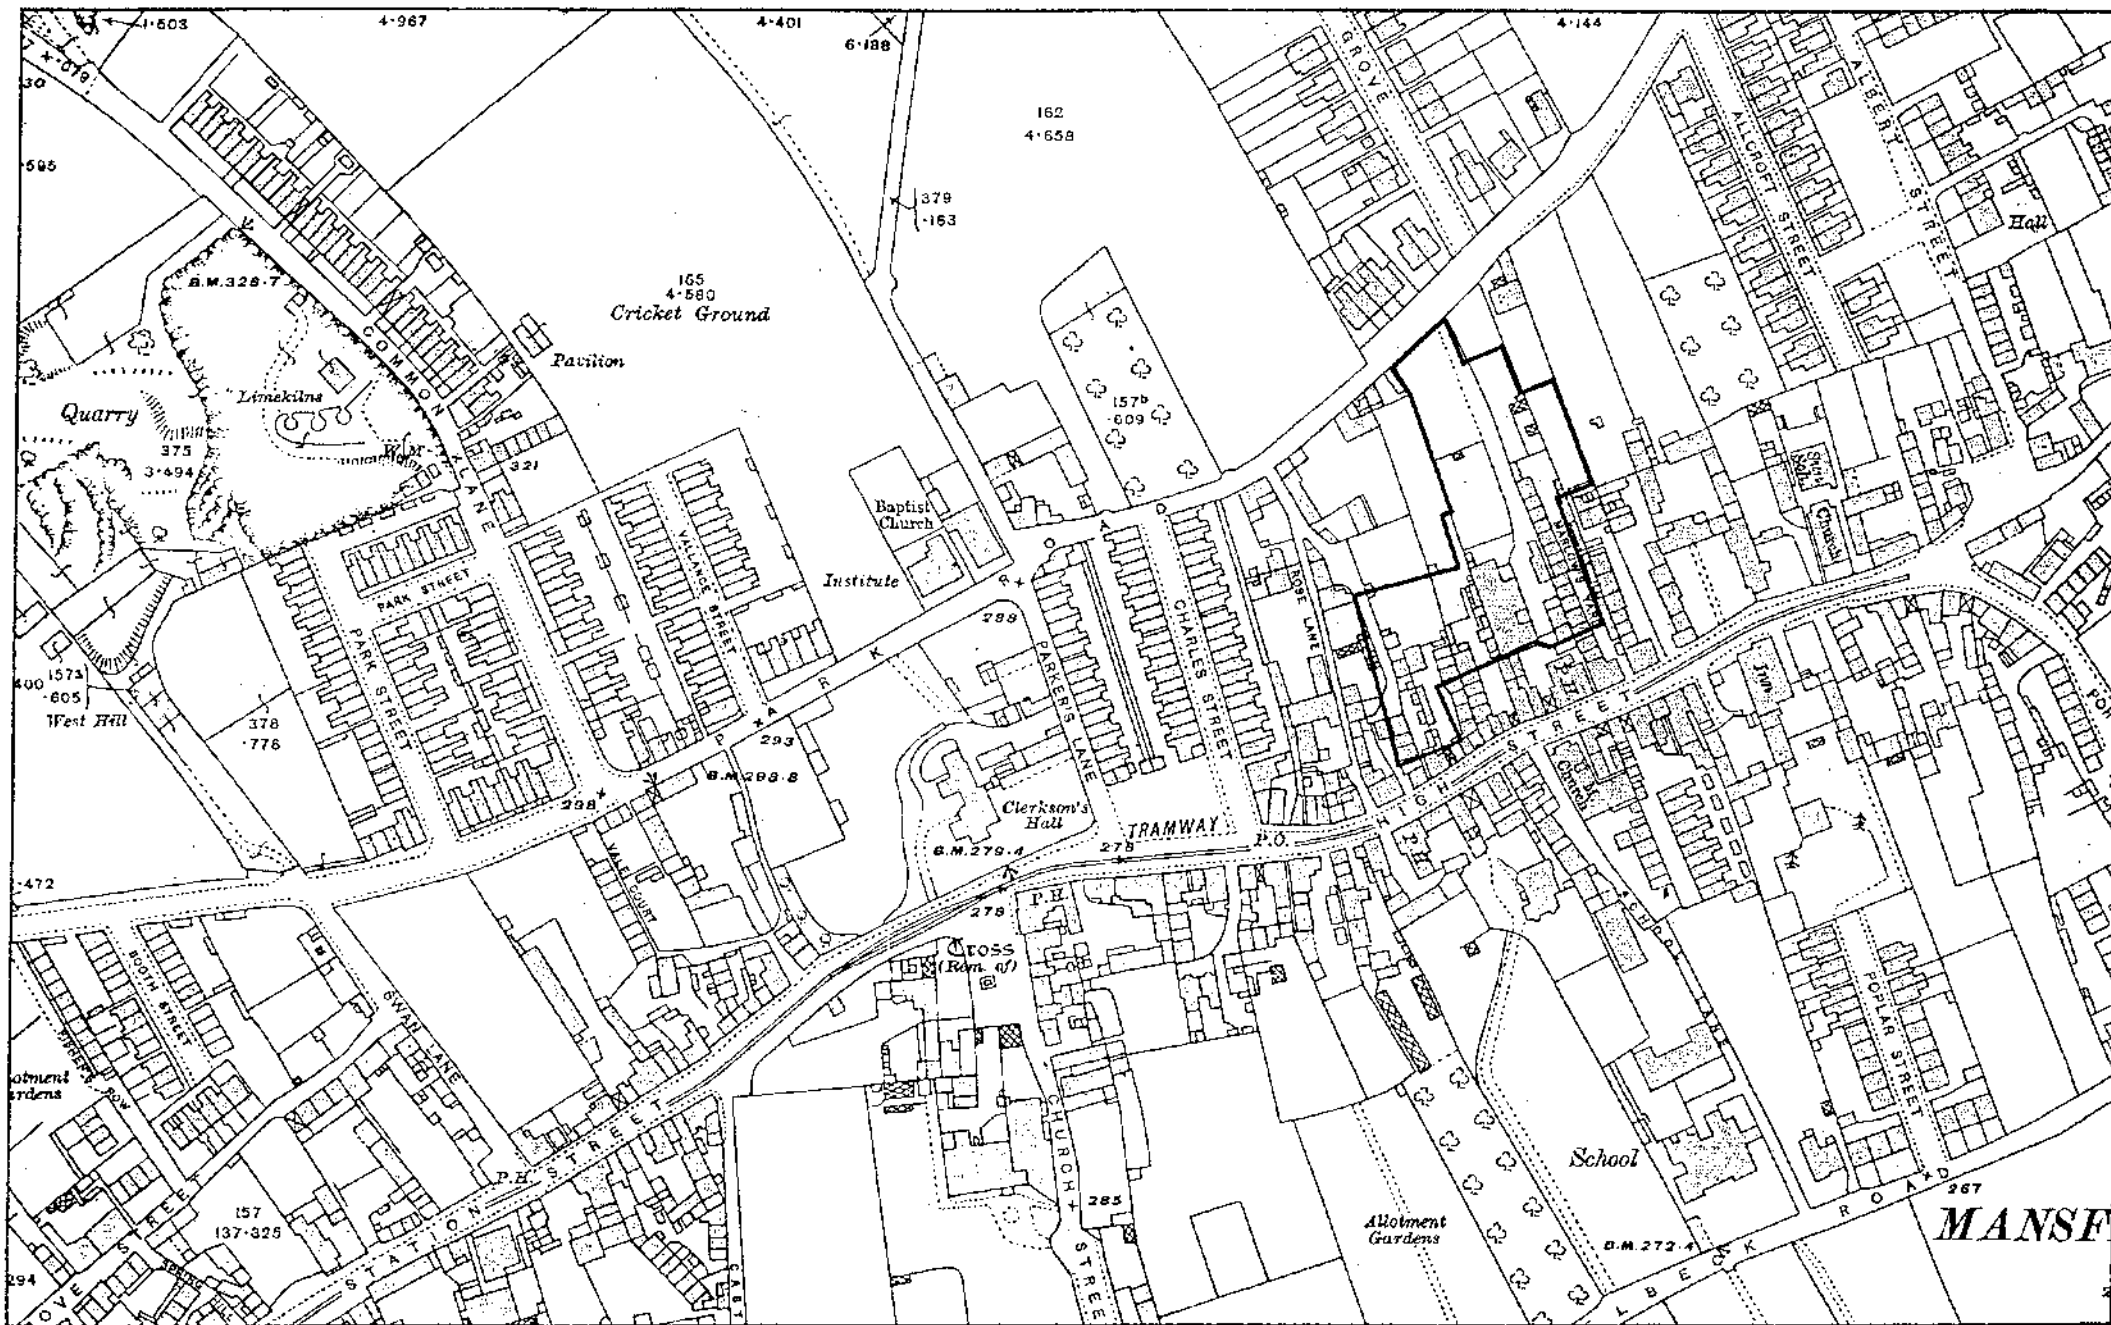
Fig 7

The maps from 1917 (**Fig.7**) and 1920 show the access way as being named Marlow's Yard and a boundary line has been drawn between the Malting House and the building to the south. By this time, some small development of a residential nature has taken place north of Park Road and in an area further to the north-east of the site.

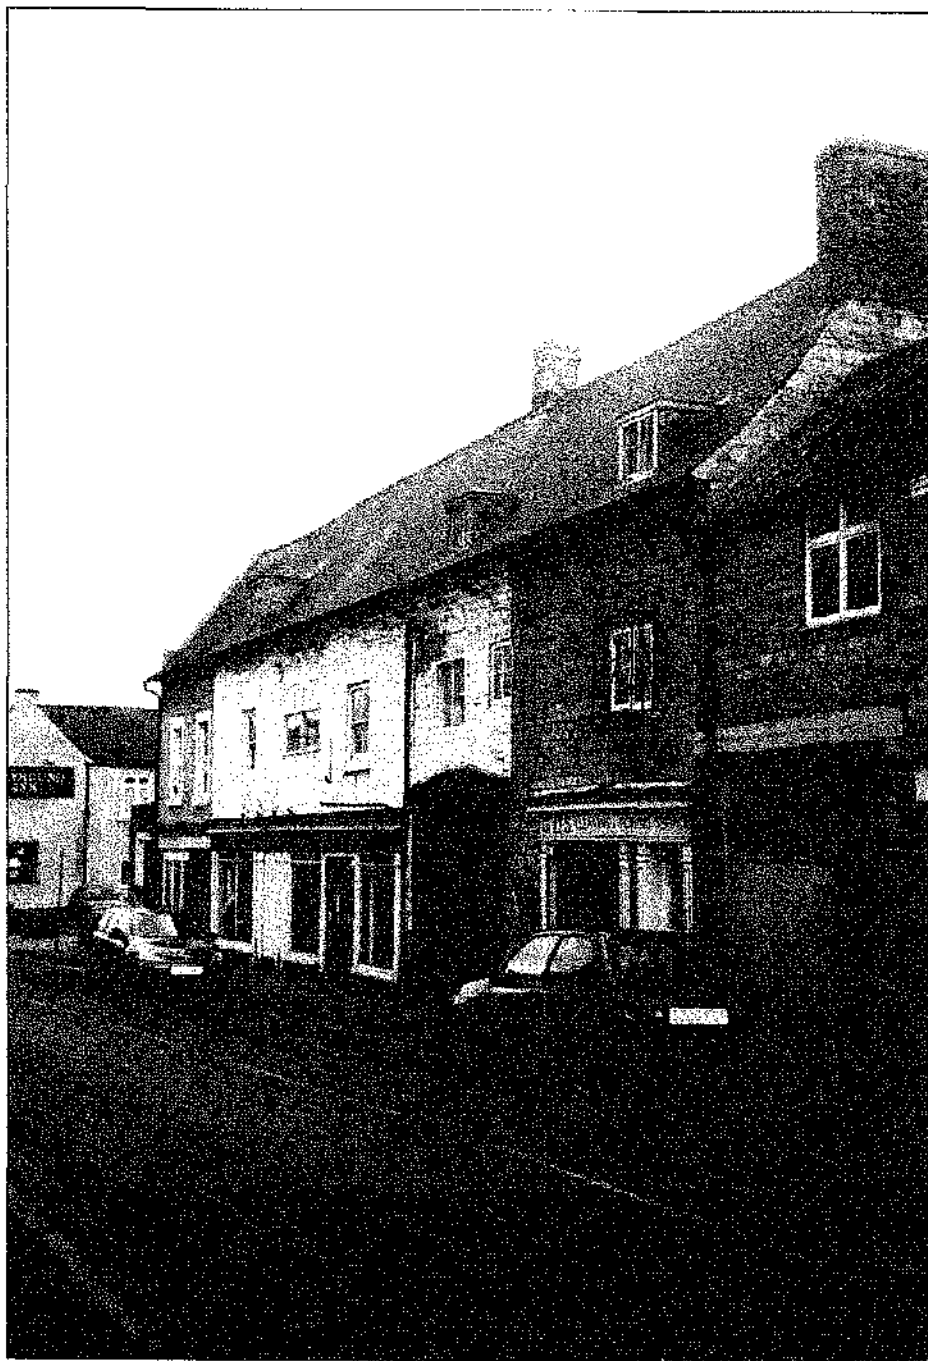
Plate 1: High Street looking south - east

The site is located within the historic core of Mansfield Woodhouse, the southern half of the site also lying within the Conservation Area defined by Mansfield District Council (**Fig. 5**). The south side is flanked by High Street, which is lined with tall, two-storeyed and many three-storeyed, stone buildings of a commercial nature. These vary in date, and are probably 17th to 19th century, although they are difficult to date precisely as they are all constructed in Magnesian limestone. Some have interconnecting backyards and cart-entrances (**Plate 1**).

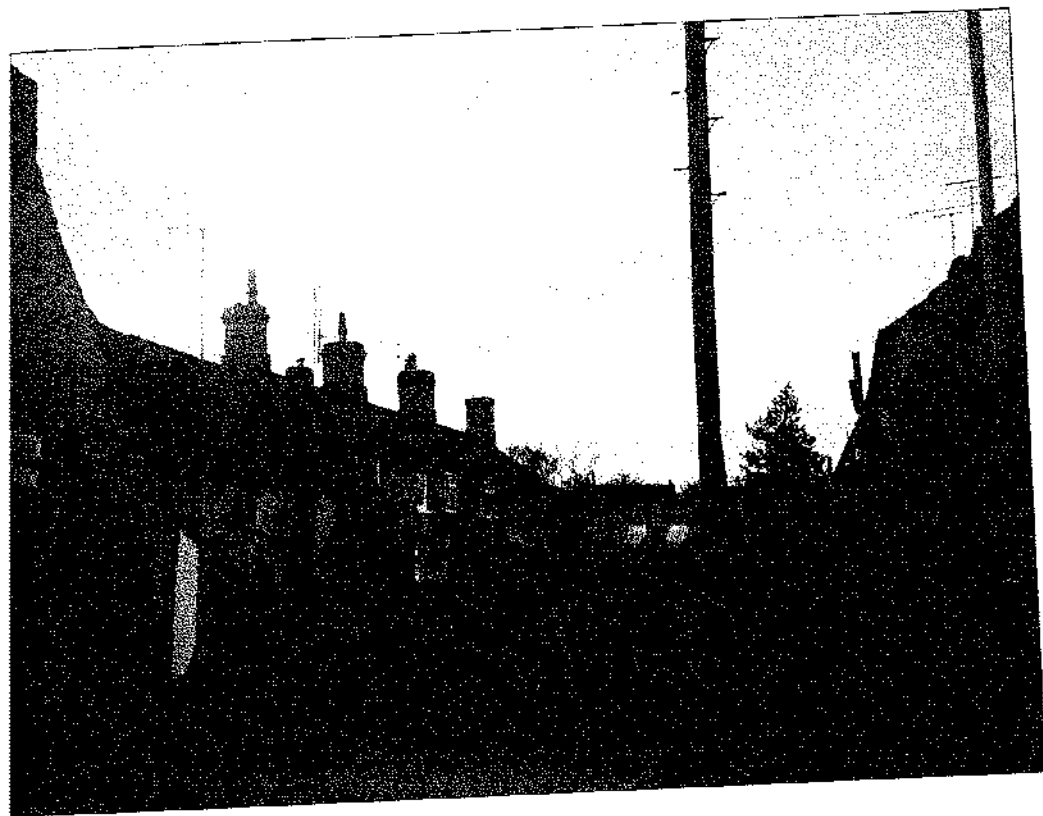
Plate 2: Cottages along east boundary of site, Looking north-west

Several listed buildings stand on High Street, although there is none on the development site. These include Nos. 21, 49, 51, 53, 55, 57, and 59, which are all Grade II listed. A row of limestone cottages extends back from High Street along the eastern edge of, and just outside, the site, on a line parallel with the row of now-demolished weavers' cottages on the site. These features are typical of the services offered along the main street of a small, country market town. The site itself may have represented long medieval burghage plots extending back from High Street, with a long yard, possibly of 17th century date or earlier, bounded by a limestone boundary wall along the eastern edge of the site. This possibility is also strongly indicated by the existence of a service lane at the back of the plot, the road now known as Park Road. On the 1880 O.S. 25" map, this road is named as Back Lane North. Another map from

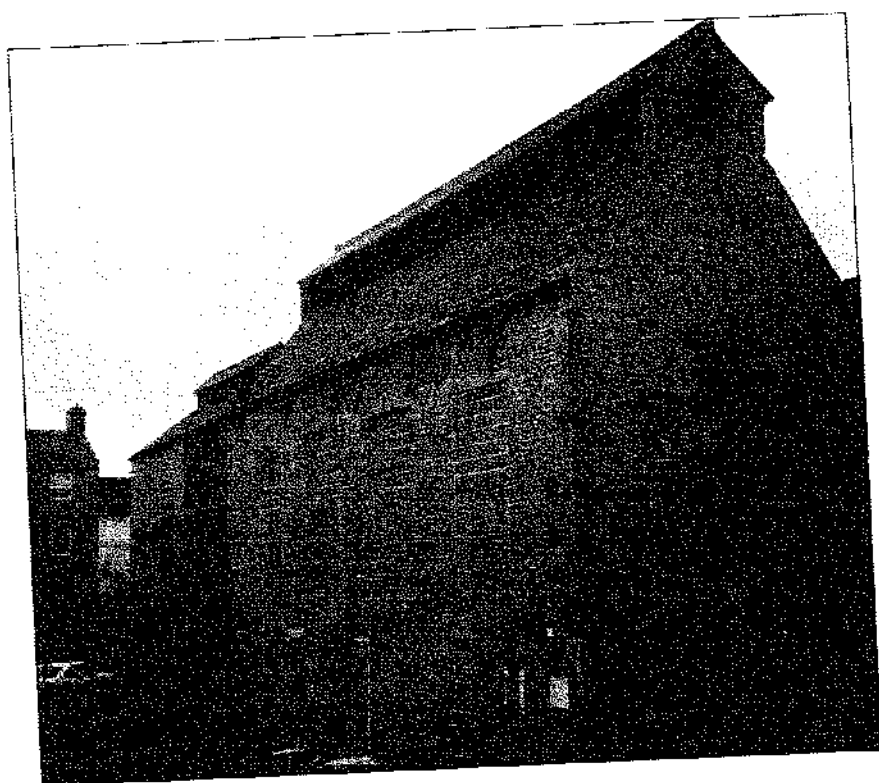
Plate 3: Malting House, looking south-west

Building **A**, the Malting House, in the southern central area of the site, is an amalgam of several buildings of different dates (**Plate 3**). The western block appears to be the earliest. It is of limestone construction (mainly rubble walling rather than finished regular coursing) and comprises three storeys, with a slightly-sunken floor level relative to the yard surface behind it. During a very limited internal inspection, it was noted that the interior was in quite poor condition. The original floors seem to remain *in situ*, although they are in a poor state of repair. The first floor is supported on large sawn timber crossbeams, into which sawn timber floor joists are jointed, with a tongued-and-grooved floor above. The crossbeams themselves are supported by crude cast-iron columns in compression between the beams and the ground floor. This use of materials may indicate a mid-19th century date. Evidence also exists for several bricked-up openings and doorways. Although the building as a whole is reputed to be a Malting House, no evidence for a large fireplace, chimney, or malting floor could be seen internally.

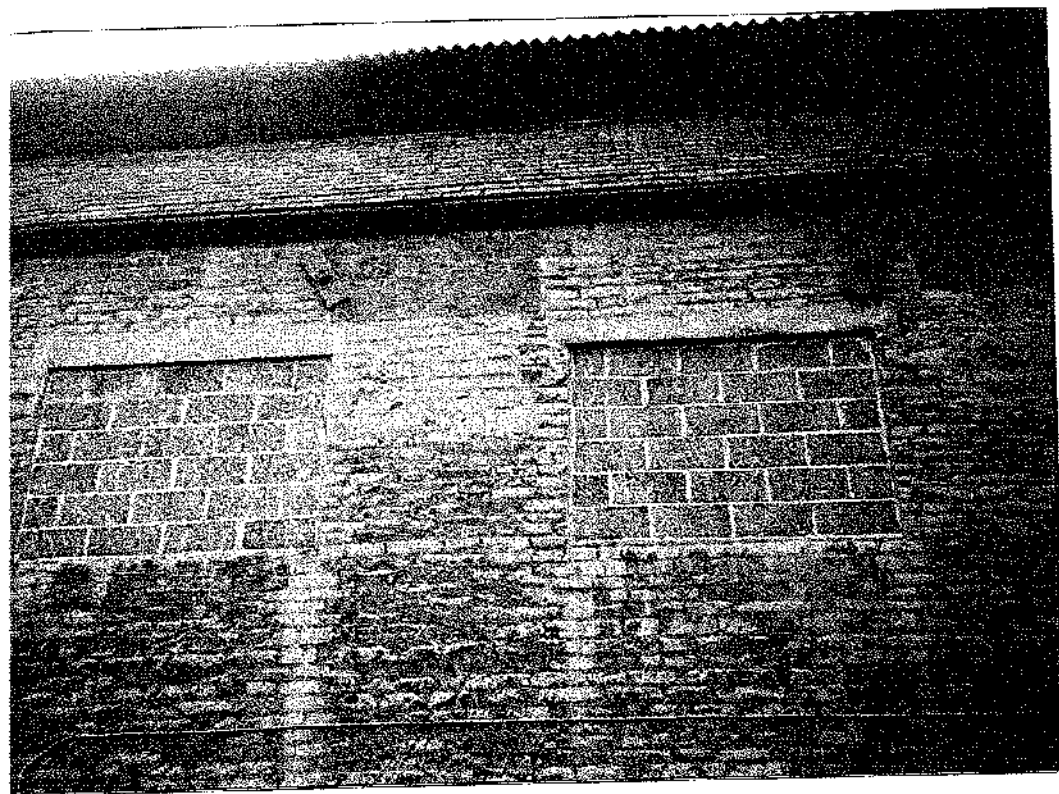
Plate 4: Malting House - detail of blocked openings, looking west

The main building of the Malting House, the eastern block, is two-storied, with a ventilated roof assembly. It appears to have been added onto the western block, but this would need to be investigated further. On the eastern face of the building, several of the openings' facings seem to be later concrete additions -- the earlier stone lintels of three smaller openings are still visible in between the present openings (**Plate 4**). The central doorway of the building is probably original, but the two on either side are probably later. An extremely limited internal inspection was made, due to the very poor condition of this part of the building, and it was noted that the height of the caves may possibly have been raised and that the roof could be a later addition. An Industrial Monument Survey, carried out in 1972, mentions a large well in the ground floor. However, this was not observed during the site inspection.

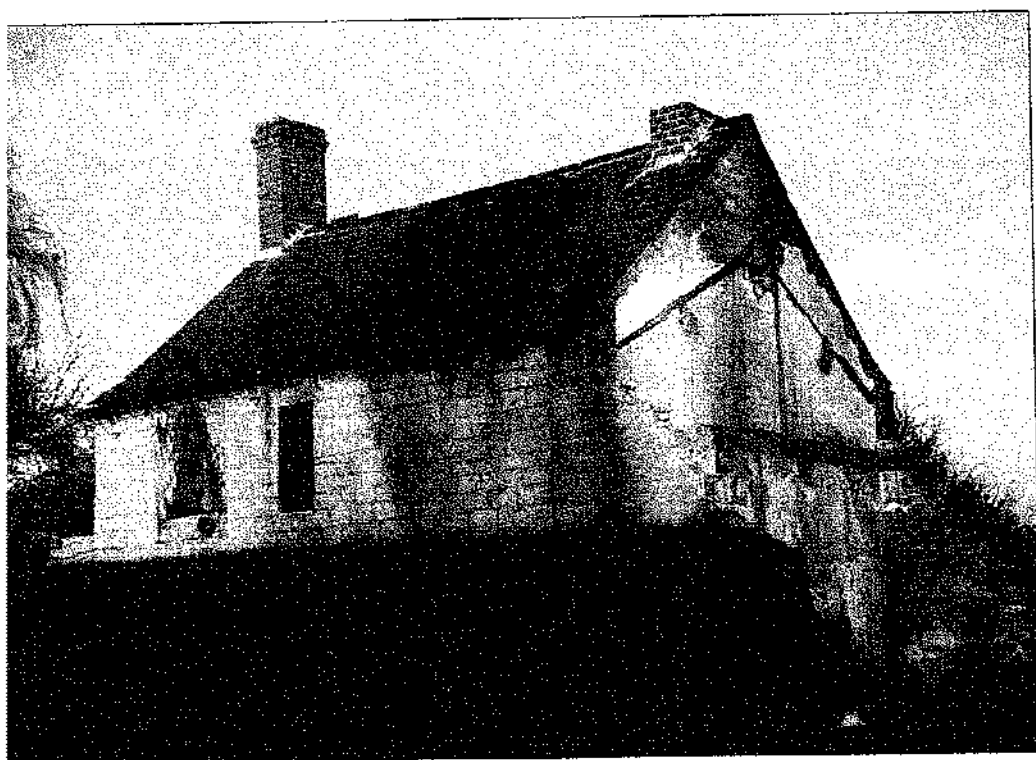
Plate 9: Weaver's Cottage looking north-east

This is the last surviving example of a row of weavers' cottages, but of later date than the rest of the terrace; the construction break with the gable end of the demolished building adjacent to it can clearly be seen (**Plate 9**) and a blocked-in first floor window can be seen in the gable end (**Plate 10**). The building is two-storeys high and the back, west-facing wall is partly set into the raised ground surface. It is of limestone construction, and tooling marks can be seen on some of the stones. There are big chimneys at either gable end, which implies that the floor plan was not open all the way across the building. Also, the chimneys appear too large for one room only and probably have two flues. The cottage is completely bricked-up, so no access could be gained to make an internal inspection. The front of the cottage (east-facing wall) is more regular and better-lit, with four windows and a central doorway. To the north are small, probably later, outhouses.
