Birmingham University Field Archaeology Unit  
**Project No. 707**  
July 2000

**Building recording and an archaeological watching brief at  
the Old Barn, Halesowen, Dudley (SMR 7928)**

by  
J. HALSTED & E. MACEY

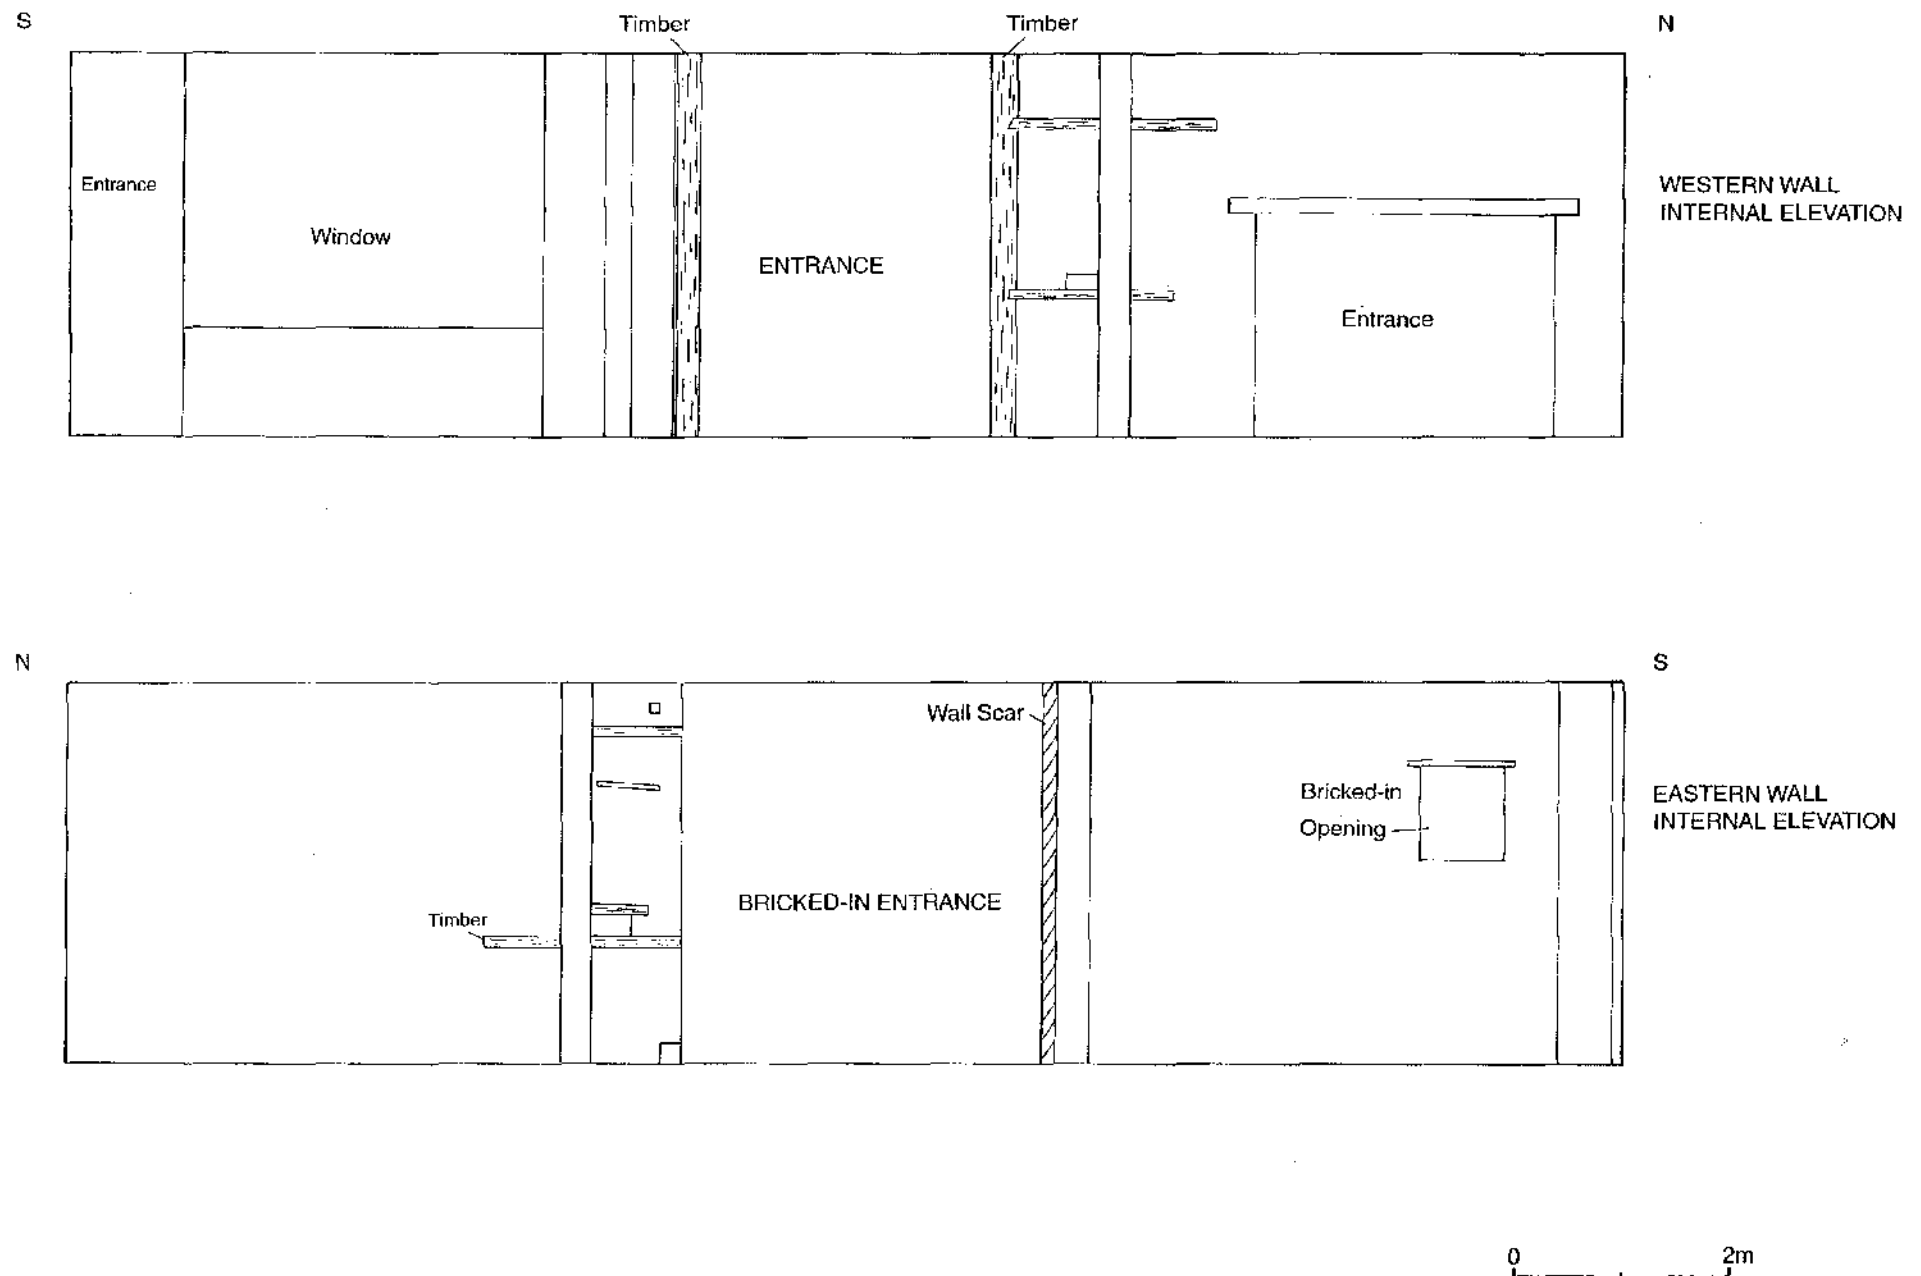
Fig.7

The east wall of the northern bay was of the same brick build as that of the north gable. There was no evidence of any former openings in this section of wall (Fig.7). The west wall of the northern bay had an entrance 2.8m in width and 2.1m in height inserted, with a steel lintel above. A shadow left by the roof of a small cross-wing on the external face of this wall indicated that the survey building had been extended later in its life (Plate 1). The floor of the northern bay was overlain with concrete-screed.

The central bay was partially divided from the north bay by the two buttresses which supported Truss 1. The build of these buttresses was one with the earliest brick build of the structure. The bay had a large entrance on its western side c.3.2m in width, flanked by two timber uprights that sat on sandstone blocks. The timber jamb on the northern side of the entrance was tied into the wall by two horizontal timbers (Fig.7), indicating that the opening was contemporary with the main build in clamped brick.

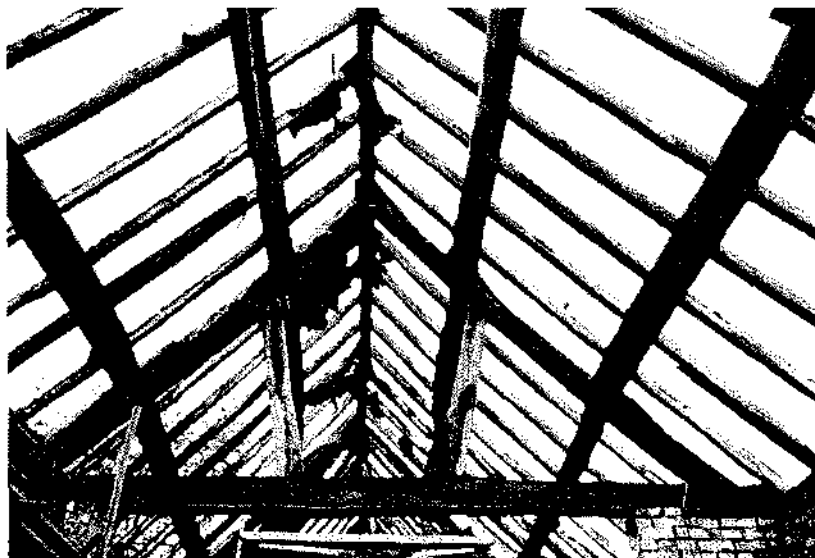
Truss 1, (Fig 5 and Plate 2), had the simplest design with cleanly sawn timber and basic carpentry. The truss consisted of a tiebeam linked by two raking struts to a pair of principal rafters. Two carpenter's marks were visible on the west, south-facing side of the truss and tiebeam. The truss supported a pair of purlins on each side of the roof truss, and a ridge purlin of relatively slight scantling. The truss was further supported by a pair of short wall stubs bonded with the brickwork of the east and the west elevations.

Plate 2: Truss 1, looking south

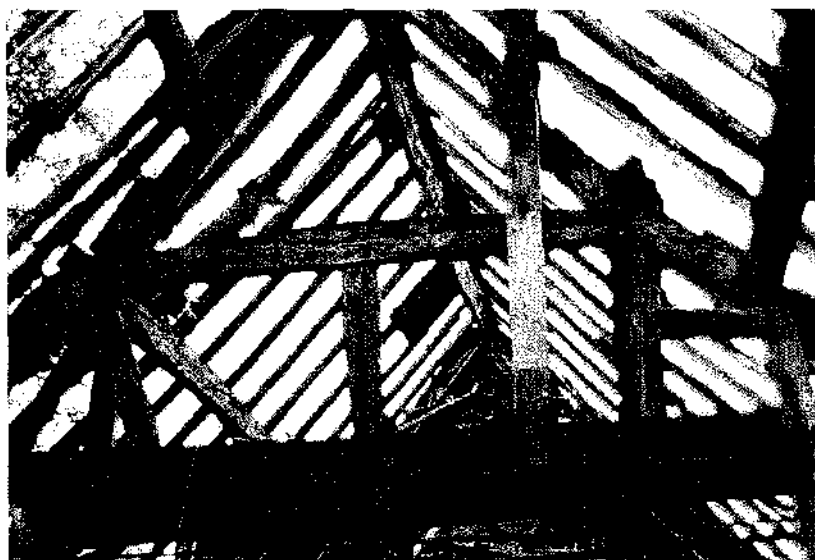
Truss 2 (Fig.5 and Plate 3) was more elaborate, consisting of a tiebeam, three struts and two collar beams. Redundant mortices in the soffit of the tiebeam and the two collars indicate that this was a closed truss. The truss marked a division between two types of roof, the one to the north having two pairs of purlins, and the one to the south a single pair of purlins. The northern purlins had been cut into the principal rafter. The southern ridge purlin was more substantial than that to the north. Various later repairs helped to support the truss, but these were not recorded.

Plate 3: Truss 2, looking south

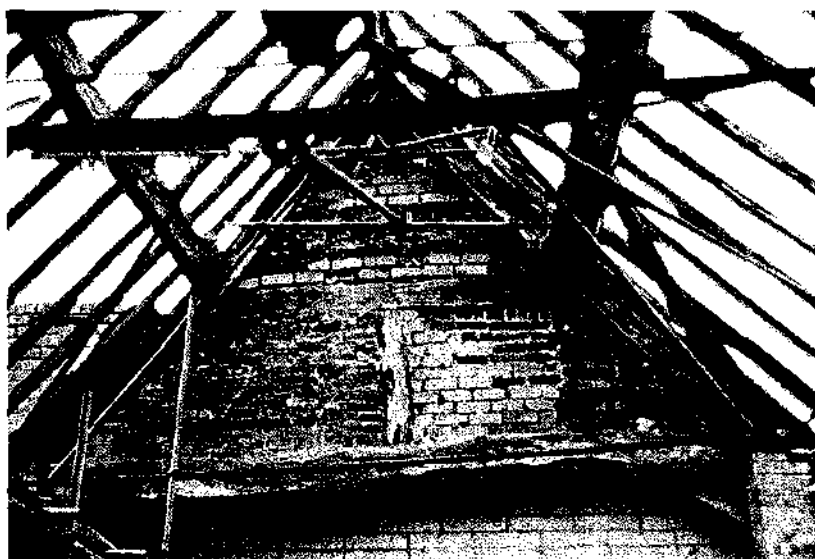
The southern truss, Truss 3 (Fig.5 and Plate 4), was retained as it was incorporated into the north gable of Old Barn Cottage. The truss comprised a tiebeam with curved knee braces, one central strut and a collar-beam. The purlins were originally supported by curved windbraces, but only the pair on the western side of the roof was *in situ*. While constructed as an open truss, the timbers above the tiebeam had been in-filled with clamped brick, while the area under the tiebeam was filled by concrete blocks.

Plate 4: Truss 3, looking south

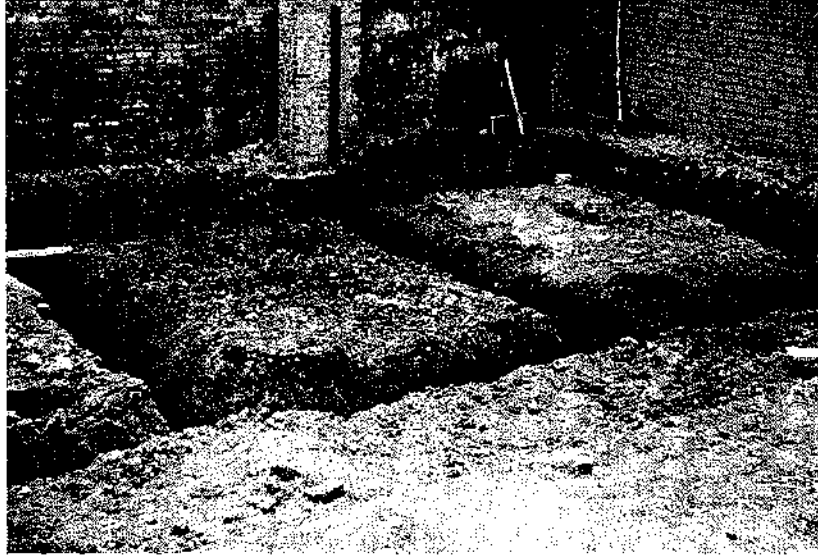
Plate 5

On Wednesday 28<sup>th</sup> June 2000, a visit was made to the site of Old Barn Cottage, Greenhill Road, Hill, Halesowen. The watching brief monitored the foundation trenches of the new building, which were largely situated within the footprint of the survey building (Plate 5). The foundation trenches consisted of two north-south aligned trenches, which measured 14.6m in length. These were joined by five shorter, 5.6m wide, beam trenches. The depth of the foundation trenches was generally c.0.75m. Natural clay subsoil was generally present c.0.3m beneath the cleared ground surface. This was overlain by a mixed demolition layer. The only archaeological feature recorded was part of the foundation of one of the walls of the central bay of the survey building (Plate 6). Four courses of clamped brick remained, to a depth of 0.3m. These were set directly into the natural clay.
