**Supplementary recording of a
former barn near Monyhull
Hall, Kings Norton,
Birmingham
(SP 0672 7909)**

Birmingham University Field Archaeology Unit
Project No. 714.2
January 2001

by
S. LITHERLAND

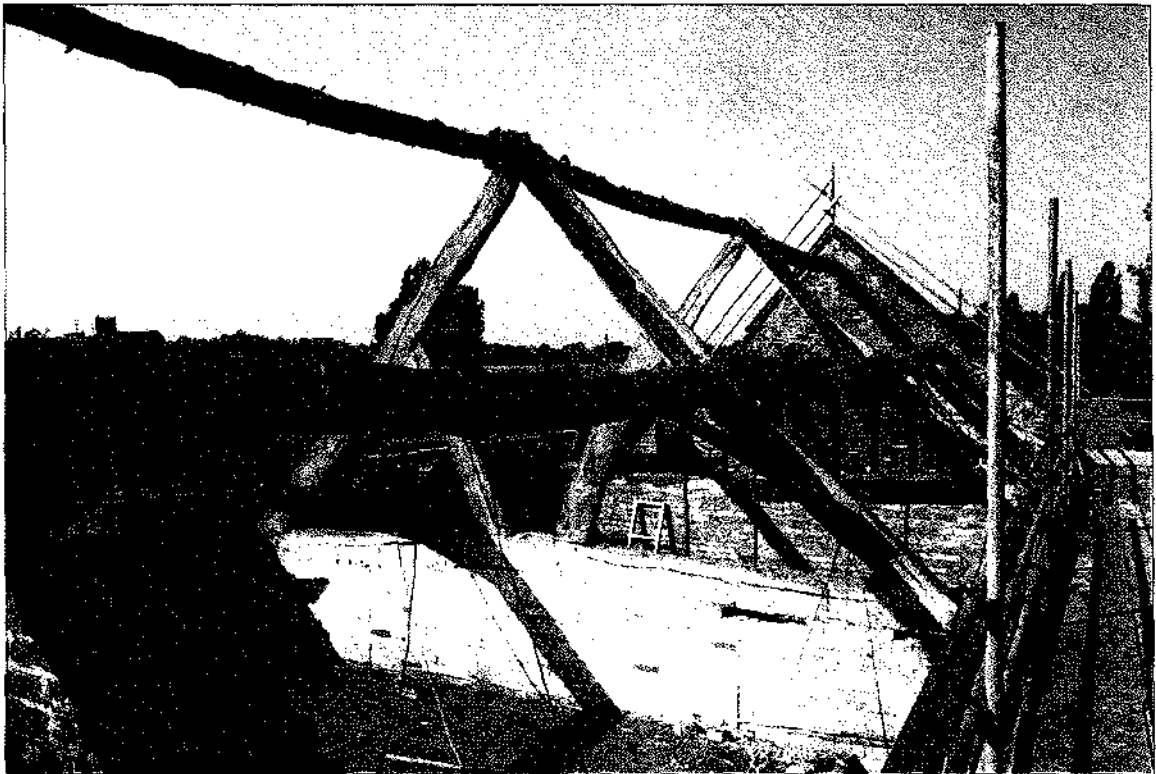
- Plate 1 View of the barn during demolition and recording, taken from the northeast
- Plate 2 View of the roof after removal of tiles and common rafters, looking west
- Plate 3 Detail of reused timbers, Truss 2, looking south
- Plate 4 View of much altered section of roof, around Truss 2, looking west

Further survey of the roof timbers was also undertaken after the tiles and lathes were removed from the roof, and later when the timbers had been dismantled (plate 2). This additional recording concentrated upon details of the joints and timbers that were not previously visible or accessible, and resulted in a revised cross-section of the roof that includes the main frame and common rafters represented in figure 3. Finally, figure 4 is not intended to be a straightforward reconstruction drawing, but instead is intended to represent some of the main features of the timber-framed phase of the building, although this is a complicated exercise for the reasons set out below.
