**A building survey of a former
barn near Monyhull Hall,
Kings Norton,
Birmingham
(SP 0672 7909)**

Birmingham University Field Archaeology Unit
Project No. 714
June 2000

by
S. LITHERLAND

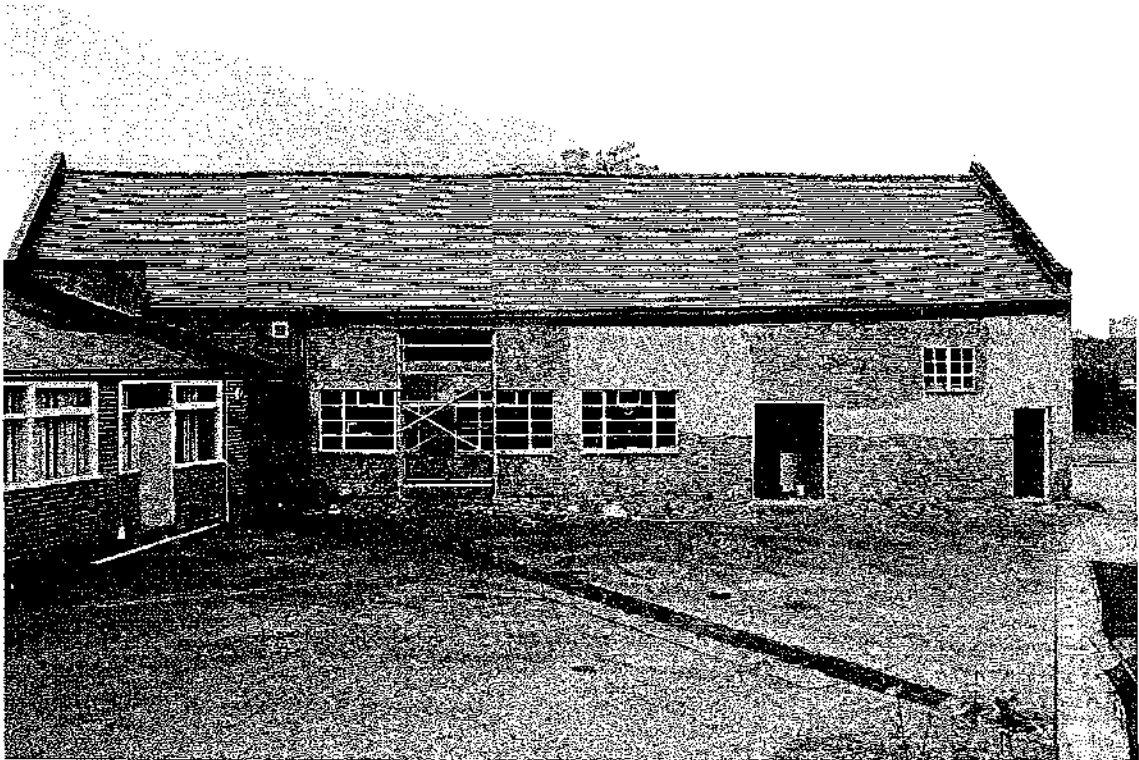
Plate 2

The survey building was a former barn, latterly used as an electrical workshop for Monyhull Hospital (Plate 2). Several later structures were attached to the south and east sides of the building. The survey building was on an east-west alignment and once occupied the southern side of a courtyard of farm buildings situated about 50m south-west of Monyhull Hall. From superficial external examination, the earliest parts of the building appeared to be 18th-century in date, employing clamped red bricks between 2¼ to 2½ inches thick.
