**Land at Home Farm  
Barns, Main Street, Teigh,  
Rutland:**

**an archaeological watching brief**

Birmingham University Field Archaeology Unit  
**Project No. 783**  
May 2002

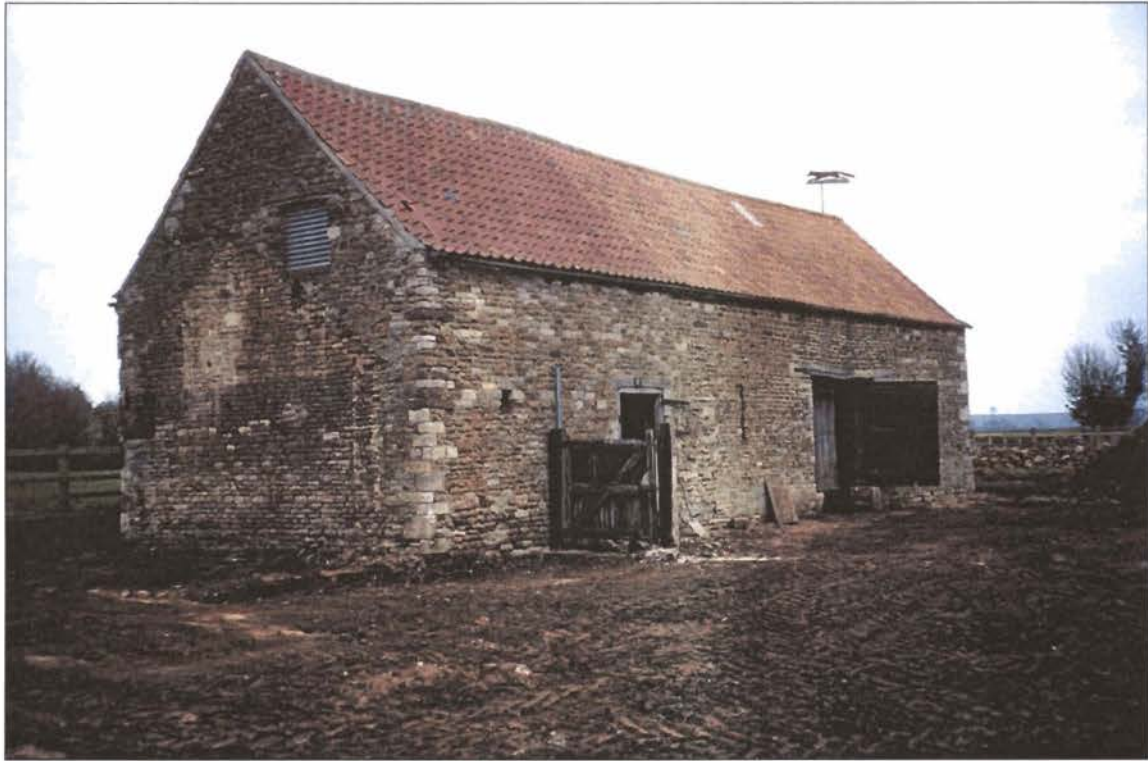
Plate 1.

Plate 1: Existing barn looking northeast

The site is located off Main Street, Teigh, Rutland (NGR SK 864161) and comprises the southern part of a 'D'-shaped pasture field which is occupied by a disused stone-built barn (Plate 1). The barn is depicted on the 1887 first edition OS 6" map with two wings and is of probable eighteenth century date, consisting of a cow-house and stable arrangement. The site is bounded to the north by a fence separating the site from the northern part of the field, by Main Street to the south and west, and by the main road between Oakham and Wymondham to the east. Two later agricultural buildings built up against the barn had recently been demolished to make way for new east and west wings to be constructed as part of the conversion and extension of the barn. The site lies within an area registered on the Leicestershire County Council Sites and Monuments Record (SMR reference number 81 NE. BK) as a site of archaeological interest. Therefore, there was good potential for the survival of archaeological remains. The underlying geology is Middle Lias clay overlying limestone bedrock.

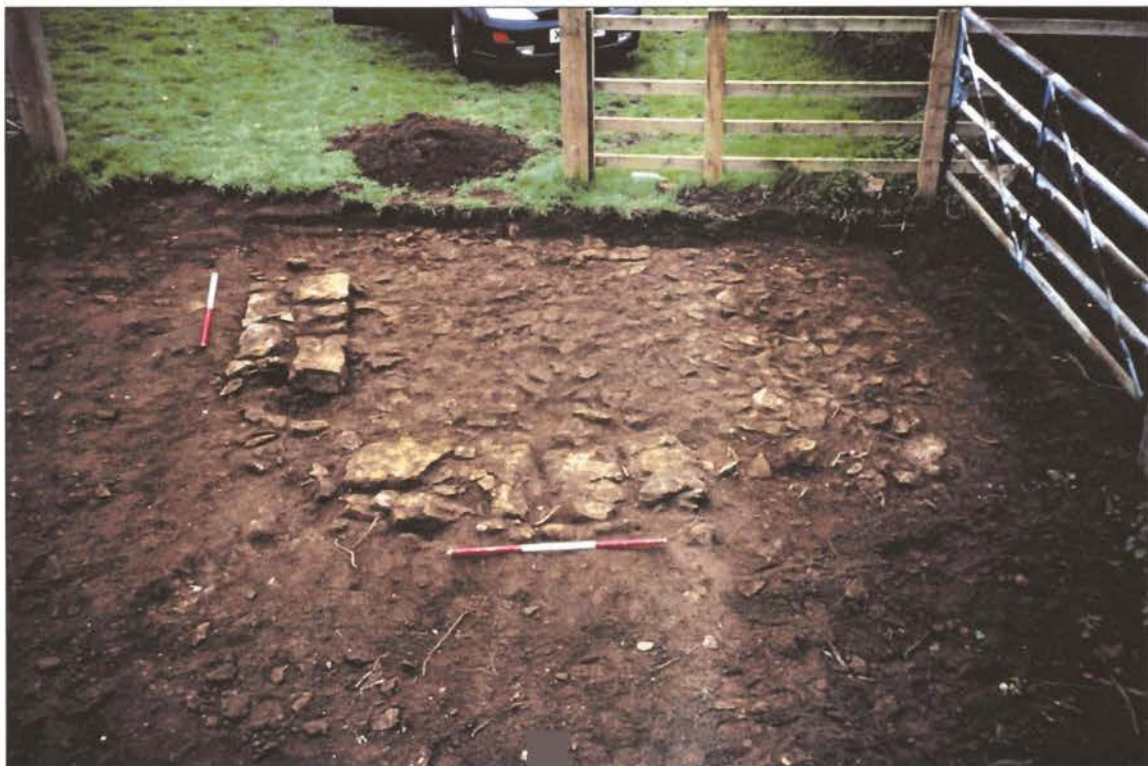
Plate 2.

Plate 2: F1-F3, Area 1 looking southeast

An area approximately 25m x 30m at the northwest corner of the site was stripped for the construction of a new access drive and a garage, to be built on a concrete raft. The natural yellowish brown sandy clay (1007) was only revealed, at the southwest corner of Area 1, close to modern road, at a depth of 0.32m below the ground surface. This was sealed by a layer of brown silty sandy clay (1006), 0.12m deep, containing sherds of medieval pottery and an iron nail, which abutted three truncated limestone walls (F1- F3, Fig.3, Plates 2 and 3), forming a structure. All the walls were composed of dressed limestone blocks (1003, 1004 and 1005) with no evidence of bonding. Wall F1 was aligned northeast-southwest, was 0.60m wide, and had been completely removed to the southwest, presumably by the construction of the adjacent modern road. The northeast end of F1 was badly truncated, but appeared to form a right-angle with northwest-southeast orientated wall F2, which extended beyond the edge of excavation. Wall F2 was of a similar width to wall F1 and both walls were made of sub-rectangular blocks, average size 0.40m long x 0.35m wide.

To the south of F1 was another wall (F3) on a similar alignment, which appeared to turn to the southeast to form a right-angle and extended beyond the edge of excavation. Wall F3 was 0.30m wide and was made of much smaller sub-rectangular blocks (1005), average size 0.20m x 0.15m, than walls F1 and F2. As with wall F1 it had been completely removed to the southwest, presumably by the construction of the adjacent modern road. Only the upper 0.20m of walls F1-3 were exposed, as this was the maximum depth of stripping here. Within the structure formed by walls F1-3 was a deposit of limestone rubble (1002) within a silty loam matrix, at least 0.14m deep. Walls F1-3 and contexts 1002 and 1006 were sealed by 0.06-0.20m of topsoil (1001) containing sherds of medieval and post-medieval pottery and iron nails.

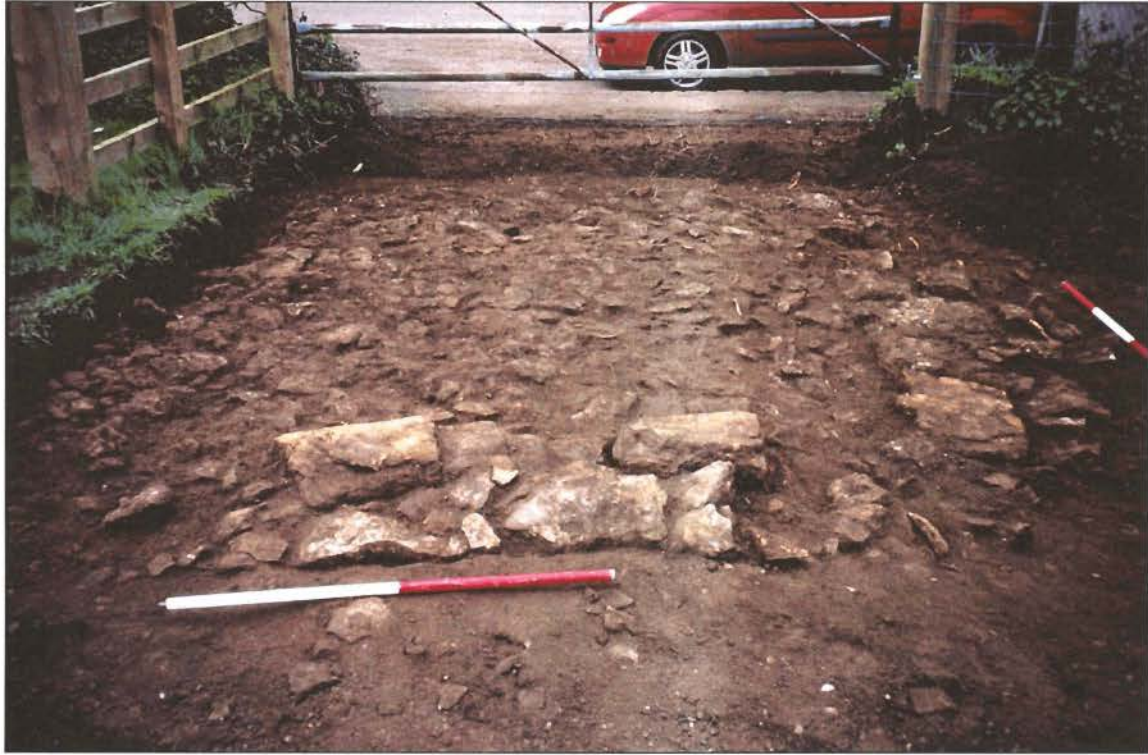
Plate 3.

Plate 3: F1-F3, Area 1 looking southwest

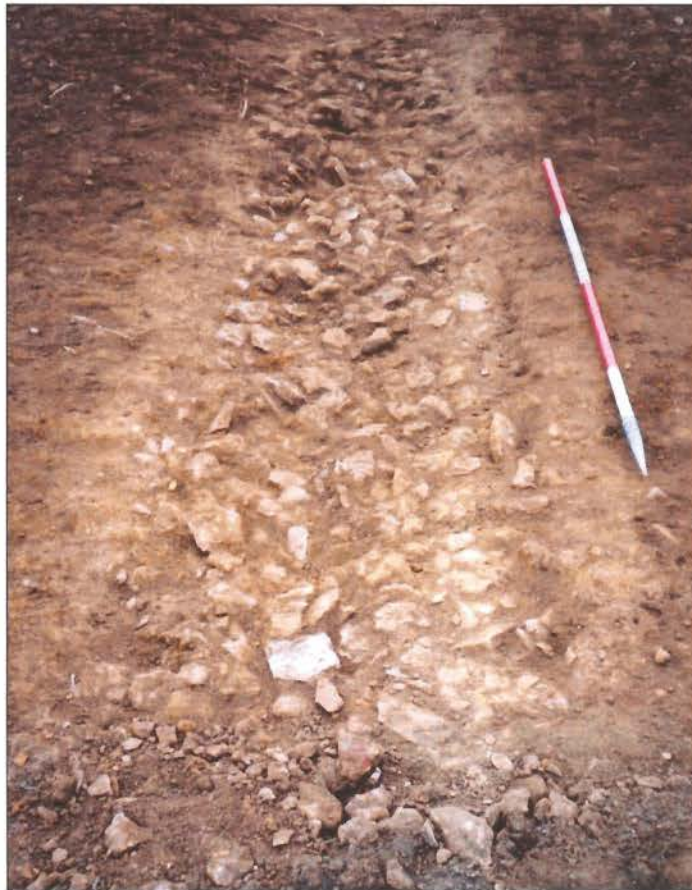
Plate 4.

Plate 4: F4, Area 2 looking north

An area south of Area 1, 13m x 12m, was stripped of topsoil to enable a new stable building to be constructed on a concrete raft. A layer of brown sandy clay silt (1009), at least 0.12m deep, containing sherds of medieval, post-medieval and modern pottery was revealed, 0.06-0.45m below the ground surface. This was cut by a north-south orientated linear trench (F4, Fig. 4; Plate 4), 1.0m wide and at least 0.20m deep, containing limestone rubble (1011), at least 0.15m deep, and was sealed by a compact brown sandy silt (1010), 0.05m deep, containing fragments of animal bone. Trench F4 terminated to the north and extended south beyond the edge of excavations, where it coincided with a slight linear earthwork bank (Fig. 2). Contexts 1009 and 1010 and were sealed by topsoil (1008), 0.20-0.45m deep, containing sherds of medieval and post-medieval pottery.

Rubble-filled trench linear trench F4 may possibly be the foundations of a wall of late post-medieval date, on the basis of the relatively large amount of post-medieval pottery recovered from the topsoil overlying it. This feature coincides with a slight linear earthwork feature, probably representing the truncated remains of F4, which could be the remains of a field boundary or perhaps a livestock enclosure. The ground works associated with the redevelopment did not affect any other earthworks visible within the site.
