**Excavations at
St. Martin's Churchyard
2001**

**Post-Excavation Assessment and
Updated Project Design.**

Birmingham University Field Archaeology Unit
Project No. 798
May 2002

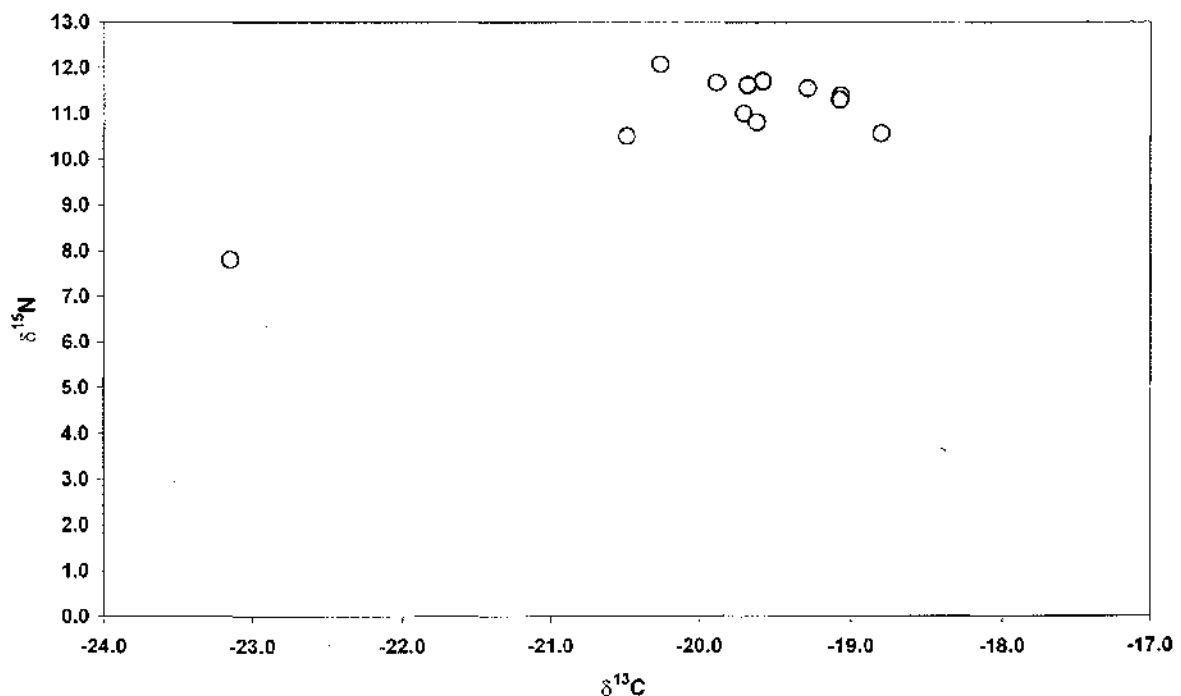
Plot of $\delta^{13}\text{C}$ and $\delta^{15}\text{N}$ values of hair taken from individuals interred at St. Martins.

The majority of the isotope data cluster around a value of approximately -19.5 ‰ for $\delta^{13}\text{C}$ and 11.5 ‰ for $\delta^{15}\text{N}$. These samples are very similar to bone collagen isotope values of humans from later medieval and post-medieval urban contexts in the UK (Muldnr, unpublished Master's dissertation, University of Bradford, Richards, unpublished data). The relatively high $\delta^{15}\text{N}$ values could either indicate the consumption of freshwater fish in some quantity, or the consumption of pigs, which in turn have high isotopic values. Studies are currently underway to explain the high $\delta^{15}\text{N}$ values often observed in these later medieval and post-medieval individuals, which are not observed in any other time period in Britain.
