**Earthwork Survey
and
Watching Brief
at Shustoke Farm,
Walsall, Black Country**

Birmingham University Field Archaeology Unit
Project No. 804
February 2002

An earthwork survey and watching brief was carried out along the route of an access road for the site of a new training ground for West Bromwich Albion Football Club. The work was carried out by Birmingham University Field Archaeology Unit (BUFAU) for de Weijer Architects, on behalf of West Bromwich Albion Football Club. The site of Shustoke Farm (Black Country SMR 3168, NGR SP 036 961) has been identified as a probable medieval moated site. The new development runs around the perimeter of the moat itself, through a relic landscape containing ancient field boundaries and earthworks identified as a series of fishponds (Black Country SMR 10424). The aim of the earthwork survey was to record all elements of relic landscape ahead of the construction of the access road, and then to monitor groundworks during its construction. The survey revealed a series of three fishponds, inter-linked by leats, in fields to the north and west of the moated enclosure. It also identified ancient field boundaries of ditch and bank type, and areas of

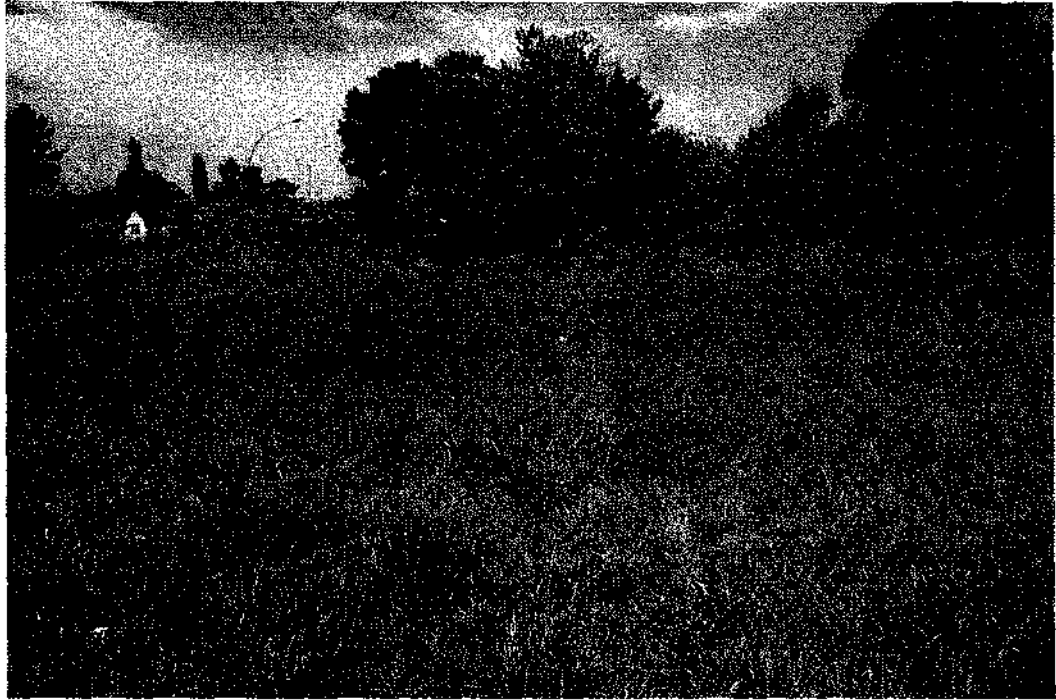
The field to the east of the moated site (Field 1, Fig. 3) was a meadow, with the remains of ancient field boundaries surviving on three sides. The east side of the study area was bounded by the Birmingham Road. There was an obvious change in the type and age of vegetation at the northern end of the field, where a large bank had been created. This was modern landscaping associated with the construction or widening of the A34 (Plate 1). Directly to the east was a line of ancient trees and the remains of a short section of very eroded bank and ditch. The southern boundary was very irregular and followed the course of a stream (Plate 2). Although this ditch showed signs of having been recut very recently (Plate 3) the boundary appeared to be of some antiquity. The stream may have once been used as the northern arm of the moat, feeding into the moat from the northeast.

Plate 1 Northeastern boundary of Field 1

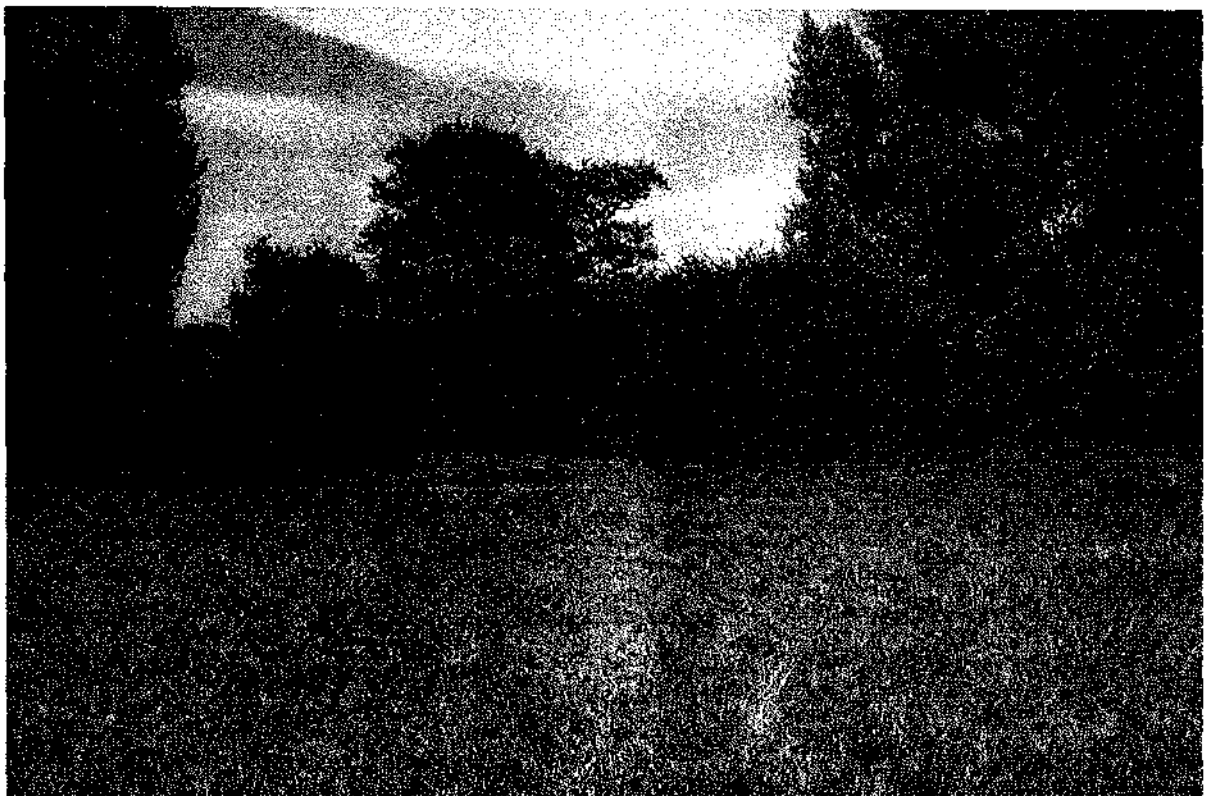
ancient watercourse and, although now dry, may represent the course of a second stream running into the site from the south. Fishpond 3 (Plate 6) lay at the bottom of the slope, in the northwestern corner of the field, and was visible as a bowl-shaped marshy depression.

Plate 6 (below)
Fishpond 3

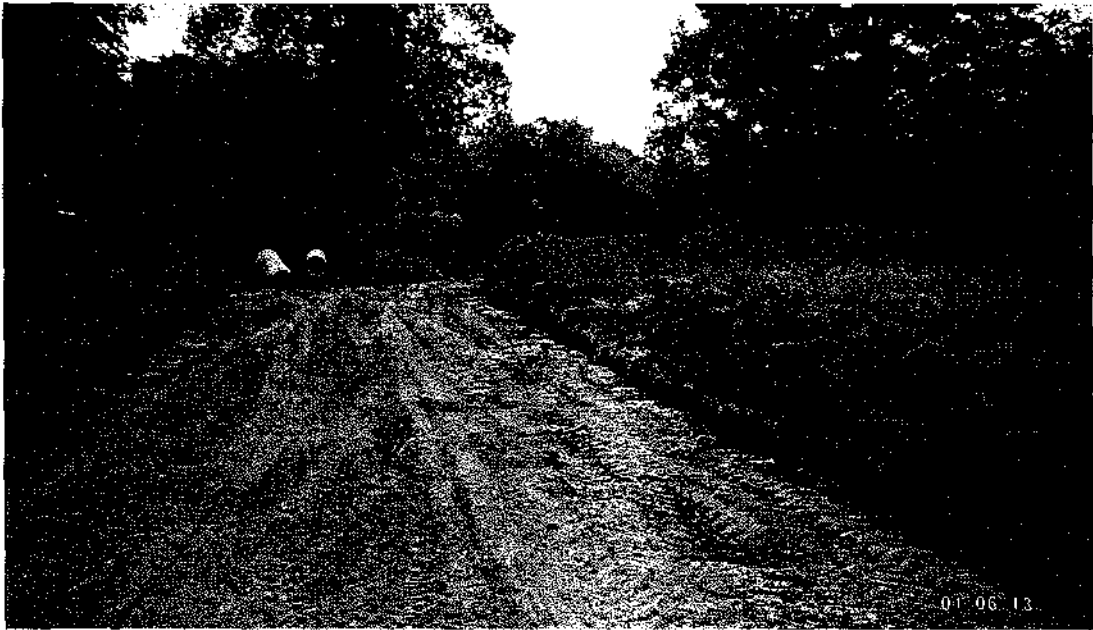
The access road (Fig. 2, Plate 7) was 7.3m wide and approximately 300m long. The footings were excavated to a depth of 0.25m onto the natural subsoil of sand and gravel, containing lenses of clay. The overburden was mostly topsoil. In some areas there was evidence that the topsoil may have been disturbed or re-deposited, as it contained modern refuse items and some patches of redeposited natural. There was no evidence for archaeological deposits of any antiquity. Where the road cut through the area of Fishpond 1 there was evidence of modern dumping (Plate 8).

Plate 7 East end of the access road

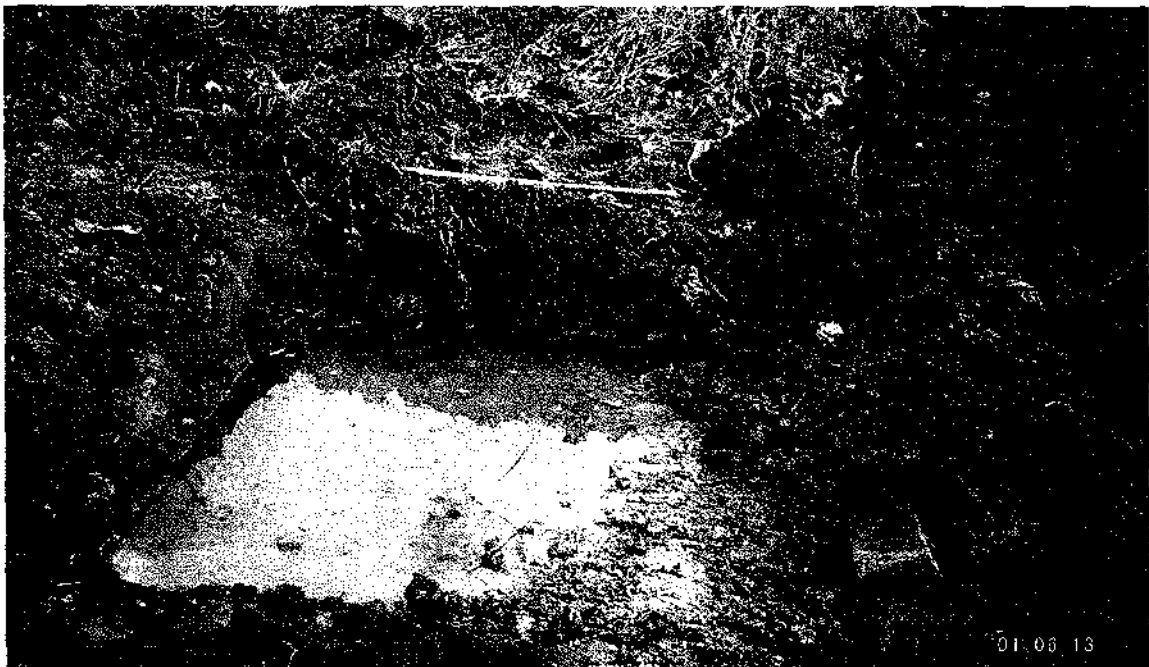
Plate 8 Modern backfill of Fishpond 1
