An archaeological assessment of the
Albion Mill and environs, Albion
Street, Wolverhampton

Birmingham University Field Archaeology Unit
Project No. 817
August 2001

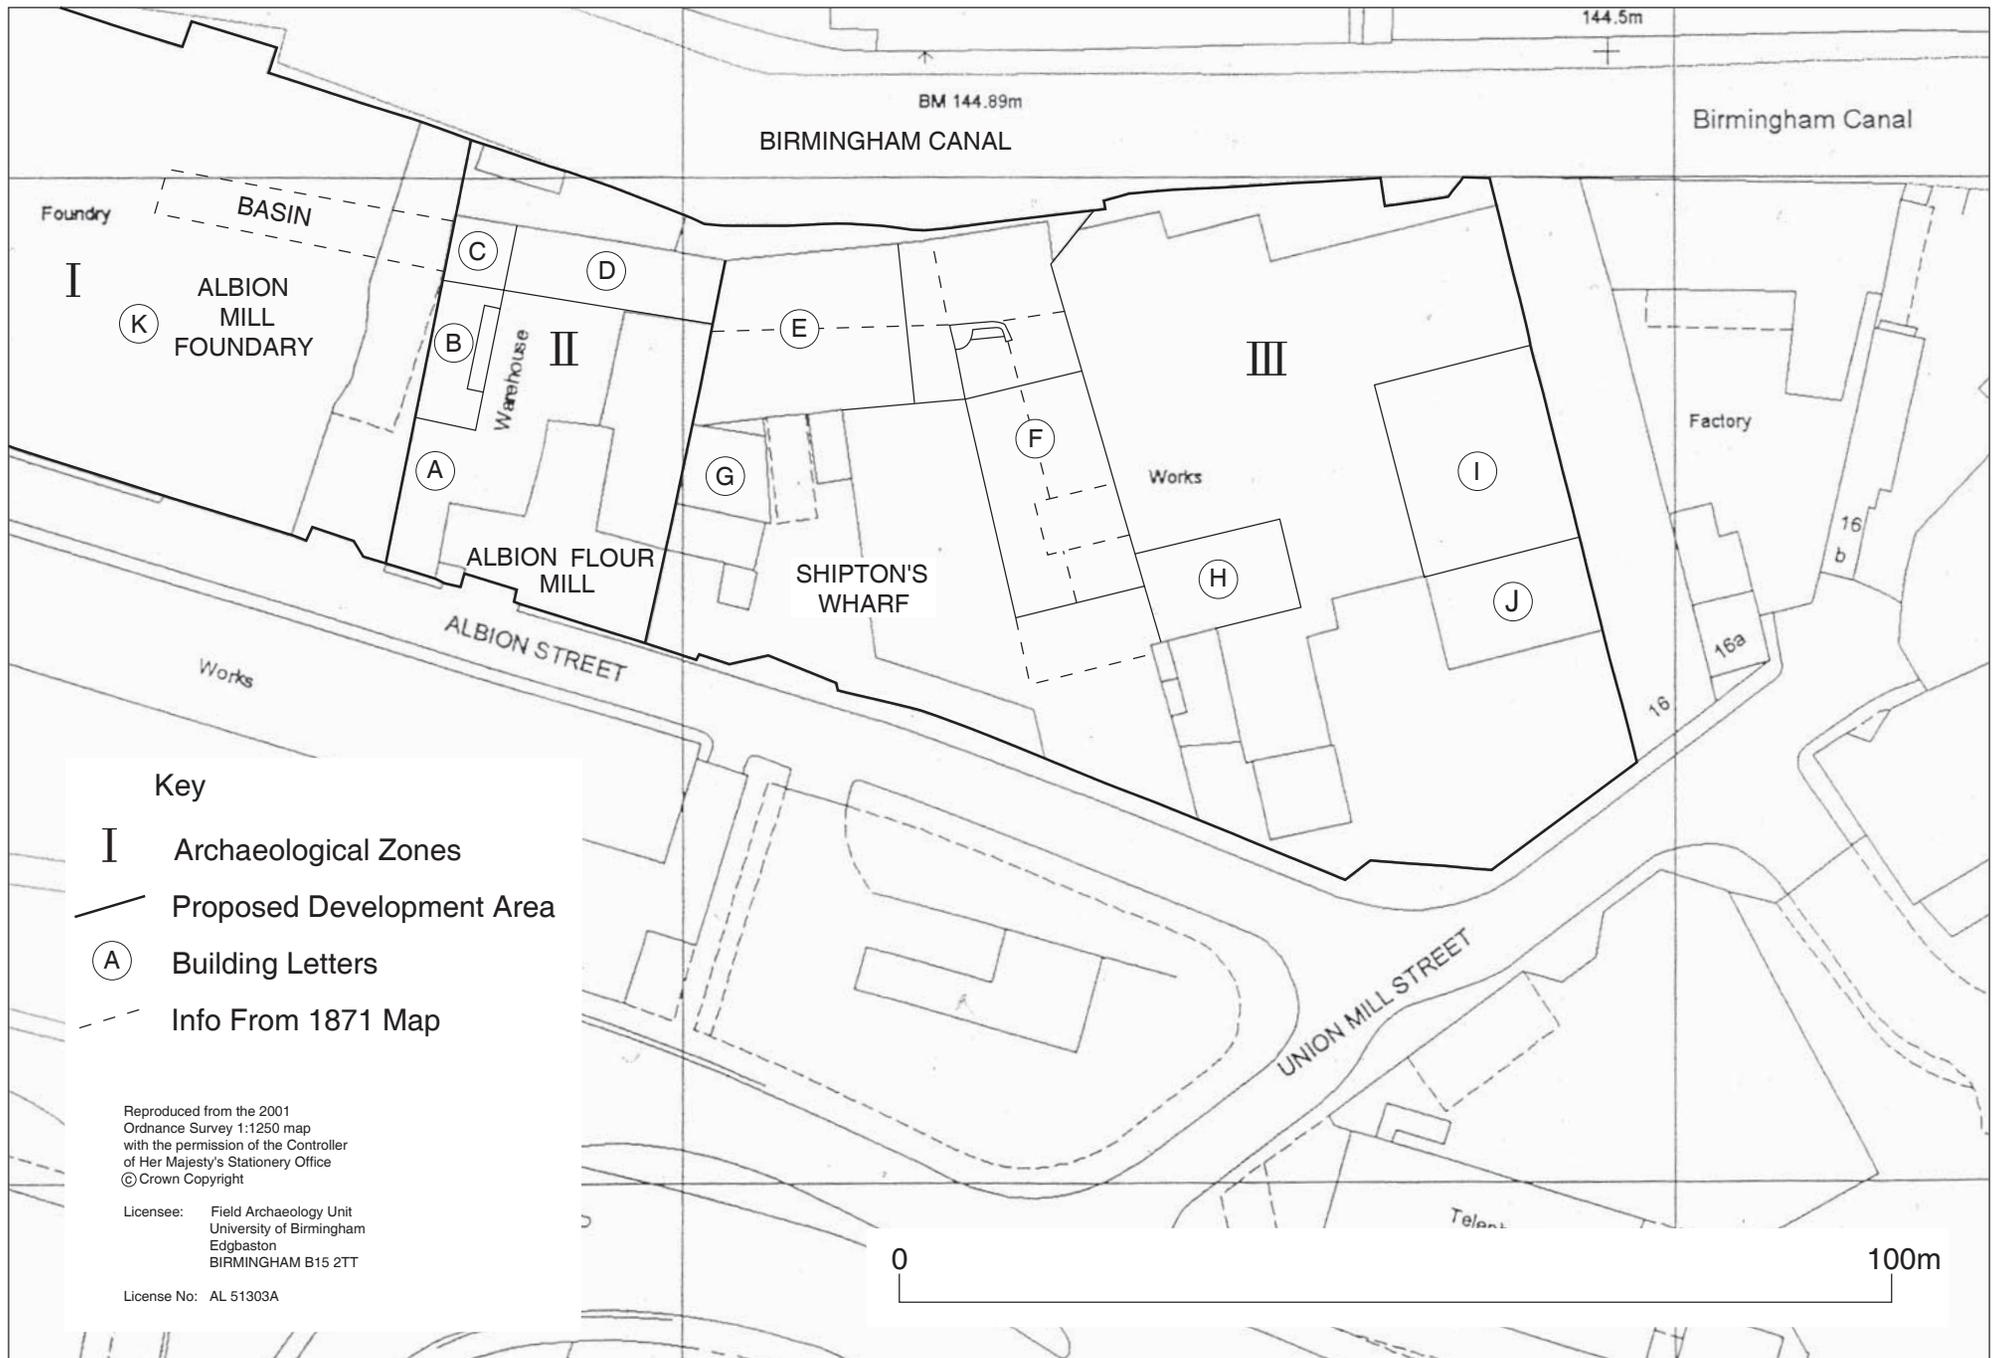
Fig.3

The Study Area was divided into three Zones, I-III, and for descriptive purposes each building was assigned a reference letter (Buildings A-K, Fig.3)

6.0 Assessment of the standing buildings (Fig.3)

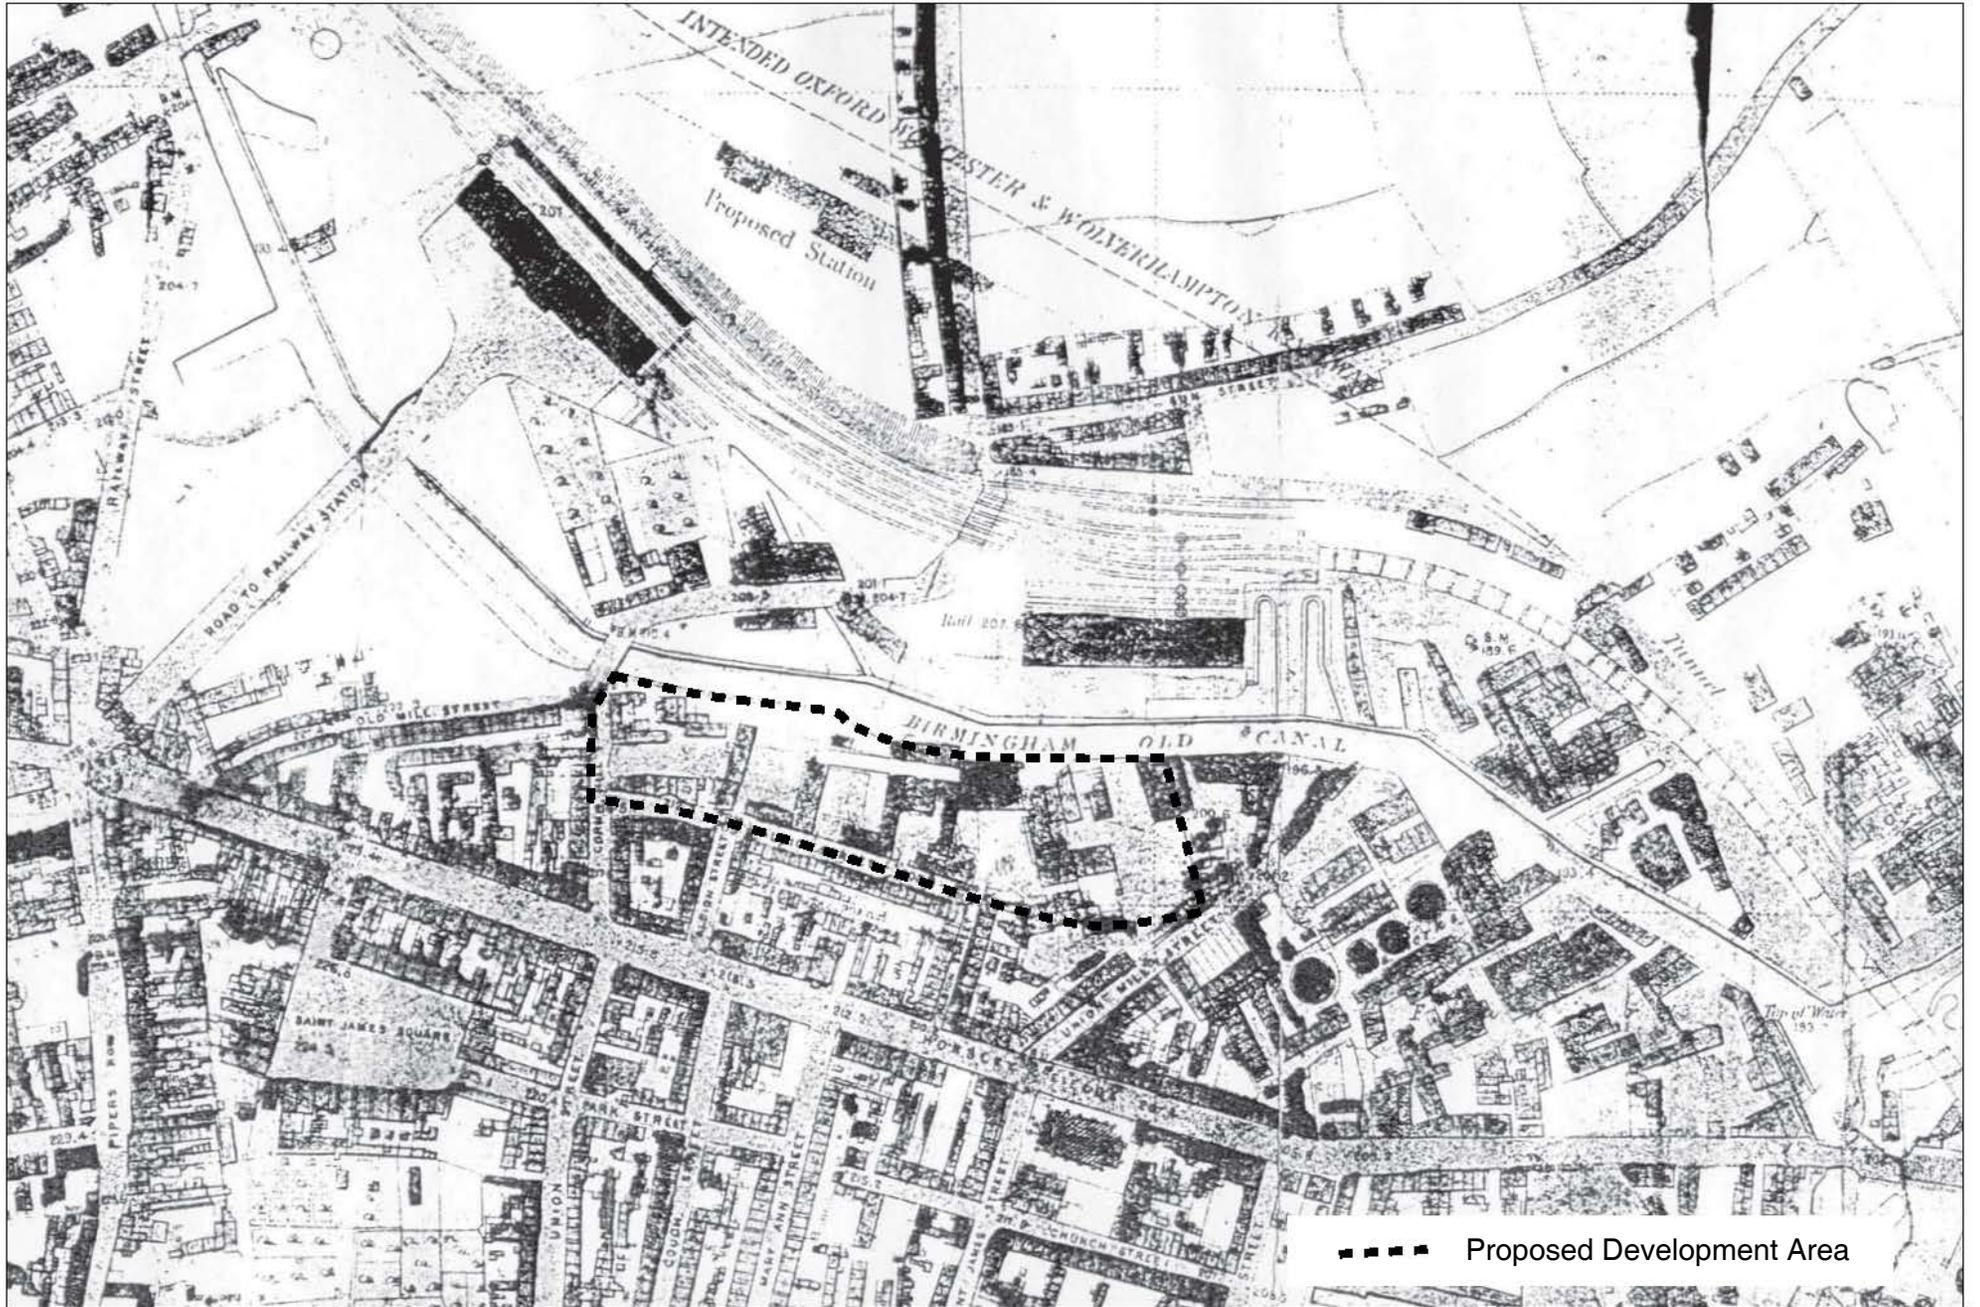
Fig.5

The Health of Towns Act Map (Fig. 5) drawn up in 1852 shows much more clearly the structures that occupied the site, and highlights their relationship with the canal and basin. There was a complex of buildings in the Study Area that fronted both Albion Street and Corn Hill. A series of structures at right angles to Albion Street divided Zone I into three separate courtyard areas, each with its own access from the road. In Zone II the canal basin is depicted as extending across the rear of the Albion Mill itself, and there appears to be a building the other side of the spur, between the canal and the basin. Building E has been built over the basin in Zone III, and Building F forms the eastern side of a courtyard. A smaller building, situated in the southwest corner of this courtyard appears to have had an elaborate frontage in the form of three protruding semicircular bays. The eastern part of Zone III is occupied by a collection of warehouses and workshops. The whole area surrounding the study area is shown as extensively built up by this period and the new line of the canal, which was re-routed c.1850, is also shown.

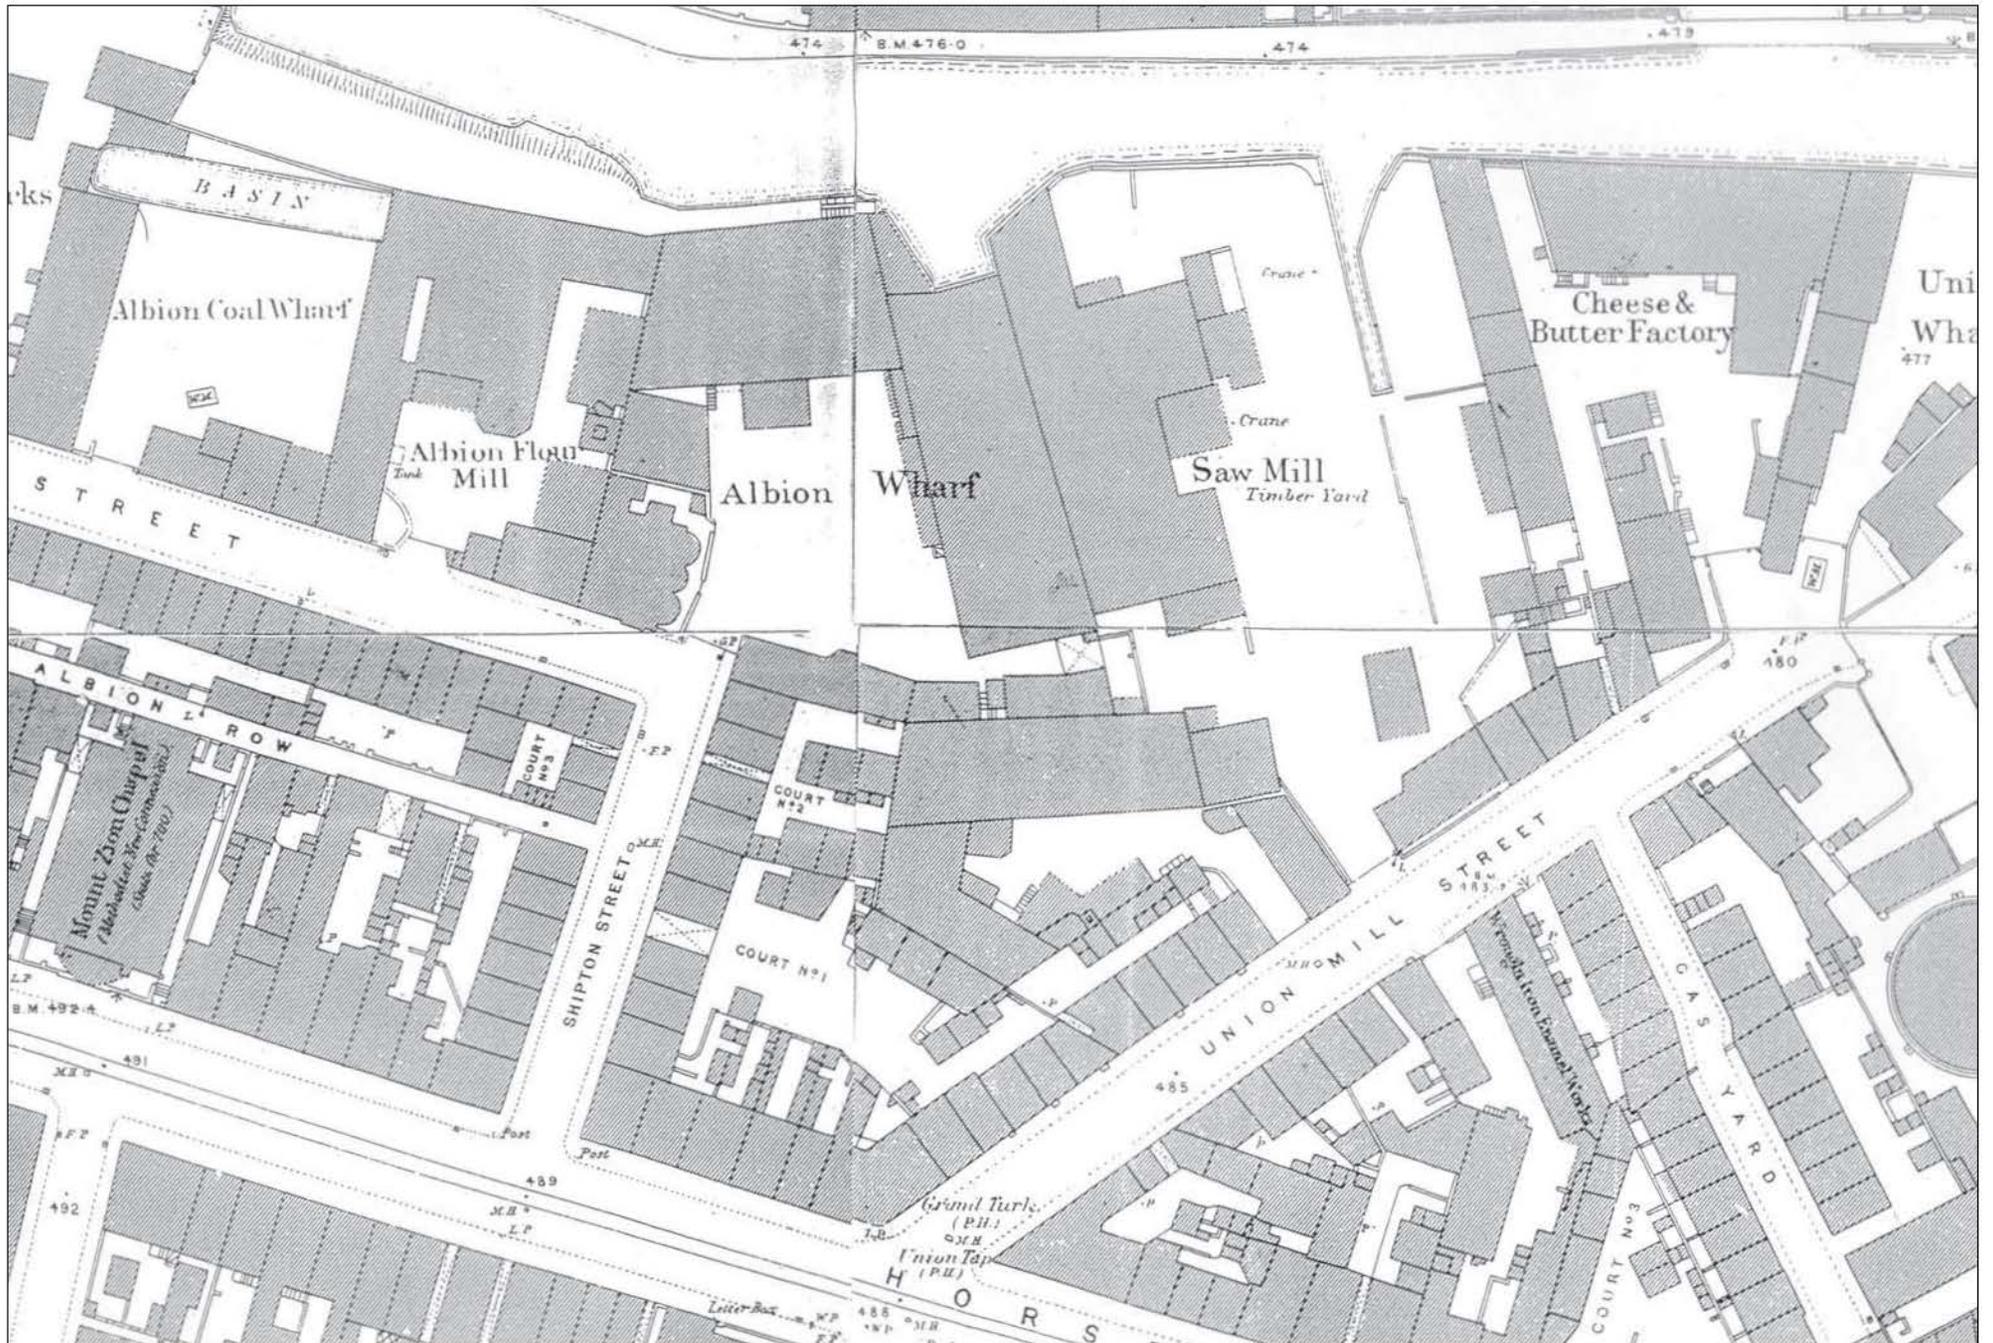
Fig.6

The First Edition 1:500 Series Ordnance Survey map (Fig.6), surveyed in 1883, shows the Albion Ironworks and the Albion Coal Wharf in Zone I. The building between the basin and the canal proper to the rear of the Albion Mill is no longer depicted, but several other buildings have been erected in the frontage of the Mill. Shipton's Wharf (Zone III) has been renamed Albion Wharf, and Building G erected

between the warehouse at the rear of the plot and the structure with the elaborate frontage to the south. An extension has also been added on to the south side of the warehouse in the courtyard area. The Washer Works is now called a Saw Mill and Timber Yard, although Shipton had purchased it as early as 1857. The actual layout of the buildings is unchanged, but the later spur off the canal appears to have been re-cut, and is now Y-shaped.

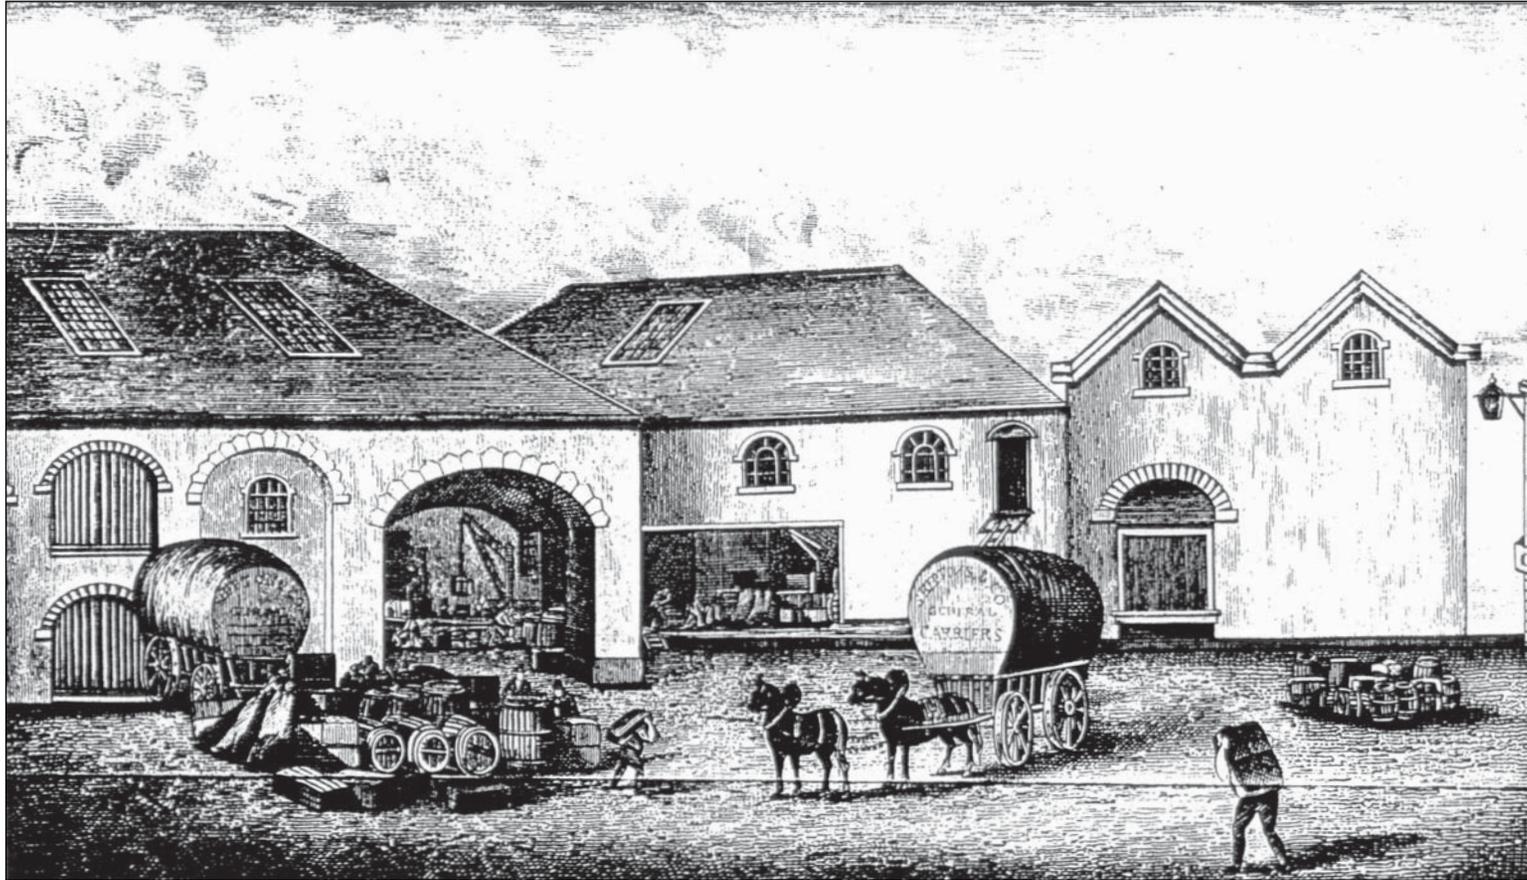
Fig.7

This building is located adjacent and parallel to the main Birmingham Canal. The western gable of Building E is partially abutted by the east-end of Building D (Plate 4), the later eastern range of the main Albion Mill complex constructed between 1864 and 1871. In plan the building is the shape of a skewed parallelogram. This was caused by the fact that the northern half of the building was constructed over the pre-existing canal basin that served the Albion Mill. As a consequence of this the floor level inside the building is about 1m lower than that outside. It is a two-storey structure consisting of two large spaces on each floor. These are divided into a northern and a southern half by a series of brick piers supporting a massive oak beam at first floor level that is aligned east/west down the centre of the building. The building has been modified and strengthened a number of times during its life. Nevertheless enough of the early fabric has survived that, when comparison is made with the 1833 etching of the building (Fig.7), it is possible to propose a reasonable outline of its original form.

Much of the west wall of the building has been extensively rebuilt and no evidence of the openings depicted in 1833 was found during the preliminary inspection. A section of original brickwork survives in the northern end of this wall, including a circular feature in the north west corner of the building whose function remains unclear. The north gable wall of the building is splayed at its base where it faced the main canal basin, above this a semi-circular window with a stone frame survives in situ (Plate 6). To the east of this window the north wall curves round to provide access to the canal basin. This window design, which is depicted on the 1833 etching, is repeated in three equally spaced windows at first floor level, although the outer two have both been damaged. This pattern of three windows is repeated in the southern end of the building, although these were subsequently blocked (Plate 7). Beneath the windows a substantial first floor timber beam has been infilled with later brickwork, so this end of the building may have been open at ground floor level. The east wall is blind apart from a blocked opening in the original brickwork towards its northern end at first floor-level.

Building F is clearly grouped with Building E in terms of function, style and ownership. It is depicted on the 1833 etching of the Shipton's yard and is referred to as a newly-built grain warehouse set at right angles to the main basin in the *Wolverhampton Chronicle* of 24 April 1833 (Thorn 1996, 116). Therefore, in the context of the site, Buildings E and F form a group of some historical significance, and in the context of the area are good and relatively rare survivals of earlier 19th-century canal-based architecture, notwithstanding the fact that Building F is the more extensively repaired and altered of the two structures.

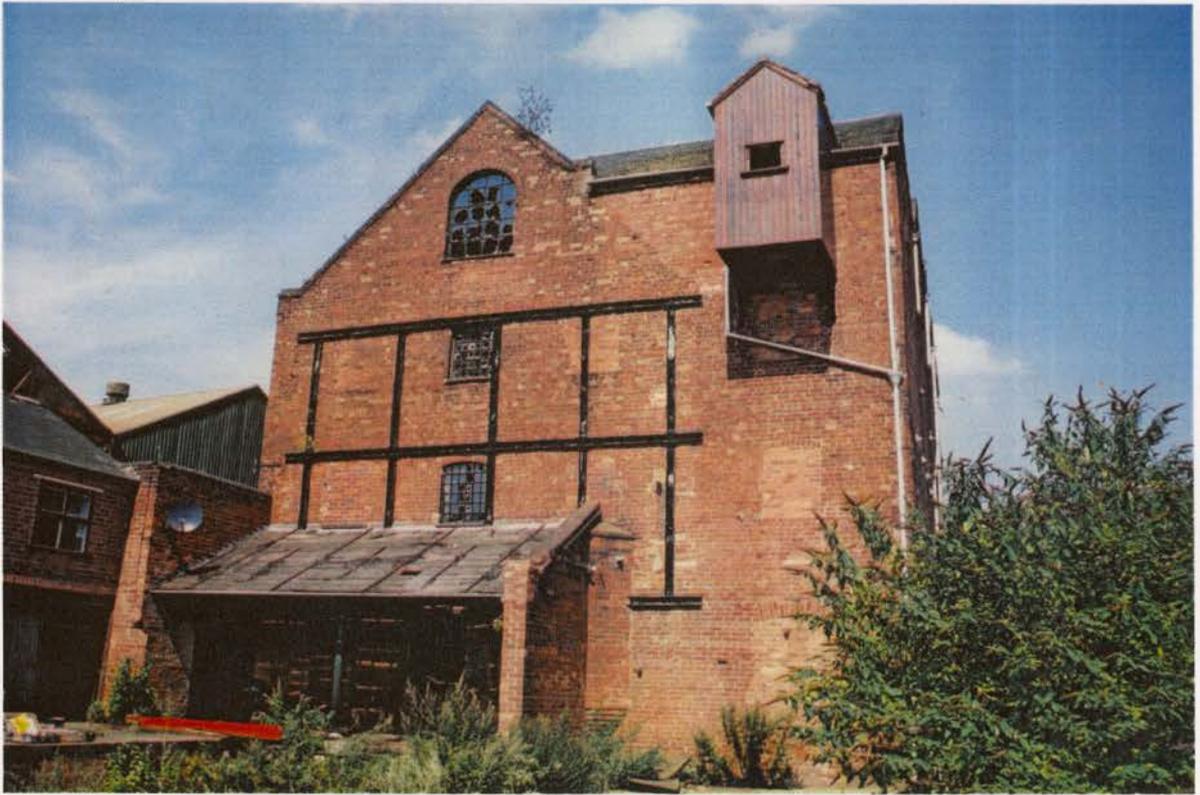
Plate 1 The southern frontage of the Albion Mill

The Albion Mill (Plate 1) will be retained as part of the proposed development and is not, therefore, included in this assessment. However, four other buildings were identified and assessed as being part of the Albion Mill complex, along with several

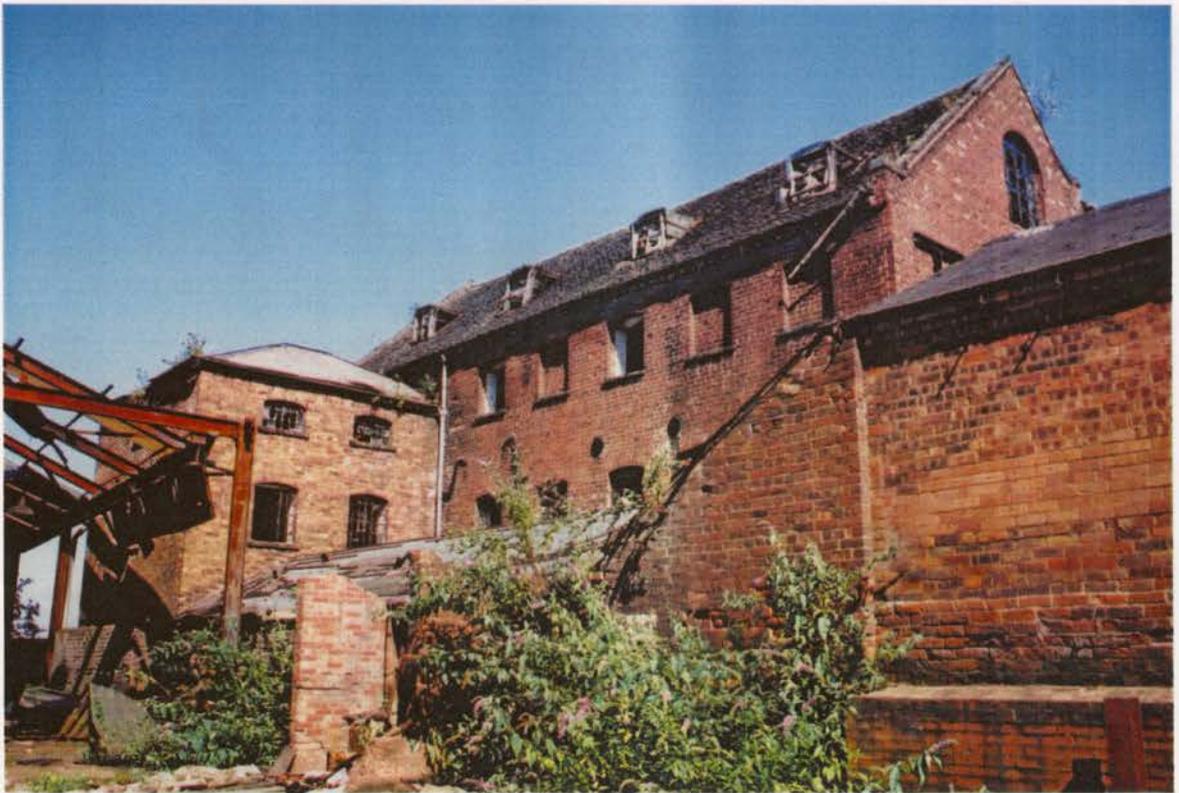
The Forecourt Range flanks the western side of the forecourt of the mill (Plate 2). It is a two-storey brick range - its ground-floor level being at the first-floor level of the other buildings because of the changes of ground level on the site.

The West Range is a narrow block running parallel to the main mill building and separated from it by a narrow yard (Plate 2). At the south end the range has a wider section, giving it an 'L-shaped' footprint, and that portion defines the south end of the yard. At its northern end it abuts the slightly earlier North-Western Extension (Building C).

Plate 2 Buildings A, B and C, western range of the Albion Mill

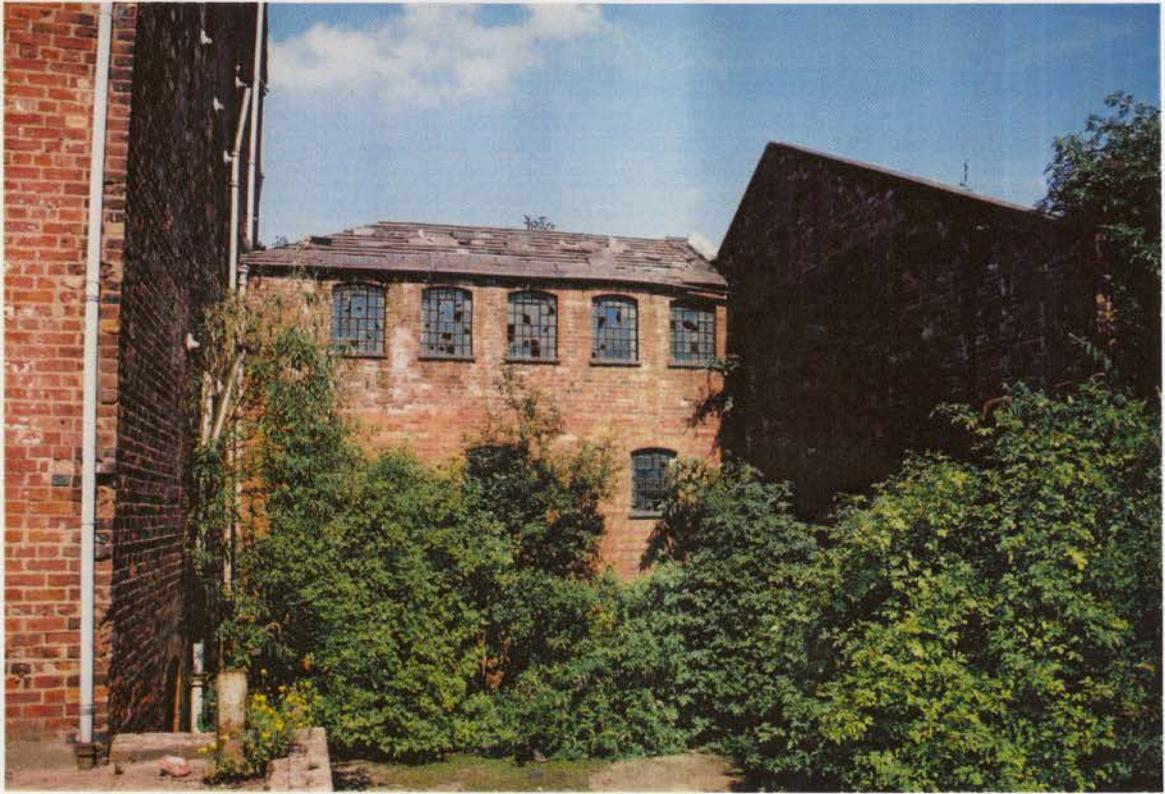
The lower eastern portion of the original mill building did not extend the full length of the building. A canal basin was built under the northern end of the main mill, and the northern end of the eastern portion stopped by its southern bank. The basin ran parallel to the main line of the canal immediately to the north, presumably with a junction to the east of the mill. At a later date, a three-storey structure was built over the open part of the basin, its western end slotted into the angle between the side of the main body of the mill and the northern end of the lower eastern portion (Plate 3).

The vertical construction breaks between the walls of the new build and the original mill walls are quite clear, as are blocked windows in what had been the northern end of the mill's lower eastern portion. Similarly, at the east end of the new range it is clear that it butted against the end wall of an existing structure, the brickwork of which continues southwards as part of the building that still fronts the yard to the south. When the new range was built, it was necessary to raise the northern part of what was presumably a sloping roof to accommodate the height of the new work. The new building's north wall also curves slightly at its eastern end to butt against the north-western corner of that earlier range. In effect, the new building consisted only of its long side walls, utilising existing walls for its end gables, and the westernmost section of its south wall.

Plate 3 Building D: eastern range of the Albion Mill

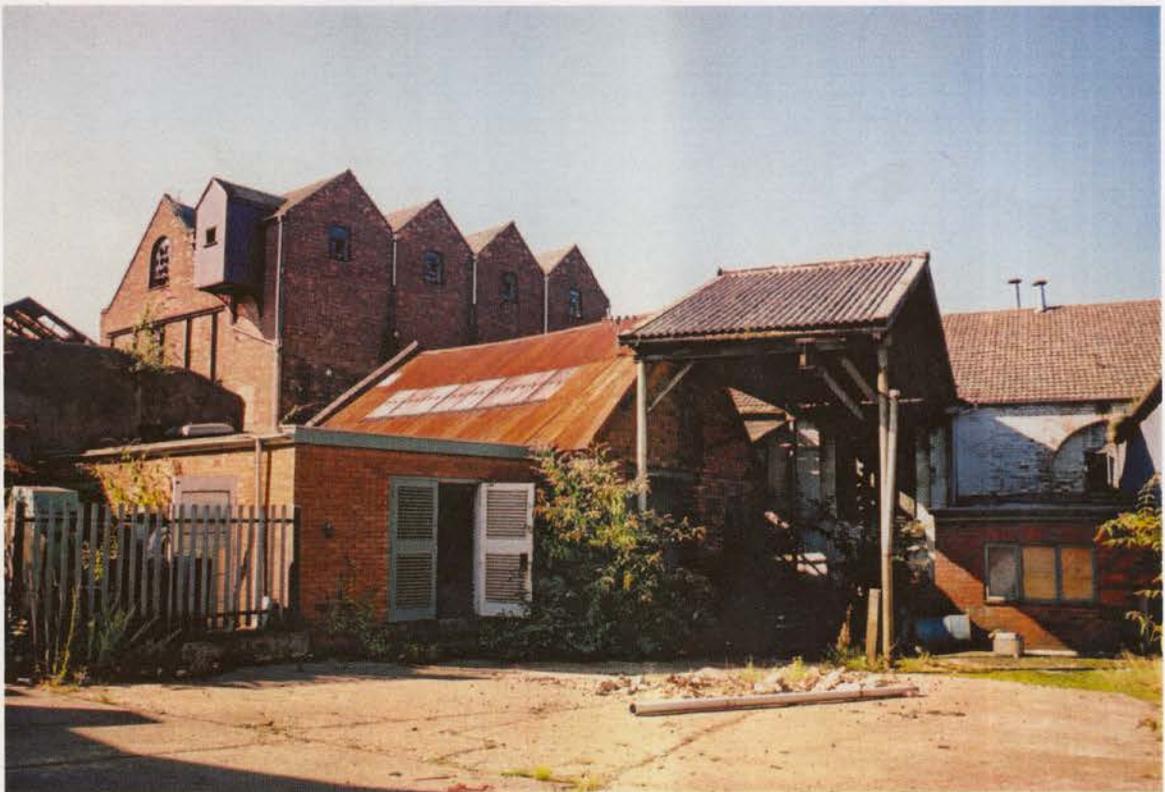
Plate 4 Buildings E and G and steel-framed canopy, Zone III

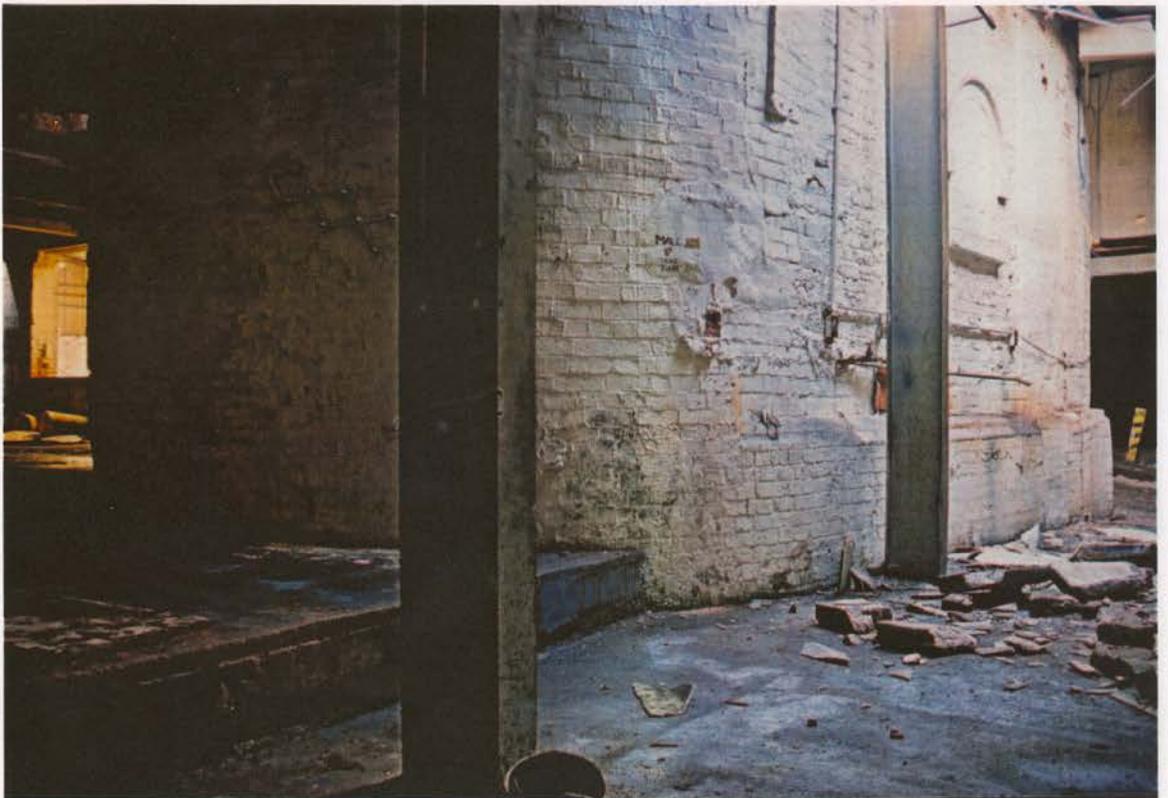
Plate 6 North wall, Building F

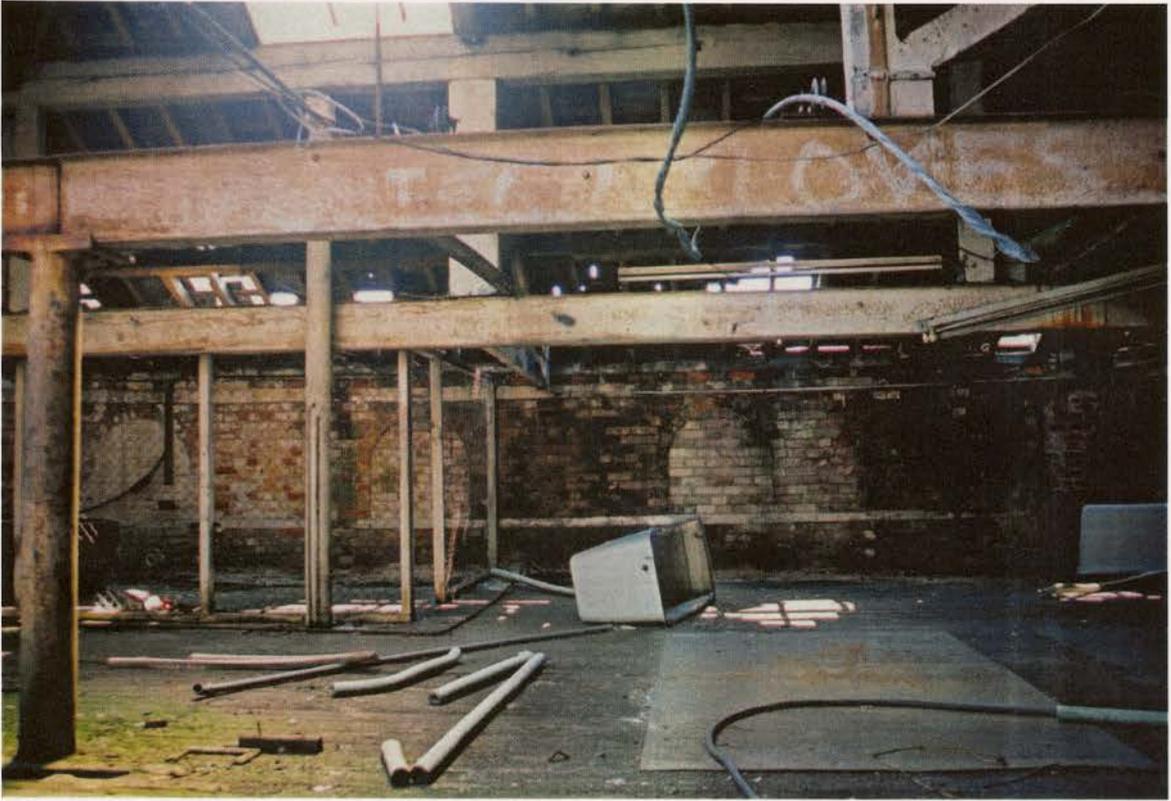
Plate 7 Roof structure and south wall, Building F

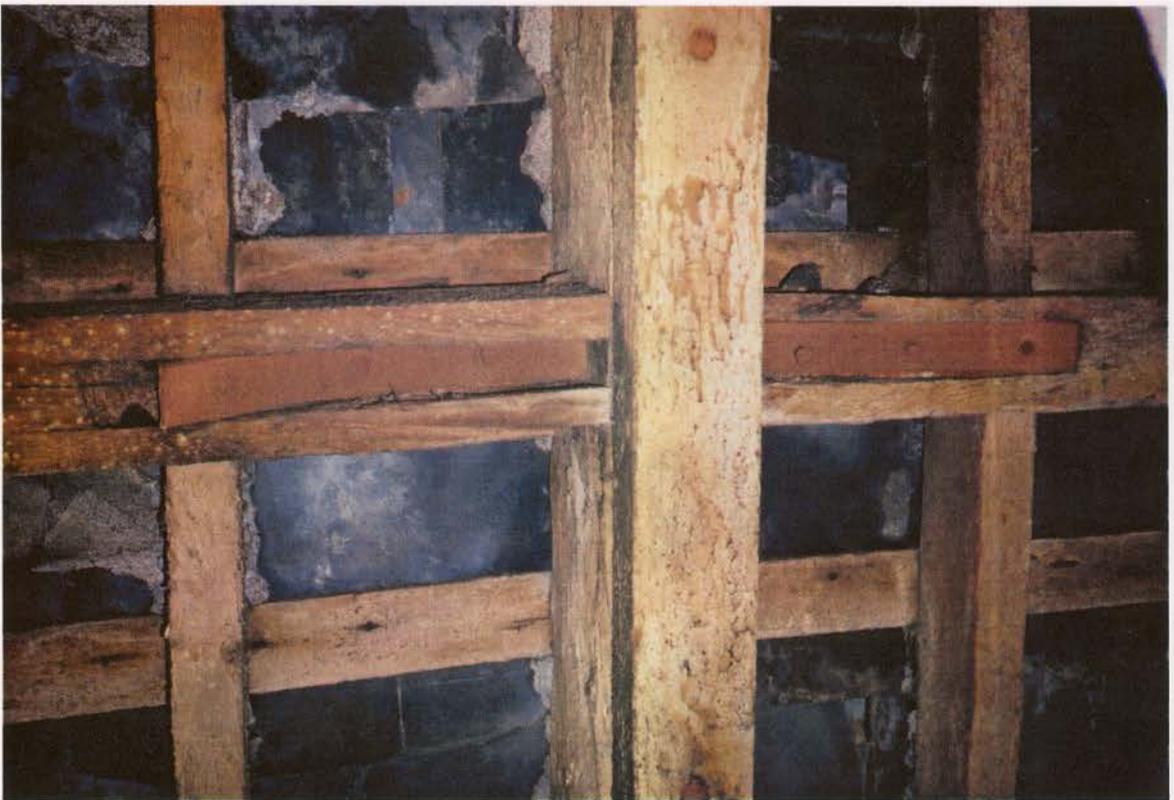
The roof is a Queen-post design consisting of eight principal trusses that support three purlins on either side. The purlins are tied to the principal rafters by iron stays (Plate 8). The roof has been extensively repaired and strengthened using steel I-beams and steel columns. These repairs appear to be contemporary with the replacement, strengthening and raising of the first floor and central spine of the building sometime in the 20th century. Trap doors in this later floor provided access, the central one of which had a pulley hoist attached to a principal roof truss.

Plate 8 Detail of purlin tie, roof structure, Building F

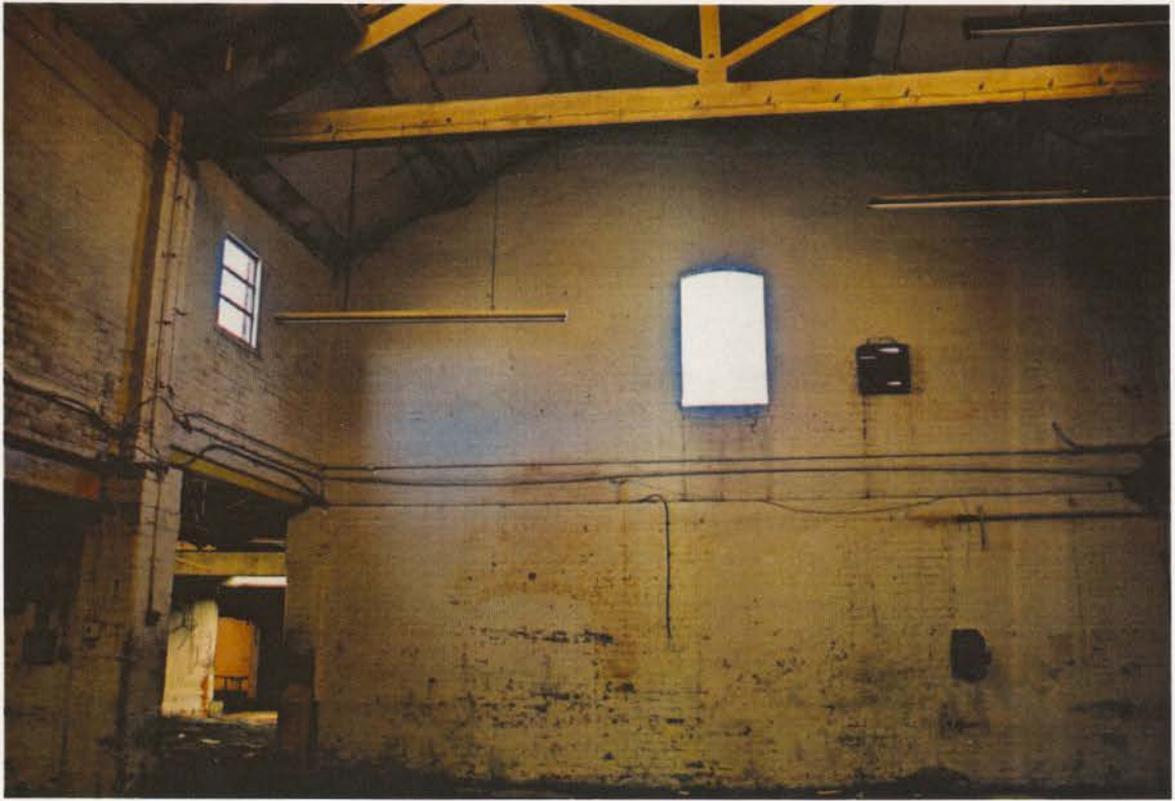
Plate 9 East wall, Building H

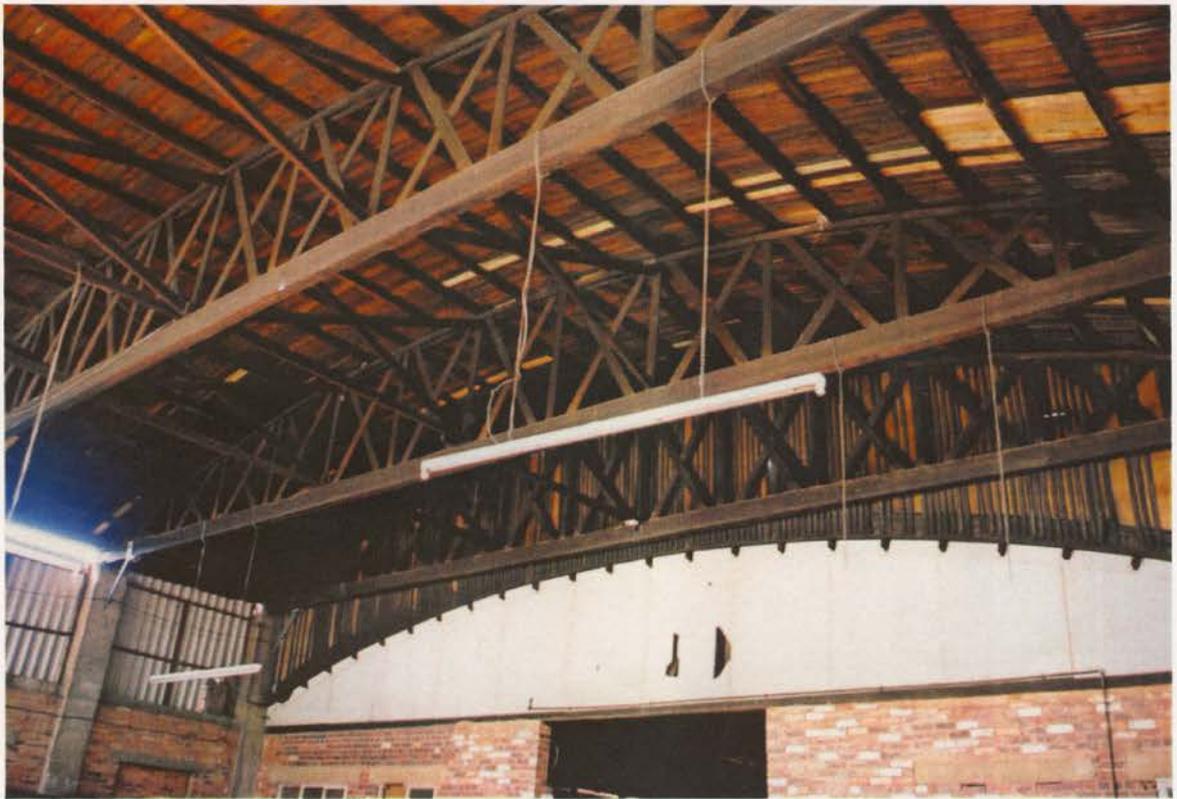
Plate 10 Belfast-truss roof, Building J
