**An archaeological
watching brief at
the site of
Cathedral School
Lichfield,
Staffordshire
2001**

Birmingham University Field Archaeology Unit
Project No. 819
August 2002

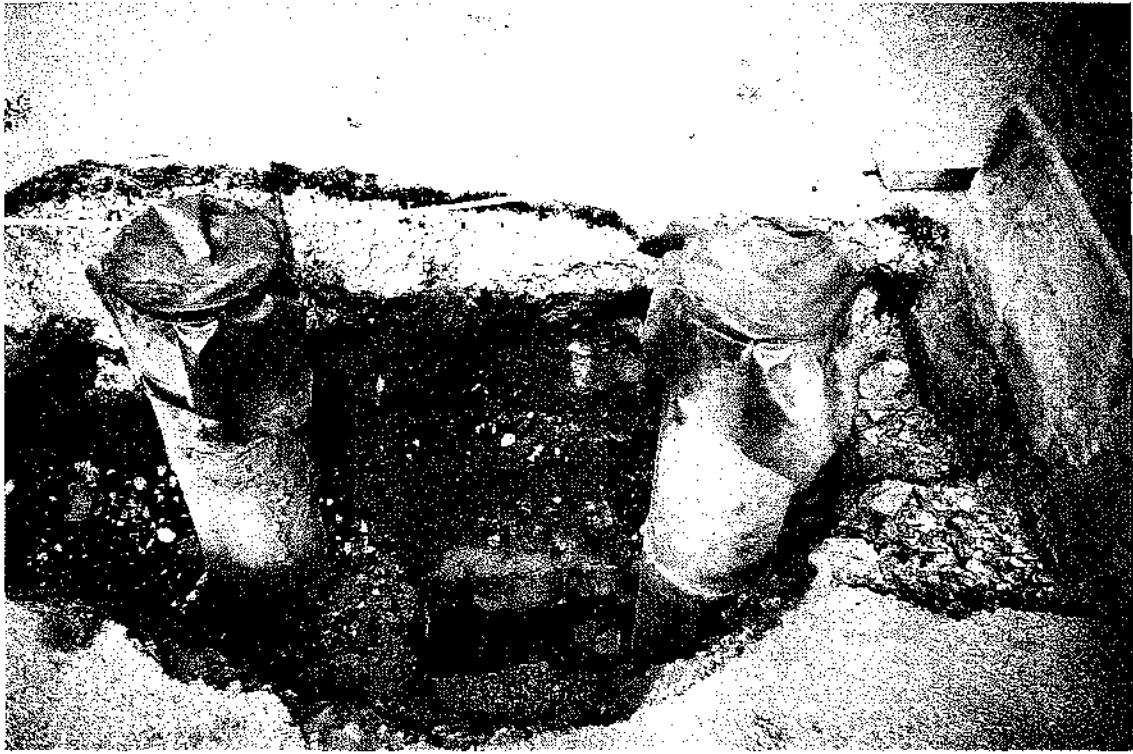
Plate 1	General site photograph (C. Flitcroft)
Plate 2	Disturbed culvert, near Augur 9 (C. Flitcroft)
Plate 3	Sandstone block, near Augur 3 (C. Flitcroft)

After the drilling of the augured pile foundations, the level of the site was reduced by 0.7m to allow a concrete base to be formed. The existence of a culvert in the vicinity of Augur 9 (Plate 2) and decomposed sandstone blocks near to Augur 2 (Plate 3) was noted during associated trench excavation prior to the general level reduction. It was difficult to determine whether these blocks related to an *in situ* structure or had been deposited as part of the general backfill/ levelling deposit. The uppermost horizon was a tarmac

The auger hit a compact red-brick layer at 0.3m and appeared to penetrate a void until a depth of 2m. This appeared to be the inside of an old culvert. The natural subsoil horizon was identified at a depth of c.3.0m
