Birmingham University Field Archaeology Unit
Project No. 827.02
February 2003

A63 Selby Bypass
Building Record of Brayton Barff Army Camp 2002

by
Malcolm Hislop

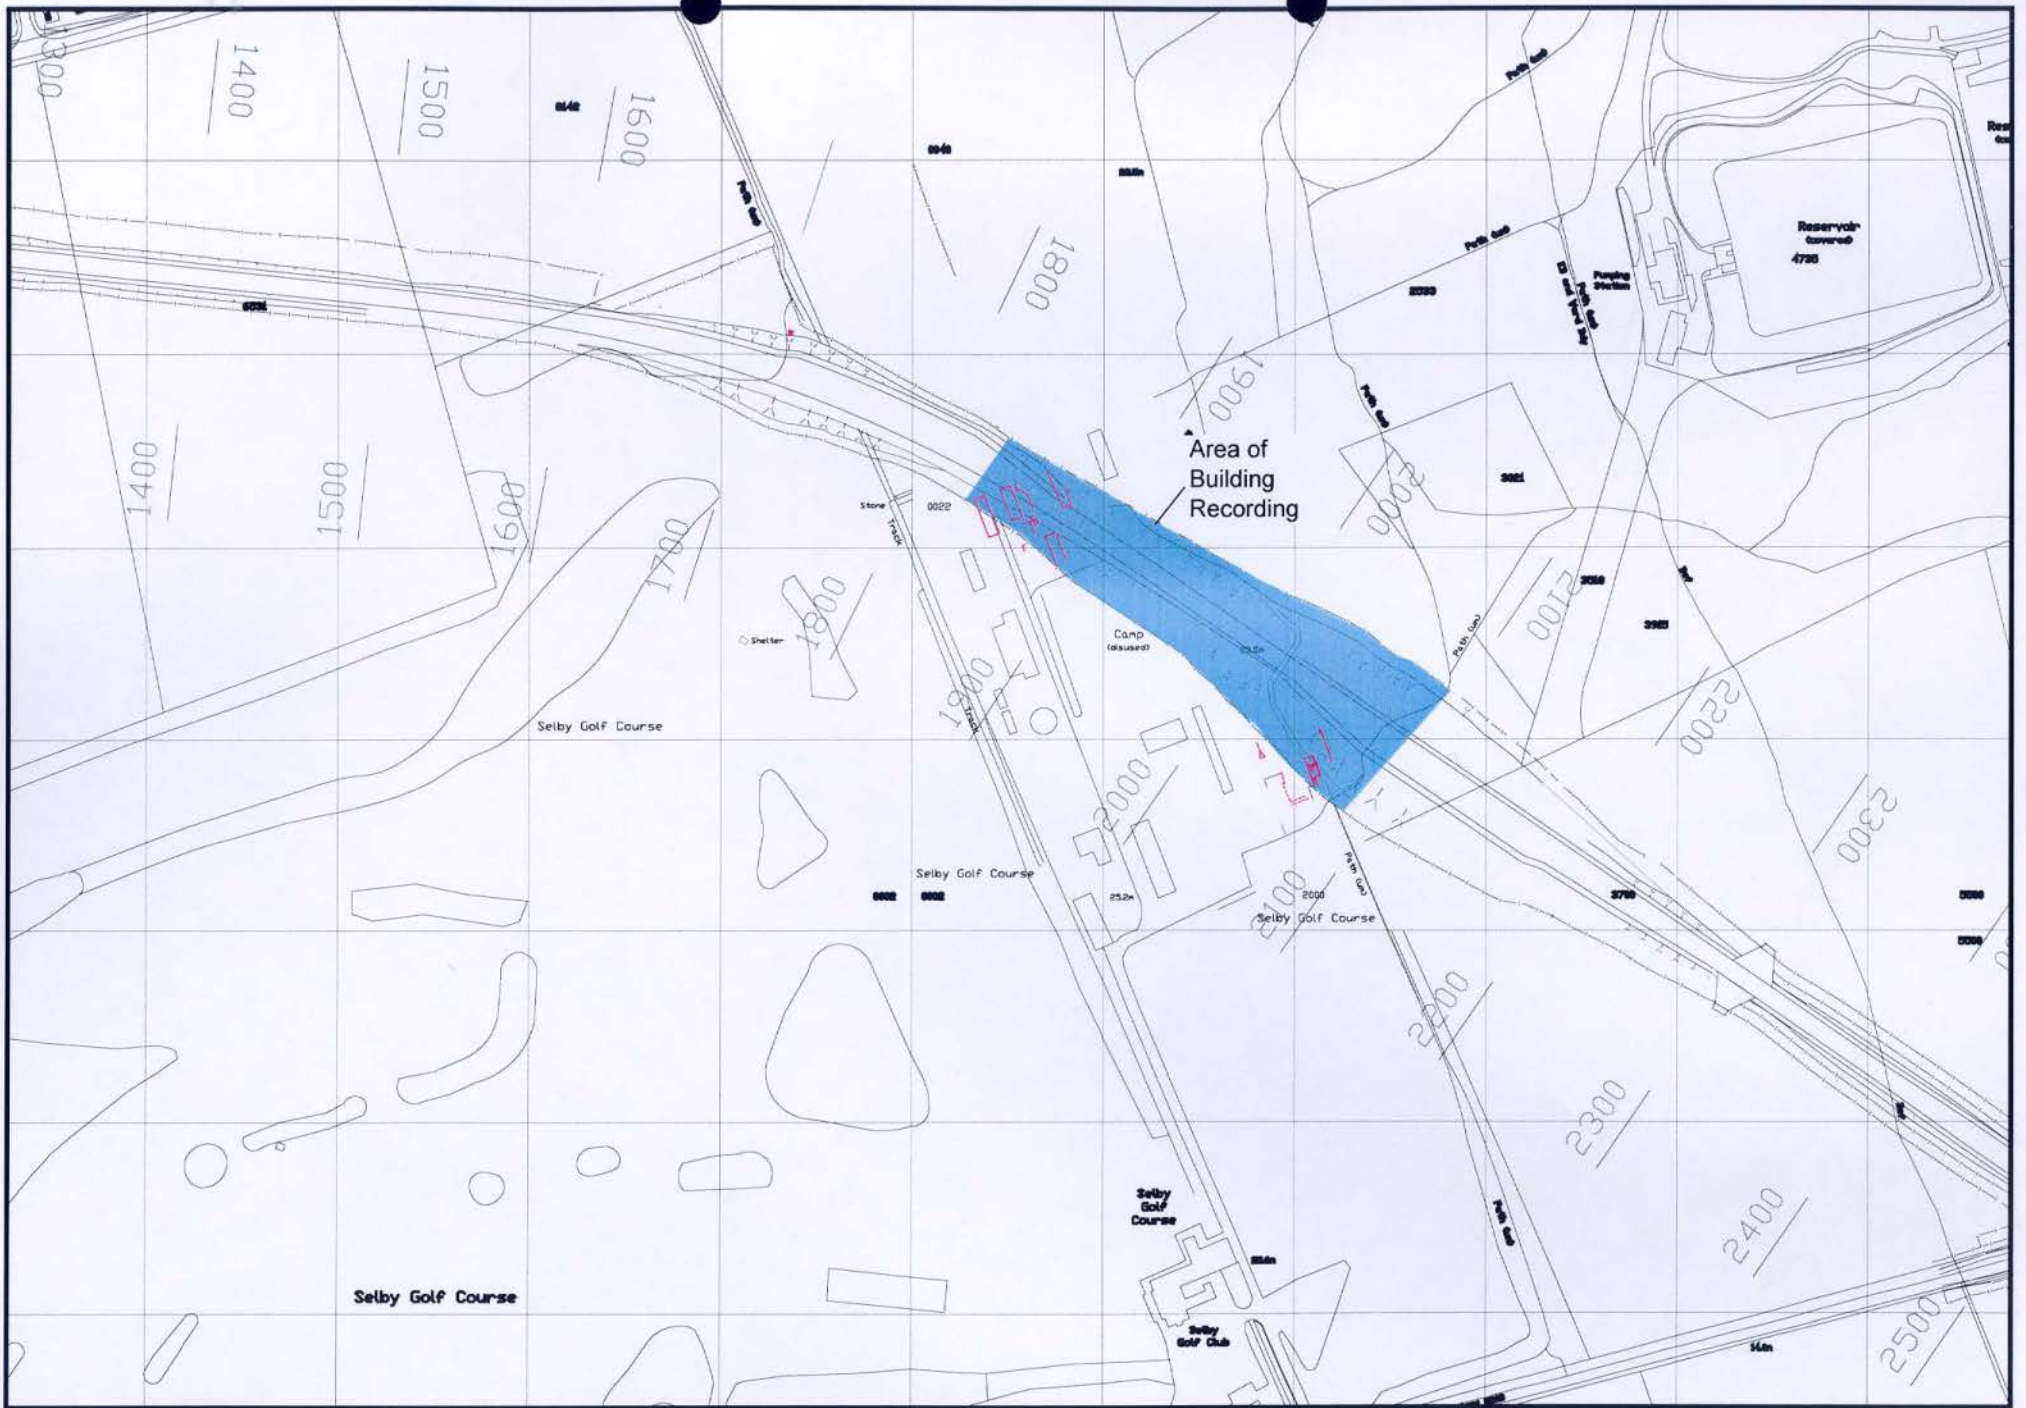
Fig.3

The site lies on sloping ground which falls away to the north; it is roughly rectangular, and can be conveniently divided, from north to south, into three main zones, corresponding with the three principal levels. The central zone is dominated by a large open asphalted space suggestive of a parade ground. The northern and southern zones each have their own architectural characters which suggest that the two areas were devoted to quite separate functions (Fig. 4).

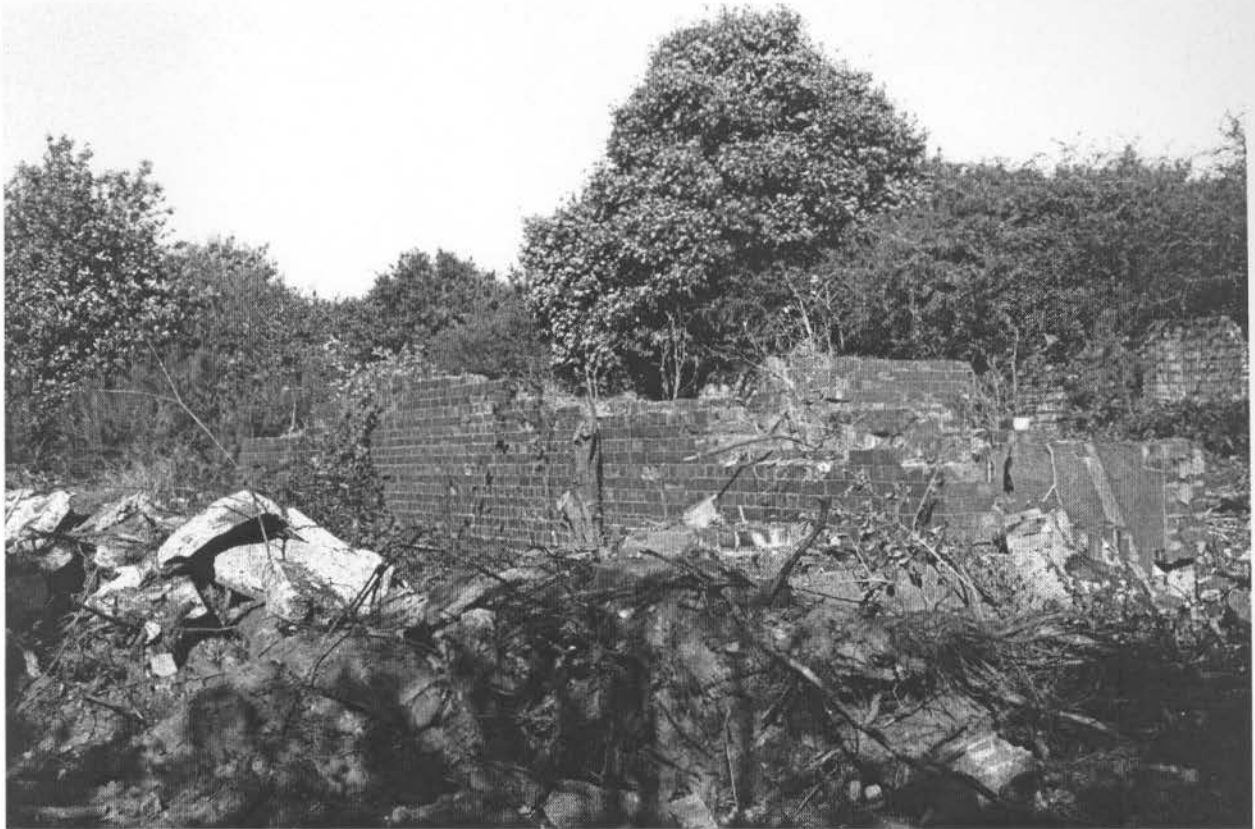
Plate 1

The walls of this early twentieth century structure survive up to 1.5m high in places (Plate 1). It was built of red brick (English bond), and apparently had flat concrete roofs, fragments of which are evident as tumble within the building (Plate 2); the bricks are 9"x 4¼" x 3", are frogged, and bear the stamp 'Carlton Main', suggesting that they were probably manufactured at Carlton Main Colliery near Barnsley, South Yorkshire. The main body of the building is approximately 12m by 5.5m and is aligned north-south. At the south corner a narrow wing (3.75m by 2m) continues the line of the west wall. This wing is open to the south and appears to have contained the entrance to the building (Plate 3). There is no surviving evidence for fenestration on the east side where the walls have been reduced to no more than 1m in height, but the west wall retains the sills of two windows which slope downwards to the interior (Plate 4). These are both 1.22m (4 feet) wide and 1.5m above the existing ground level on the west side.

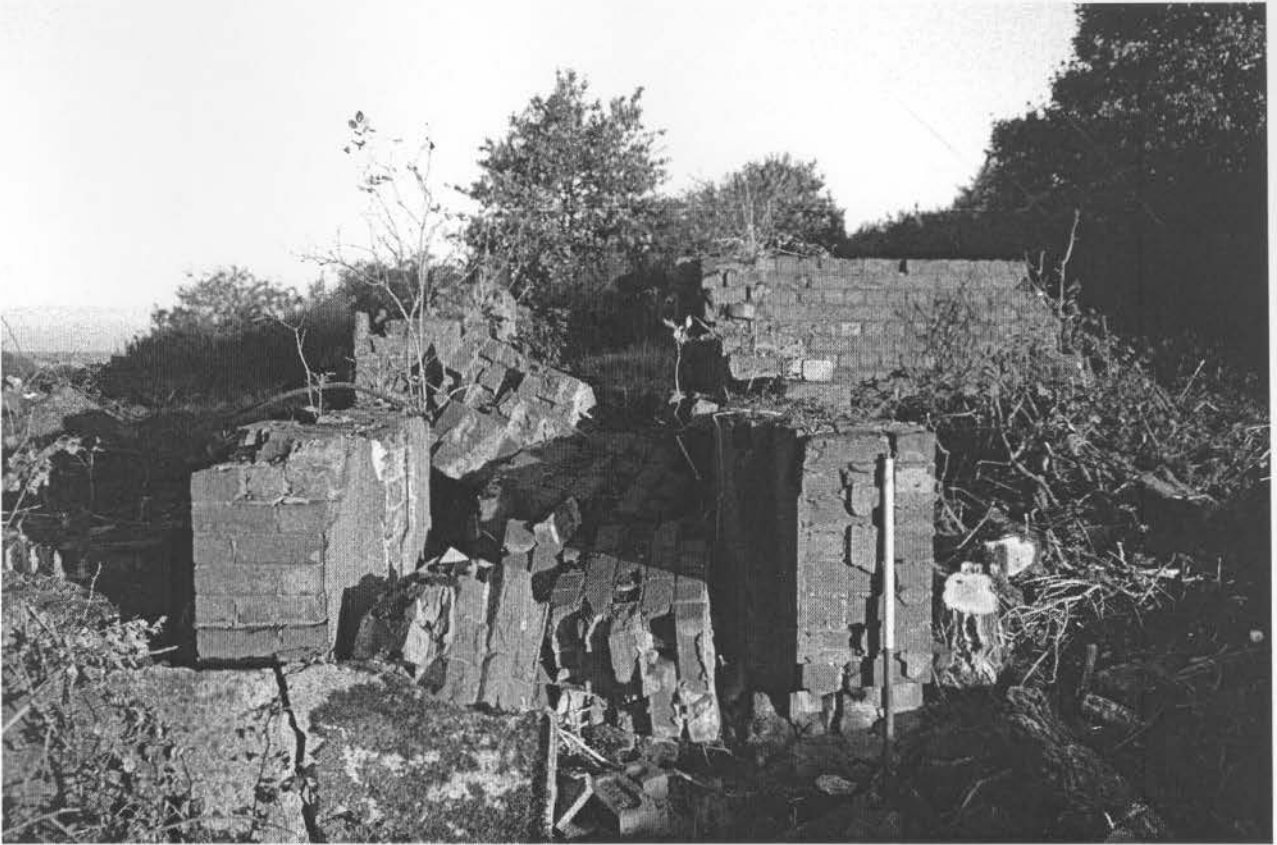
Plate 3

Internally, the walls are cement rendered. An entrance passage contained within the wing leads into the main building. Immediately inside the wing, the passage is flanked by a pair of buttress-like features (Plate 3); the fronts of these slope backwards from the floor, whereas the backs are perpendicular. There is another pair at the end of the passage (Plate 5), and further examples inside the main structure, and they appear to indicate entrances. The line of the entrance passage continues through the building, being demarcated on the east by the edge of a long, rectangular, table-like structure (Plate 2), evidently a working surface of some kind. At its north end a brick partition wall extends towards the north, so lengthening the line of the west passage. To the east, two walls extend towards the east and then return to the north and south respectively, and suggest a passageway on the east side as well. 'Buttress' features at the north ends of these two corridors (Plate 6), co-

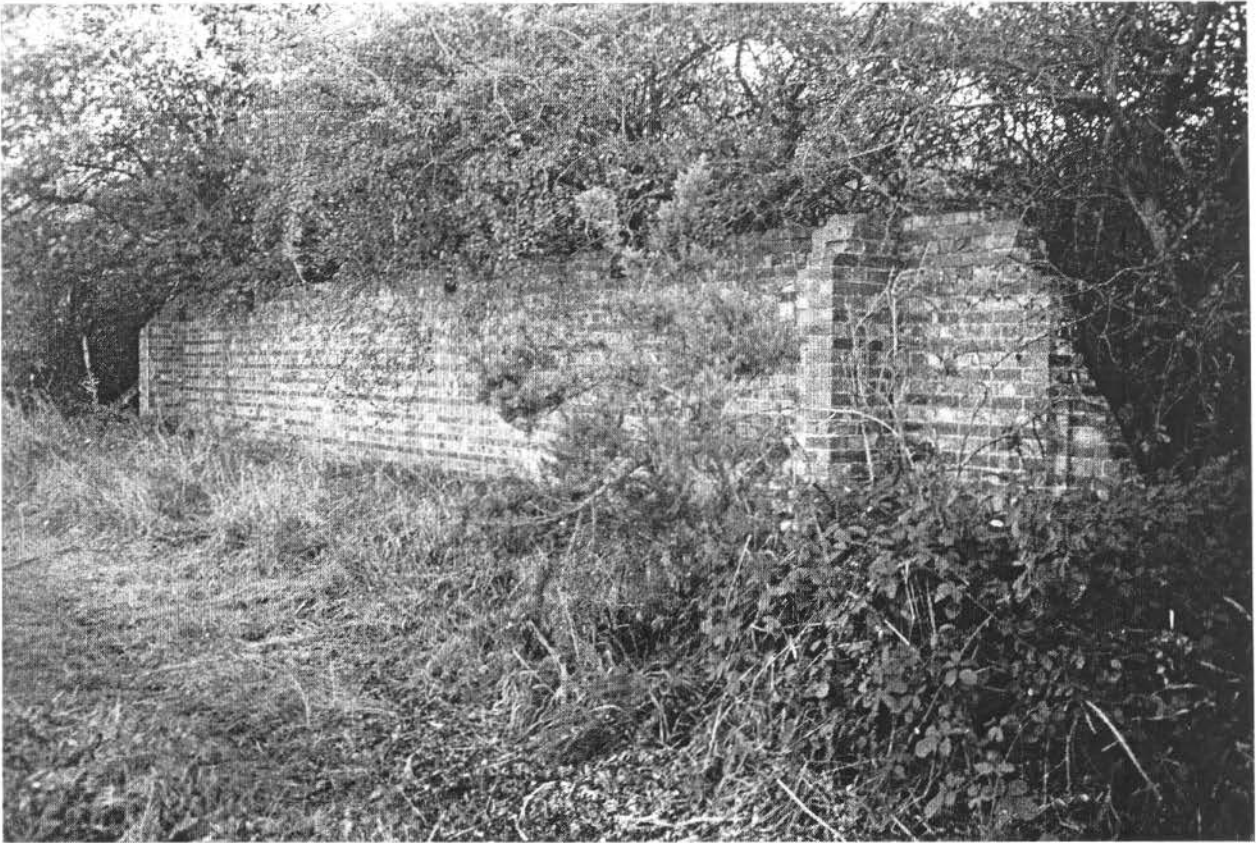
Plate 7

Building B (Plate 7) now has the appearance of an isolated wall though closer examination shows that it was originally slightly more complex. Probably early twentieth century, it is built of red bricks (English bond), the bricks being $8\frac{3}{4}'' \times 2\frac{3}{4}'' \times 4''$, frogged, and stamped 'Yorkshire Brick C. Castleford'. The wall is approximately 20m long and is aligned north-south. At the north end, attached to the west side, are the remains of a small building. A surviving door post (on the east side) indicates that it was entered from the south. Immediately to the south of the entrance is a buttress. A similar arrangement appears to have existed at the south end of the wall, though the structural remains are now less evident. There are now no indications of function though the terminal buildings or rooms would each have been an appropriate size to have accommodated a lavatory.

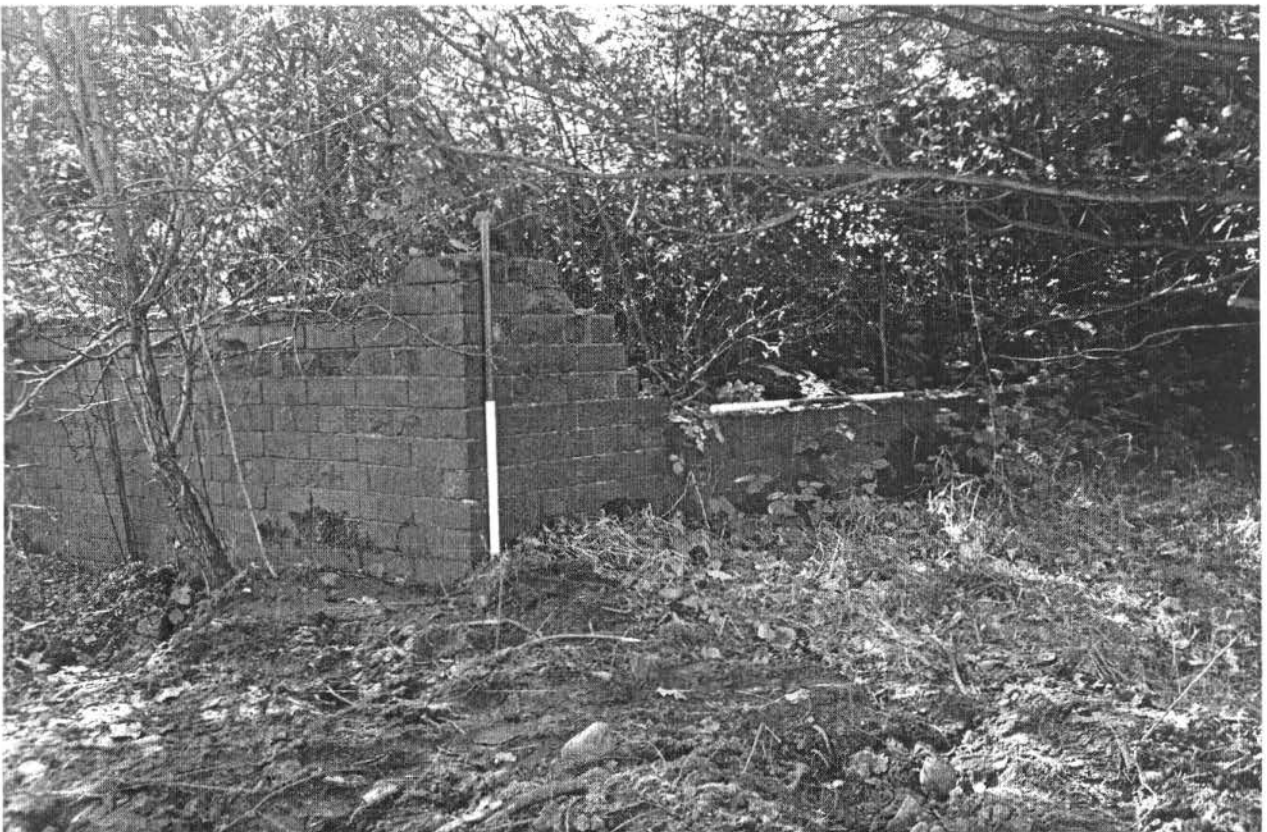
Plate 8

This structure (Plate 8) lies on the edge of the bypass route and to the west of Building A. It was built, probably in the early to mid-twentieth century, of frogged red bricks (English bond) $9'' \times 4\frac{1}{4}'' \times 3''$. However, no manufacturer's stamp was visible at the time of the survey. Building C is aligned north-south, and facing east. The north end, where the walls survive up to 1m in height, is well defined, though other parts are less in evidence. On the east side, a deliberately executed break in the brick wall appears to indicate an entrance (Plate 9). There is no trace of this eastern wall continuing to the south, but a 4-foot wide concrete path leads towards the entrance and extends beyond the threshold into the building itself. This suggests an opening of at least the same width. This path was bounded to the east by a brick wall (foundations only) which extends along much of the length of the building. A little towards the north of the path this wall appears to have returned to the west, but there are no indications of this on the east wall of the main building. A conclusion that may be drawn, perhaps, is that there was an outer entrance here, giving access from the north to an outer enclosure on the east side of the building proper.

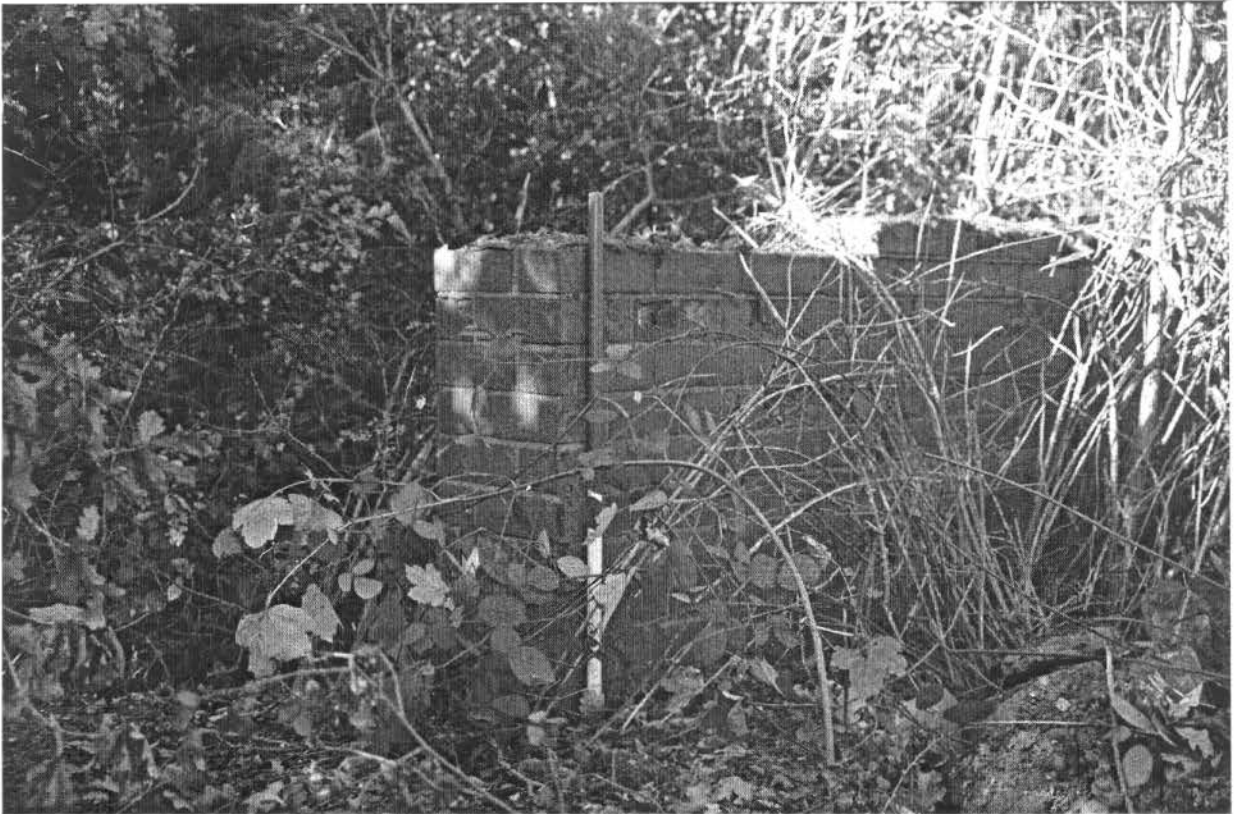
Plate 9

At the south end of Building C, a long wing extends at right angles from the east side to form an L-shaped plan with the main block. This appears to have housed a 6-foot wide entrance passage. The construction method is distinctive, the two walls comprising a series of concrete block pillars, the bay spaces between them being infilled with red brick. This form of construction is encountered elsewhere in the complex (Buildings E-J below).

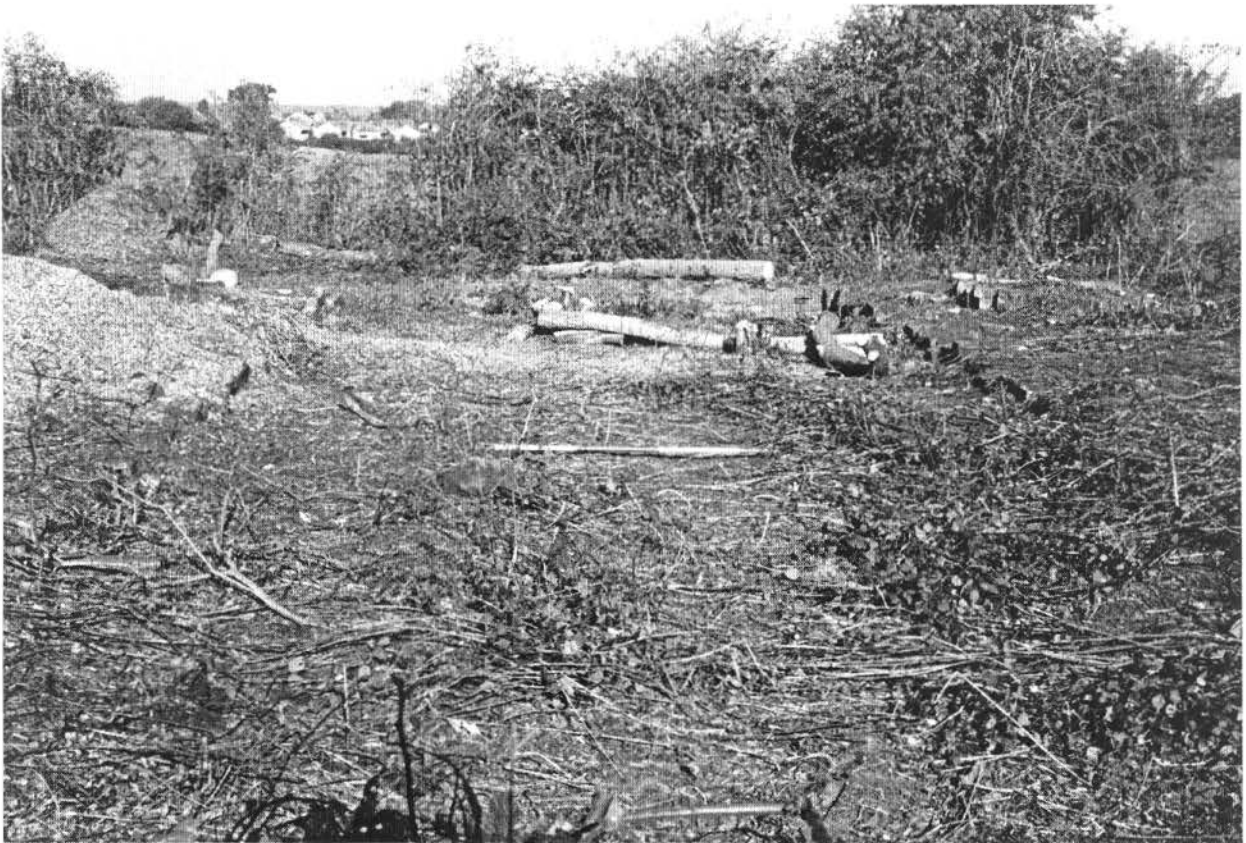
Plate 10

At the north end of the site is a series of early to mid-twentieth century buildings on the same alignment as Buildings A-D, and uniform to a considerable degree in detail and layout (Plate 10). The walls survive to a height of no more than 0.5m but were built of concrete block pillars (Plate 11), alternately 9" and 14" wide. The resultant bays were infilled with red bricks (stretcher bond), which measure 9"x 4¼"x3". Fragments of corrugated iron hint at the character of the roofing material. Each building is approximately 23m (70 feet) x 7m (23 feet) externally, and divided into twelve 5 foot bays by the concrete pillars. They are spaced 9.20m apart.
