**Mayhouse Farm, Hadley,
Worcestershire:
a programme of
archaeological work
2001**

Birmingham University Field Archaeology Unit

Birmingham University Field Archaeology Unit
Project No. 875
February 2002

Site code: WSM 30946

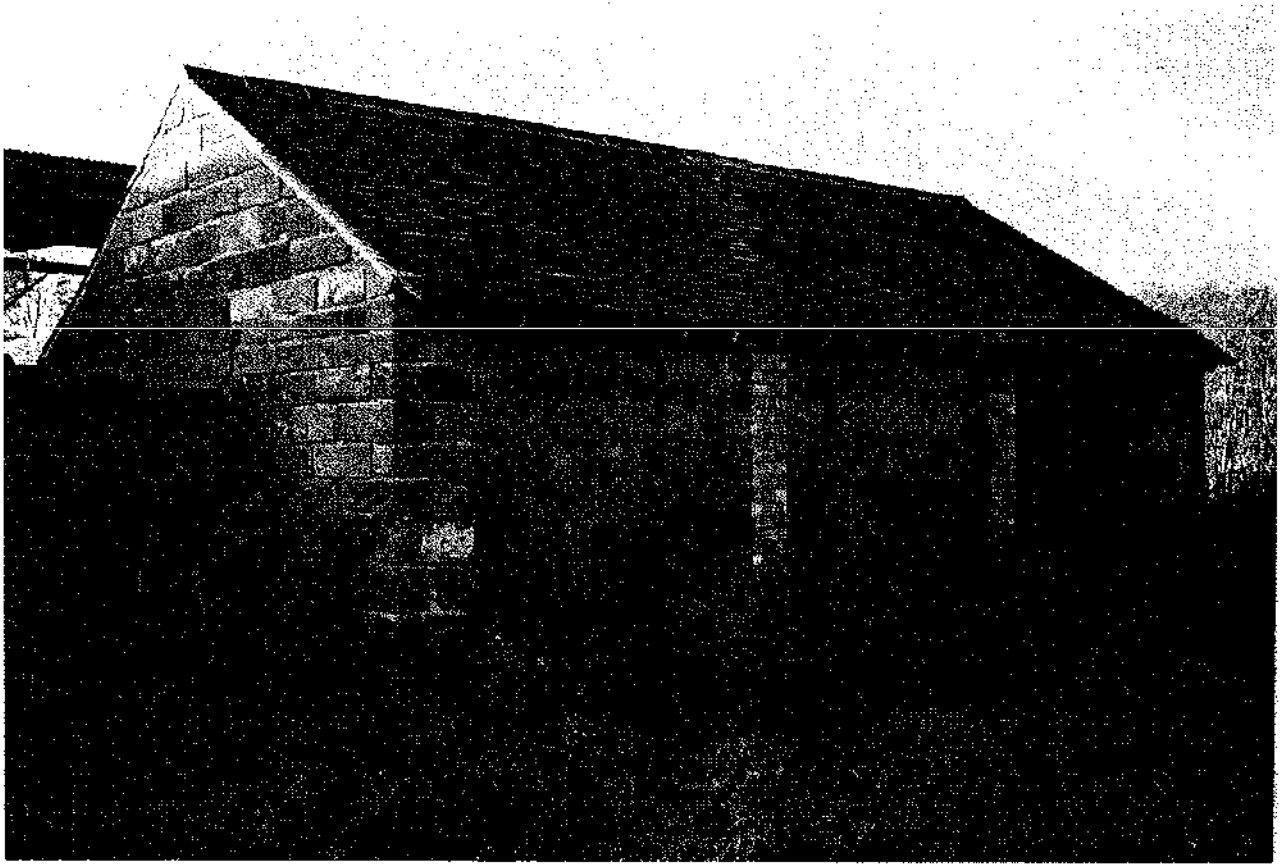
Plate 1

The mid-nineteenth century cart shed on the east side of the yard has been renovated during the mid-twentieth century. It is built of dressed sandstone blocks with irregular herringbone pattern tooling; plain tile roof. One storey, three bays. Brick (9"x 4¼"x 3¼") internal walls, and twentieth century roof on steel girders.

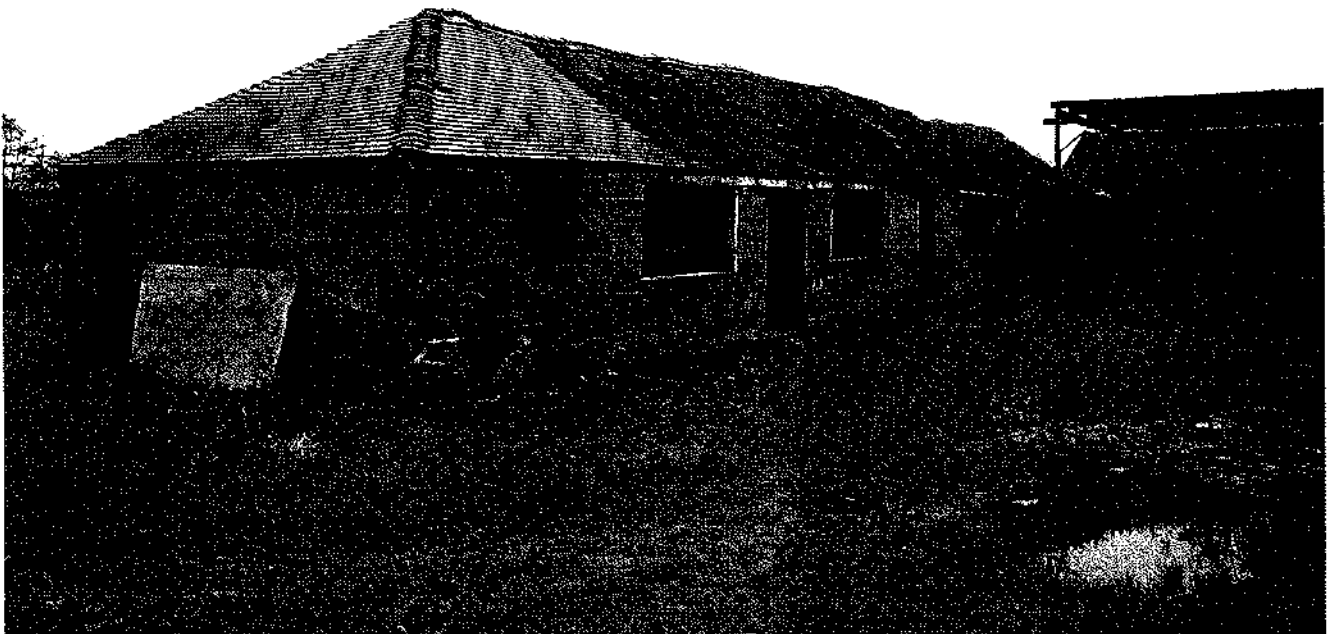
Plate 2

Stratigraphically later than the cart shed are the cow sheds of the north range, which date from the late nineteenth century, and were later modified during this period. They are built largely of sandstone blocks, similar in character to those of the cart shed, though there is also some later red brickwork on the south elevation. Hipped clay tile roof. One storey, eleven roof bays in length divided into two sheds of four (west) and six (east) by a feed preparation bay that is defined by stone transverse walls. A continuous feed passage extends along the north side of the building, and has access doorways at the east and west ends, and to the north, into the feed preparation bay. Feeding trough to the north and manure channel to the south. Cattle entrances to the south, one to the west shed, and two to the east shed, each flanked by a pair of windows. *The south elevation* incorporates some archaeology, which demonstrates that the present form of the building is the result of modification. The left-hand bay is in stone and contains an original window, now barred. The next three bays to the right are brick (9"x 4½"x 3"), built in English Garden wall bond, and contain one doorway and flanking windows. The rest of the south front is also brick (9"x 4¼"x 2¾") in a similar bond, but stratigraphically later in date, and pierced by two doorways and flanking windows. All these windows, in both phases of brickwork, have been enlarged by lowering the sills. The brickwork has been bonded into the ends of the sandstone transverse walls that define the feed preparation bay. A timber wall plate, carried by these walls, indicates that prior to being built up in brick, this elevation was open fronted, the wall plate being supported by morticed

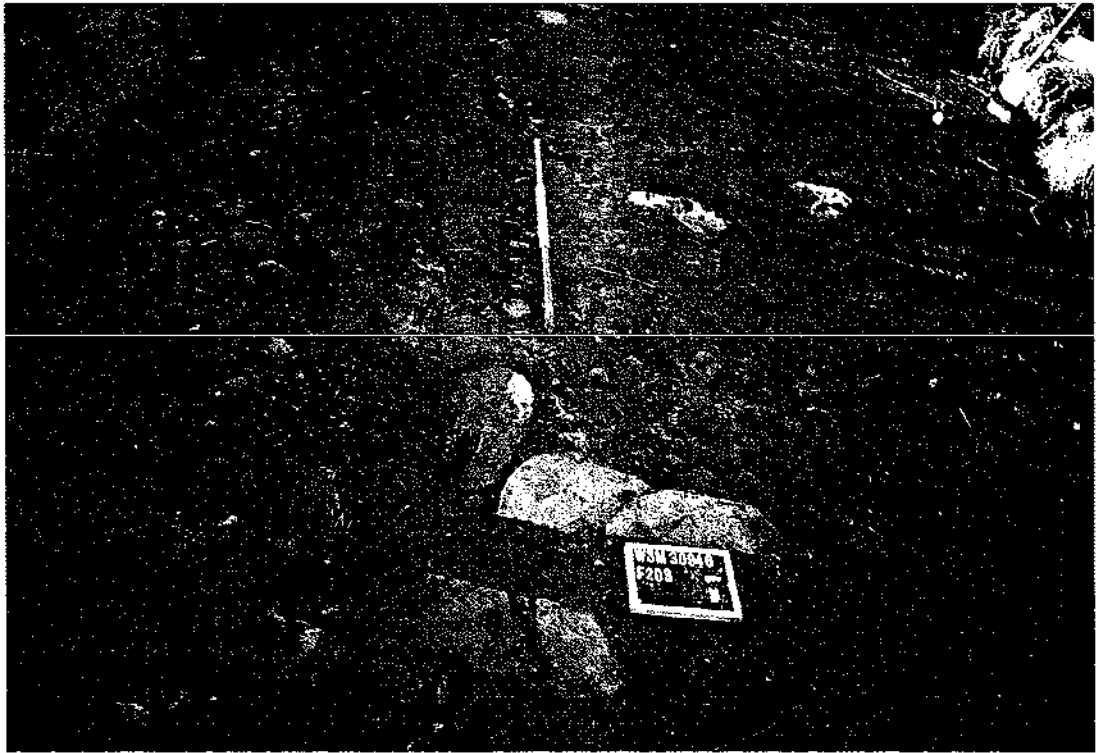
Plate 14

Further to the east were the truncated remains of an 'L'- shaped drain (F203, Fig.10, Plate 14), cut into the natural subsoil (2013). It was aligned northeast-southwest and turned towards the north at its northeast end. Drain F203 was vertical sided, 0.74m wide and 0.16m deep, and was lined with red clay (2002) containing tile and animal bone and dressed sandstone blocks (2009), possibly reused, each up to 0.70m long by 0.15-0.18m high by 0.20m wide. It was filled with a dark brown clay silt (2011) containing animal bone. East of F203 was a circular posthole (F210), 0.15m in diameter and 0.15m deep, with steep sides and a flat base. It was filled with a brown silty clay (2030) containing a sherd of post-medieval pottery and fragments of tile.

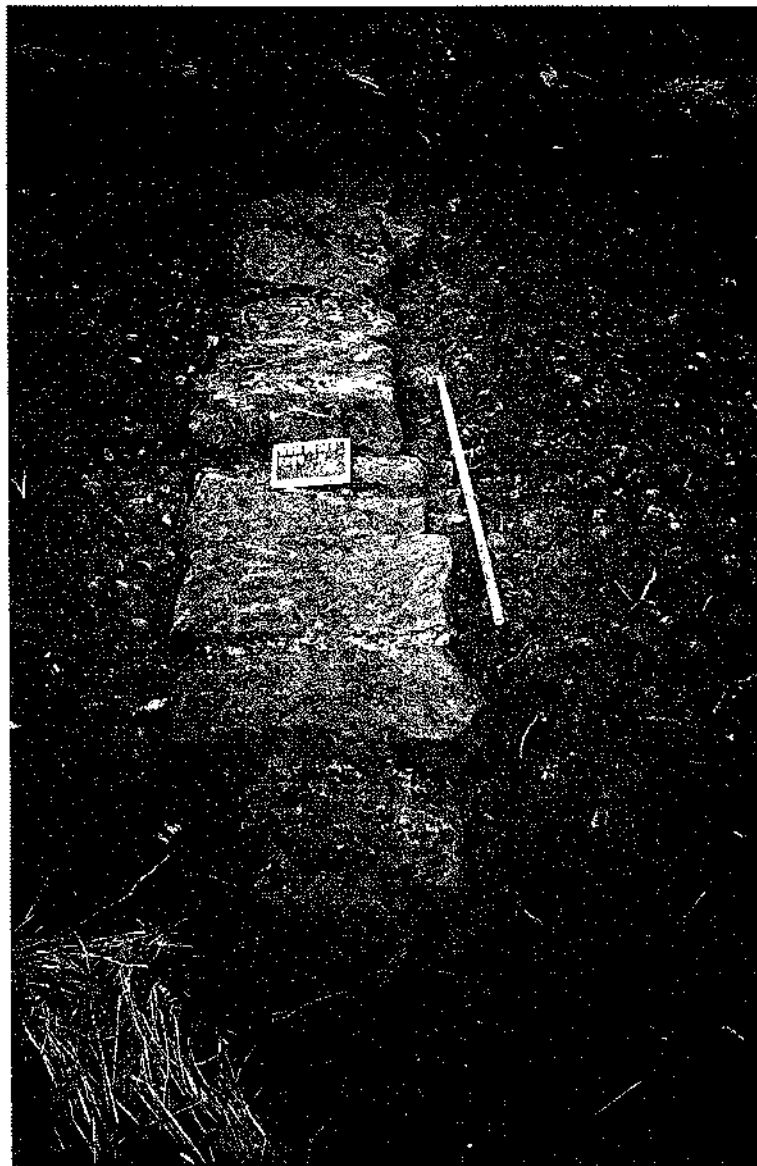
Plate 15

The natural subsoil (2013) was a reddish brown clay. It was overlain by 0.30m of topsoil (2012) containing a worked flint, shell, sherds of medieval and post-medieval pottery, a fragment of clay pipe stem, glass, iron nails and iron fragments. At the west end of the trench, was a linear feature (F208, Fig. 8), aligned north-south and cut into the natural subsoil. It was approximately 6m wide and 0.6m deep, with gently sloping sides and a flat base. The feature was filled with three contexts. At its base was a layer of cobbles within a red clay matrix (2027), 0.53m thick, containing sherds of post-medieval pottery, fragments of tile, a fragment of clay pipe stem and animal bone. Context 2027 was cut by a culvert (F209, Fig. 8, Plate 15)

with brick sides (2033 and 2034) and a cover of sandstone slabs (2029), on a similar alignment to F208. The silty fill (2032) within the culvert, contained sherds of post-medieval pottery, a clay pipe stem, an iron nail and animal bone. Overlying both 2027 and culvert F209 was a buff sand (2028), 0.02m deep, and another cobble layer in a sandy matrix (2024), 0.05m deep, containing sherds of post-medieval pottery and fragments of roof slate.
