**An Archaeological  
Watching Brief at Manor  
Farm, Halesowen Abbey,  
Halesowen, West  
Midlands**

Birmingham University Field Archaeology Unit  
**Project No. 887**  
June 2003

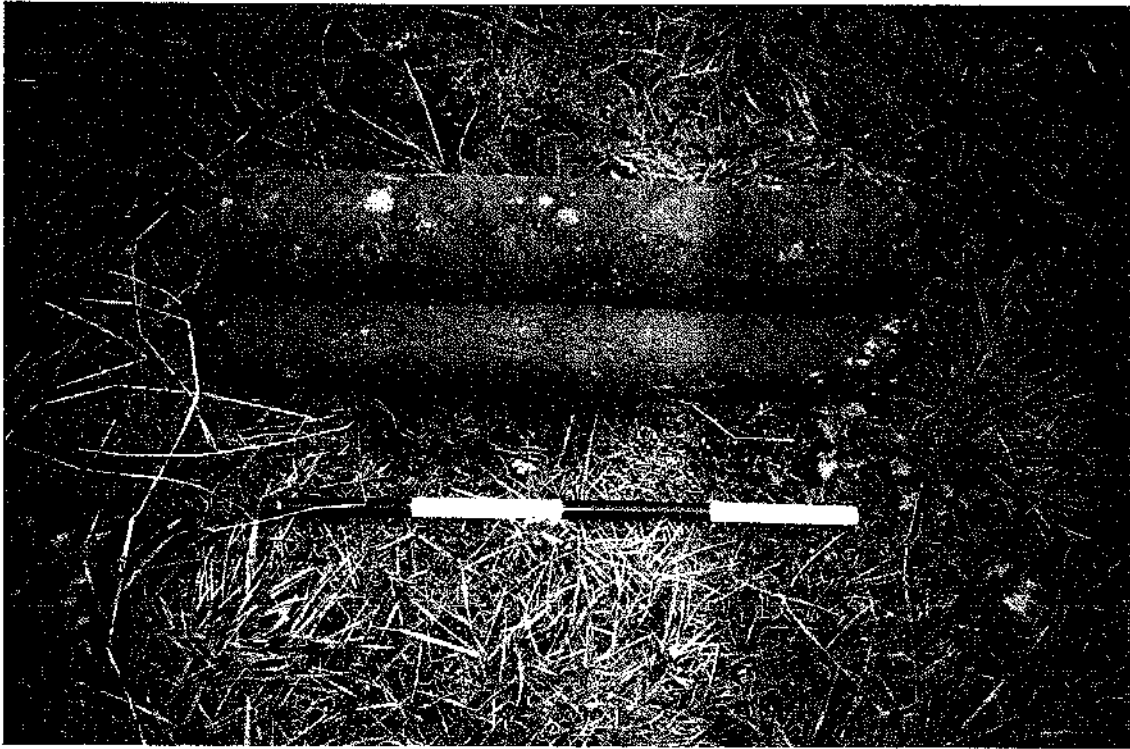
Plate 3

Section of a tri-lobed shaft. 13<sup>th</sup> century. One end is drilled to accommodate an iron tie, which survives (Plate 4). The shaft was free-standing and may have come from an open arcade, perhaps a cloister arcade (but see Stone 6 below). 46cm long with 8.5cm diameter lobes.

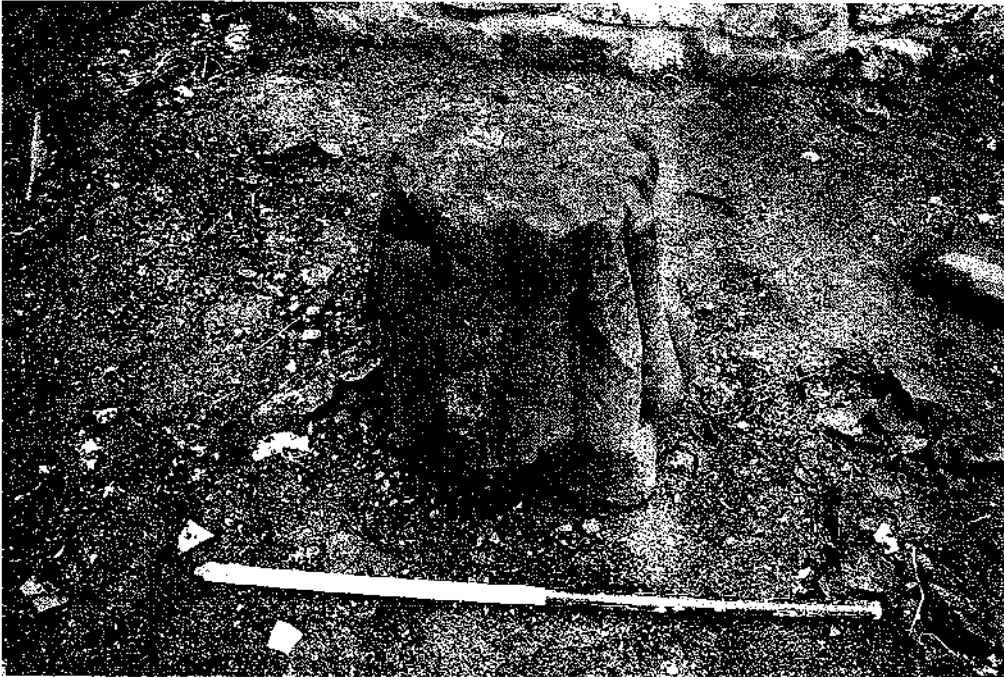
Plate 5

A practice piece? 13<sup>th</sup> century. Conical shape with flat top and base. A series of 15 ribs protrudes from it; these are mostly rolls though one appears to have a (very eroded) fillet. A superficial interpretation of this piece might suggest that it crowned

a column, being the lowest member of an umbrella vault. The pattern of ribs, however, is not consistent or coherent. There are various degrees of prominence and variation in the widths of the gaps between the ribs. On the bottom of the stone is a number of keying grooves. 38cm high with *c.*39cm dia. base and *c.* 50cm dia. top.

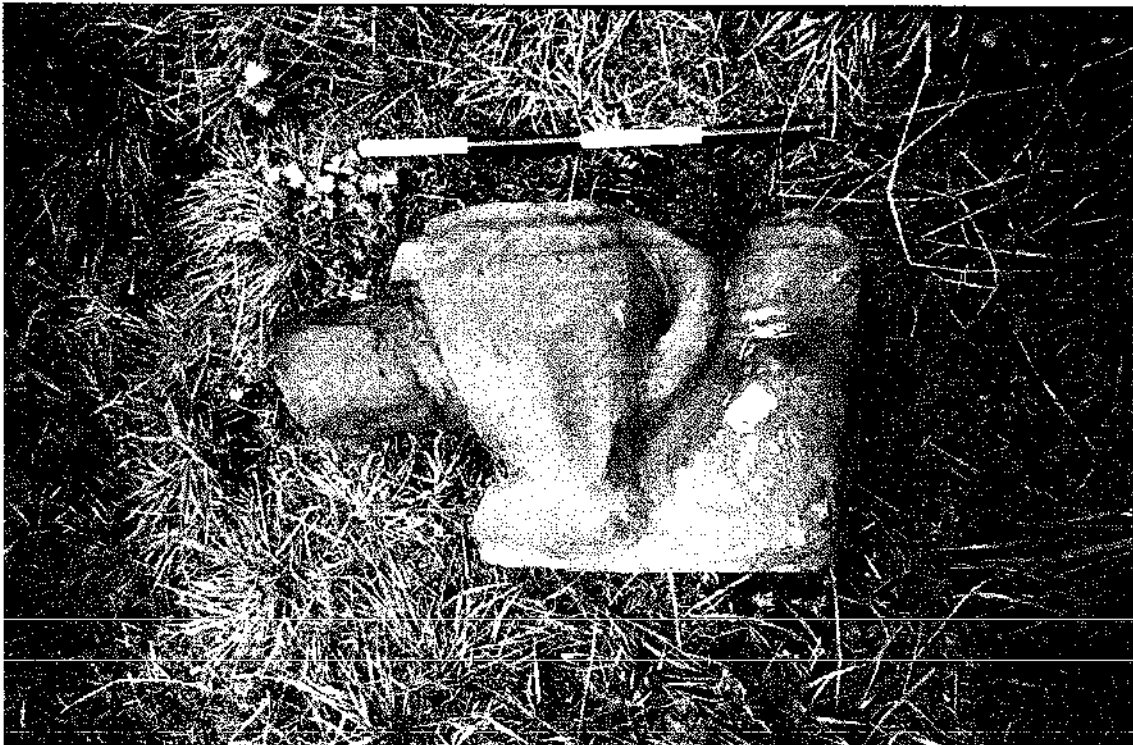
Plate 6

Part of the sculpture of an animal, probably a lion. 14<sup>th</sup> or 15<sup>th</sup> century. Only the hind quarters of the beast survive. It is in a crouching position with the lower parts of the rear legs horizontal. The tail curls round behind the left leg. The best parallels are with the lions that are often found at the feet of later medieval sepulchral effigies. Both sides of the piece have been sculpted to an equal standard, as though they were both intended to be on view, but the end of the original block has been retained, the rear of which has what seems to be a centrally placed vertical setting out line (Plate 7). This seems to militate against the idea that the lion occupied a position on the top of a tomb. Another curious aspect of this end block is that the upper part has been cut back on each side to form a necked protrusion with the resemblance of a handle. It is possible that this is an unfinished piece and that the 'handle' was fashioned by the sculptor to assist manoeuvrability while work was in progress. 45cm long, 28cm high, 23 cm wide.

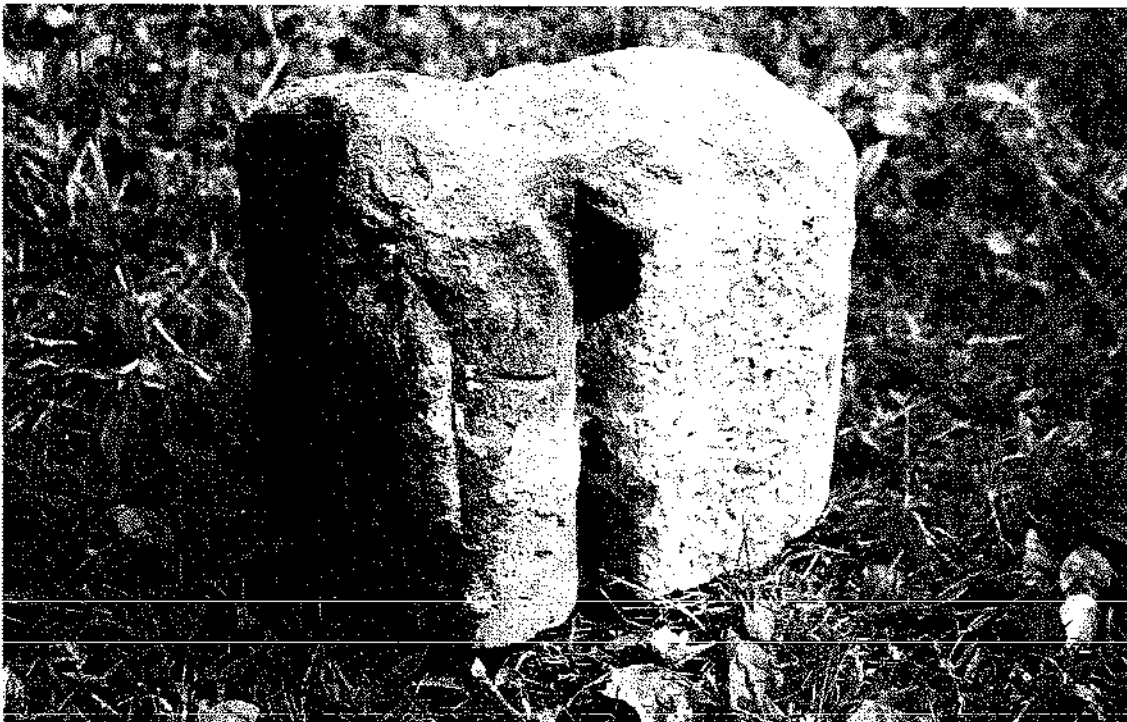
Plate 10

Section of a roll and fillet-moulded shaft, probably part of a door jamb. 13<sup>th</sup>-century. 19cm high, 22cm long, 14cm wide.

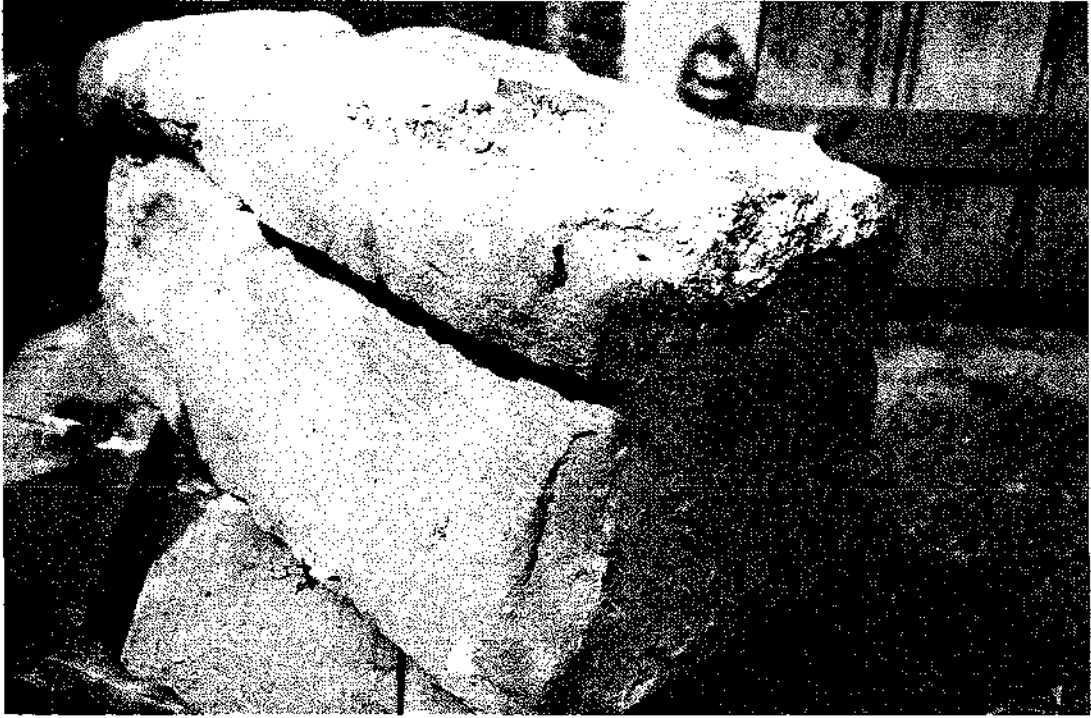
Plate 11

Coping stone. Half roll-moulded lip, with the face beneath it splaying outwards. Possibly from a plinth. 25cm high, 45cm long, 21cm wide.
