**An Archaeological  
Evaluation and Building  
Record of Wroxeter  
Farm, Shropshire**

Birmingham University Field Archaeology Unit  
**Project No. 893**  
March 2002

by  
Malcolm Hislop and Roger White

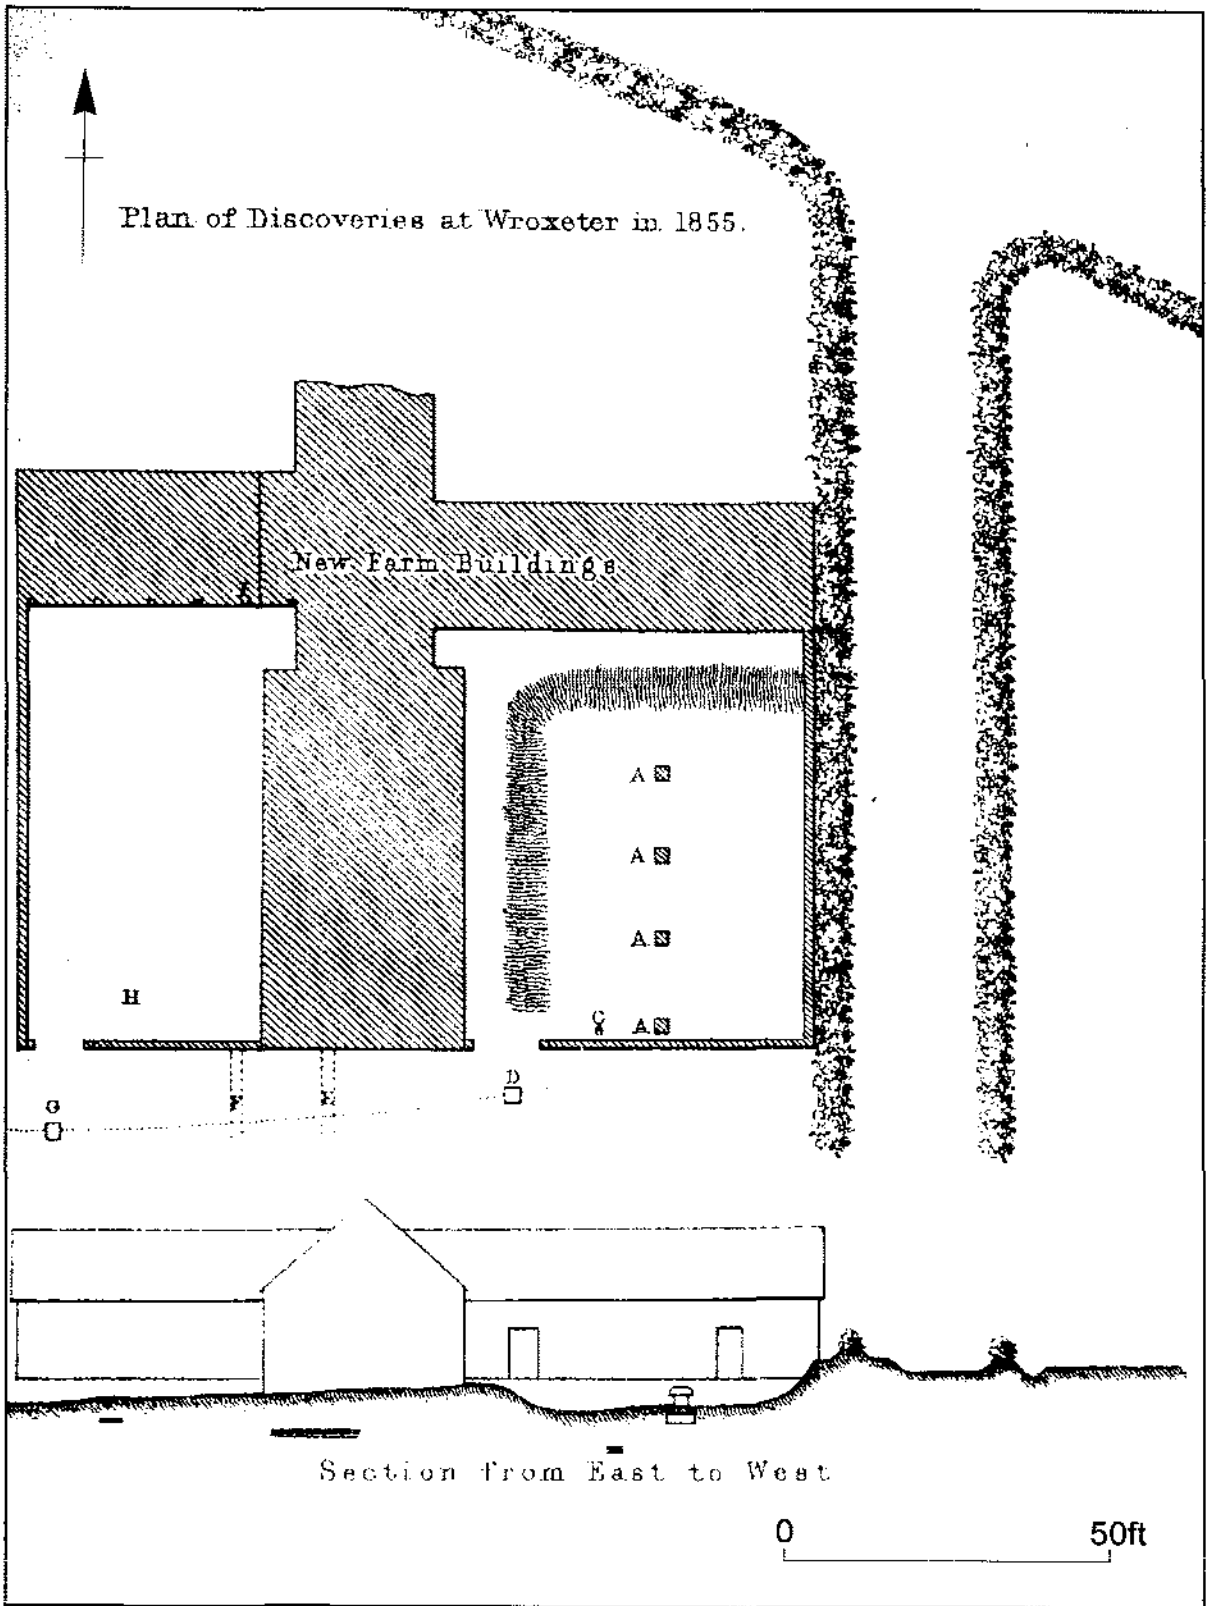
Fig.4

The earliest record of any buildings on the site is probably that published in 1860 by Thomas Wright, which consists of a plan made by Sir Henry Dryden (Wright 1860, pl.18 facing 205) (Figure 4). The occasion of Dryden's interest was that in digging foundations for some new farm buildings, the excavators had uncovered a row of moulded column bases. Wright gave the date of 1855 for the construction of the farm buildings by the tenant, Mr Stanier (Wright 1860, 205), though Dryden himself, writing in 1880, recalled that it was in August 1854 that he visited the site and drew up his plan (Dryden 1880). This earlier date is confirmed in Scarth's account (1859, 61). Dryden depicted a cruciform building with two yards to the south enclosed by walls, the colonnade extending from north to south within the area of the south-east yard.

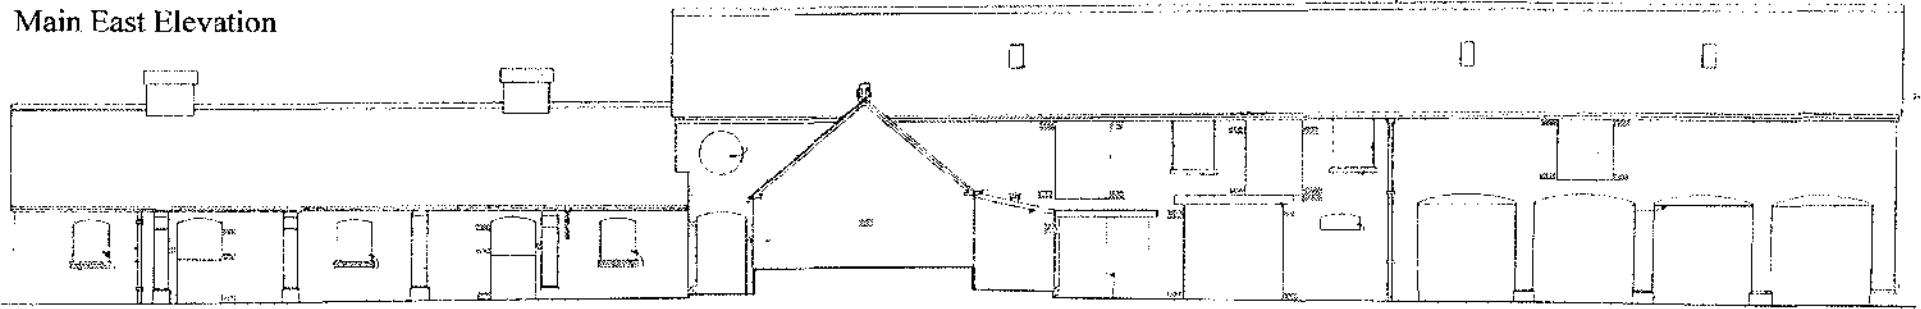
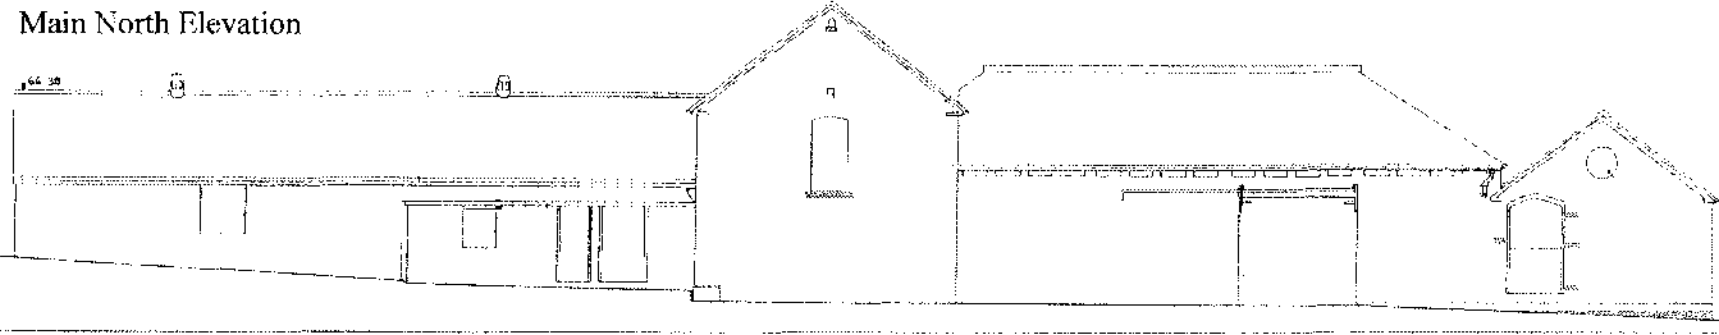
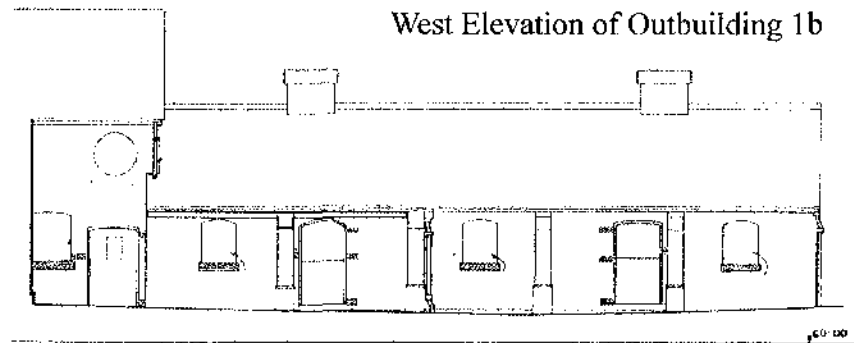
Fig.9

Main East Elevation

Main North Elevation

West Elevation of Outbuilding 1b

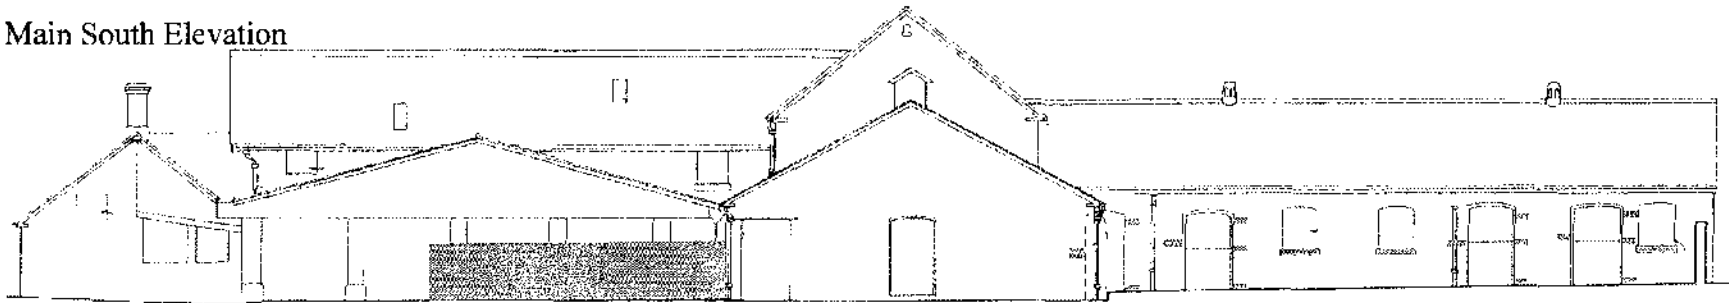
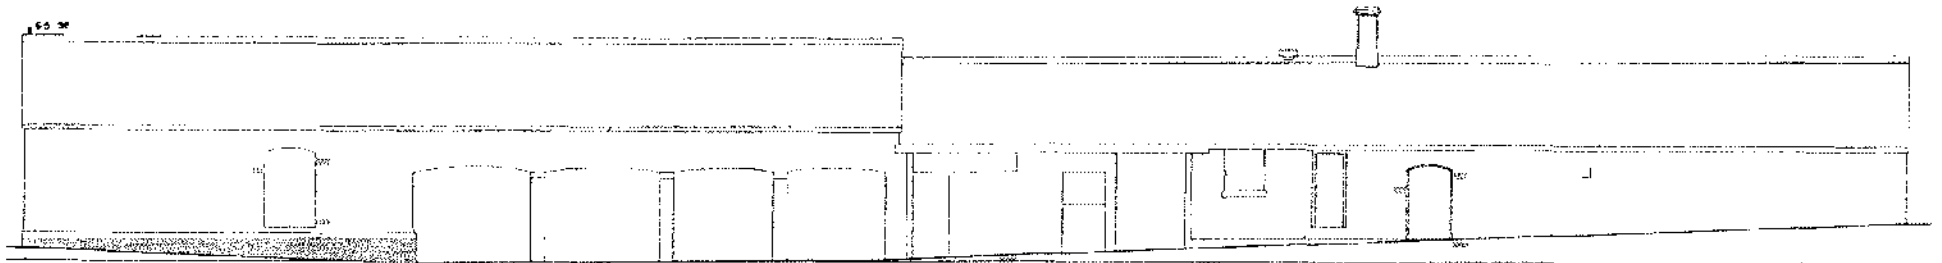
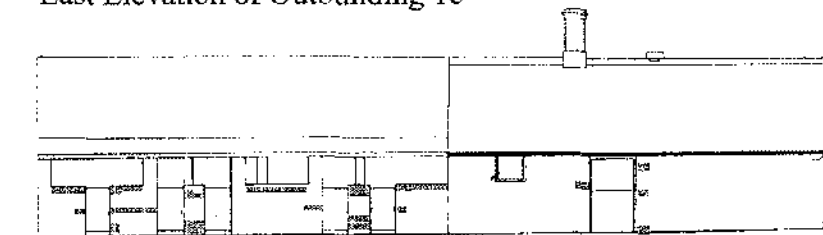
Fig.10

Main South Elevation

Main West Elevation

East Elevation of Outbuilding 1c

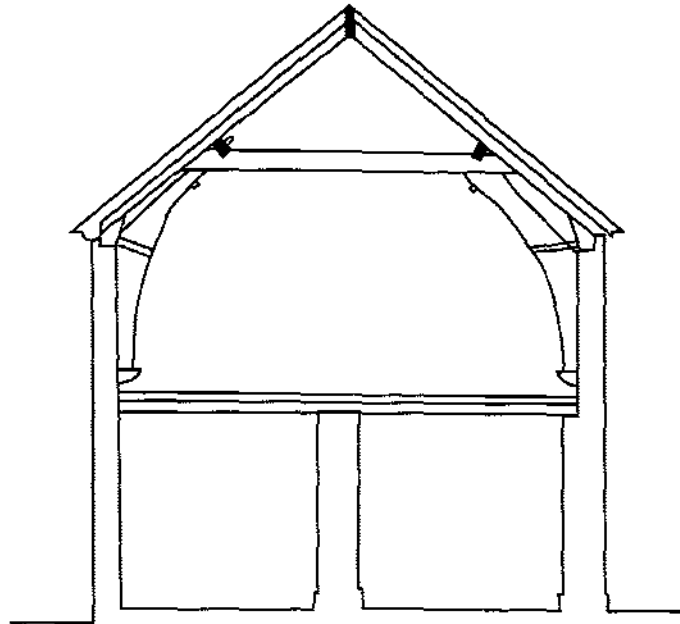
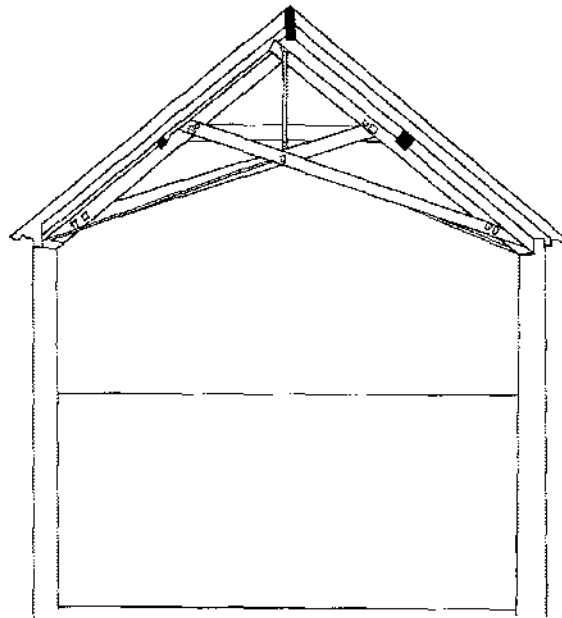
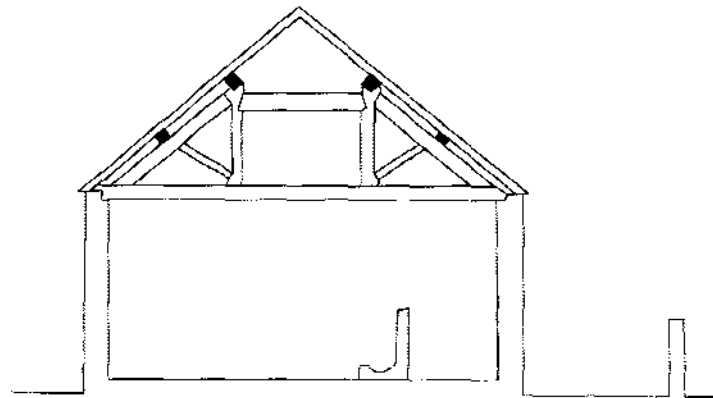
Fig.11

There are six roof bays and five roof trusses (numbered 1 to 5 from the north to south). Trusses 1, 3 and 5 might be described as upper base cruck trusses (Section A-A, Figure 11). The cruck blades stand on wooden corbels set into the walls, and rise to a collar, which supports the purlins. The crucks are bolted to the tie beams and strapped to the wall plate. Truss 2 was originally of the same character but the crucks have been replaced by long, straight inclined posts which support the collar (Plate 6). The cruck corbels have been sawn off flush with the wall, but the ends remain embedded in the brickwork. In addition, the mortises for the tops of the crucks survive in the tie beam. Truss 4 is at the position of the wall at the south end of the cart sheds, and comprises two stub walls capped by stone corbels, similar to those on the ground storey, which support a tie beam and purlin supports. A collar towards the north end of the roof supports the end of the hoist beam (Plate 4).

The southern end of the upper storey was probably a hayloft. There are lozenge patterned arrangement of loops to the east and south, a doorway to the east, a single circular pitching hole in each of the south, east and west walls, and another owl hole in the south gable. In the floor are the two trap doors through which it would have been possible to drop hay. The roof trusses are quite different from those in the other part of the range. Principal rafters stand on wooden corbels and are strengthened by scissor bracing, the ends of the braces being bolted to the rafters and the intersection strapped to the apex (Section B-B, Figure 11).

*The east wing* (Figures 8, 9 & 10) was built as a completely self-contained stable block with a loose box at the east end. It is a one-storey, 6-bay building with a pair of stable type doors at each end flanking a pair of central windows, the left hand one louvred. Inside, the two end bays are separated from the central stabling by brick partition walls. The west end housed a feed room, the east end a loose box. The loose box, which retains a cobbled floor, was self-contained, but a door at the south end of the western partition wall allowed communication between the feed room and stables. The stables themselves appear to have accommodated four horses. The original fittings have gone but holes in the internal buttresses that mark the bay divisions probably indicate the positions of the stalls. An inserted doorway at the north end of the west wall gives access to a feed passage on the north side of the building which was formed to serve an inserted trough. The roof trusses are of queen post construction (Section C-C, Figure 11).

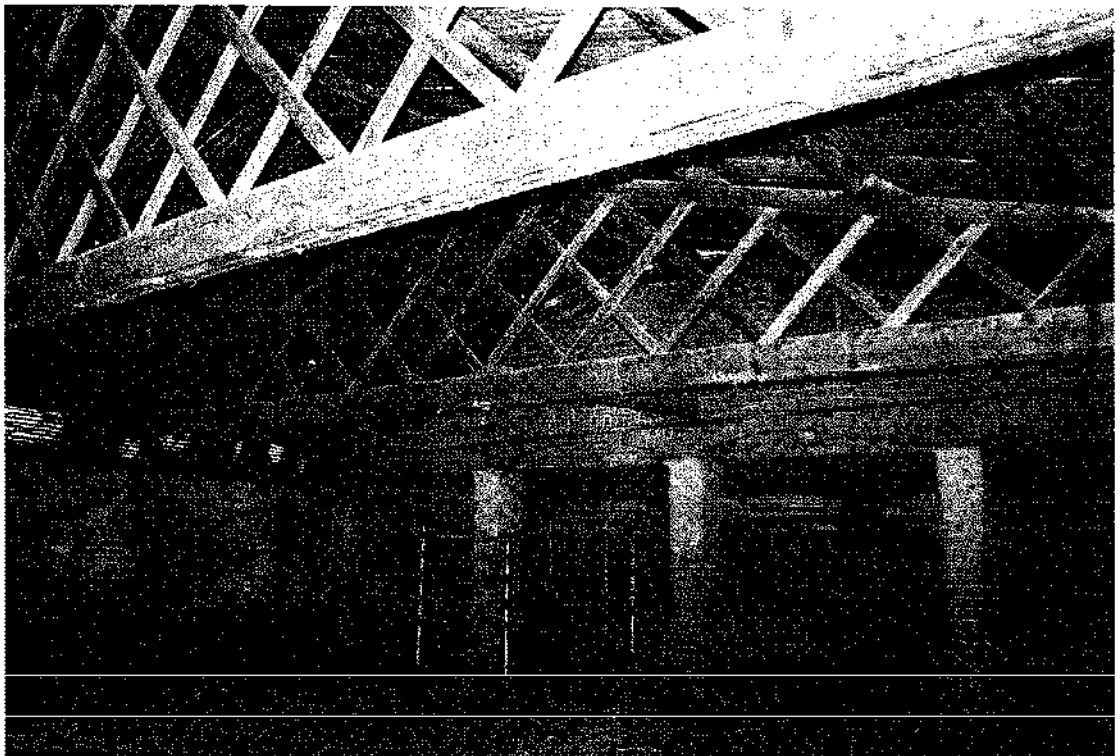
Plate 10

Some time after 1929 a corrugated iron roof was raised over the northern part of the south-west yard. It was carried on a number of Belfast trusses (Plate 10).

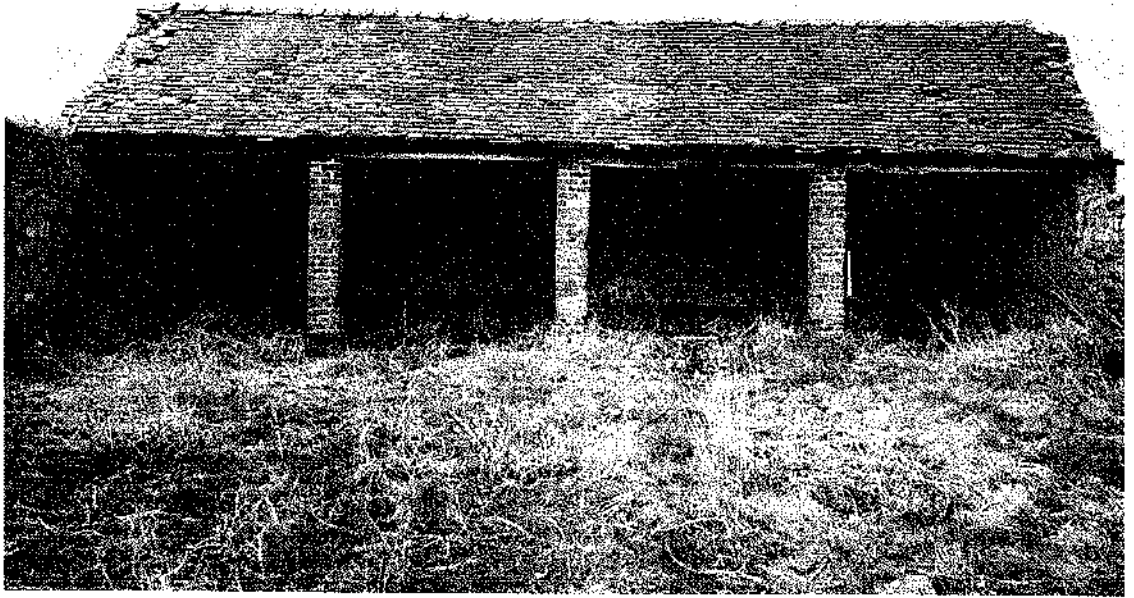
Plate 11

Standing in an isolated position to the north-west of the main complex is a shelter shed (Plate 11) with fold yard in front of it. Both the shed and the yard wall are built of coursed rubble of various stone types. In addition, the shed incorporates some red brick. The constructional character is of a much lower quality than the other farm buildings, and both wall and shed give the impression of having been built by amateurs rather than by craftsmen.

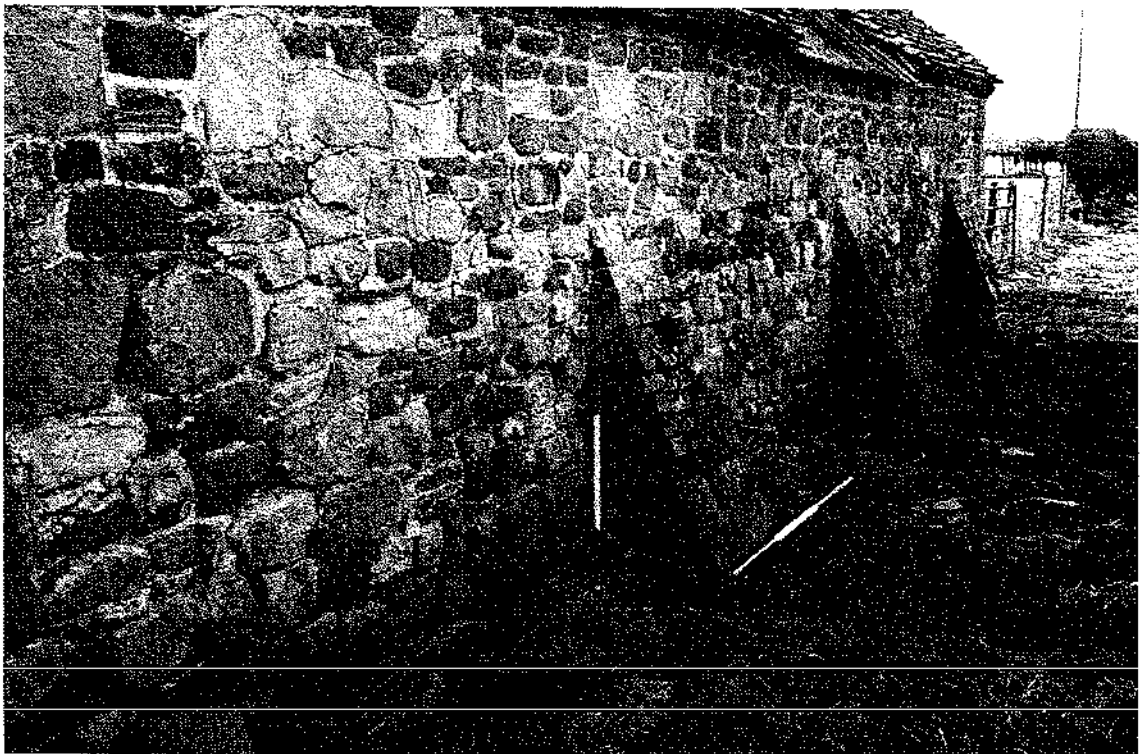
Plate 12

The shed is aligned east - west facing south. It is a single-storey building, four-bay building, with square brick pillars supporting a re-used wall plate. To the rear (north), and corresponding with the bay divisions, is a series of three low brick buttresses with courses inclined down towards the building (Plate 12). To the east of the eastern buttress is an apparent vertical joint in the north wall, but this makes no archaeological sense, and may represent no more than the inexpertise of the builder. In the east gable is a brick window opening with cambered arch (Plate 13).

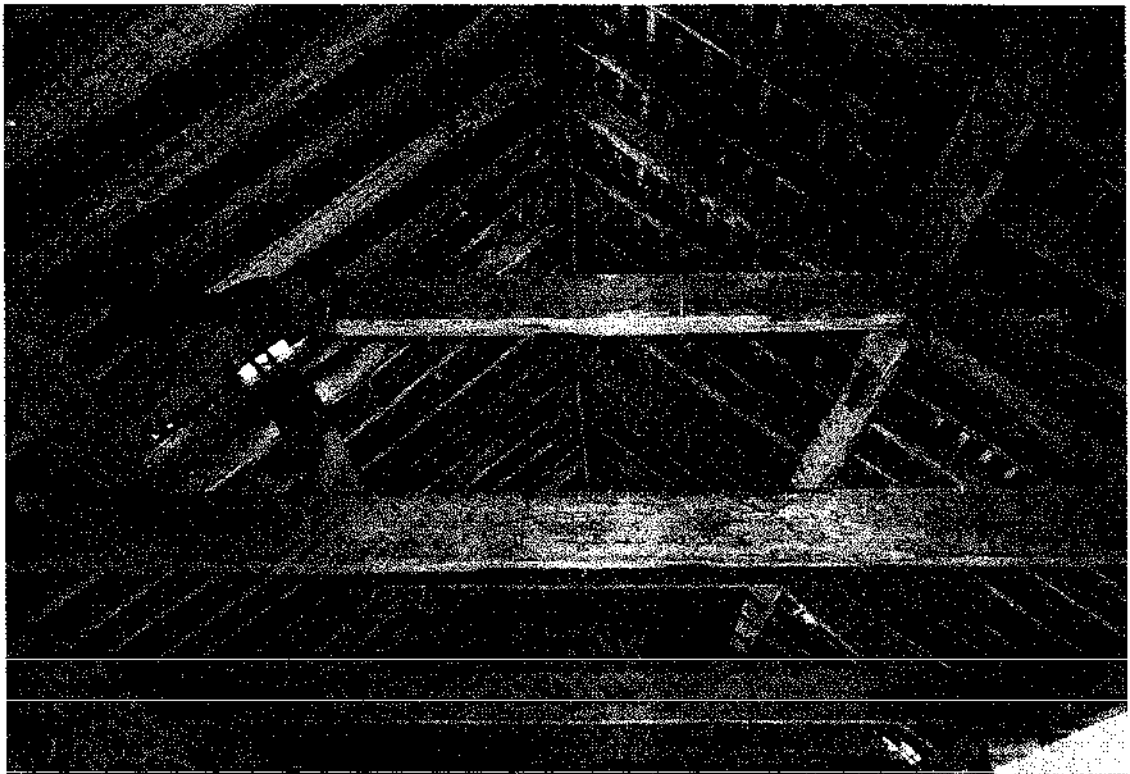
Plate 14

The roof trusses have tie beams, and short principals supporting a collar, which in turn supports a single pair of purlins (Plate 14). Several of the timbers are re-used, and the trusses are not bolted together like those of the other buildings. Despite the gable window, there is no evidence for a loft.

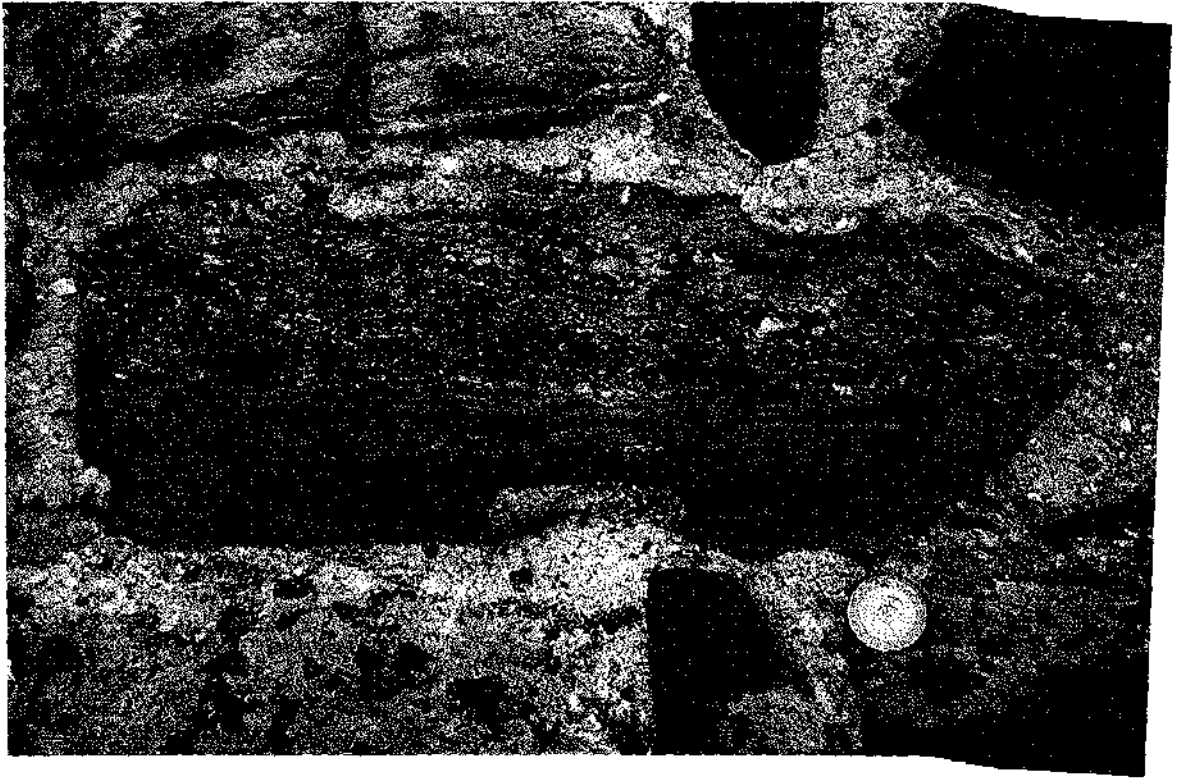
Plate 15

The remaining stones within this wall, and the other farmyard walls, are predominantly red Keele Beds, Hoar Edge Grit or Big Flint Rock. The walls have been substantially re-pointed in recent times, mostly by the Directly Employed Labour used on the site from c. 1950-1990 and thus do not present much archaeological information. The exception is the Shelter Shed and its adjacent yard and farmyard wall. This has a proportion of Roman stone within it but a large element of the stonework is an unusual horizontally bedded and extremely coarse sandstone that varies in colour from dark grey to buff. This stone can include gravel up to 10mm in size, apparently water-sorted in origin (Plate 15). David Pannett has examined this stone at the author's request and his report is appended:

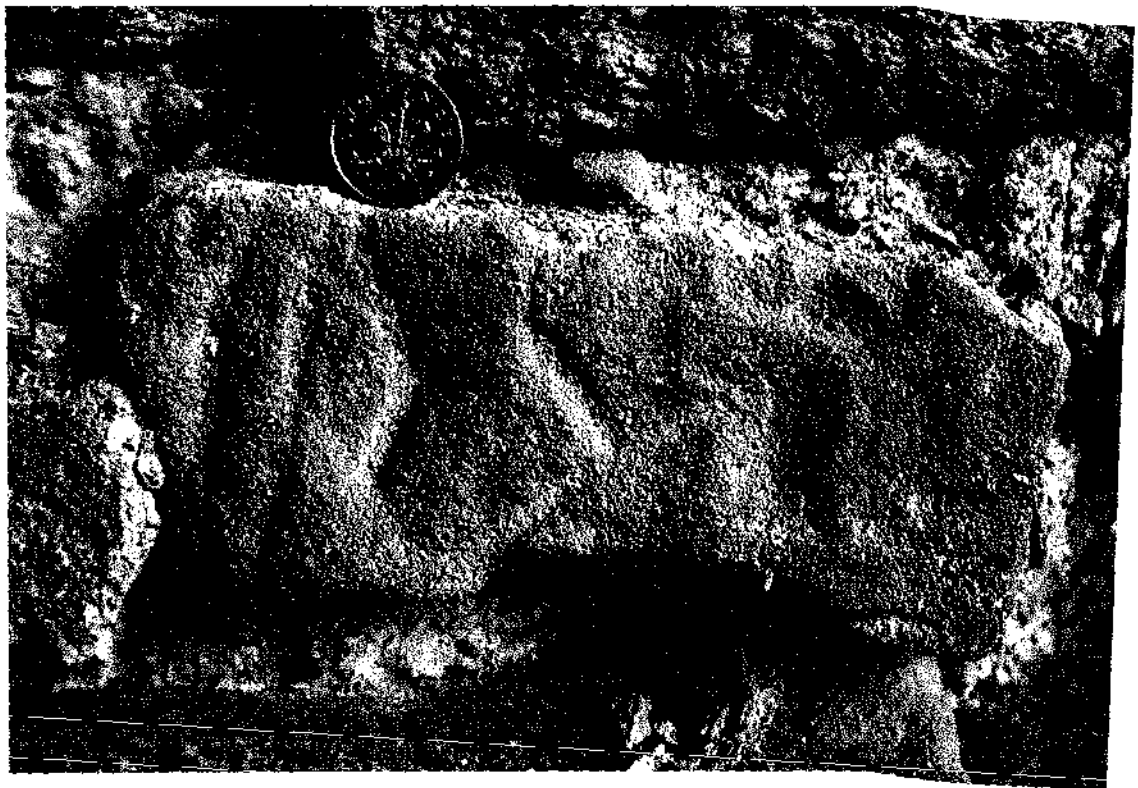
Plate 16

would be more prominent. Having said this, however, the only piece of carved stone found in the entire complex is within this building. Built into the west face of the east wall of the shelter shed is a single brick-sized piece of Hoar Edge Grit c. 180mm x 50mm in size (Plate 16). Its face is carved in a complex and apparently geometric pattern that is, however, too fragmentary to interpret easily. It does not appear to be part of a tombstone nor does it seem to be architectural in origin. It may, therefore, be part of a free-standing sculpture such as the elaborate figural door frames that exist in Rowley's House Museum (*VCH* 1, *fig. 23*).
