**A5 (T) Nesscliffe Bypass,  
Shropshire:  
An Archaeological  
Watching Brief 2002**

Birmingham University Field Archaeology Unit  
**Project No. 901.01**  
November 2002

**A5 (T) Nesscliffe Bypass, Shropshire**  
**An Archaeological Watching Brief 2002**

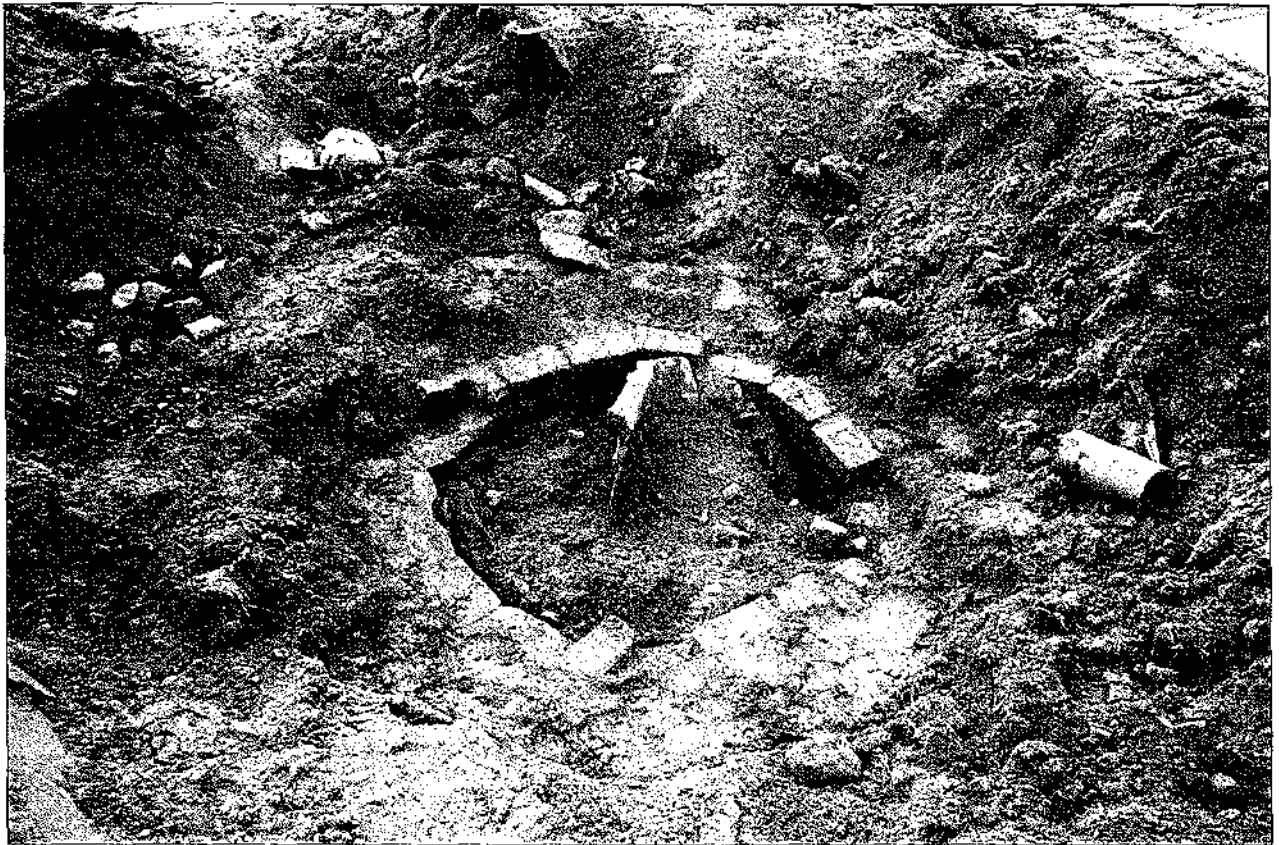
Plate 1

- 1 Well near Wofshead Farm, Field 4
- 2 View southwest from middle peat kettle hole, Field 4
- 3 View north from Kinton Lane, Field 6
- 4 View southwest from Kinton Lane, Field 9
- 5 View south, Broomhill Bank Field 18
- 6 View north, Broomhill Bank, Field 18
- 7 View north from Felton Butler Lane, Field 23

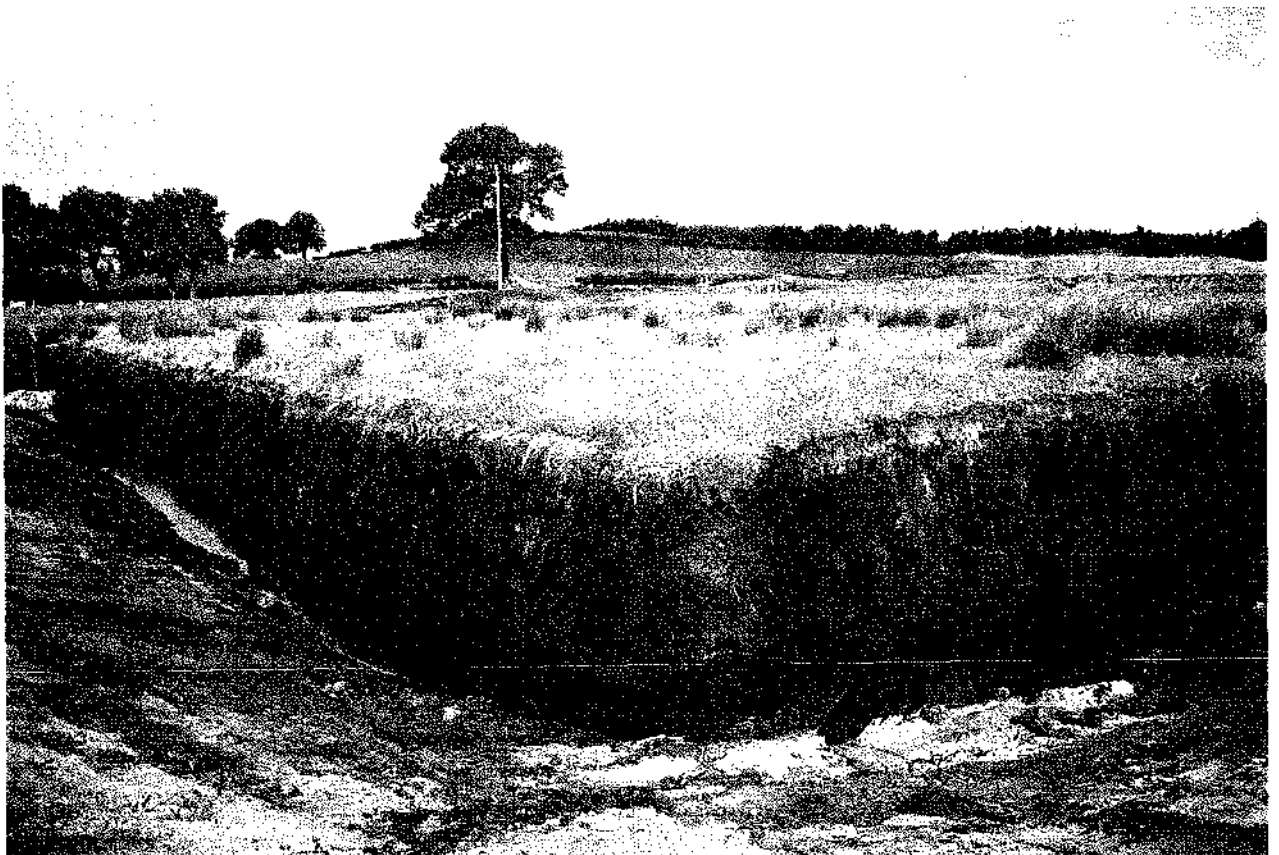
Plate 2

This area was again characterised by quite shallow topsoil, approximately 0.25m deep, overlying a greyish-yellow mixed clayey subsoil. The gradient of the road corridor begins to increase dramatically up to Wilcott Lane (Plate 2). Part of the area at the bottom of this slope (Field 16) on the western edge is currently a pond, approximately 30m south of chainage 2750, with a drainage pipe flowing into it. On the eastern side the soil is very dark in colour and has a much greater organic content than that within the rest of the road corridor. This area was also quite wet. On the less low-lying land the subsoil had a high sand content. The watching brief specifically targetted the area of a cropmarked feature. The topsoil in this area measured approximately 0.3m in depth, and the subsoil was a brownish orange sand. Field 18 is illustrated on Plates 5-6.

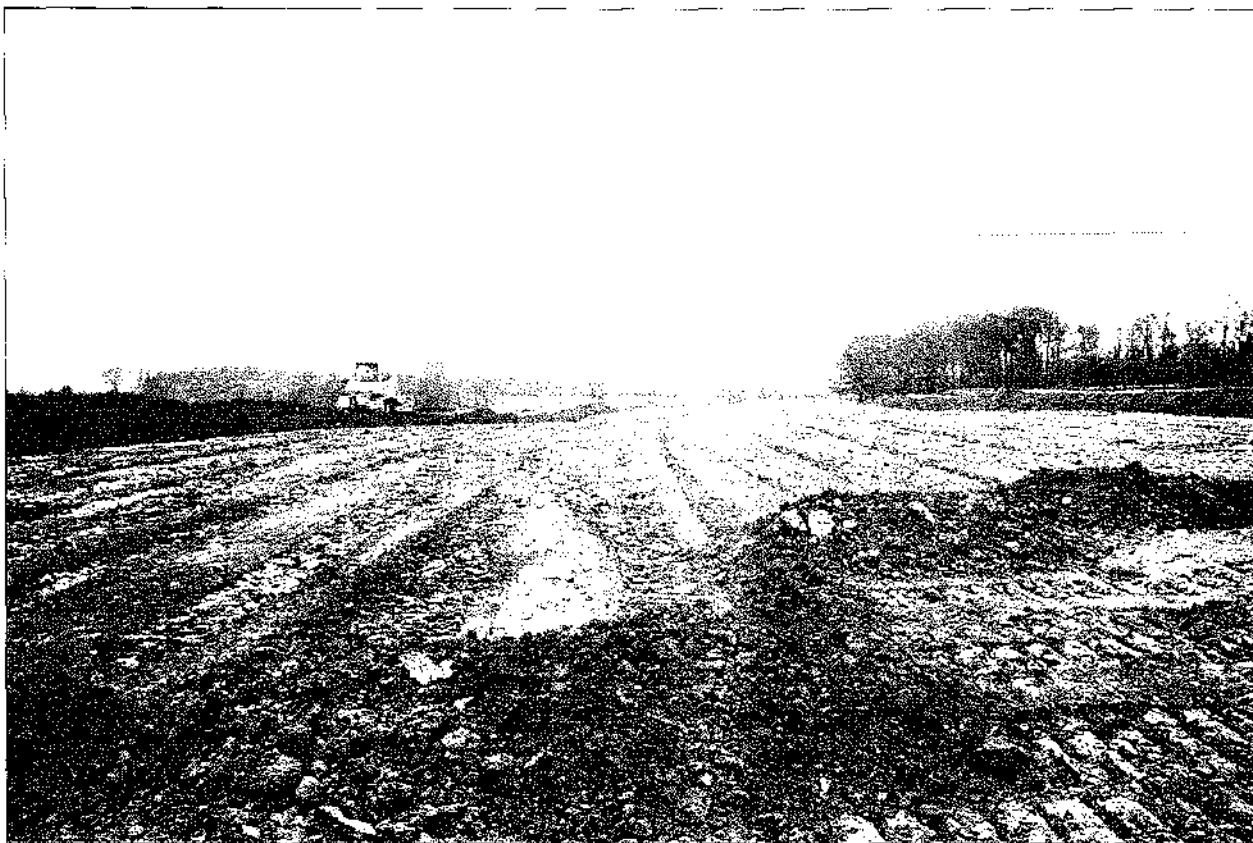
Plate 3

The topsoil and subsoil within Fields 6-7 to the north of Kinton lane (Field 6 (Plate 3) and Field 7) were similar in composition to the subsoil and topsoil recorded at Wolfshead Farm. To the south of Kinton Lane the watching brief was maintained in an attempt to identify any archaeological features associated with the excavated cropmarked pit alignment, outside the excavated area, although in the event, none were found. Within the excavation the features were identified below the b-horizon soil which was not fully removed by machining outside the area archaeologically-excavated. In Fields 8-9 (Plate 4) the subsoil exposed by machine excavation had a notably higher clay content.

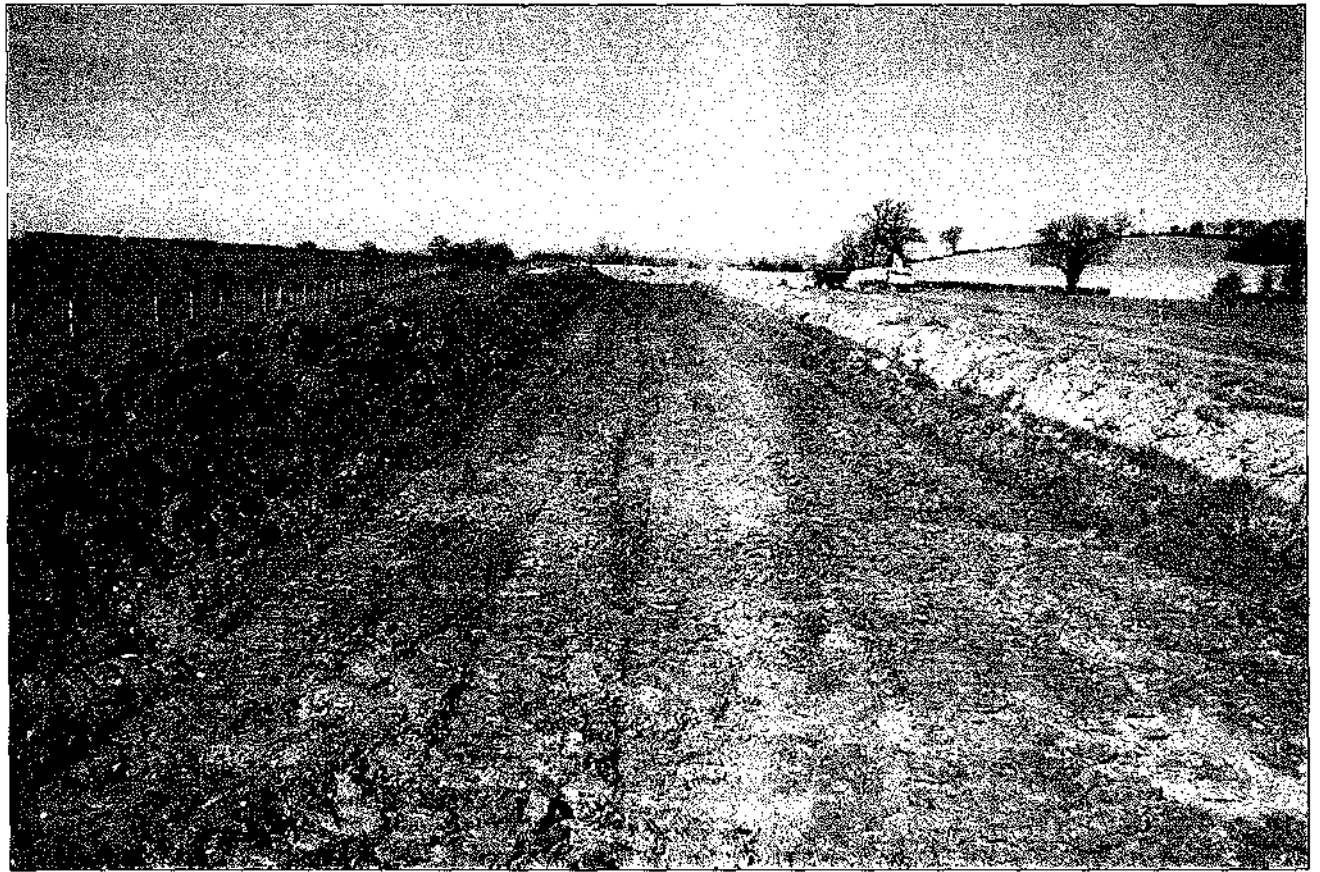
Plate 7

In this part of the route the natural topography was less undulating. The subsoil had a higher clay content. Several modern land drains and irrigation pipes were noted during machine excavation within these fields. The topsoil within Fields 21-26 measured between 0.25-0.4m in depth. Field 23 is illustrated on Plate 7.
