**An Excavation and
Watching Brief at Rock
House Farm, Great
Haywood, Staffordshire**

Birmingham University Field Archaeology Unit
Project No. 902.1
August 2002

by
Kate Bain and Malcolm Hislop
with an appendix by Robert Howard

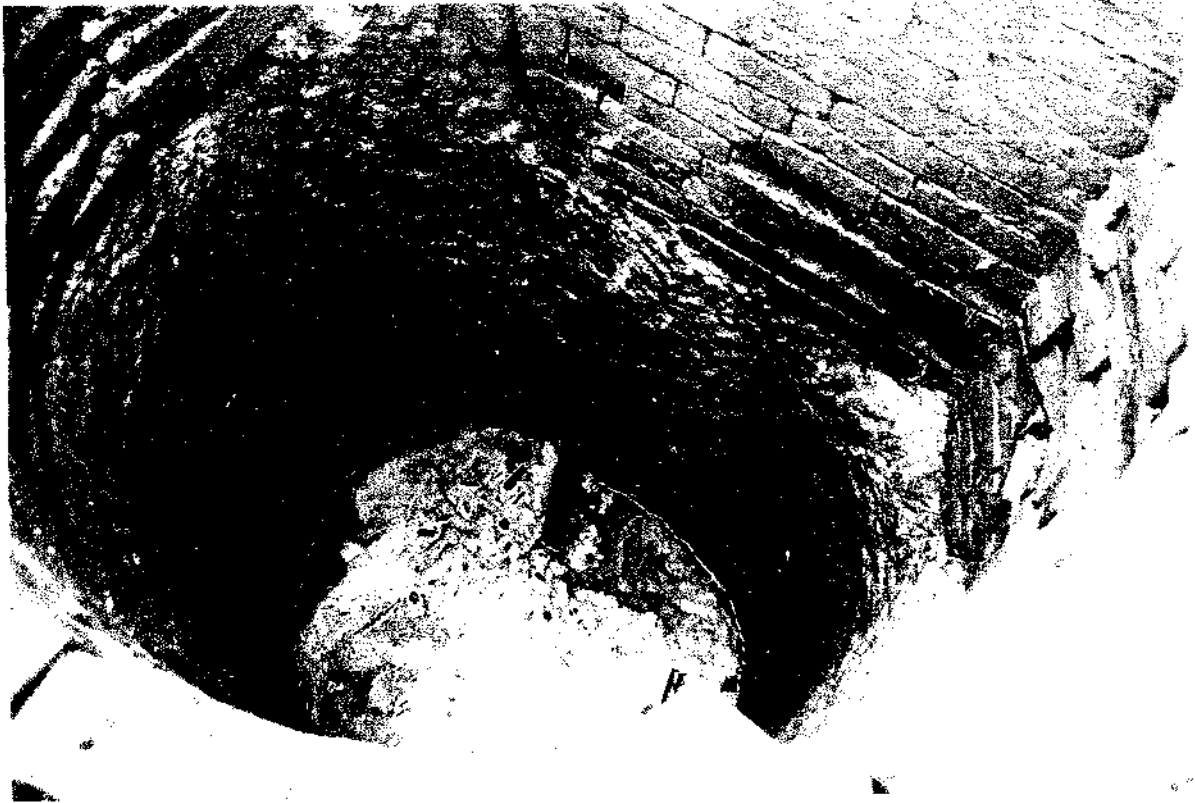
Plate 3

Following the demolition of the outside lavatory at the north east corner of the house, a well was uncovered. It was cut through the natural sandstone, and had several courses of 19th century red brick at the top (Plate 3). It retained a pipe for a former pump.

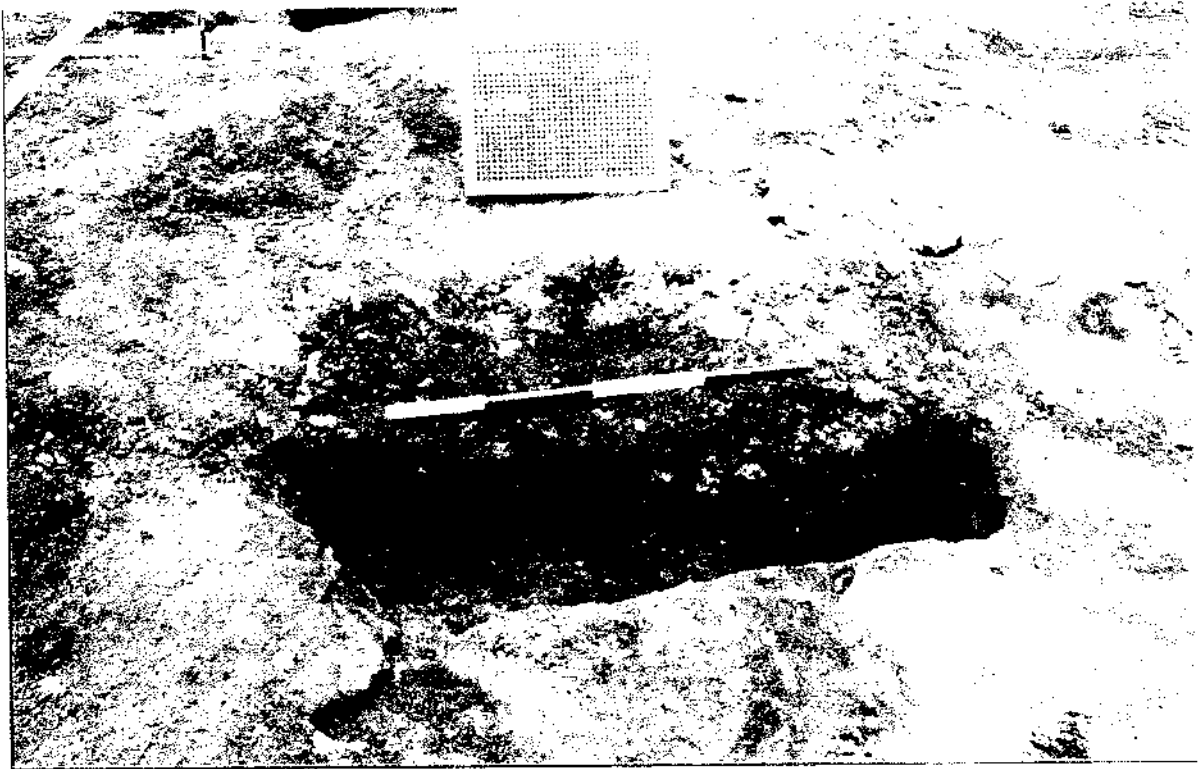
Plate 4

Cutting through this context in the area of the Phase 4 fireplace was a sub-rectangular feature identified as a shallow pit (F200, Plate 4). It cut into the sandstone to a depth of 0.18m and was filled with two ashy deposits (2001 & 2002). The primary fill of this feature (2002) contained two sherds of 18th century pottery, a fragment of clay pipe, and three iron nails. Approximately 0.40m to the west was a large (0.38m x 0.18m) blackened stone.

The only visible feature, the shallow pit, at the north end of the site, which cuts through 2004, was probably related to the occupation phase that immediately followed the reconstruction of this bay of the cruck house in the 17th century. The position of the pit indicates that it would have been situated within the area of the hearth, and ashy deposits within it suggest that it was connected with burning activity. It seems probable that it acted as an ash pit within the early post-medieval fireplace.
