Birmingham University Field Archaeology Unit  
Project No.924  
October 2002

**An Archaeological Evaluation of the Former Royal Brierley Crystal Works  
Brierley Hill, Dudley, West Midlands**

by  
Malcolm Hislop

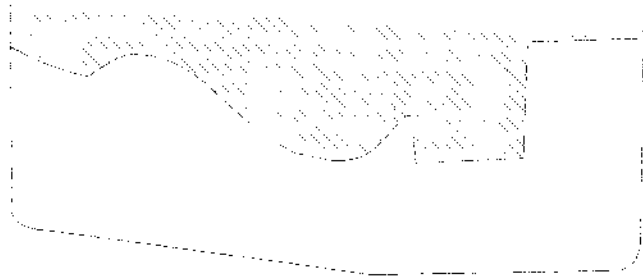
Fig.9 The Main Phases

## 7.0 Survival and Character of the Buildings (Figure 9)

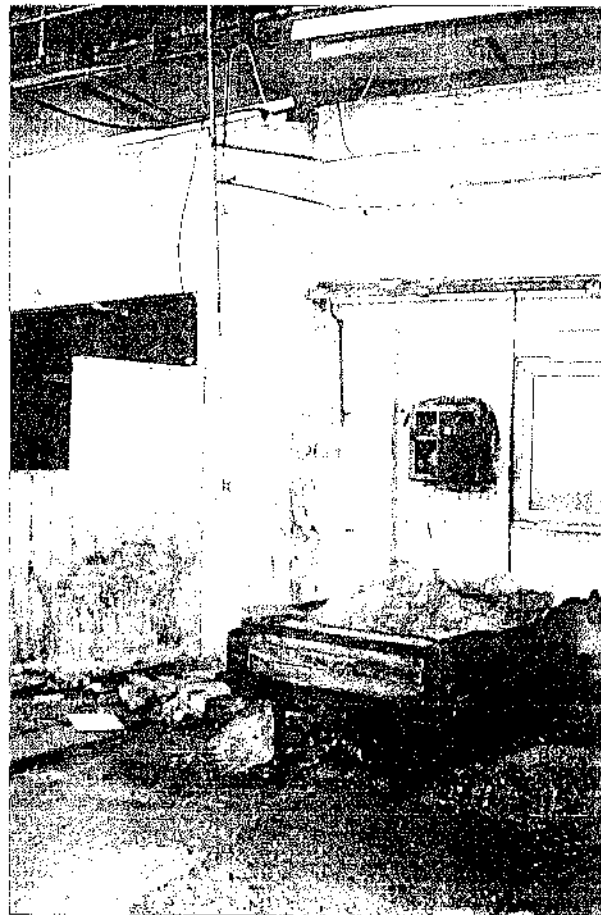
Plate 1

1. Rebuilt stub of former south-west wall of 1870-84 factory
2. Fragment of southwest wall of 1870-84 factory
