**Broome Mill and Cottage  
Pools, Churchill &  
Blakedown, Wyre Forest,  
Worcestershire:**

**Conservation Statement**

Birmingham University Field Archaeology Unit  
Project No. 930  
July 2002

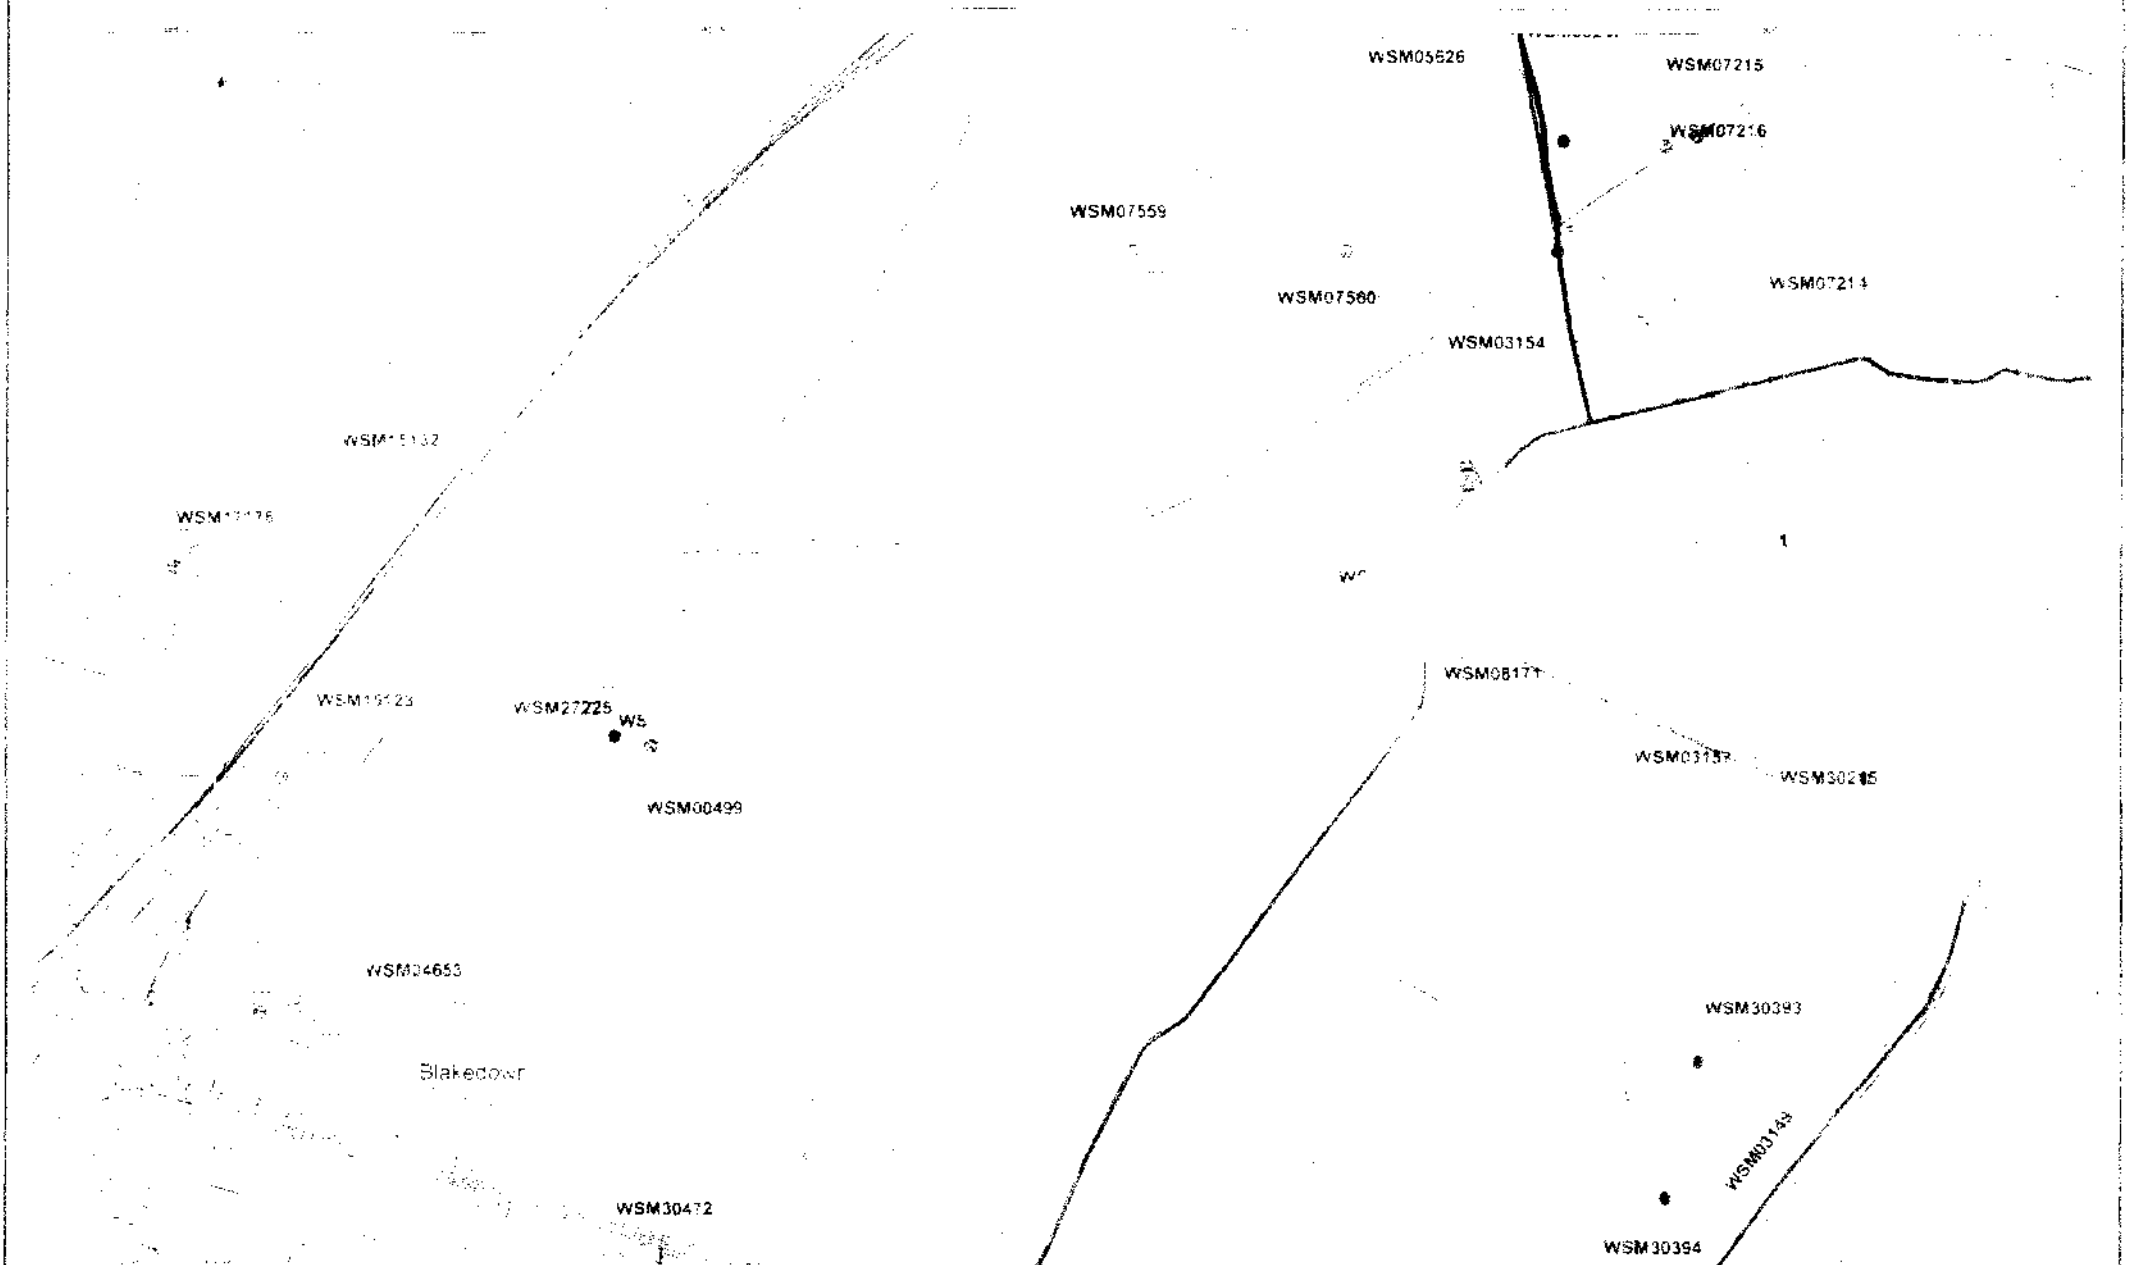
Fig.3 (SMR Map)

7.1.2 The above sites, where relevant, will be mentioned in more detail in the following section. Fig. 3 shows some of these sites in relation to the pools.
