**River Sow Improvement
Scheme.**

**The Mill, Millbank, Victoria
Park, Stafford, Staffordshire**

**Archaeological Evaluation 2003,
An Interim Assessment**

Birmingham University Field Archaeology Unit
Project No. 947.02
February 2003

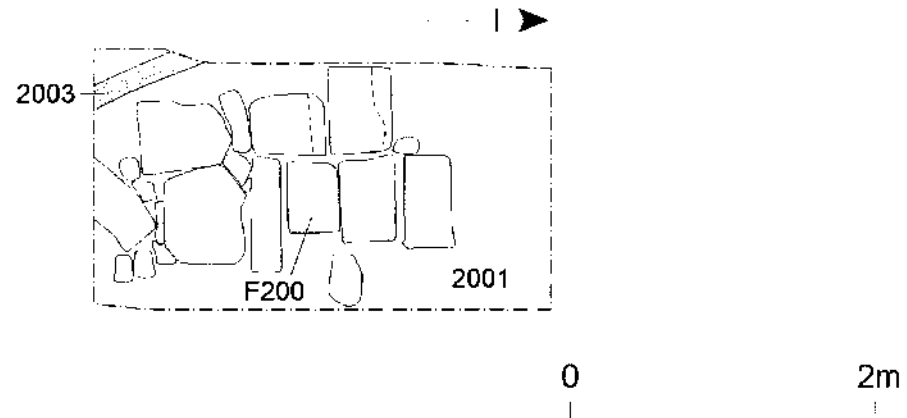
Fig.5 Trench B

This trench was 3m long and 1.7m wide and excavated on a north-south alignment. The trench was excavated to a depth of 0.7m below the present ground surface (AOD 73.75m). Two rows of large sandstones (F200/2002, 2.3m long, 1.2m wide) were located running on a north-south alignment, covering the majority of the trench. The largest stone measured 0.8m x 0.3m x 0.2m, with the smallest measuring 0.1m x 0.1m x 0.1m. The stones were covered with a 0.4m thick layer of brick and rubble (2002). F200 and 2001 were cut by a modern ceramic drainpipe (2003) in the southwest corner of the trench. The entire trench was covered with a 0.3m layer of rubble and hardcore forming the surface of a footpath.

It is likely that the wall (F200) located in Trench B is part of the same structure, although any deposits in the area of Trenches C and D would have been truncated. The limited area of the evaluation makes it difficult to ascertain the exact character of the deposits, although the structures are almost certainly associated with previous mills. Further excavation along the line of the new pipe, and dendrochronological dating of the timber beams would help to date and characterise the archaeology.
