**Handsworth Park,
Birmingham.
An Archaeological
Evaluation.
2002**

Birmingham University Field Archaeology Unit

Birmingham University Field Archaeology Unit
Project No. 979
November 2002

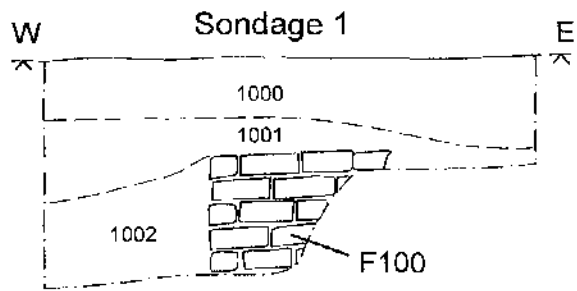
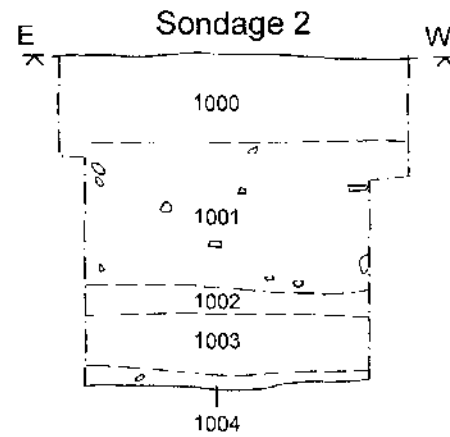
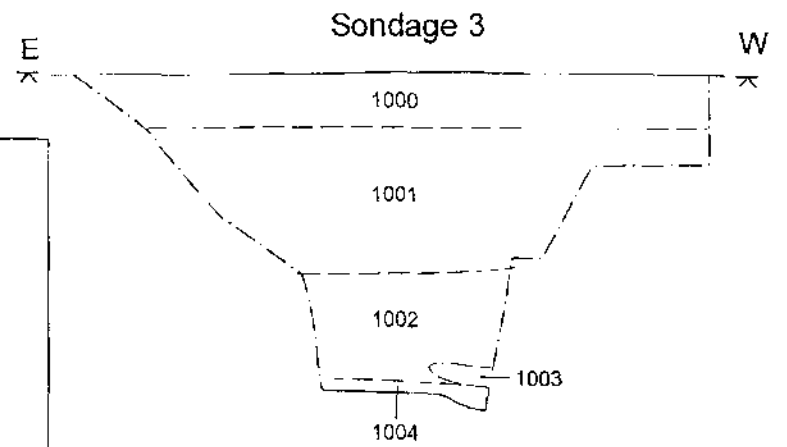
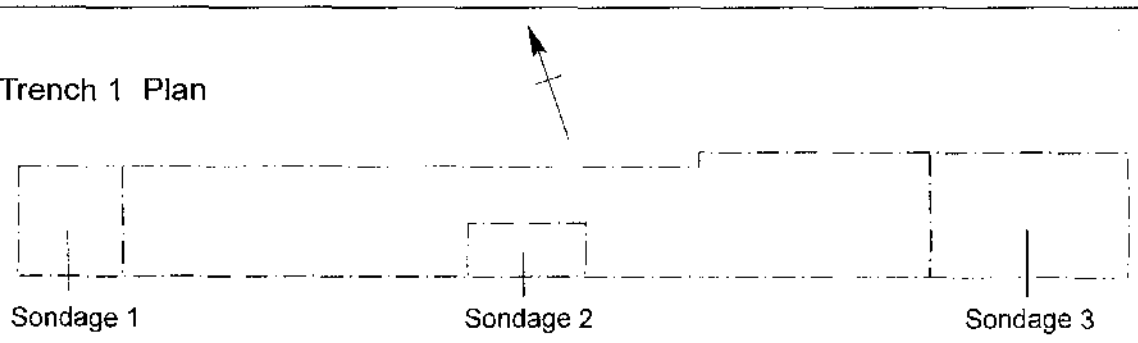
Fig.4

Sondages were hand dug in the eastern end and the centre of the trench to find the depth of the natural subsoil. Mechanical excavation to this depth was not possible due to the presence of a service running along the north side of the trench. Natural was encountered at a depth of 1.1m (110.693m AOD in Sondage 3 and 110.628m AOD in Sondage 2).

Above the natural were three thin layers of sand (a light grey/white sand [1004], which was under a grey sand [1003], which was, in turn, under a brownish yellow sand [1002]). No finds were recovered from these layers. Over these layers was a silty layer containing some brick rubble and post-medieval pottery [1001]. Topsoil [1000] overlay all these layers.

Apart from the relatively modern service trench, only one feature was identified in Trench 1. This was the remains of a small wall (F100) in the western end of the trench. Five courses of bricks remained, in a stretcher pattern bonded by a yellow mortar. The bricks measured 3 x 9 x 4 inches. The wall was built directly over [1003] with no evidence of a foundation cut or layer. It was sealed by [1001], a rubble layer. Layer [1002] appeared to be built up against the wall, but it is also possible that it was cut by it.

A small wall was found in Trench 1 (F100). When the park was originally landscaped, a low wall was constructed along the edges of the road by the main gate with an iron fence embedded into it (park staff *pers. comm.*). F100 could be the remains of that wall. The wall is unlikely to be from the remains of the Rectory, as the brickwork appeared to be fairly modern

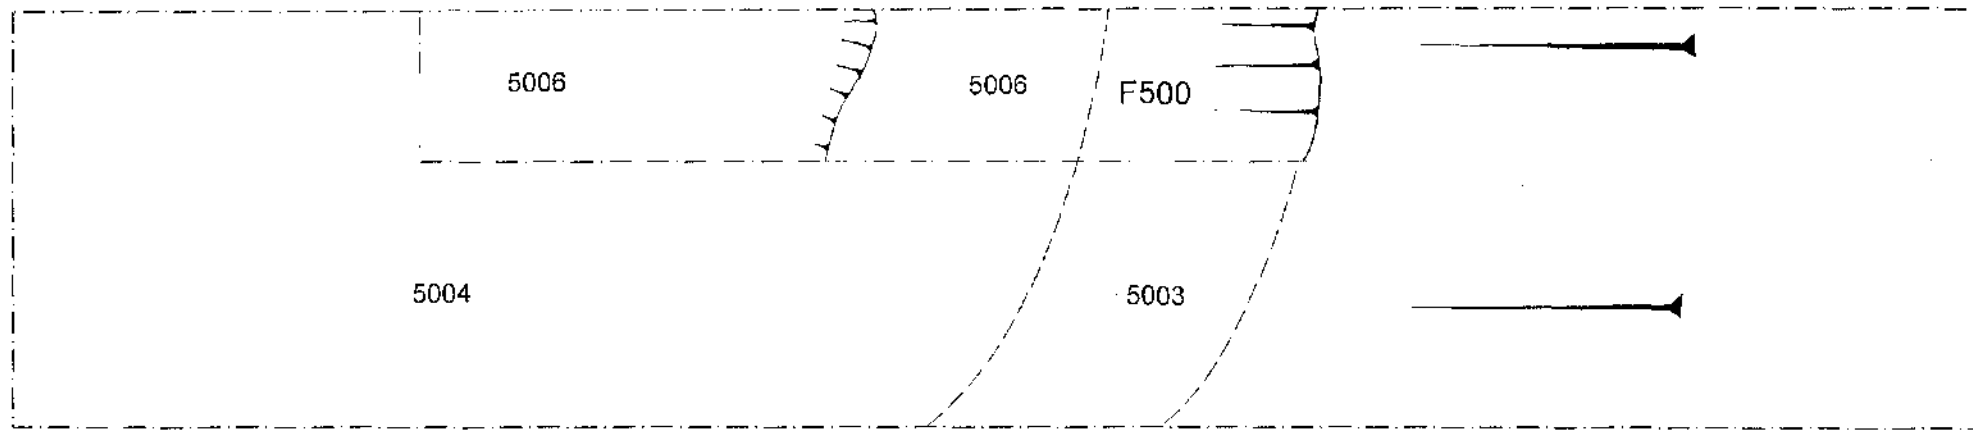
Fig.6

There was a build-up of layers over the natural [5006], which was identified in the northern end of the trench, at a depth of 1.1m below ground level (111.625m AOD). This was cut by F500, the only feature identified, which was the possible medieval fishpond. Measuring c.5m to the end of the trench, this was a large feature filled with organic deposits. The edge of the feature sloped fairly gently towards the southern end of the trench. The bottom fill in this feature was a band of sand [5005], whose colour changed gradually from red to grey, which was very water-logged in the southern end. Over this was a distinct band of very dark grey silty sand [5004], loose and damp, again becoming water-logged in the southern end. No finds were found in these layers and they may represent undisturbed deposits dating to the medieval period. Samples were taken for environmental analysis. There was a shallow layer of reddish brown silty sand [5003] overlying these fills in the northern end of the feature. [5003] contained finds of nineteenth century date, and is probably related to the backfilling of the pond in the late-nineteenth century.

Over F500 was a layer of rubble and silt, [5002] and the topsoil [5000]. The topsoil contained modern finds (not kept), which included bin bags, and is probably connected to a more recent phase of landscaping.

The fishpond was identified in Trench 5. This has been dated to the medieval period (Mould 1998), which suggests medieval activity somewhere in the area. It is possible that there was a settlement to the north and east of the Church, rather than the south. No evidence of the medieval fishpond was found in Trench 4. This is probably because the edge of the pond does not extend this far north and is located somewhere under the modern path, although it may be because the edge of the pond has been truncated away.

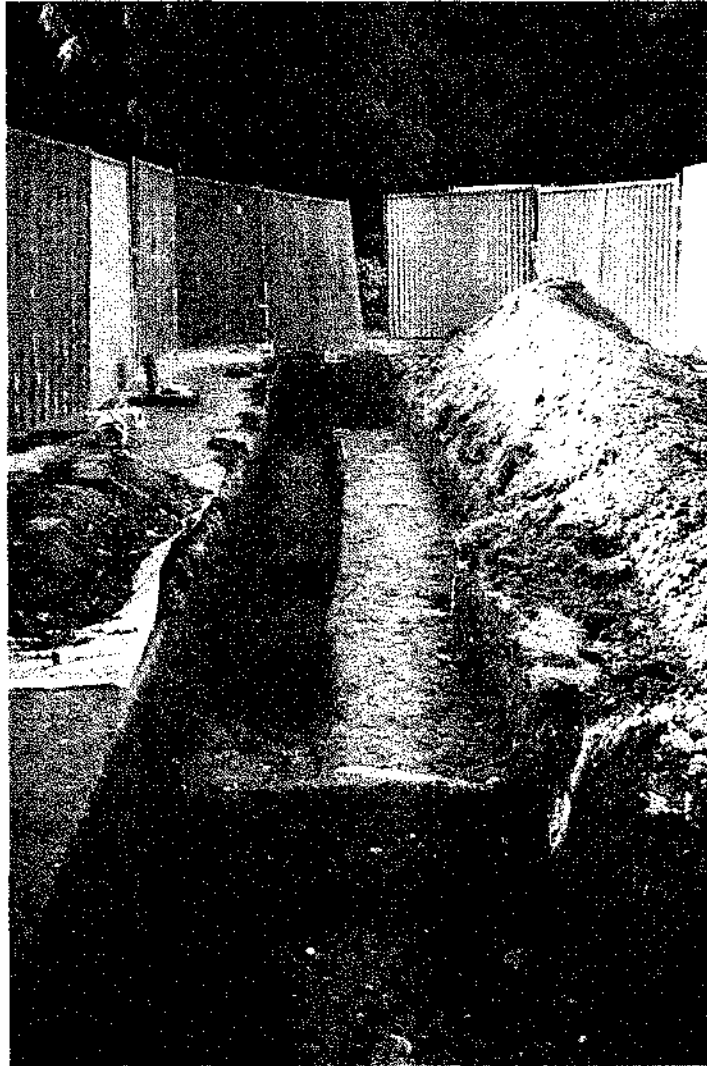
Plate 1

6.1 Trench 1 (Figs. 3 and 4; Plates 1 and 2)

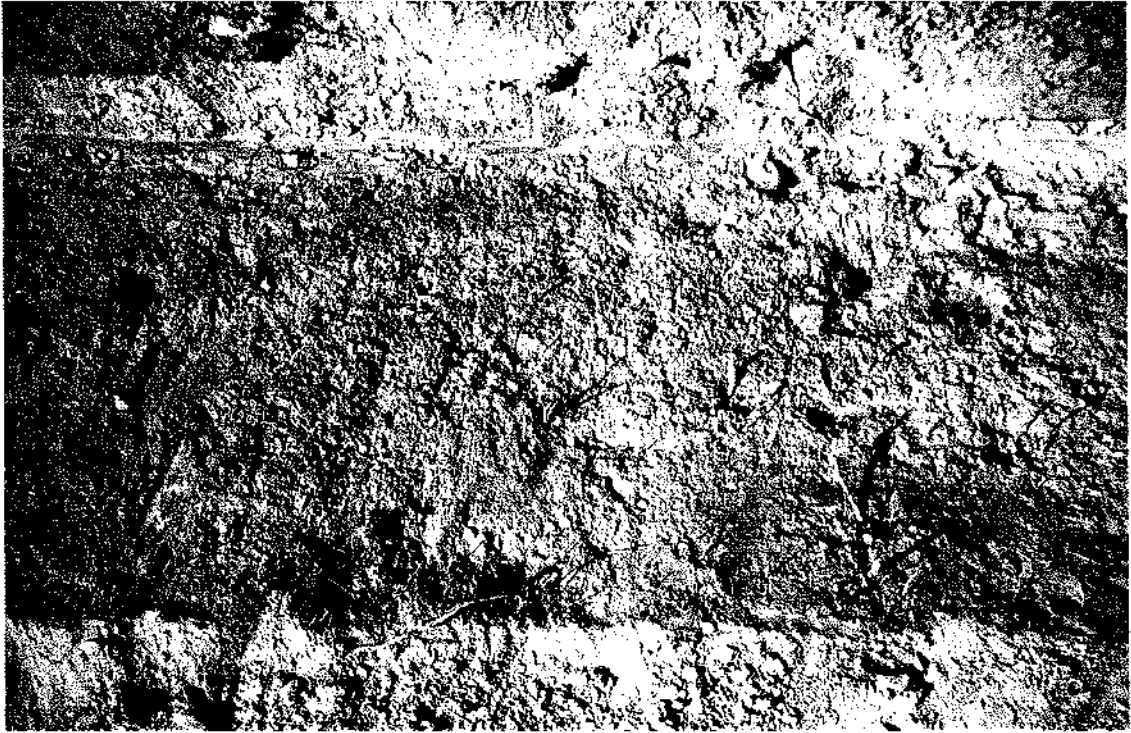
In Trench 4, layers of rubble build-up were identified over natural. Natural was encountered at a depth of 1.3-1.5m. No features were revealed. The rubble layers contained finds that were late-nineteenth and early/mid-twentieth century in date and

probably represent phases of landscaping from the original construction of the park and later alterations.
