Birmingham University Field Archaeology Unit
Project No. 985
February 2003

Installation of C.C.T.V. at Aston Hall, Birmingham
An Archaeological Watching Brief
2002

by
Kate Bain

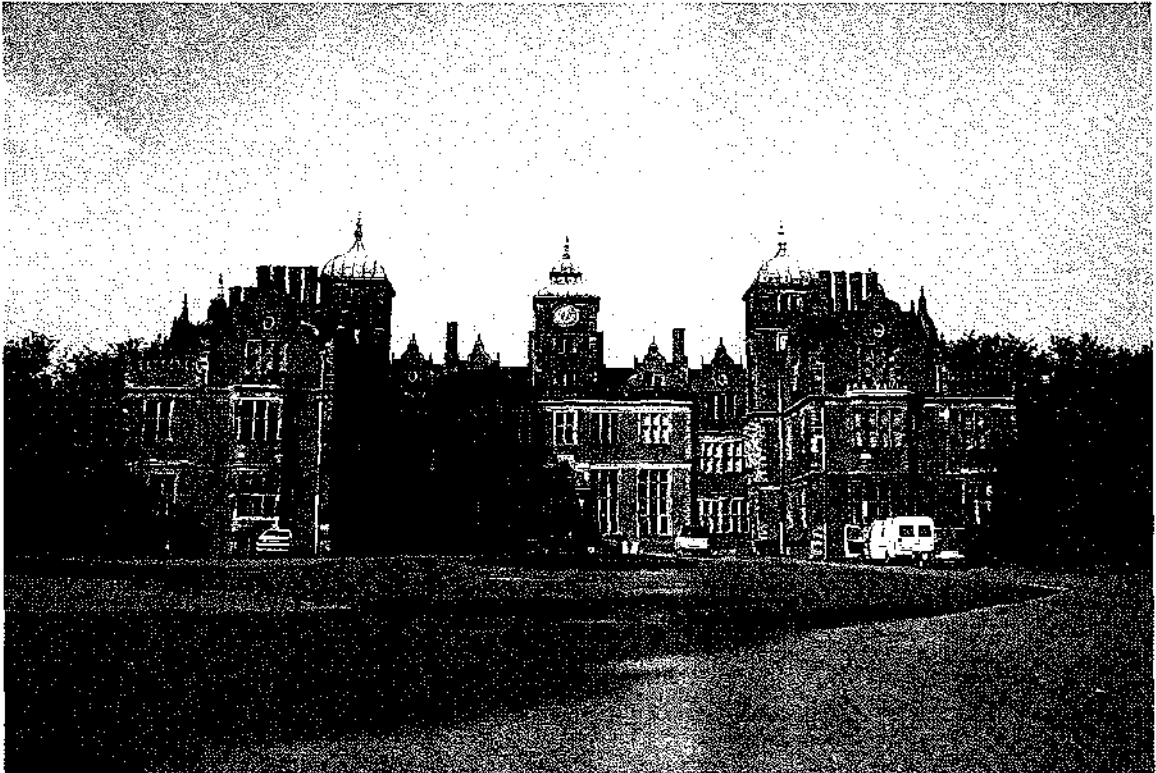
Plate 1

- Plate 1. Aston Hall, general shot, looking eastwards
Plate 2. Trench 1
Plate 3. Trench 2

Aston Hall is a Grade I Listed Jacobean Building with a surrounding Grade II Listed park (see Plate 1).

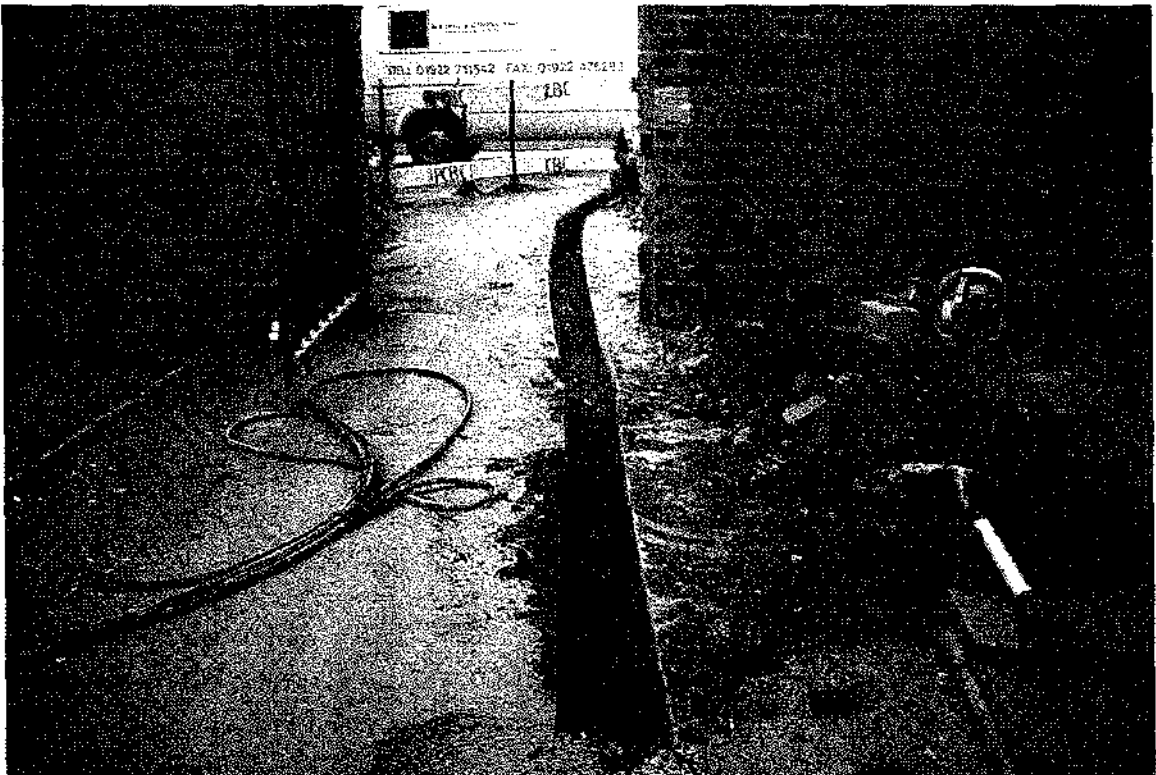
Plate 2

Trench 1 was located approximately 15m to the west of North Lodge, passing under the archway in the garden wall along the northern side of the hall and was aligned approximately north-south. The trench measured 8.70m in length and 0.30m in width.

The earliest layer encountered in this trench was a brownish orange silt-sand containing fragments of rubble (1001) with the rubble content lessening towards the northern end of the trench. Overlying 1001 was a 0.07m thick layer of modern tarmac (1000). At both ends this trench joined onto a previously existing cable trench.

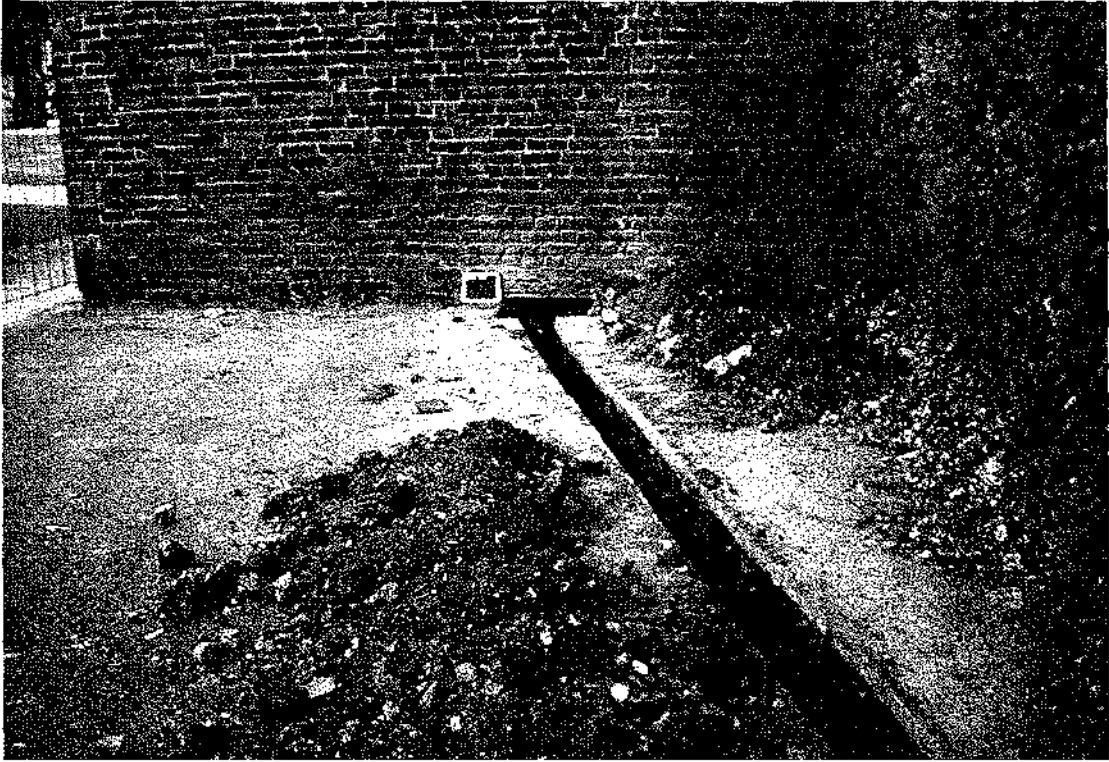
Plate 3

Trench 2 was located approximately 12.5m to the west of South Lodge, 2.80m from the archway in the garden wall along the south side of the hall. The trench measured 6.0m in length and 0.30m in width.

The trench was aligned roughly northwest-southeast and abutted the garden wall at the northwest end. At this point the trench widens into a 0.50m square. This trench terminated at a junction with an extant cable trench.

The earliest layer encountered in this trench was an orange-brown sandy silt (2001) which was immediately overlain by the modern tarmac surface (2000). At its northwest end the trench opens out into a 0.50m square, the southern facing section of which revealed the footings for the wall (F200), against which the trench butts. The foundations could be seen to extend to 0.40m below the modern ground surface. Each brick measured approximately 0.22m long by 0.08m high and had been crudely mortared in a stretcher pattern (2002). The bricks were predominantly red in colour however some variations existed within this. The red bricks forming the majority of the wall appear to be of mid-19th Century date. The variations in size and colour of some bricks in the wall suggest that these had previously been used in other walls forming standing buildings or garden structures.

The brick wall seen in Trench 2 formed part of the foundations to a garden wall (F200) which, from the morphology of the majority of the bricks, appears to be mid-19th Century in date. However, some of the bricks used to construct the wall appear to be different in both size and colour. This suggests that during the construction of this wall, bricks from previously standing buildings or garden features were re-used.
