**St. Peter's Gardens,
Wolverhampton**

**Phase 2 Landscaping
An archaeological watching brief
2003**

Project No. 1002
August 2003

On behalf of
Wolverhampton City Council

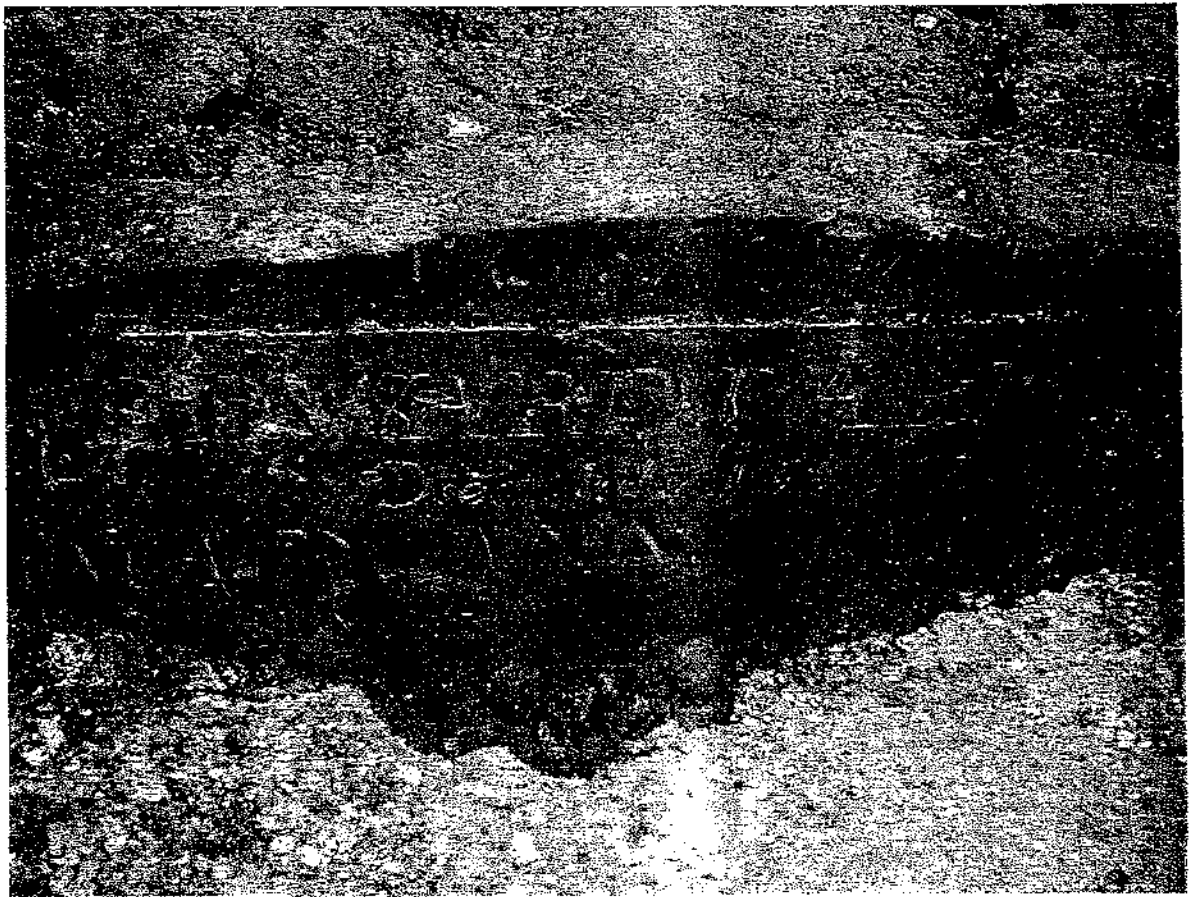
Plate 5

The entrance of the vault was in the western wall and was sealed with an engraved sandstone headstone (Plate 5), which read;
