**Walall Town Centre Transport Package:
An assessment of the Cultural Heritage Resource**

Sarah Watt and Malcolm Hislop
(including text by Nigel Baker)

Walsall Town Centre Transport Package: Cultural Heritage

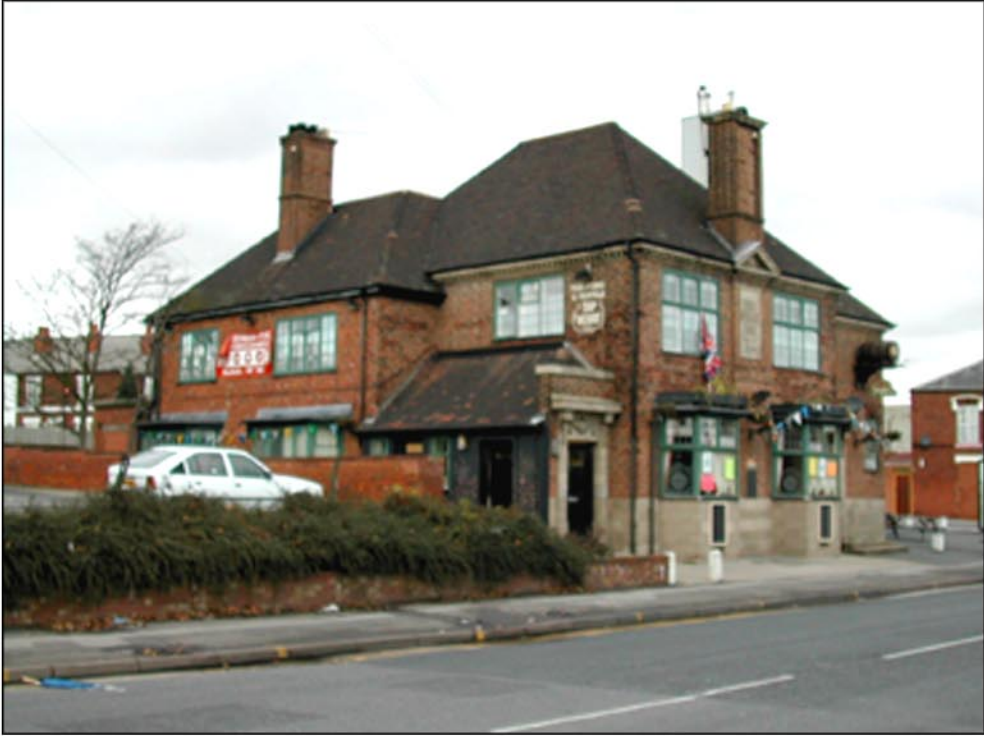
Plate 1: The Forge and Fettle.

The Forge and Fettle (Site 1; Plate 1)

Public house. Late 19th century. Eclectic 17th century style combining sub-Gothic with Queen Anne. Red/brown rough textured bricks with high plinth and dressings in ashlar, high hipped plain tile roofs, and brick stacks. 2 stories, 2:1 bays. Main building to left and slightly lower entrance wing set back to right. The centrepiece of the main building is an external chimney stack, pedimented at eaves level; it bears a stone plaque inscribed 'The Forge Inn'. The ground storey is dominated by two large canted bay windows; otherwise mullioned and transomed wooden framed windows with leaded lights. Doorways in the entrance wing and in a single-storey porch to the left hand side of the main block. Both have stone surrounds and festoons over.

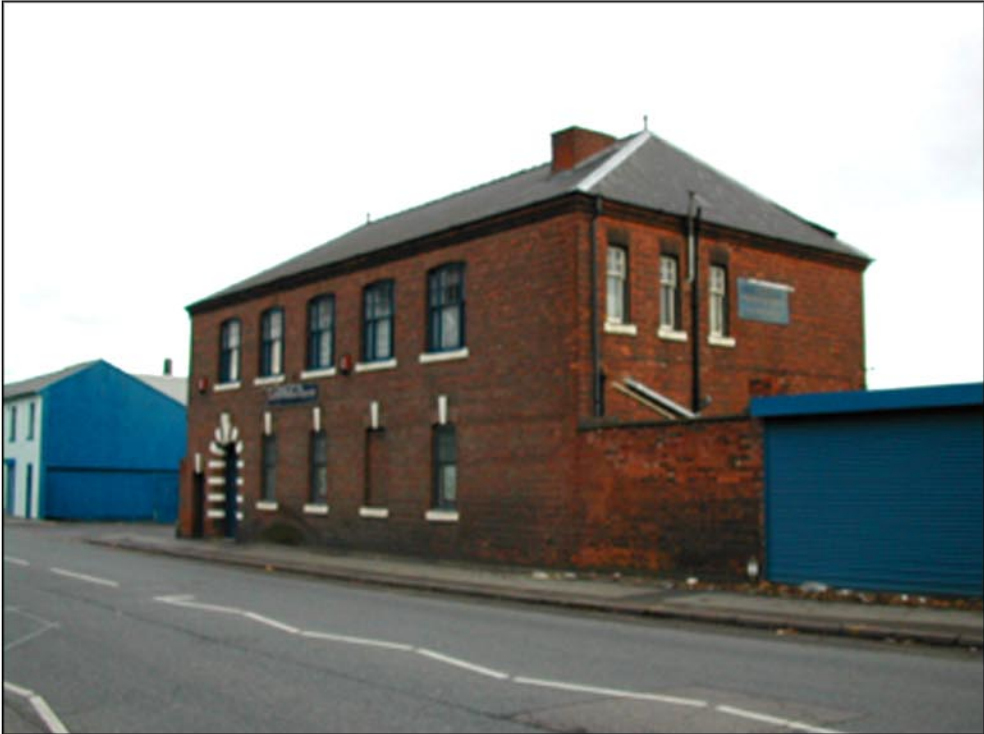
Plate 2: Elite Photography.

Elite Photography (Site 4; Plate 2)

Early 20th century. Red brick laid in English bond with painted stone dressings, hipped slate roof and brick stack. 2 stories, 6 bays (right hand bay blind); segmental-headed windows, those to ground storey with raised keys. Glazing bar sashes, those to first floor tripartite. Two segmental-headed doors to the left, the right hand one larger and with Gibbs surround.

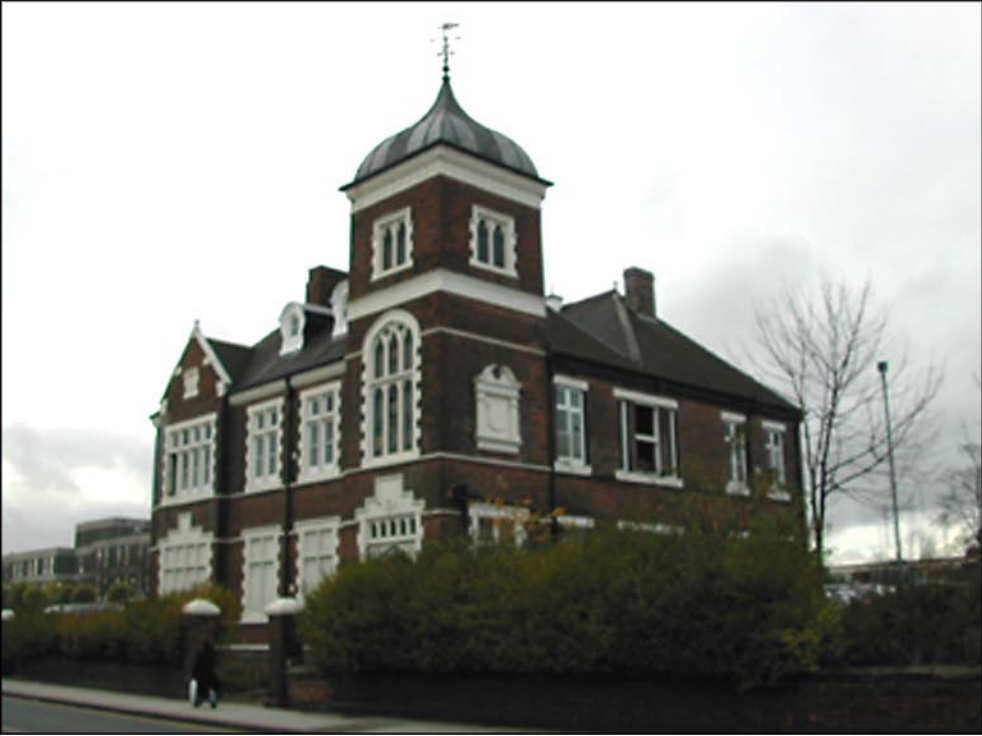
Plate 3: Former Workhouse Board of Guardian's office.

Former Board of Guardians Offices (Site 5; Plate 3)

Workhouse Board of Guardians Office. 1898-1900. By Henry E.Lavender of Walsall for the Board of Guardians of Walsall Poor Union. Red brick laid in English bond with painted stone dressings and hipped plain tile roof. 2 stories and attic. 1:2:1 bays; gabled bay breaking forward to left, and 3-storey porch tower to right with lead covered ogee cupola on corbelled oversailing eaves cornice. Large mullioned and transomed windows with sill bands, and hood moulds to ground storey. Queen Anne style dormers with segmental-arched open base pediments and flanking volutes. 4-centred arch door with panelled spandrels, two orders of colonettes and an overlight with 5-light panelled tracery, all beneath a stepped hood mould. Large 4-centred arch window above with intersecting tracery.

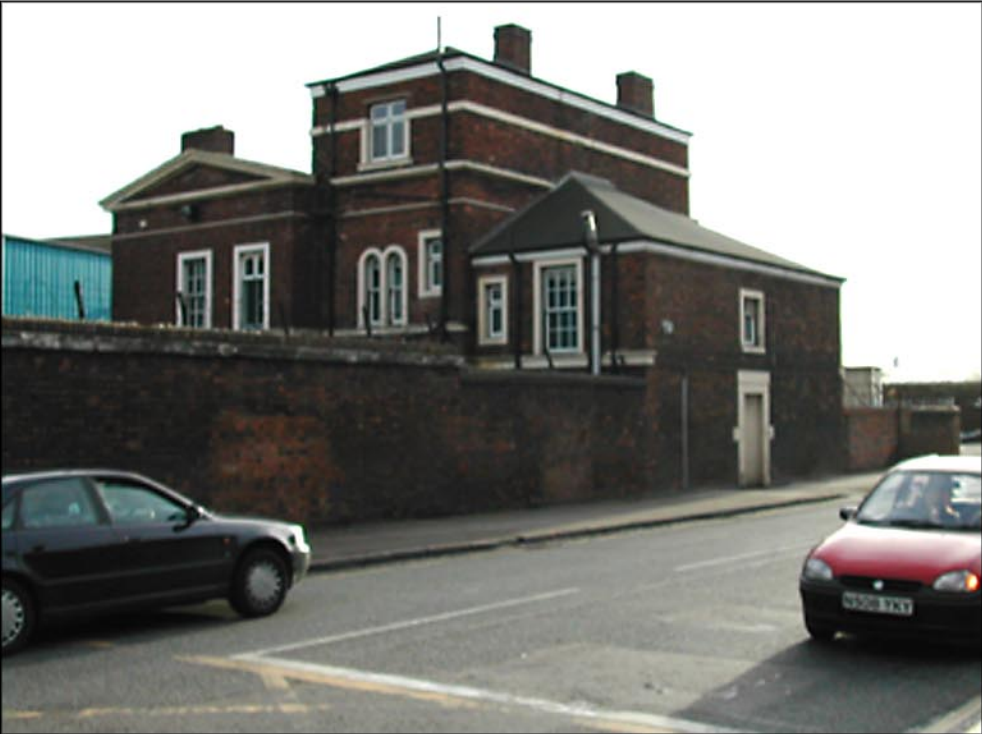
Plate 4: Bridgeman House.

Bridgeman House, Pleck Road (Site 7; Plate 4)

House. Mid-19th century. Italianate style. Red brick (Flemish stretcher bond), hipped felted roofs, brick stacks. Irregular (north) front centred on a three-storey central block with pyramidal roof. To the left, breaking forward from the centre block, is a two-storey pedimented section with central door. To the right, is a lower two-storey gabled wing. The house is articulated horizontally by moulded window sill bands and eaves cornices. Glazing bar sash windows, some with semicircular heads. A pair of canted bay windows to the right hand return.

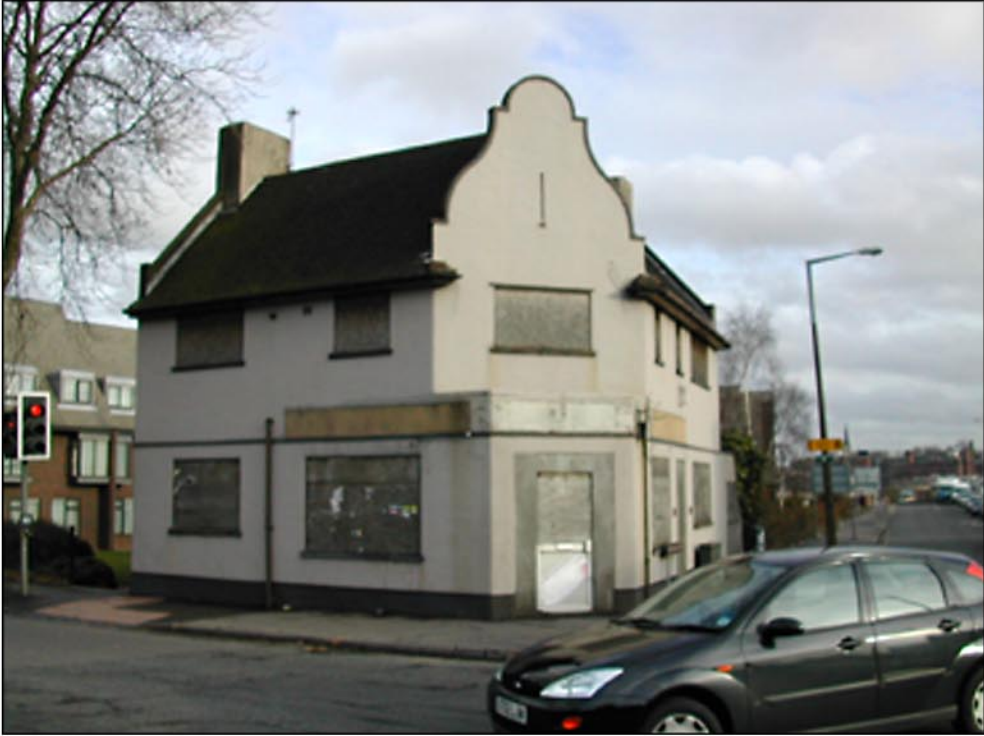
Plate 5: 87 Pleck Road.

No.87 Pleck Road (Site 6; Plate 5)

No.87 Pleck Road, latterly in use as a public house, dates from *circa* 1900. It is built to a Vernacular Revival design with rendered walls, plain tile roof with brick coped gables, and brick stacks. The building has two storeys delineated by a first floor band. There are side elevations to Pleck Road (two bays) and Bridgeman Street (three bays) but the main entrance front is towards the corner. Here, there is a flat roofed porch, possibly an addition, containing a later 20th century door, and above, a shaped or Dutch gable containing a slit window. There is a second entrance in the Bridgeman Street elevation. All the windows are boarded up but appear to have wooden sills; it could not be ascertained whether they were original.

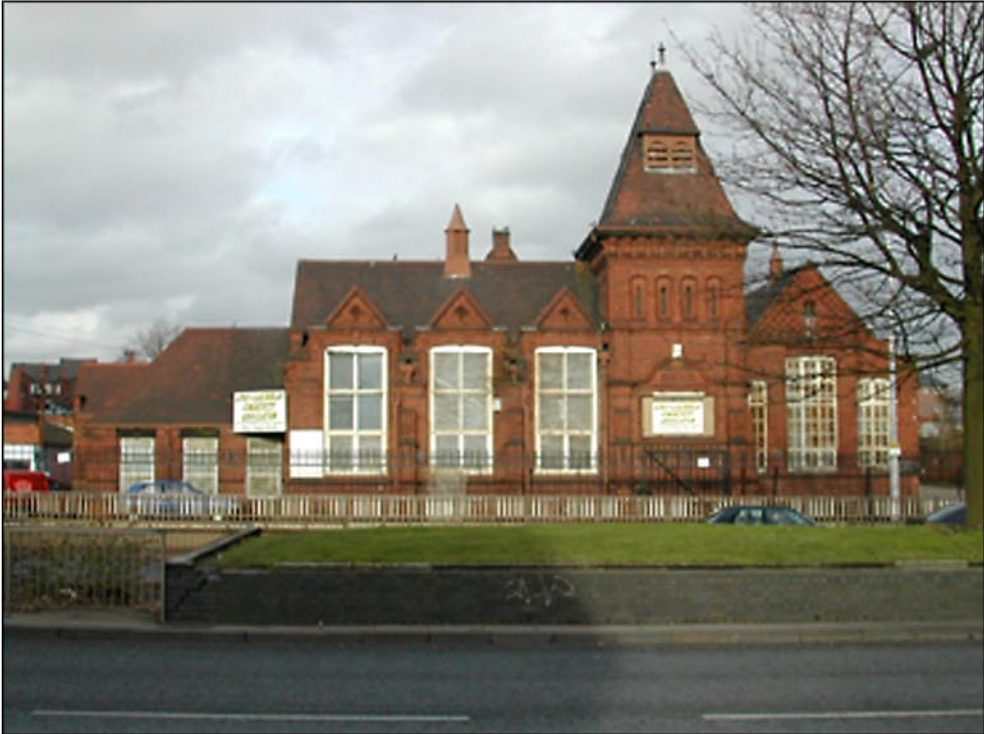
Plate 6: Afro-Caribbean Centre.

PART 1		PART 2			PART 3
Feature	Description	Scale it Matters	Significance	Rarity	Impact
Form	Afro-Caribbean Centre, Wolverhampton Road. School. Flemish Gothic/Queen Anne style. Brick with plain tile roofs. One storey with tower.	Local	Not on statutory or local lists, but of local interest.	Moderate rarity in a local context, but not regional or national contexts.	Not affected
Survival	Only minor alterations	Local	Local	Not rare	Not affected
Condition	Good	Local	Local	Not rare	Not affected
Complexity	Street front of one period	Local	Local	Not rare	Not affected
Context	A surviving element of the late 19 th century development of Pleck Road.		Local	Not rare	
Period	Late 19 th century	Local	Local	Not rare	Not affected

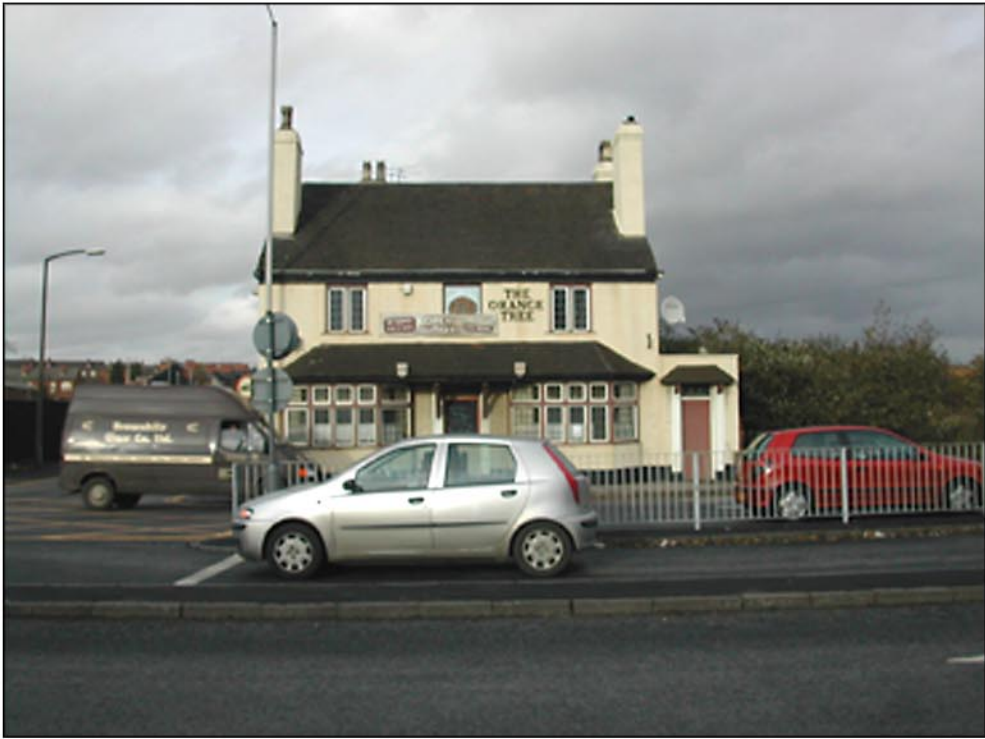
Plate 7: The Orange Tree.

PART 1		PART 2			PART 3
Feature	Description	Scale it Matters	Significance	Rarity	Impact
Form	The Orange Tree public house, Wolverhampton Rd. Vernacular revival. Rendered walls, plain tile roof. 2 stories, 3 bays. Central door & flanking canted bay windows.	Local	Not on statutory or local lists but of local interest.	Not rare	Not affected
Survival	Exterior survives largely intact.	Local	Local significance	Not rare	Not affected
Condition	Good	Local	Local significance	Not rare	Not affected
Complexity	Single-phase front elevation.	Local	Local significance	Not rare	Not affected
Context	A surviving element of the late 19 th century development of Pleck Road.	Local	Local significance	Not rare	Not affected
Period	Late 19 th century	Local	Local significance	Not rare	Not affected

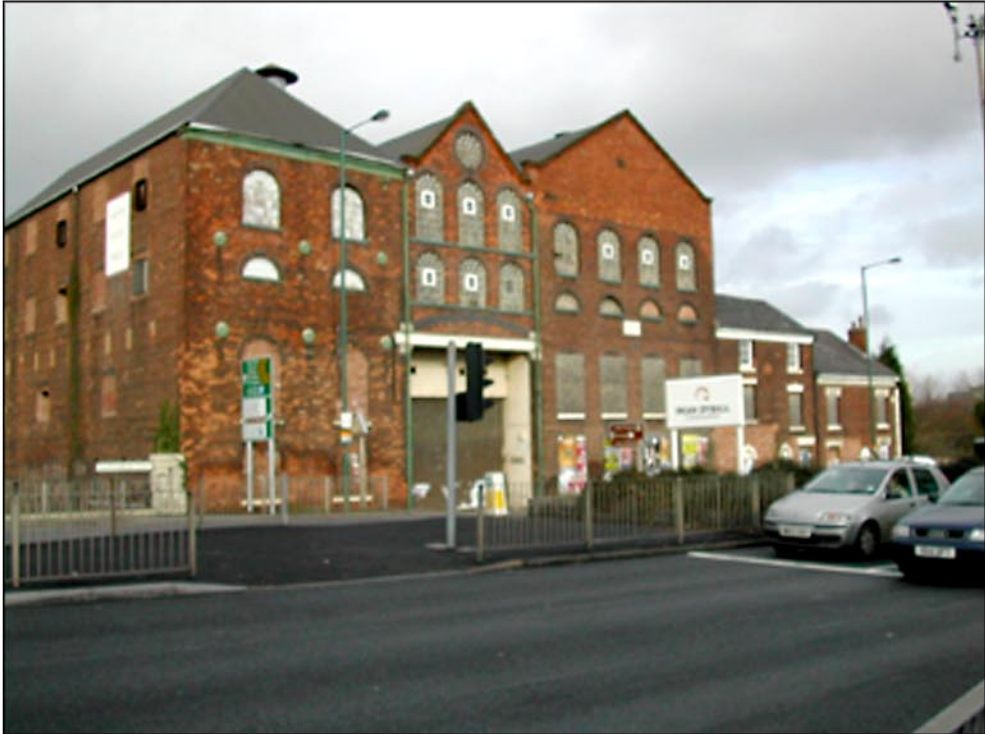
Plate 8: The Albion Flour Mill.

PART 1		PART 2			PART 3
Feature	Description	Scale it Matters	Significance	Rarity	Impact
Form	The Albion Flour Mill. Now empty. Brick. 4 stories & attic. 2:3:4 bays. Central gabled entrance block & 2 flanking wings. Attached terrace of houses.	Local	On the local list of buildings of special architectural or historic interest, but not on statutory list.	Local rarity	Minimal
Survival	Good. Only minor alterations to main front.	Regional. See context	Regional	Regional	Minimal
Condition	Fair, but requires renovation.	Regional. See context	Regional	Regional	Minimal
Complexity	3 structural phases are apparent. There are vertical joints in the brickwork between the central block and wings. One wing is of the same build as a pair of attached houses. A 4 th phase is represented by an addition of another house to the terrace.	Local	Local	Local	Minimal
Context	Associated with the adjacent canal locks and wharves.	Regionally important in view of its association with the canal. Within a conservation area.	Regional	Regional	Minimal

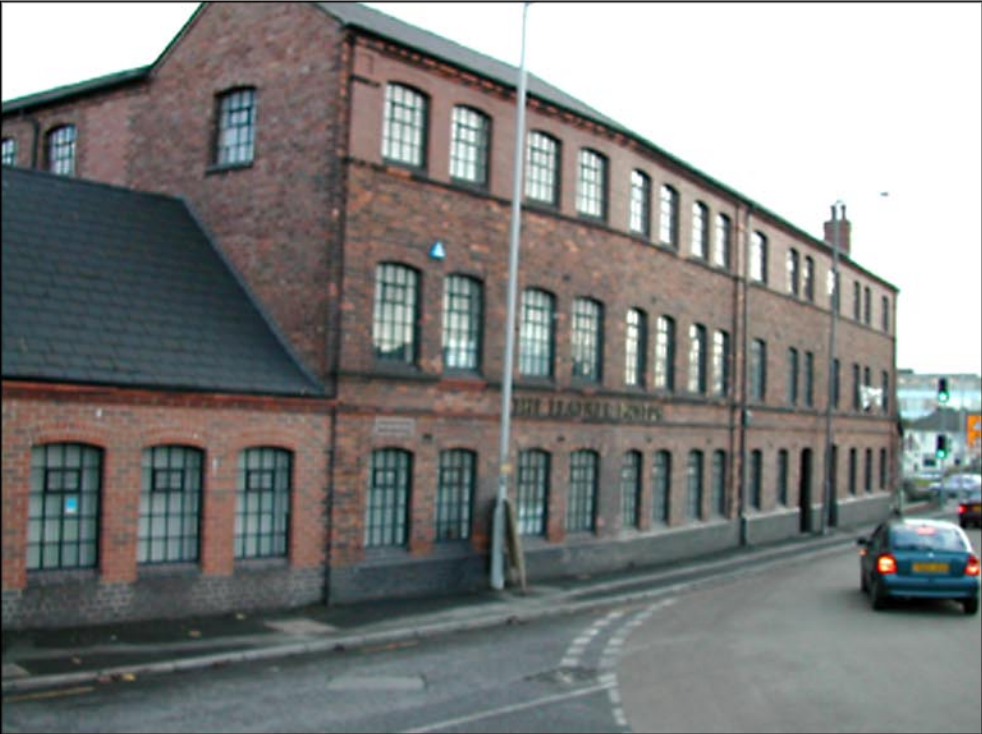
Plate 10: The Leather Museum.

PART 1		PART 2			PART 3
Feature	Description	Scale it Matters	Significance	Rarity	Impact
Form	The Leather Museum. Leather goods manufactory. Brick with slate roof. 3 stories, 15 bays. Also attached 2-storey, single-bay building.	Local	On SMR & local list of buildings of special architectural or historic interest, but not on statutory list.	Not rare	Not affected
Survival	Mostly survives, but some late 20 th century rebuilding to the 3 rd storey.	Local	Local	Not rare	Not affected
Condition	Good. Well maintained.	Regional	Regional	Moderately rare	Not affected
Complexity	Largely of a single period.	Local	Local	Not rare	Not affected
Context	In a area of contemporary industrial buildings.	Local	Local	Not rare	Not affected
Period	Late 19 th century.	Local	Local	Not rare	Not affected

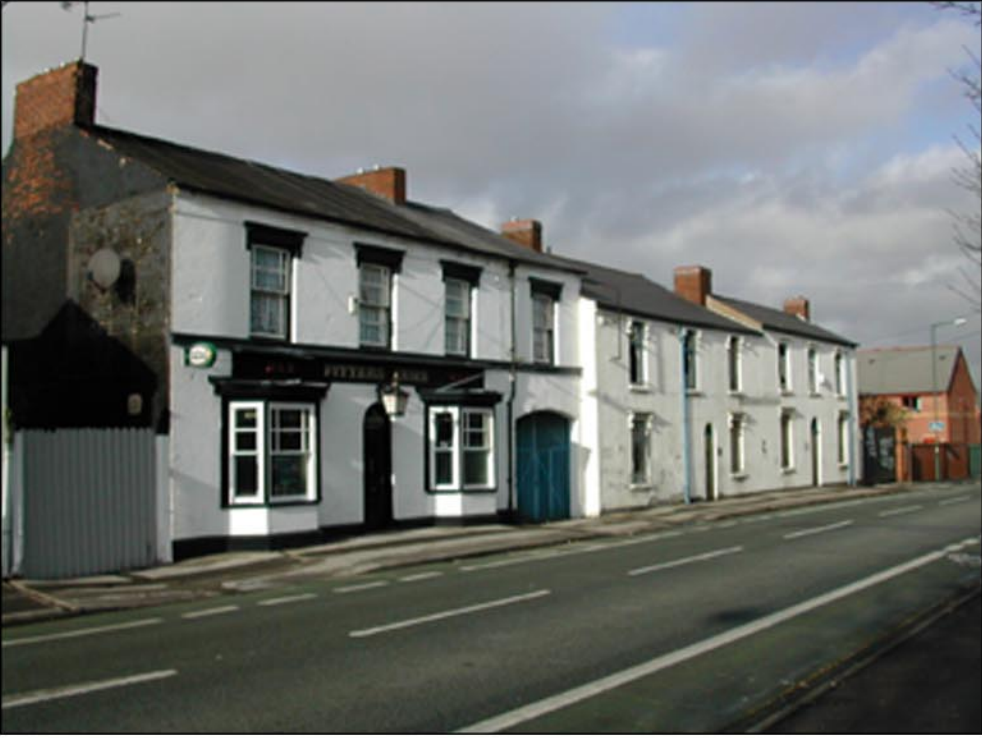
Plate 11: The Fitter's Arms.

PART 1		PART 2			PART 3
Feature	Description	Scale it Matters	Significance	Rarity	Impact
Form	Fitter's Arms public house, Hatherton Street. Rendered brick walls, felted roof. 2 stories, 4 bays. Canted bay windows flanking doorway. Carriage arch.	Local	Not on local or statutory lists, but of local interest.	Not rare	Not affected
Survival	Intact exterior	Local	Local	Not rare	Not affected
Condition	Good.	Local	Local	Not rare	Not affected
Complexity	Single main period	Local	Local	Not rare	Not affected
Context	Attached to a row of near contemporary terrace housing, and related to the 19 th century industrial development of the area. E.g. the former Albion Tannery (q.v.) is also on Hatherton Street.	Local	Local	Not rare	Not affected
Period	Mid to late 19 th century	Local	Local	Not rare	Not affected

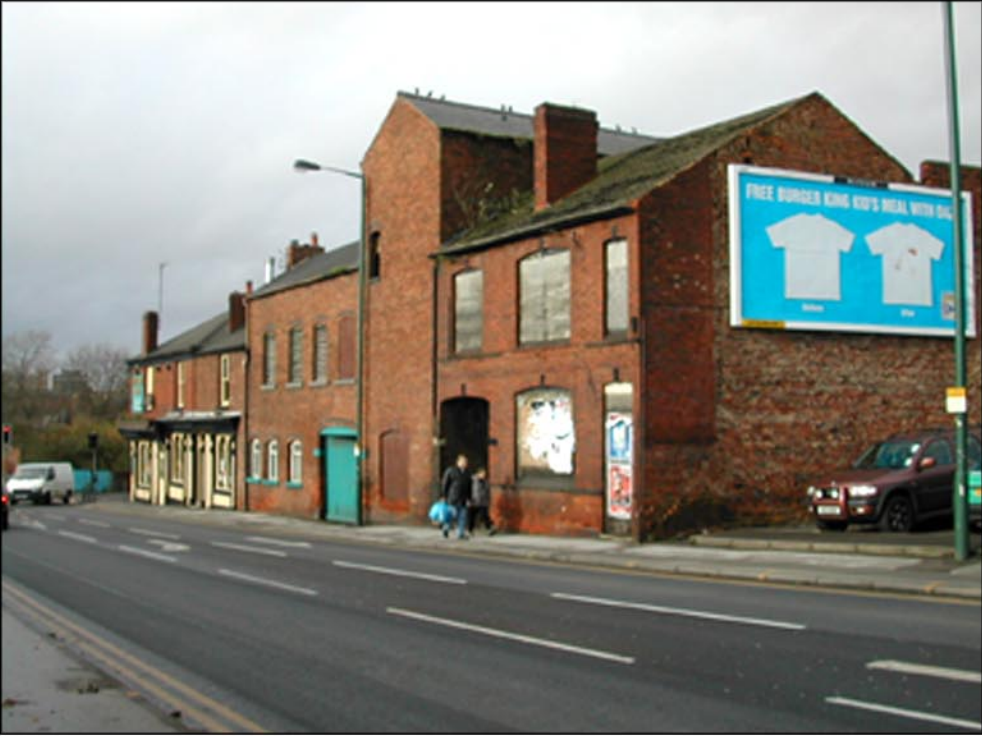
Plate 13: Littleton Arms and attached industrial buildings.

Survival	Exterior survives largely intact. Interior of pub altered.	Local	Local, based on an exterior inspection.	Not rare, based on an exterior inspection	
Condition	Public house in good condition. Industrial buildings appear structurally sound, but neglected.	Local	Local, based on an exterior inspection.	Not rare, based on an exterior inspection	
Complexity	At least two phases. Eastern bays of public house later than main block.	Local	Local.	Not rare	
Context	An important part of the 19 th century townscape. Group value with the former Albion Tannery, and the Fitters' Arms and attached terrace housing, both on Hatherton Street.	Local	Local.	Not rare	Negative impact of the loss of part of the historic 19 th century townscape, particularly the character of the area centred on this road junction cannot be mitigated.
Period	Mid to late 19 th century.	Local	Local	Not rare

It is provisionally recommended that the buildings scheduled for demolition – the Littleton Arms and its adjacent buildings – should be subject to a Level 3 (RCHME) recording programme prior to their demolition.

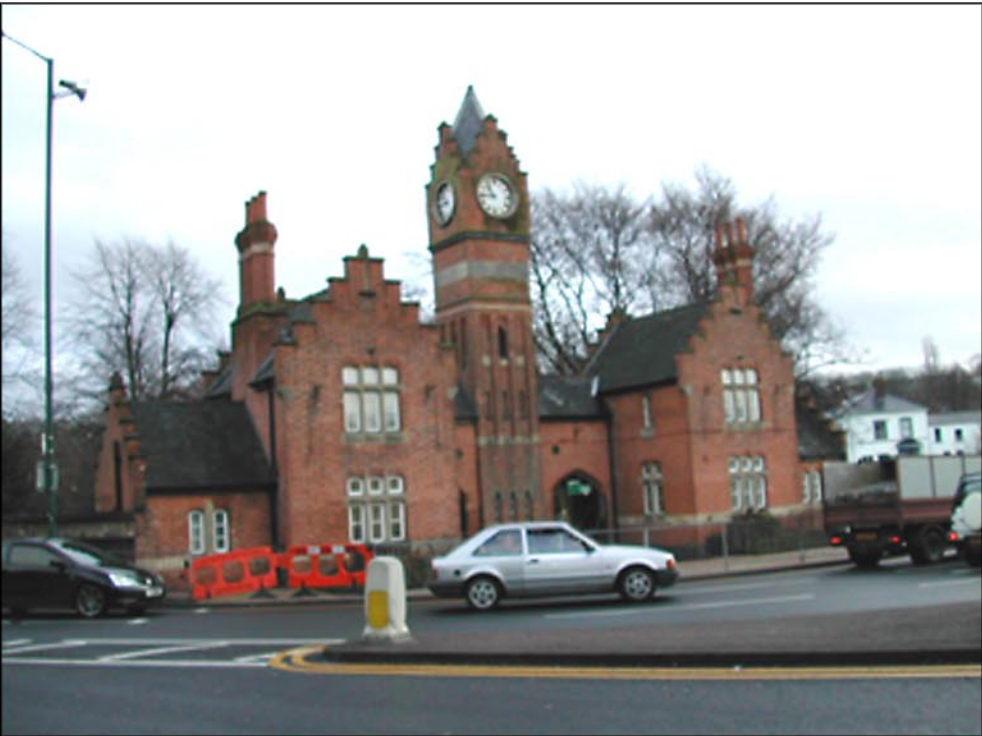
Plate 14: Arboretum Garden and Clock Tower.

PART 1		PART 2			PART 3
Feature	Description	Scale it Matters	Significance	Rarity	Impact
Form	Arboretum gatehouse and clock tower. Brick & ashlar dressings, slate roofs. H-plan. One and two stories with central clock tower. 1:1:3:1:1 bays.	Local	Within a conservation area and on the SMR, but not locally or statutorily listed. However, it is of local importance for both aesthetic and historic reasons.	Not rare	Not affected
Survival	Complete.	Local	Local	Not rare	Not affected
Condition	Good.	Local	Local	Not rare	Not affected
Complexity	Single-period.	Local	Local	Not rare	Not affected
Context	Part of the 19 th century streetscape. Group value with the High School on the other side of the Road	Local	Local		Not affected
Period	Late 19 th century	Local	Local	Not rare	Not affected

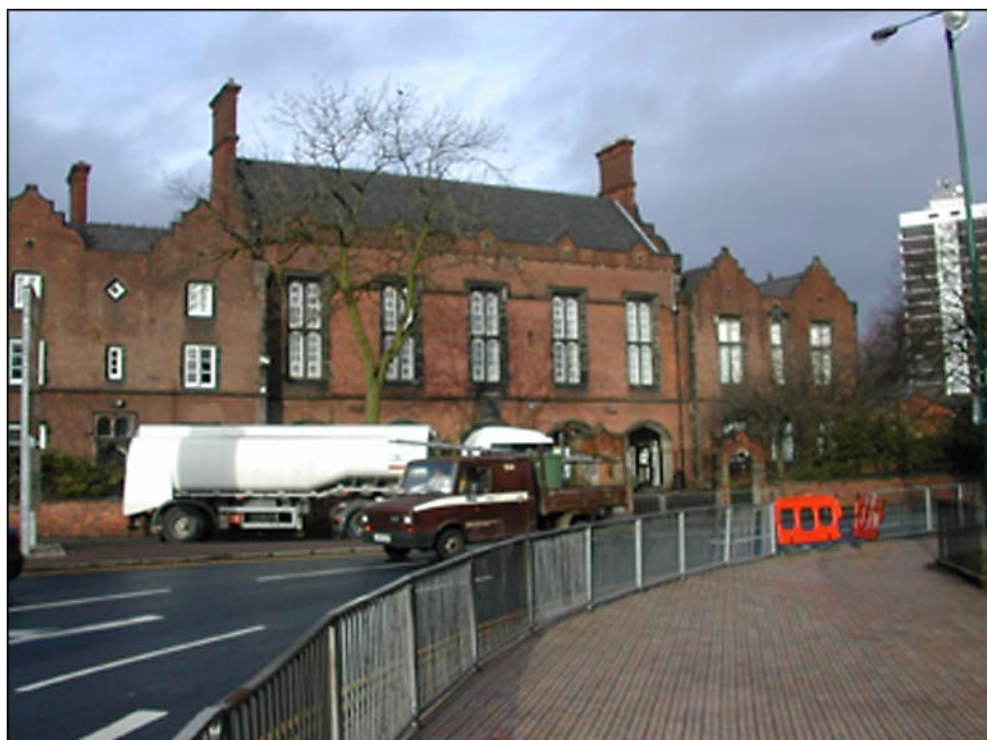
Plate 15: Queen Mary's High School.

PART 1		PART 2			PART 3
Feature	Description	Scale it Matters	Significance	Rarity	Impact
Form	Queen Mary's High School. Jacobethan style. Brick with ashlar dressings, slate roofs. 2 stories, 3:5:3 bays, with dutch gabled flanking wings.	Local	On SMR but not on statutory list. Local significance.	Not rare	Unaffected
Survival	Good	Local	Local significance	Not rare	Unaffected
Condition	Good	Local			Unaffected
Complexity		Local			Unaffected
Context	Group value with the Arboretum gatehouse and clock tower (cf) with which it defines the historical character of this part of the town	Local	Local		Unaffected
Period	Dated 1840	Local			Unaffected
