Birmingham University Field Archaeology Unit
Project No. 1025
February 2003

Hillfield Hall, Solihull
An Archaeological Evaluation

by
Eleanor Ramsey
With a contribution by Dr Marina Ciaraldi

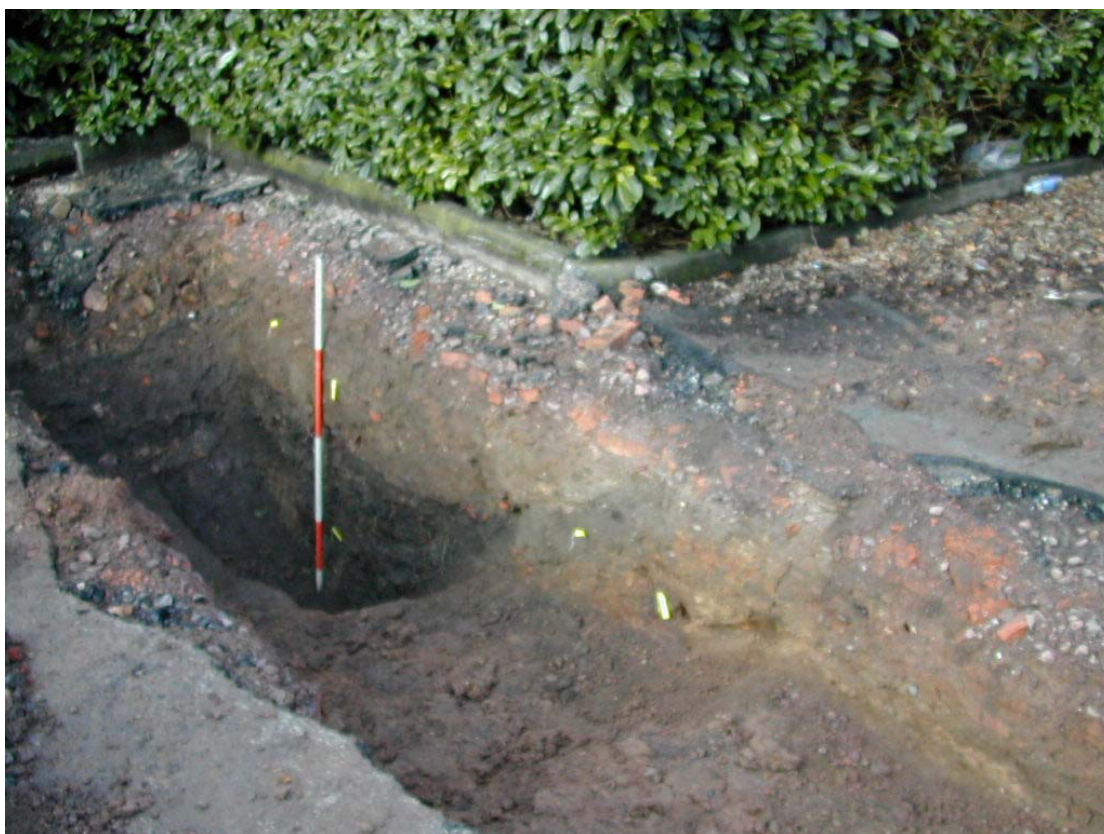
Plate 1 Moat and bank in Trench 1

Trench 1 (Fig. 4, Plate 1)

The red clay subsoil (1021) was exposed at a depth of approximately 0.8m below the modern carpark surface. Pressed into the subsoil, central to the trench, was an area of rounded cobbles with occasional brick fragments (1005) which may comprise a surface. Overlying this possible surface was a layer of dark brown silty clay with brick fragments (1001), which obscured the surface except where exposed in a sondage. At the north-western end of the trench, a large feature aligned approximately north-east – south-west was identified (F100), and was interpreted as part of the moat. This feature was excavated to a depth of 1.9m below the modern carpark surface and continued under the north-west end of the trench and was not fully excavated due to safety considerations. The majority of the fills of the moat feature (F100) were modern deposits containing plastic, metal and concrete etc (1000, 1002, 1006, 1008 and 1020). This is not surprising, given that the moat in this area was visible as an open feature as late as 1950 (Williams 2002). At the edge of the moat (F100) was a deposit of redeposited red clay (1007), which in section was evident as a 7.5m wide bank. A revetment of hard grey angular stone (1022 not illustrated) was identified within the section through the moat abutting the redeposited red clay, but was not continuous throughout the section. A deposit of light grey brown silt clay with tile (1003) was also identified overlying the redeposited clay at the edge of the moat, and possibly represents an earlier episode of backfilling. One fragment of Post-Medieval pottery was recovered from this context, which was sampled for environmental assessment (see below). Central to the trench a layer of rounded cobbles, brick and grey-brown silty clay (1018) was identified. This layer abutted and respected the southern edge of the bank of redeposited red clay (1007). The brick recovered from this context (1018) was identified as dating from the 18th century. Overlying this layer was a series of levelling layers and deposits and former tarmac surfaces (1009, 1012, 1013, 1016 and 1017). Cutting these layers was a series of drains aligned north-west – south-east, and north-east – south-west. Overlying the whole trench was a levelling layer of angular gravel and crushed brick (1014) and a tarmac surface (1010).

The archaeological evidence recovered from the evaluation most importantly highlights the location and preservation of archaeological deposits within the north of the development area. The identification of the moat, revetment and bank within Trench 1 is not surprising, as this had been a visible earthwork until 1950, and the modernity of the backfill confirms this. The layer of cobbles, brick and silt that overlies the natural and abutts the south-eastern edge of the bank is likely to be a Post-Medieval levelling deposit. The small amount of cobbled surface identified beneath this layer within Trench 1 was undated, and not enough was exposed to confirm or reject any hypothesis concerning date and function. Although only Post-Medieval and modern deposits were encountered within the moat fill in this trench, it is possible that earlier deposits survive at a lower depth.

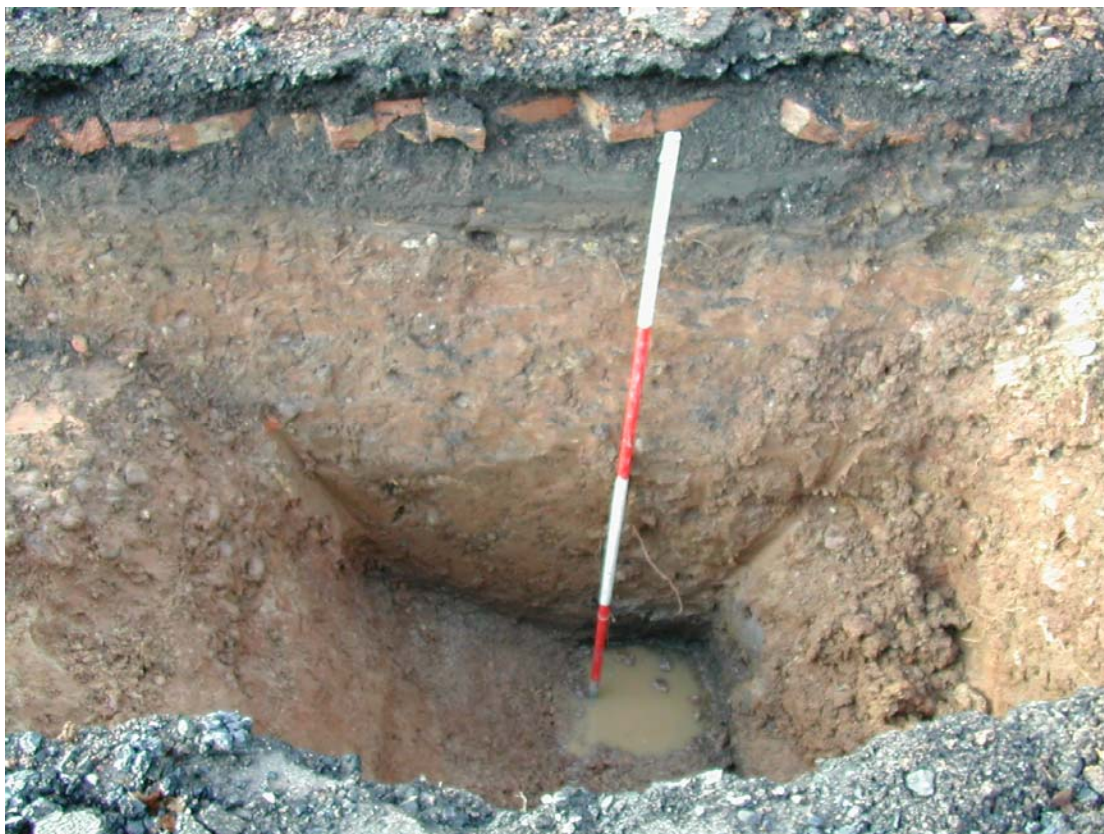
Plate 2 Moat and revetment in Trench 2

Trench 2 (Fig. 5, Plate 2)

The red and blue mottled clay subsoil (2008) was encountered only in two machine-excavated sondages, one at the southern end of the trench, one at the northernmost end of the trench. A large feature (F204) was also encountered at the northernmost end of the trench, and was identified as the continuation of the moat. The southern edge of this feature had a steeply-sloping side, and was tested to a depth of approximately 2.5m using a mechanical excavator. At the base of the machine-excavated sondage a layer of dark grey-brown organic silt (2010) was encountered, though for safety reasons this layer could not be sampled. Overlying the sloping edge

of this feature and extending horizontally to the south was a layer of cobbles (2005), approximately 0.1m deep, with brick and tile pressed in to the top. It is possible that this layer represents part of a weathered bank and revetment of the moat feature (Nichol, pers. comm.). Overlying the layer of cobbles (2005) was a layer of redeposited natural subsoil, a pink-red clay mixed with yellow sand with occasional brick and tile fragments (2004). The brick from this context is likely to date from the 18th – 19th century (Litherland, pers. comm.). This layer continued throughout the trench and was approximately 0.2m – 0.3m deep, except at the northern end of the trench where it also comprised the main fill of the moat feature (F204) overlying the fill 2010. A shallow, irregular feature (F203) was identified cutting the re-deposited clay layer (2004) at the northern end of the trench. The fill of this feature was a loose, light brown sandy silt with roots present (2009). It is likely that this feature represents disturbance by root activity and is not of archaeological origin.

The continuation of the moat with associated revetment and weathered bank at the northern end of Trench 2 was identified as having been infilled, sealed and thus preserved by a substantial layer of redeposited clay natural. This suggests that while no earlier structural remains or deposits were encountered during the evaluation itself, the preservation of such remains within this trench is possible, as the majority of this trench was excavated to the top of the redeposited clay layer. It is also possible that the lowest fill identified at the base of the moat within the machine-excavated sondage relates to an earlier fill. Where the brick and tile within the redeposited clay layer was complete enough to enable dating, it was determined to be hand-made and bonded with lime mortar and is likely to be 18th-century in date at the earliest (Litherland pers. comm.). It is possible that the redeposited clay relates to the excavation of the pond feature to the west of this trench. All other features identified in this trench truncated the redeposited layer.

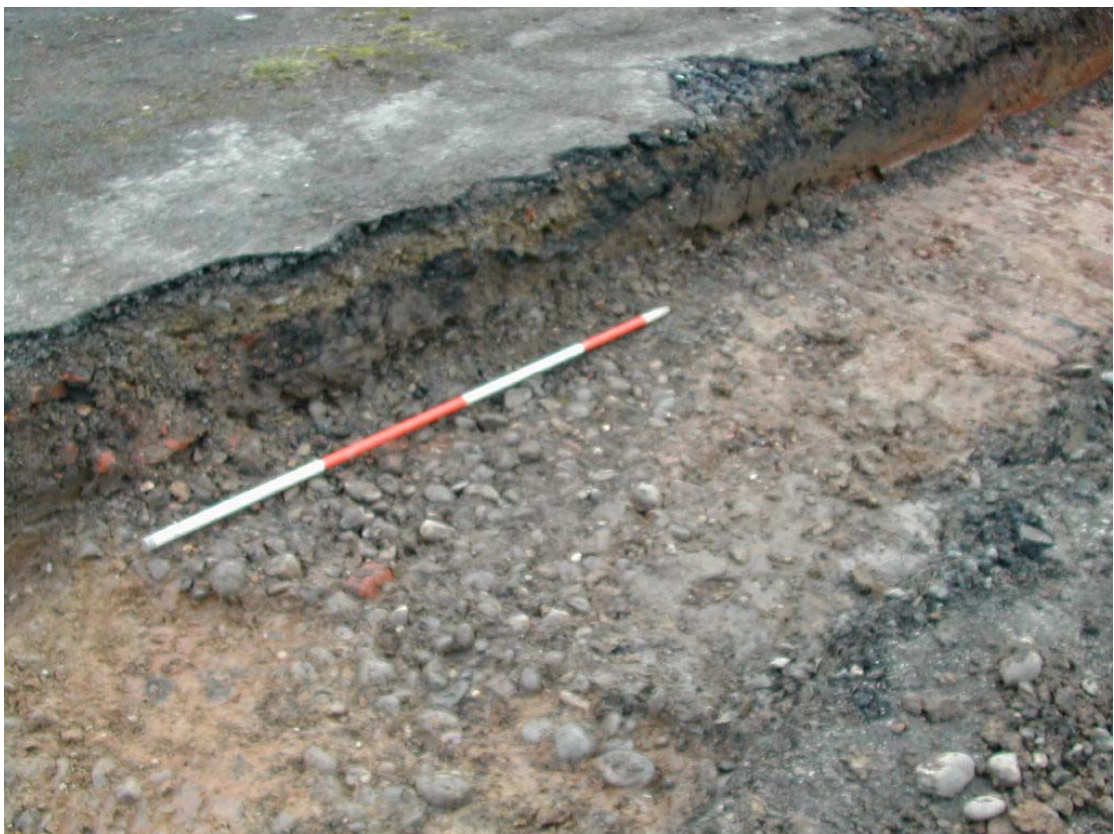
Plate 4 Cobble surface in Trench 5b

Trench 5 (Fig. 7, Plate 4)

The stratigraphy within Trench 5b was similar to the stratigraphy in Trench 5a. The red clay subsoil (5008) was identified approximately 0.5m below the modern carpark surface. A discrete spread of cobbles (F506, 5016) was identified central to the trench directly overlying/pressed into the subsoil. The cobble spread was irregular in plan and approximately 4m wide, 0.05- 0.1m deep, and contained fragments of brick and one fragment of vessel glass. No other features were identified within this section of the trench. Sealing the cobble spread and overlying the subsoil was a layer of mid-brownish yellow silty clay (5013). Overlying this layer (5013) was a layer of brownish black mixed clinker, ash, charcoal with brick rubble (5012) which in turn was sealed by modern levelling layers of yellow hardcore and sand (5011) and the modern carpark surface (5010).

The three trenches located to the south of the Hall (Trenches 4, 5 and 6), that targeted the area of most intense development, produced little in the way of archaeological evidence. The post-holes encountered were securely dated to the Post-Medieval period, and it is likely that the cobble spread encountered within Trench 5b is also of this date. The linear features identified were not securely dated.
