Hillfield Hall, Solihull.
An Archaeological Desk-
Based Assessment

Birmingham University Field Archaeology Unit
Project No. 1025
December 2002

by
Josh Williams

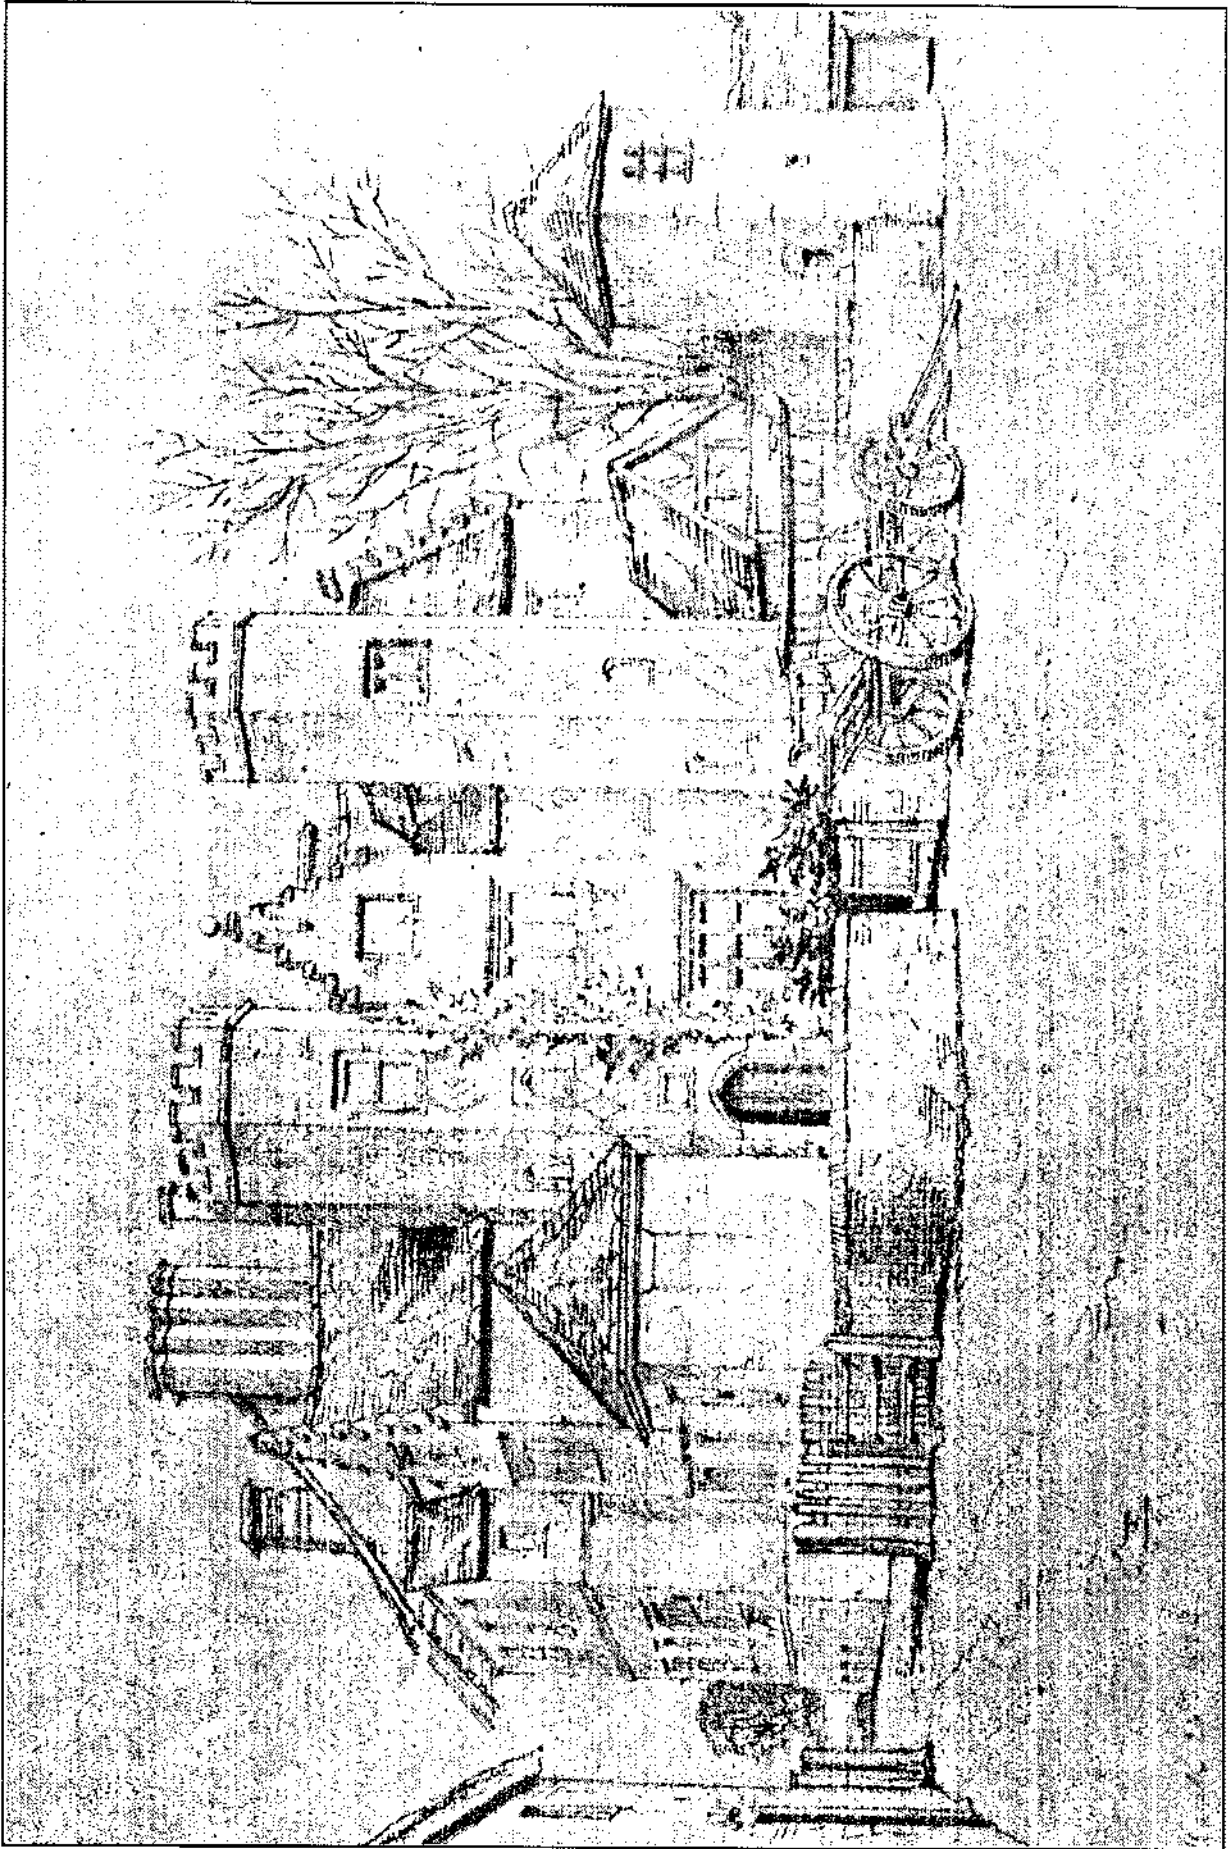
Fig.10

A picture from 1853 by A. E. Everitt (Fig. 10) shows the northwestern front of the Hall prior to the fire and shows the three-storey structure with the entrance in the northern tower. The picture shows structures to the north of the hall and additions to the front on the north and western sides, none of which is present today. The picture does not show the stables or other remaining structures standing today.

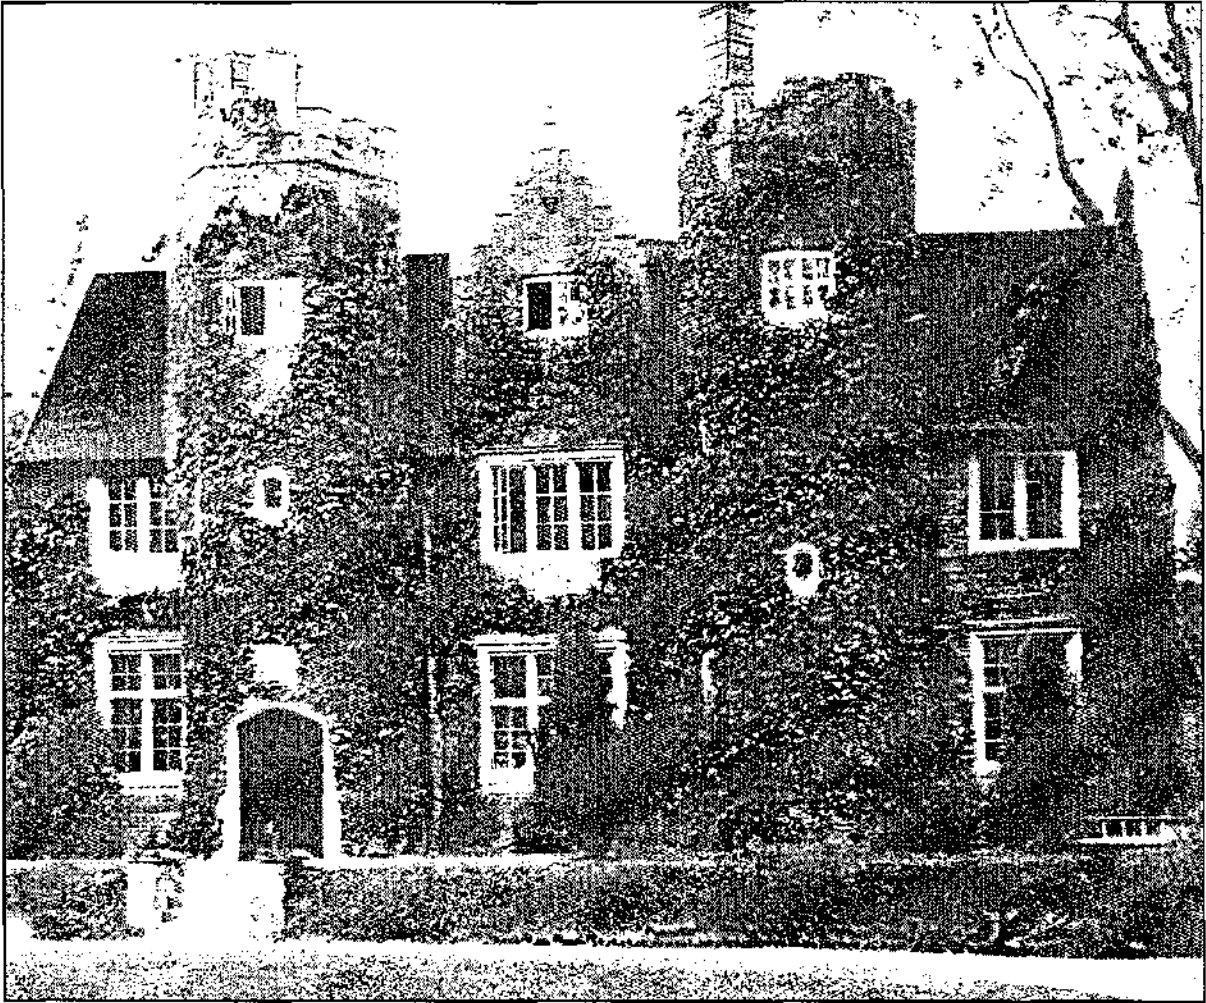
Fig. 11

A photograph (Fig 11) from 'earlier this century' (Woodall and Varley 1987) shows the Hall similar to its appearance today, without the extensions to the south. A landuse map from 1950 (Fig 9) shows the Hall as a more rectangular structure, with possible outbuildings to the east. The Hall appears to have been slightly extended to the south, and, apart from the gatehouse and stables, the other outbuildings appear to have been demolished or reduced in size. The moat and fishpond are still visible on the map.

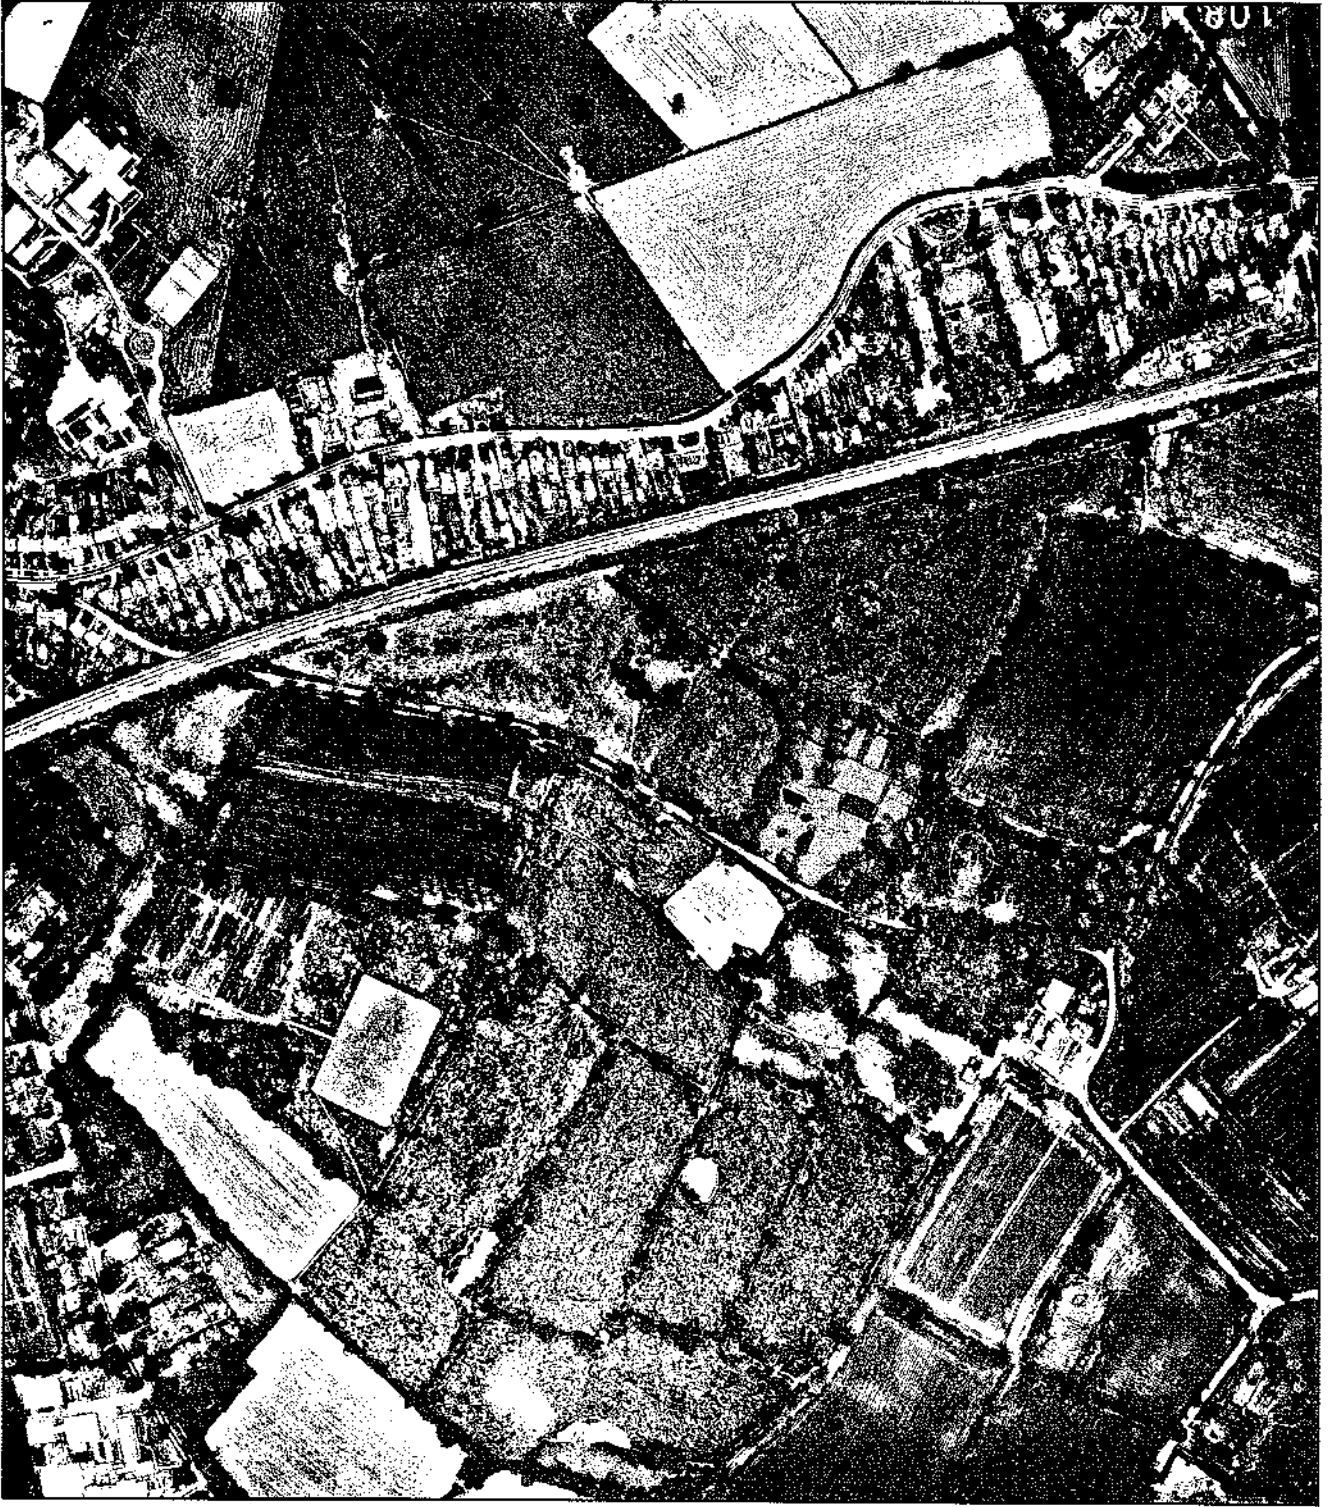
Fig.12

An aerial photograph from 1977 (Fig 12) is not clear enough to discern all of the buildings, but it would appear that the Hall by this time had been massively extended to the south, and the southeastern part of the site had been landscaped for car-parking. The grounds of the Hall are still as large as on the original OS map. The large fishpond is visible to the southwest, but no trace of the moat can be seen on the photograph. The land around the Hall has still not been developed with the modern houses by this time.

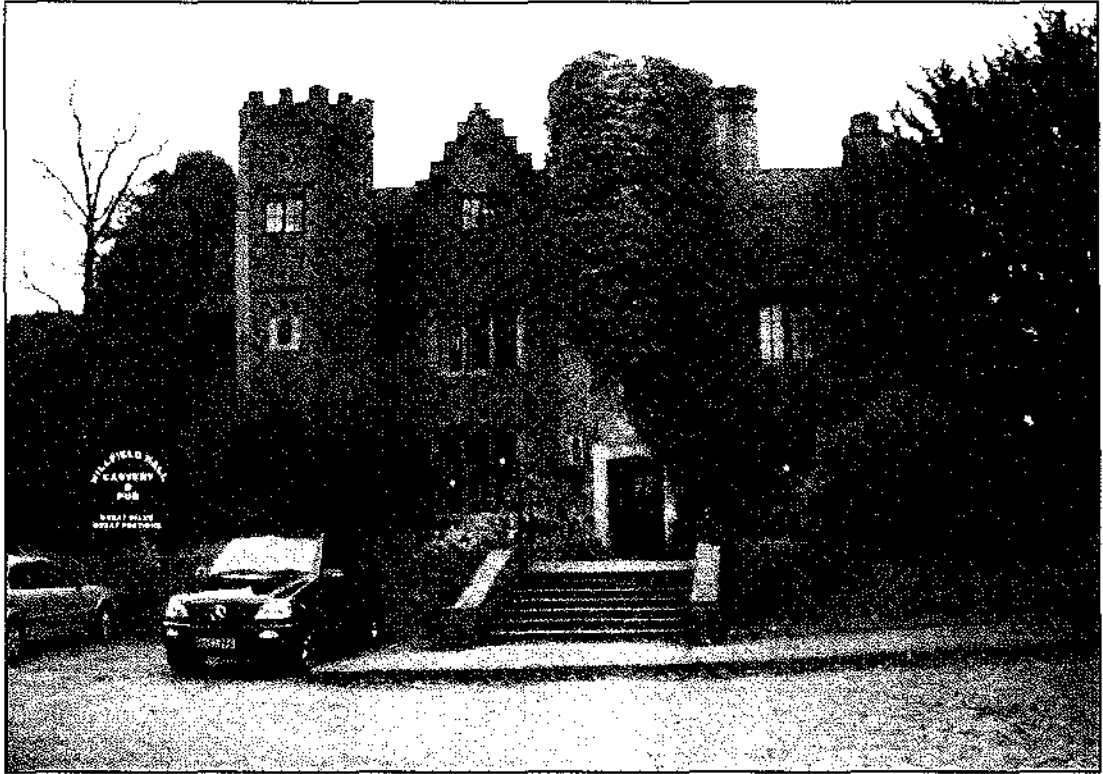
| Plate 1 | The Hall – Showing the 1576 Frontage |

A detailed description of the Hall and its history can be found in Woodall and Varley (1987), but only a brief description is given here. The Hall, three stories high and facing northwest, was constructed from red brick with diaper patterns in blue brick, in the style of a Medieval gatehouse. The front had two octagonal turrets with embattled parapets, with the main entrance through the northern turret. This gave the impression of an imposing looking building, but it was, in fact, only one room deep. Within the main body of the house there were three reception rooms, the hall, two parlours, seven sleeping chambers and a long gallery on the top floor.

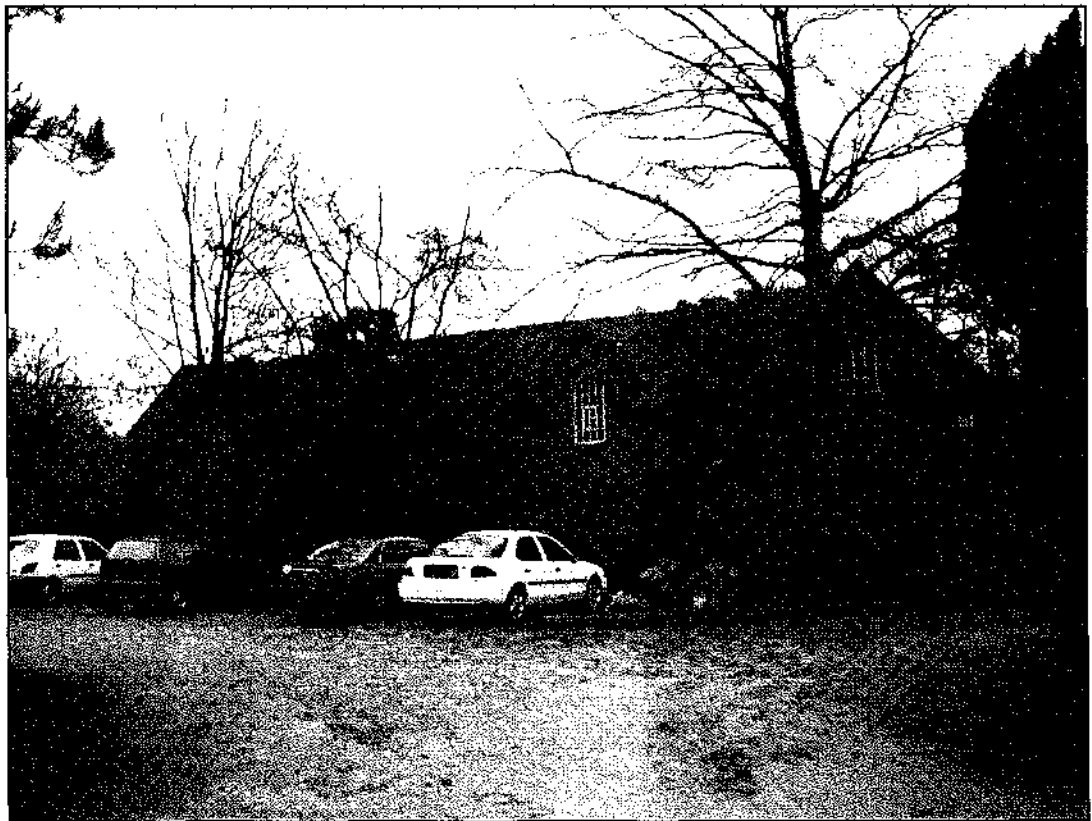
| Plate 2 | The Stables |

To the west of the hall, on the south side of the courtyard, is the old stable block. This block has also been constructed from red brick and is two stories high. At present the stables are not in use, although until recently it was a public house. To the northwest

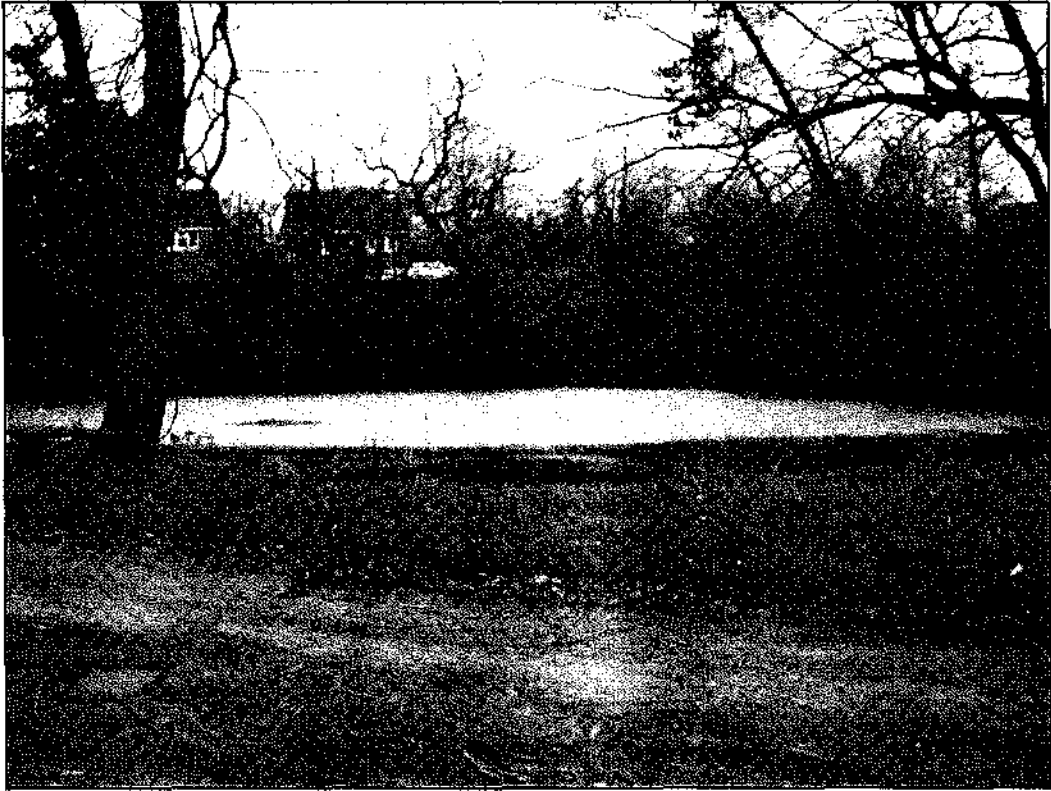
| Plate 3 | The Fishpond in the Southeast Corner of the Site |

To the north of the courtyard is a small wooded area, containing a slight dip in the ground which could be the only visible remains of the medieval moat. To the south and southwest of the stables is an unused tarmaced area and in the southwest corner of the site is a larger pond, possibly the remains of a fishpond. This pond is largely overgrown and has not been maintained. This pond will remain as part of the new development.

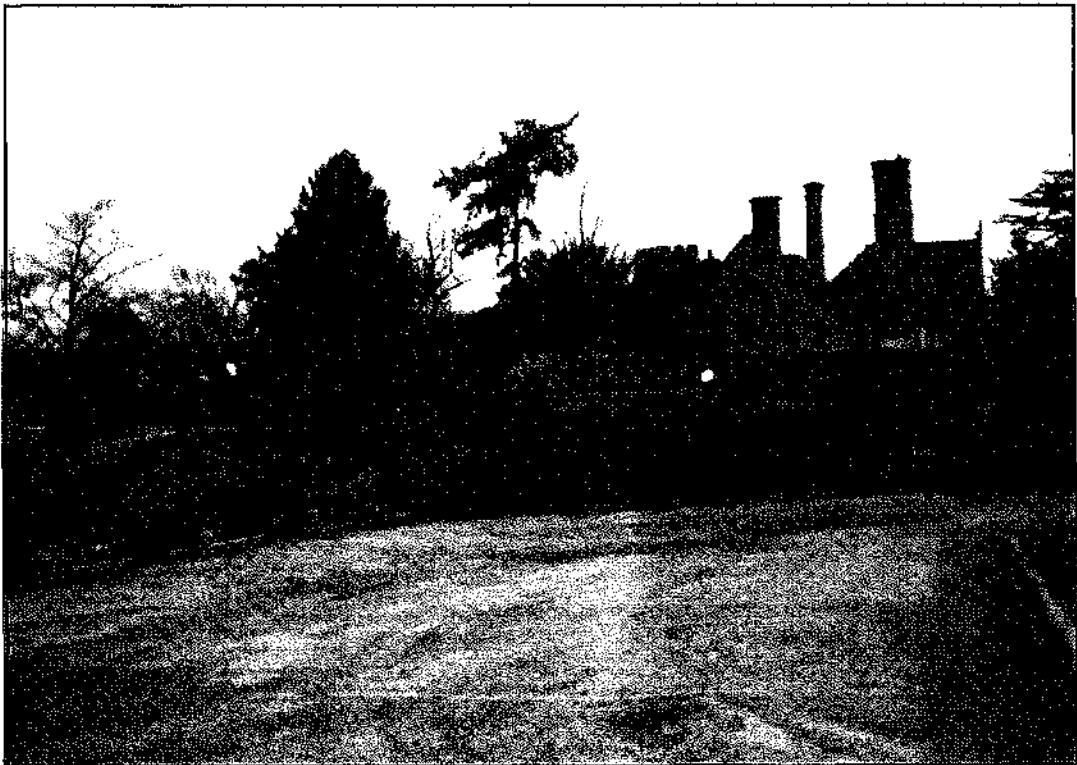
| Plate 4 | The Hall and Stables From the Southwest Corner of the Site, Showing the Car-park and Terracing |

A small brick wall runs from the south west corner of the hall to the southeast corner of the pond, terracing a tarmaced car park in the southeastern corner of the site. This area slopes slightly upwards to the south, and at present seems to be disused. This area will be most heavily developed under the planning proposals. The land surrounding the site has been completely developed with modern housing.
