Dudley Flint Glassworks

Archaeological Investigations at Stone Street Square, Dudley, West Midlands 2003

> by Steve Litherland

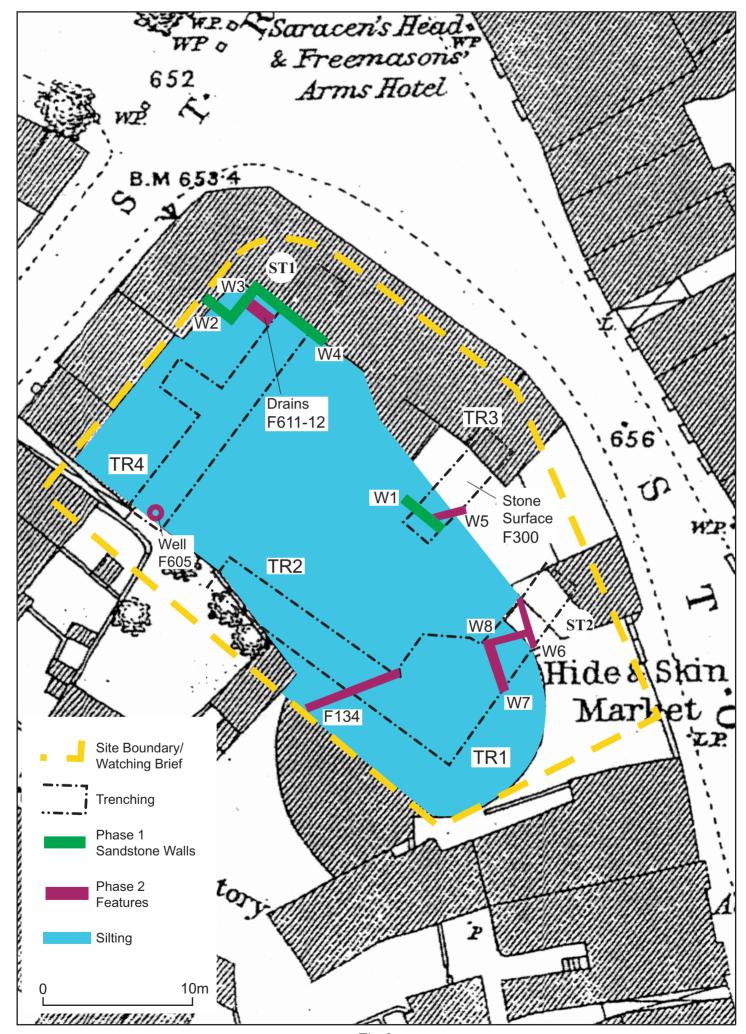
Fig.8

- 7. Extract from the Ordnance Survey 1:500 plan of 1883
- 8. Overall plan of pre-glassworks features (overlaid on 1883 Ordnance Survey plan)
- 9. a. Structure 1 pre-glassworks features

Method (Fig. 8)

Pre-Glassworks (Figs 8-11)

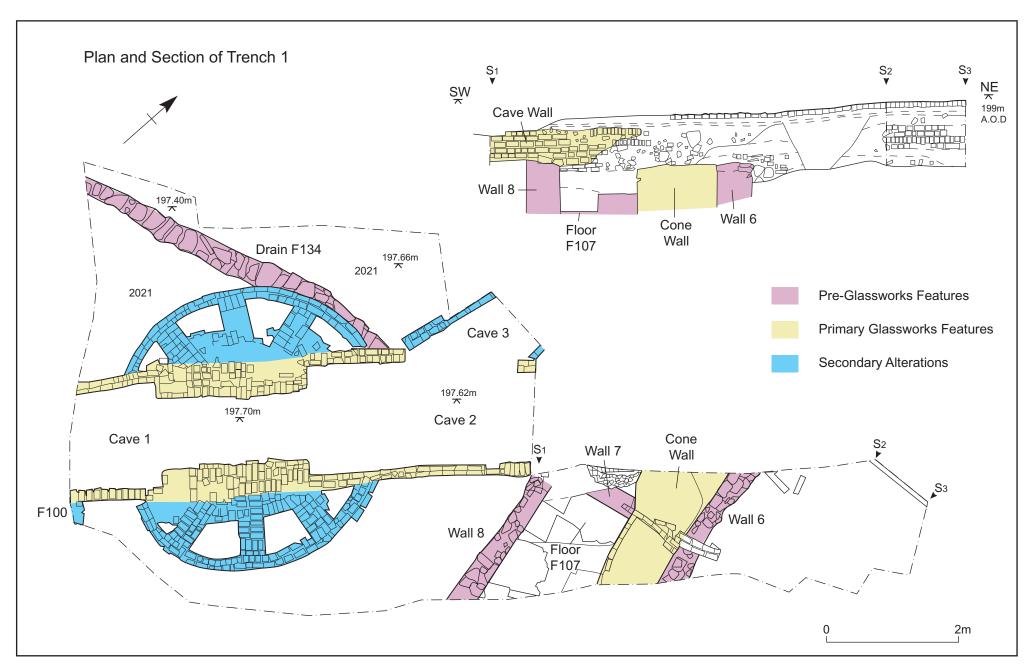
Fig.10

- b. Incorporation of Structure 1 into the Stone Street Range of the glassworks
- 10. Plan and section (S1-S3) of Trench 1
- 11. North-east facing section of Trench 2

The below-ground components of the furnace were largely intact although all remnants of the floor, superstructure and stoking arrangements had been destroyed. Like the cave system there was further evidence of extensive alterations to the furnace structure that were probably associated with the 1801 rebuild noted above. These alterations involved the construction of two semi-circular siege bases, one on either side of the central fire stacks, but while the main cave system was incorporated into the later furnace, any evidence for the primary furnace arrangement was destroyed. The foundations for the circular furnace were probably cut through the levelling deposits (2017, 2019, Fig. 11)

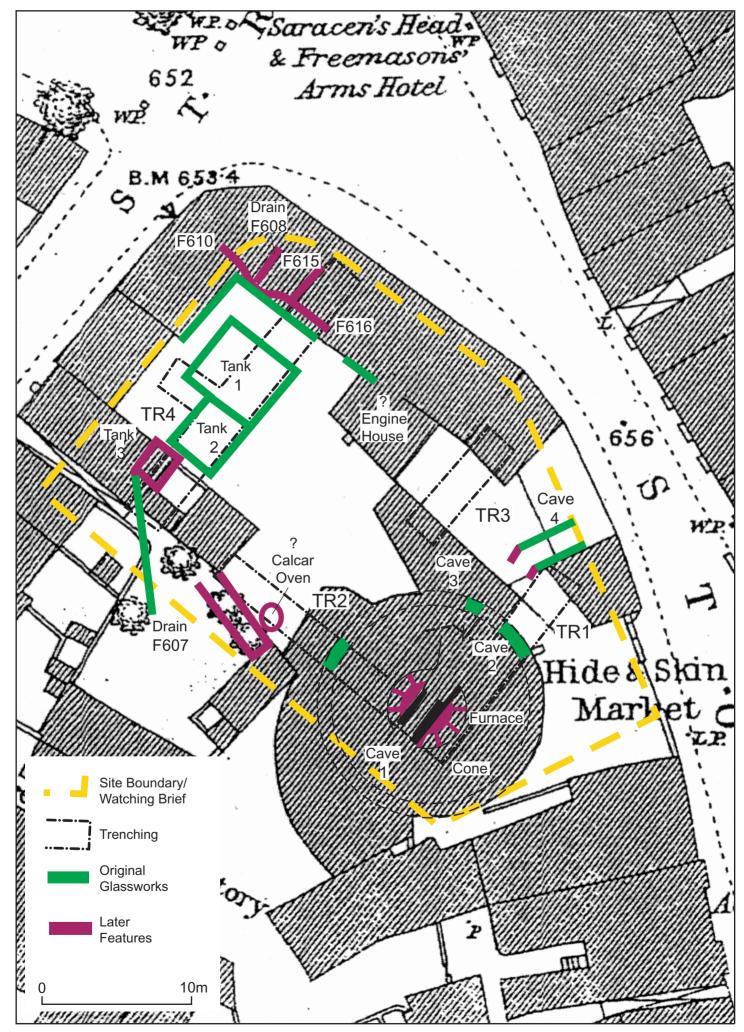
Fig.12

- 12. Overall plan of glassworks features (overlaid on 1883 Ordnance Survey plan)
- 13. Interpretation of the glassworks
- 14. Diderot and D'Alembert's drawings of an English-style cone glasshouse

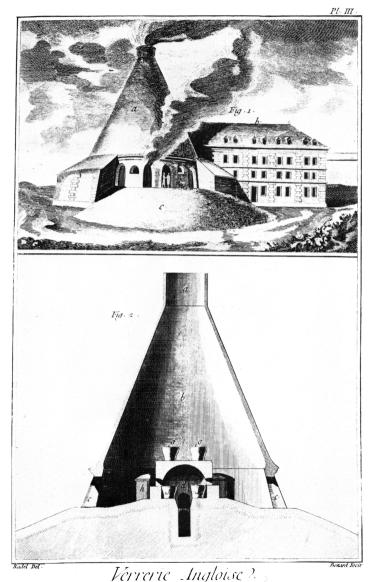
Exterior view and section of a 'verrerie Angloise' – an English-style cone glasshouse – from Diderot and D'Alembert's encyclopaedia. a, b = interior 'chimney' of cone building; f = crucibles on sieges; g = crucibles drying off on roof of furnace; h = annealing arches.

design, and has been found at glass cones elsewhere, for example the Red House (Fig. 16) and the illustration of the 'Verrerie Angloise' in Diderot and D'Alembert's 'Encyclopedia' (Fig 14). However, it has become increasingly apparent as more excavations are conducted that the design of flue structures within glass cones was very idiosyncratic, and that it is difficult to generalise or infer too much from particular examples. What can be said unequivocally is that Cave 3 was cut into the build of Cave 2. This implies that the later alterations incorporated substantial parts of the original 10-pot furnace and cave system. The size of the bricks used in the Cave 3, which were $3\frac{1}{2}$ inches tall, probably means that they were made before 1803. This was when the brick tax was revised to make any brick that was larger than 10 by 5 by 3 inches when it came out of the mould liable to a double duty.

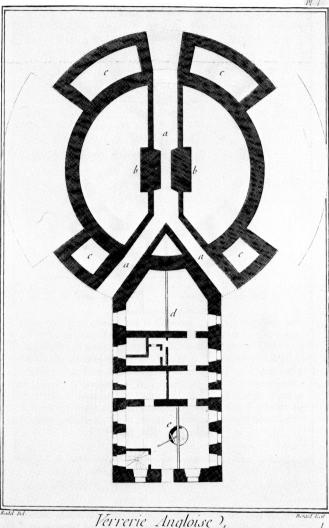
Plan of the foundations of an English cone glasshouse, showing the three large flues (a) which feed air from the outside to the central coal-fired furnace. (b) indicates the siege foundations, and (c) the annealing furnace foundations. From Diderot and D'Alembert's encyclopaedia.

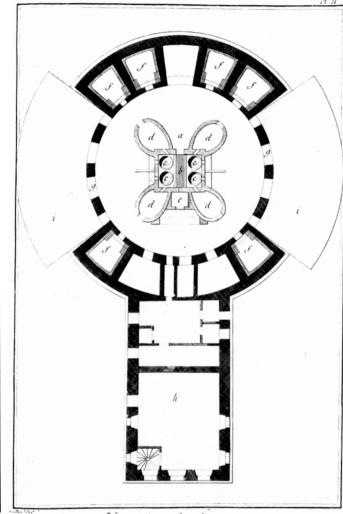
Plan of the ground floor of an English cone glasshouse showing the central four-pot furnace with an iron grill (b) for burning coal fuel between the sieges. (c) indicates the crucibles, and (d) the pot-arches. Four wing furnaces were used for firing pots before they were placed in the main furnace, and a small fritting oven (e) is also attached to the main furnace. Six annealing furnaces (f) flank the walls of the cone. Also visible are the linnet holes for conducting heat from the main to the wing furnaces. From Diderot and D'Alembert's encyclopaedia.

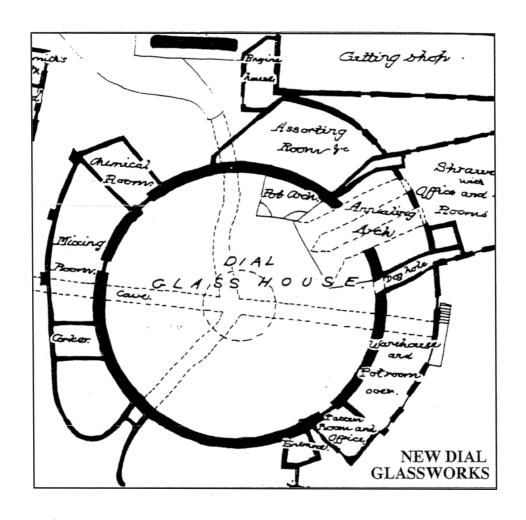
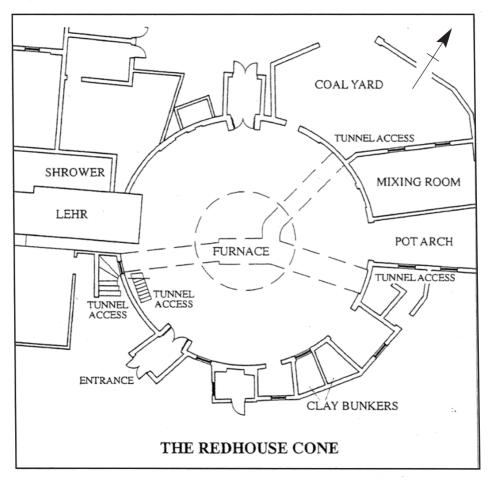
Fig.16

Comparative Ground Plans of the Red House and New Dial Glasshouses.

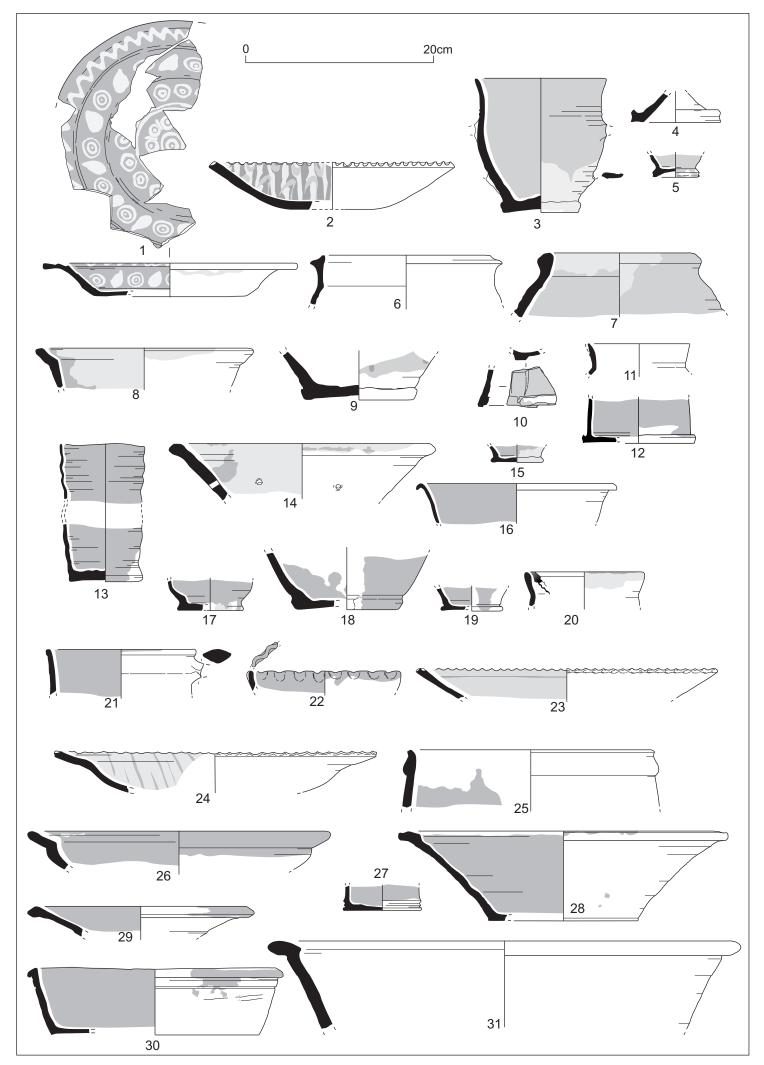
Fig.20

- 20. The Pottery

documentary record (see Appendix 1), must remain open. However, analysis of the pottery (see Appendix 2 and Fig. 20) found a significant quantity of misfired wasters or semi-wasters to be prevalent in late 17th and early 18th-century contexts that may be indicative of pottery production somewhere in the vicinity at this time.

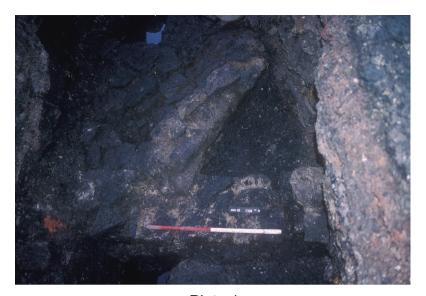
Plate 1

- 1. Detail of Wall 1 overlain by Wall 5, Trench 3, looking north east
- 2. Stone surface (F300), Trench 3, looking south west
- 3. Sandstone walling (Structure 1) overlain by brick walls of the Stone Street Range of the glassworks with curved wall (F610) in foreground

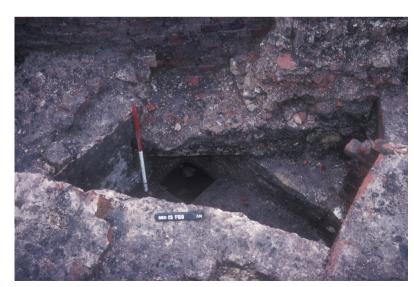
Plate 4

- 4. Sandstone walling, floor and drain of Structure 2 surviving between the brick-built foundations of the glassworks, Trench 1, looking north
- 5. Sandstone drain (F134) and with glass furnace built over, Trench 1, looking east

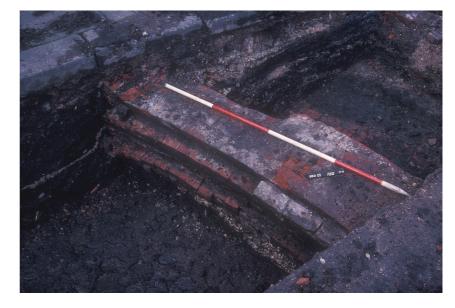
Plate 6

- 6. Detail of cone wall foundations
- 7. General view of furnace and associated flue system, looking south west
- 8. Junction of Flue 2 and furnace, looking west

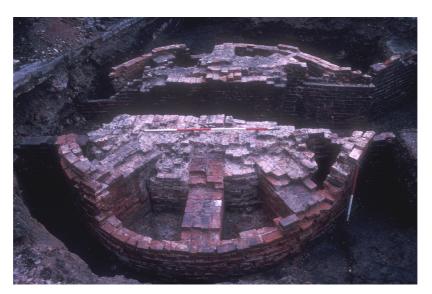
Plate 11

- 9. Junction of Flue 2 and Flue 3, looking east
- 10. Detail of Flue 4, looking north east across Stone Street
- 11. Detail of furnace base, looking north west

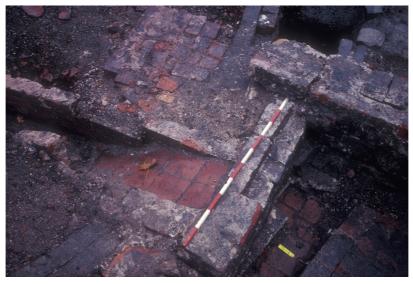
Plate 12

- 12. Detail of drain (F608)
- 13. General view of the tanks and Priory Street frontage, looking north west
- 14. Detail of Tank 1
- 15. View of Tank 3, well (F605) and drain (F607), looking north

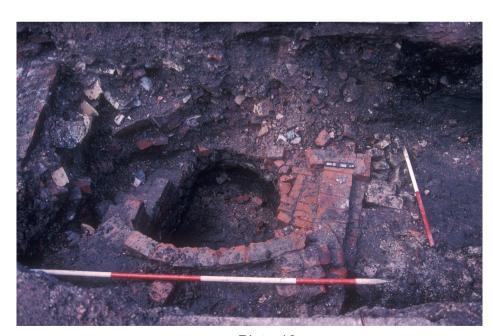
Plate 16

- 16. Detail of ?calcar oven (F201), Trench 2
