**Himley Hall, Himley,
Staffordshire**

**Archaeological Watching Brief
March 2003**

Birmingham University Field Archaeology Unit
Project No. 1033
March 2003

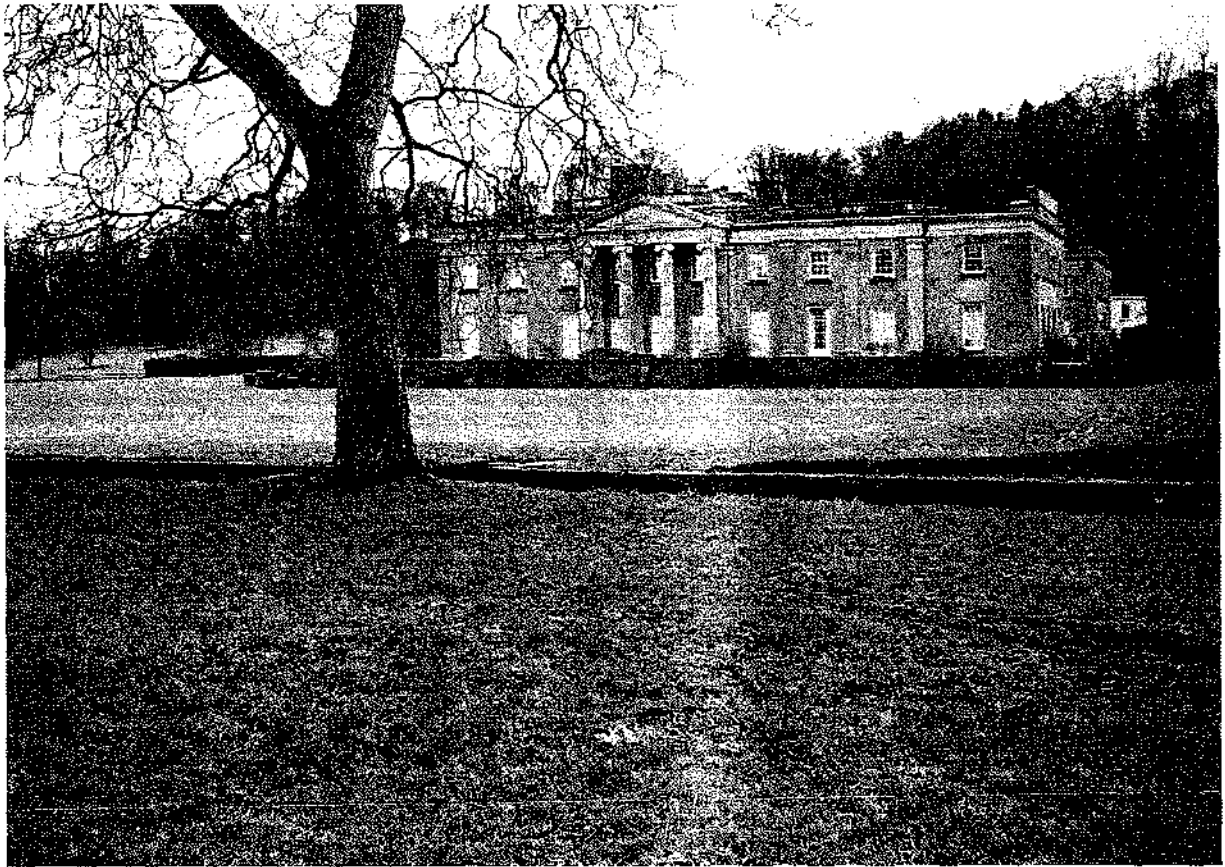
Plate 1

Himley Hall (Plate 1) is believed to occupy the site of a former medieval moated manor house (SMR 01149). An etching by Stebbing Shaw (Plate 2), dating to around 1735, depicts a large house occupying the platform, rising directly from the moat, with a wide water filled moat on three sides at least. The house is shown as having a westerly aspect and was reached by a permanent brick or stone bridge across the moat. The manor house, and the Barony of Birmingham, was inherited in 1740 by John Ward of Sedgley. He

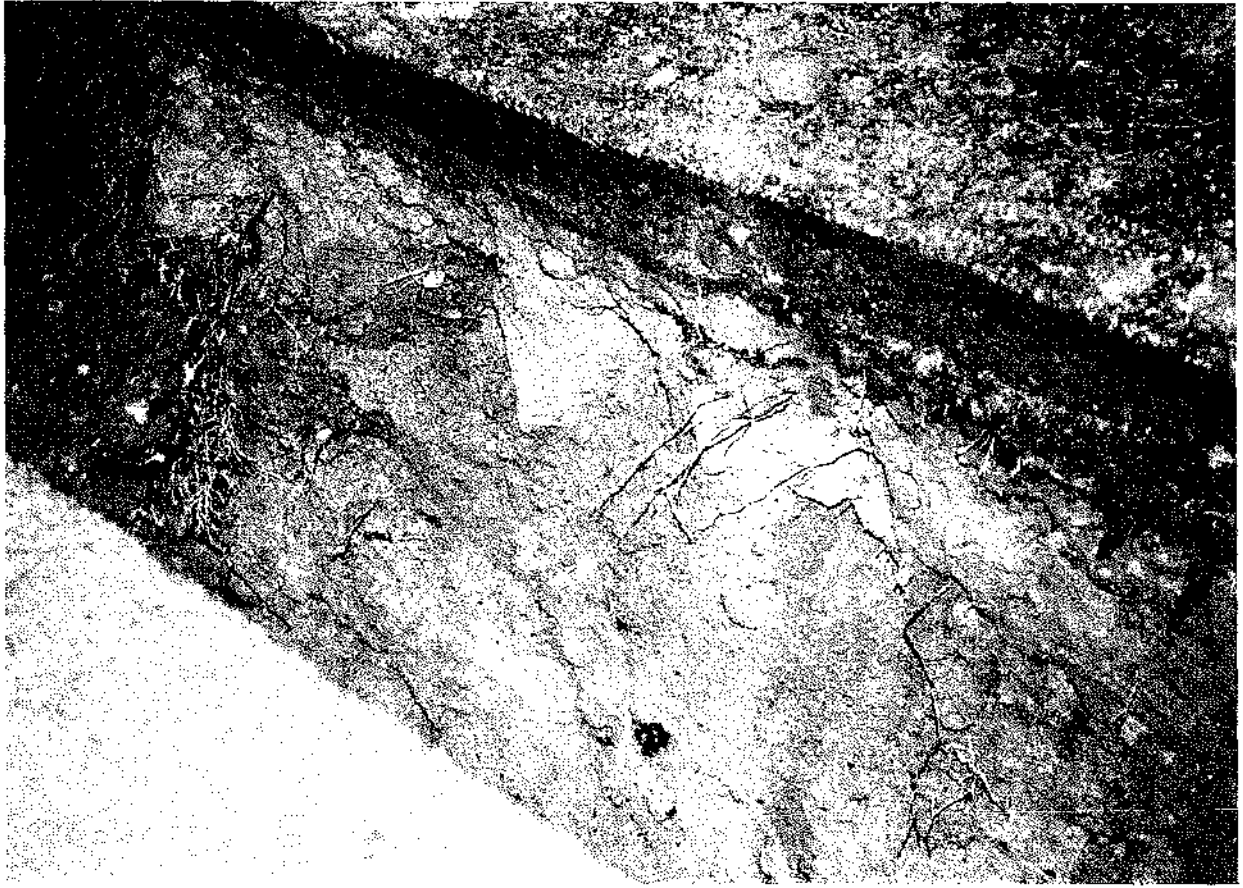
Plate 3

The earliest layer encountered in Trench 2 was a red sandy layer (2007). At the base of the trench, and cut into layer 2007, a number of sandstone blocks (F200, Fig. 3), which were part of a robbed out wall, were observed projecting slightly from beneath the east facing section. The blocks were unworked, or roughly hewn, and had been covered in a thick deposit of mortar (2006). The mortar and sandstone blocks had been sealed by a layer of red/brown sand (2004) which included charcoal flecks, brick and tile fragments, pieces of slate and lumps of mortar. Layer 2004 was overlain by a band of dark ashy sandy silt (2003), which formed a levelling layer for a floor, made from a single course of crudely made bricks (2005). The bricks were spaced out along the section with only their corners projecting, suggesting a herringbone pattern for the floor (Plate 3). The brick layer had been sealed by a mix of sand and pebbles (2002) containing modern glass bottles, over which was a band of hardcore (2001) sealed by modern tarmac.
