**Shipton's Wharf, Albion Street,
Wolverhampton:
An Archaeological Building
Record, 2003**

Project No. 1040
September 2003

By
Malcolm Hislop and Richard Cherrington

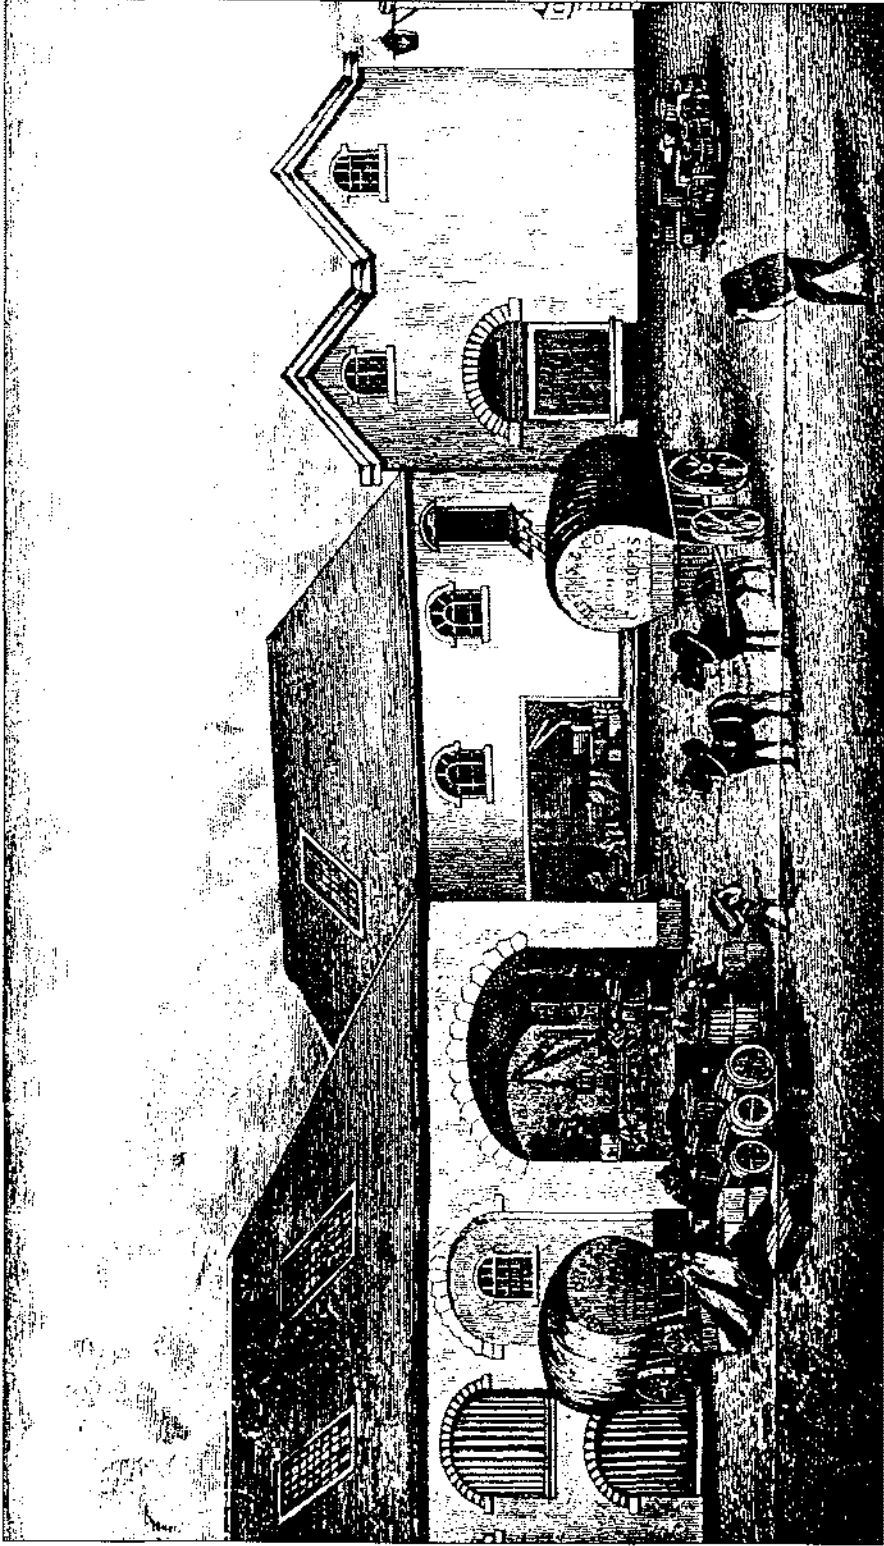
Fig.3

The *terminus ante quem* for the construction of buildings E and F, both of which were covered wharves and warehouses, was established as the year 1833, when both structures were depicted in an advertisement (Fig. 3). Building E was raised by Henry Pratt, presumably sometime before December 1831 when the site later known as the Albion Wharf was purchased from him by James Shipton who established a general carrying business there. It was Shipton himself who raised Building F as a grain warehouse. Building G, which was part of the Shipton's Wharf complex lying immediately to the south of Building E, was built between 1871 and 1883 (Litherland Morriss and Nichols 2001, 4).

To the left (west) of the left-hand jamb a sandstone impost survived, its cast face apparently representing the position of the jamb of an original opening (Plate 1). At first floor level sandstone imposts survived on both sides, in each case accompanied by the first few voussoirs of an elliptical arch made of wedge-shaped 14" gauged bricks, grooved to suggest joints. The rest of the arch had been destroyed by the insertion of the loading hatch, but the remnants suggest a low elliptical arch. The structural evidence, then, points to the central recess having evolved from two separate arched openings, one at ground and one at first-floor level. The drawing of 1833 corroborates such an arrangement (Fig.3).

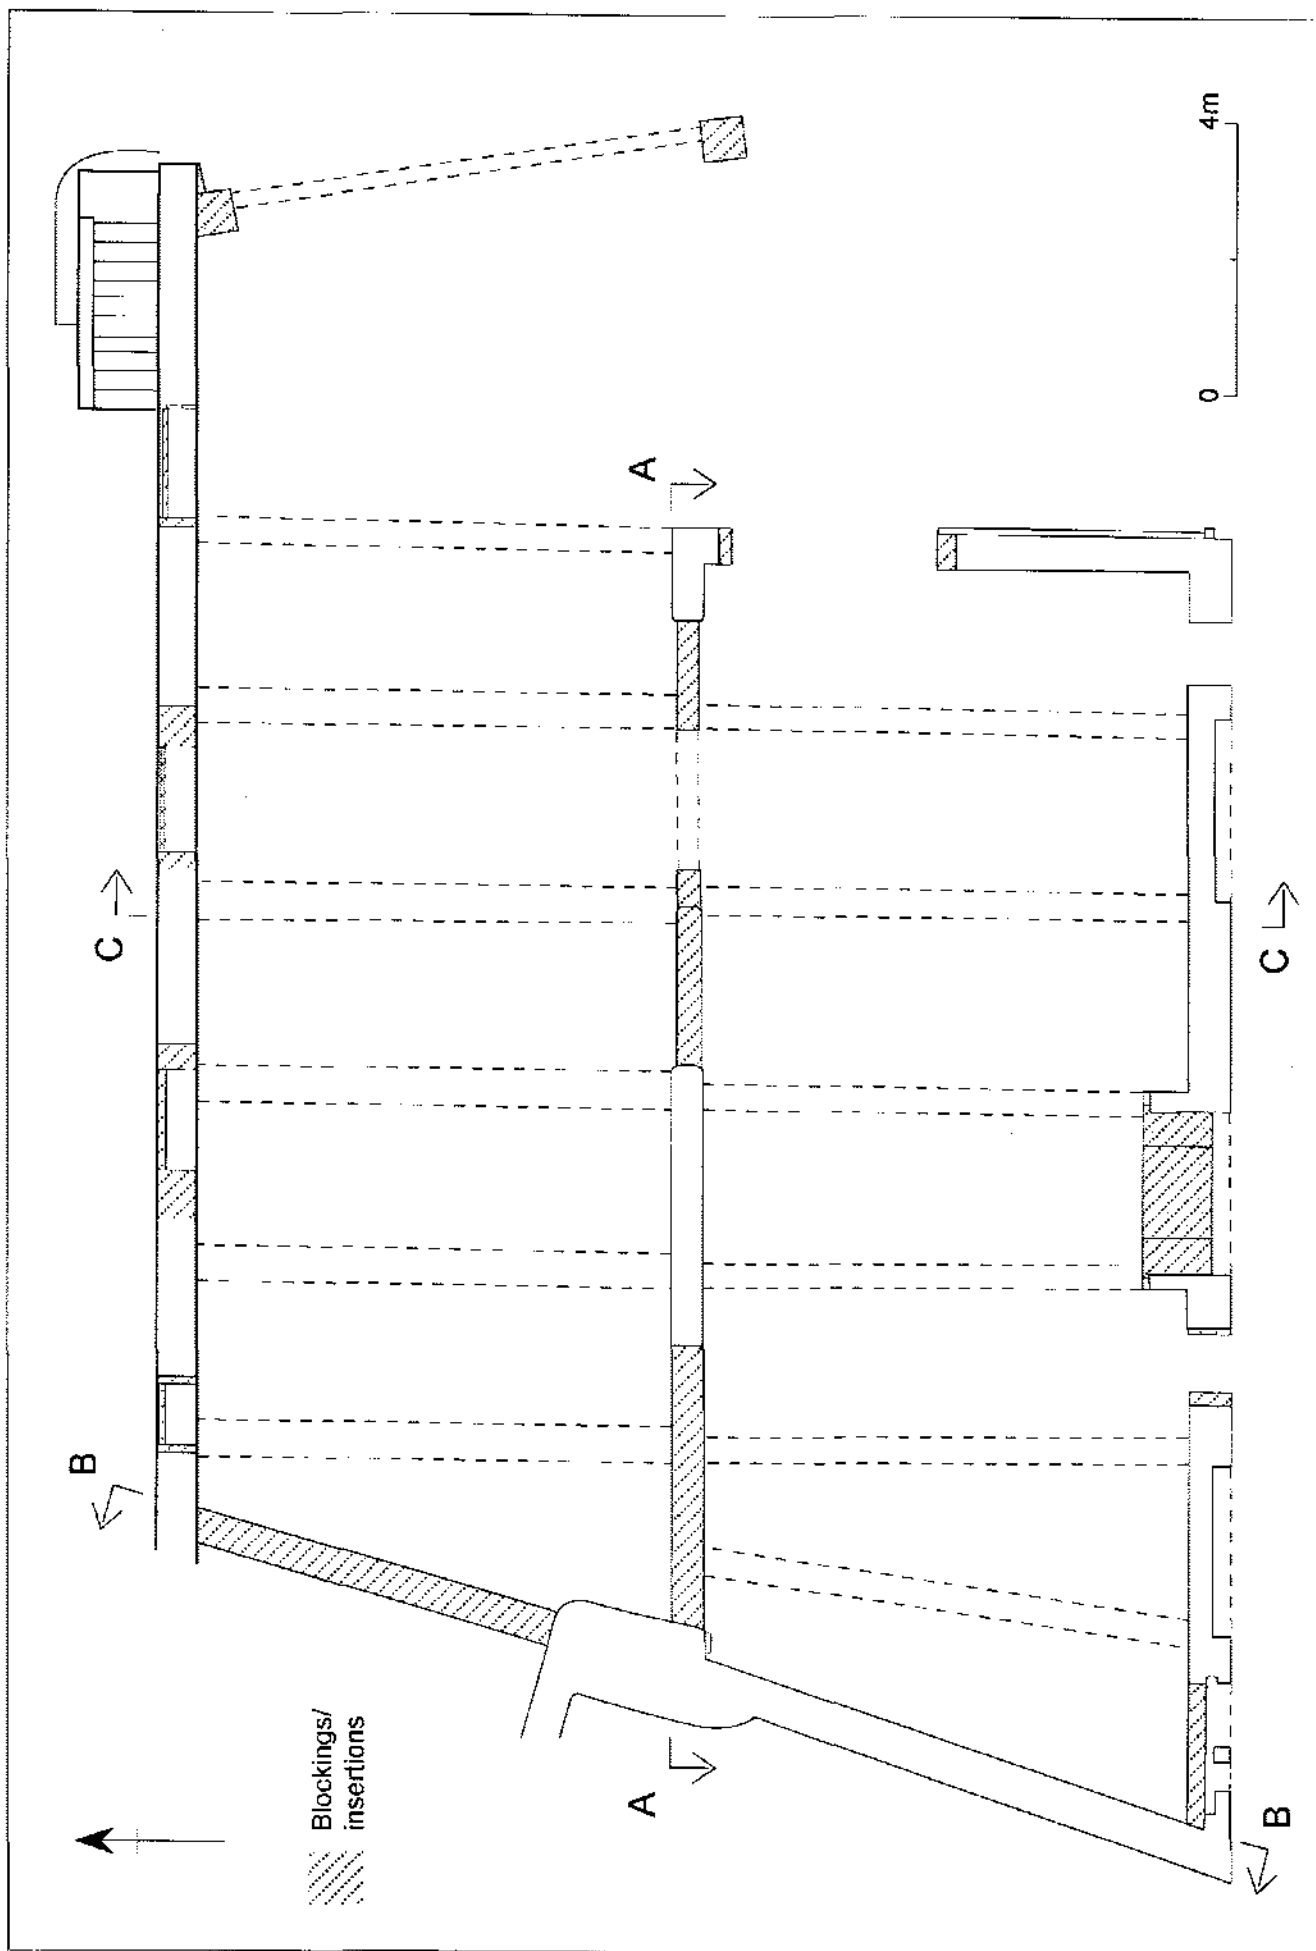
Fig.4 Building E, ground plan

Building E was a two-storey structure with walls of 9" x 4 $\frac{3}{4}$ " x 2 $\frac{1}{2}$ - 3" red bricks laid in a mixture of Flemish bond and English garden wall bond, and a hipped plain tile roof. Aligned east-west, with the principal front towards the Albion Street yard to the south, the building had an irregular trapezoidal plan (Fig. 4 and 5).

The greater part of the interior was divided longitudinally by a spine wall into the former canal basin to the north, and the former wharf to the south. The concrete floor of the former wharf was 0.88m below the level of the yard to the south, but judging by the height of the Gothic doorway at the west end of the elevation (2.10m) the yard level had not been built up to any great extent. On the south side of the wharf, immediately behind the central recess of the south elevation, was a projection containing two blocked openings, the blocked doorway visible on the south elevation, and an earlier, wider opening probably connected with the stone impost to the south and part of the original build. The evidence suggests a hatch and platform for the loading and unloading of goods.

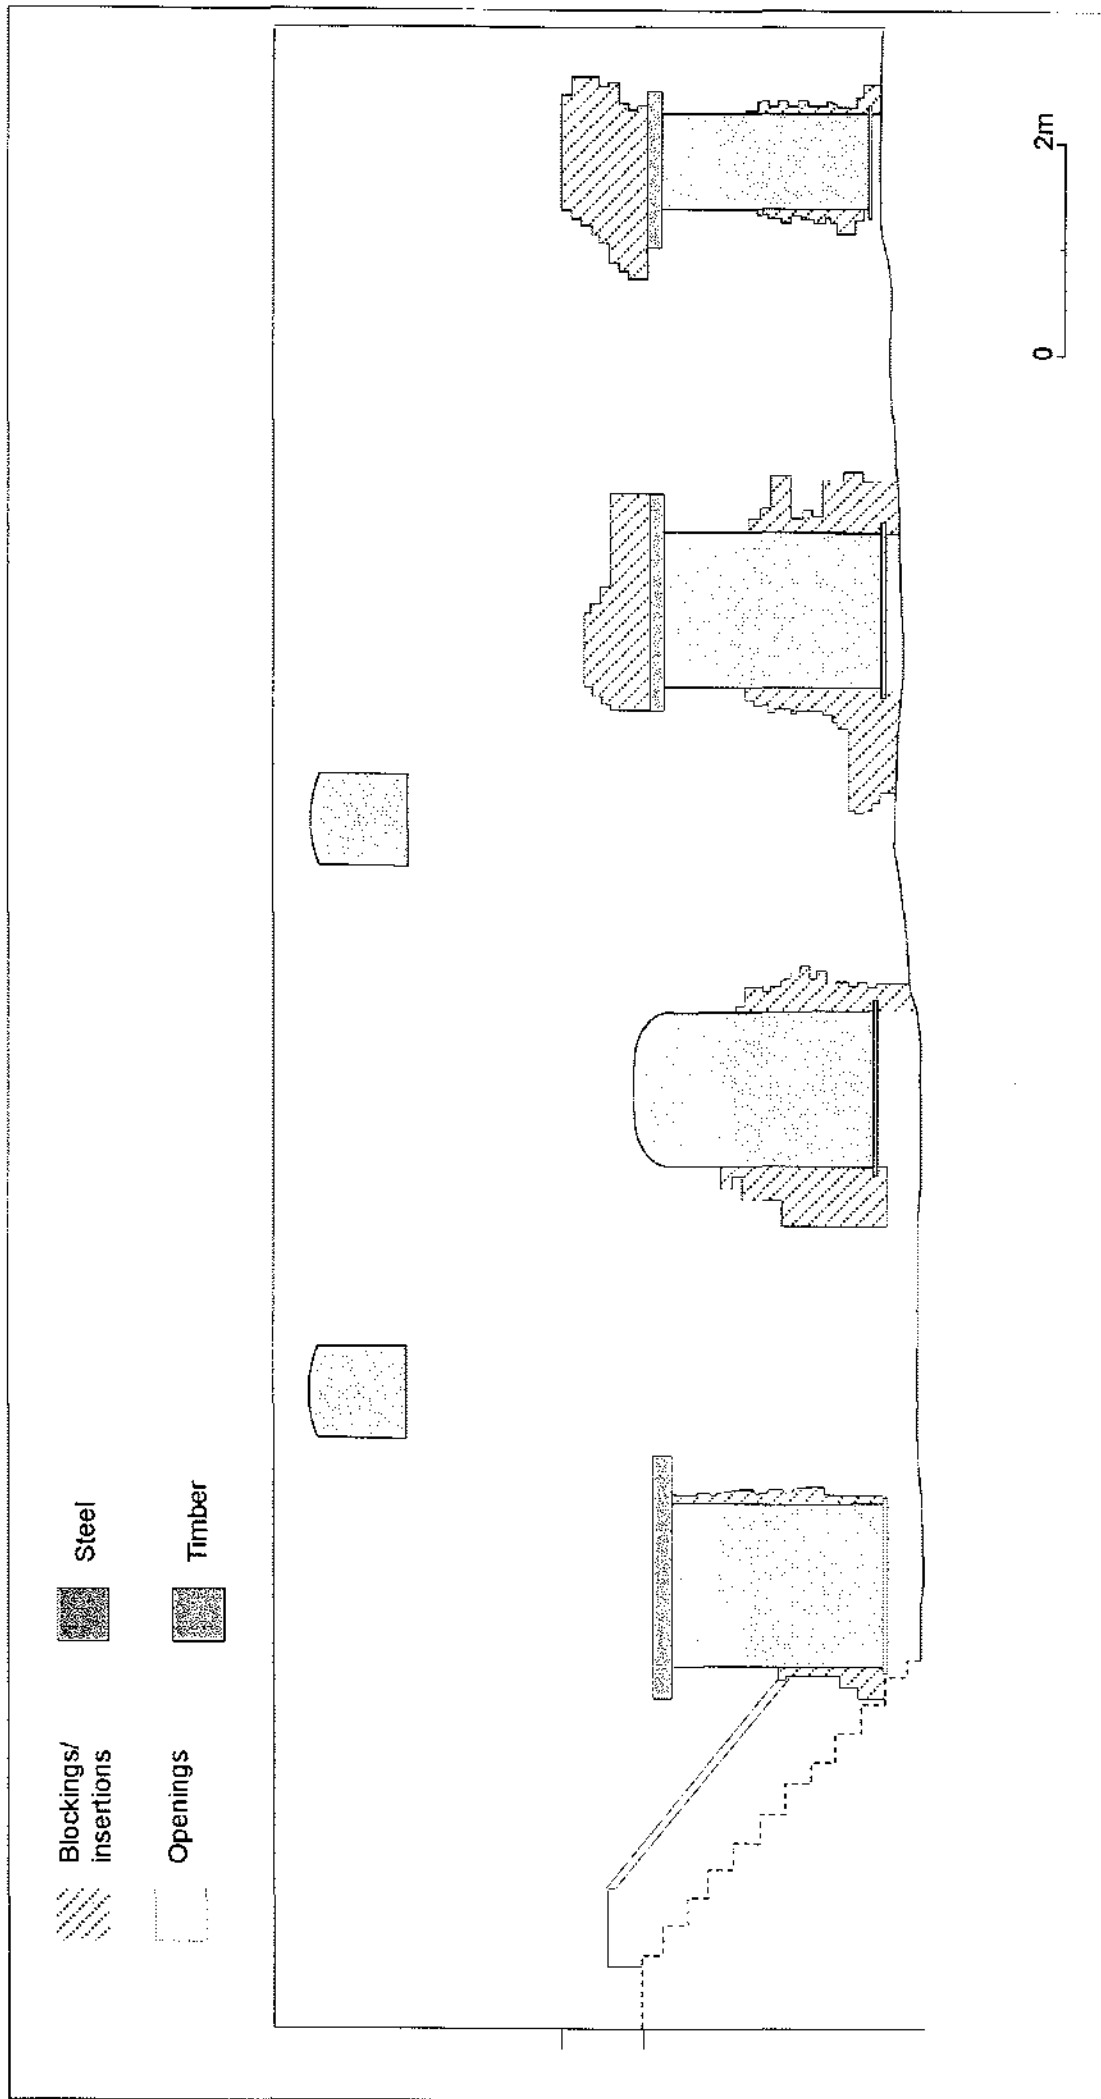
Fig.7 Building E, north facing elevation

The north wall of Building E, towards the canal, was built in English garden wall bond (two stretchers to one header) and had a stepped brick eaves band. There were four windows at ground level. The left-hand (east) one, which had a steel lintel, was an insertion, the next to the right (west) retained the basket arch and the upper jambs of an original opening, though the lower jambs had been rebuilt. The other two both had wooden lintels, and although fragments of the original jambs survived, both windows had been substantially enlarged. There were two small first-floor windows with segmental heads. At the right-hand (west) end of the elevation was a straight joint with the adjacent building. At the left-hand (east) end of the elevation was a flight of steps leading to first floor level, though it was not obvious what it communicated with. Only one stone survived from the original parapet coping, which had been rebuilt in brick.

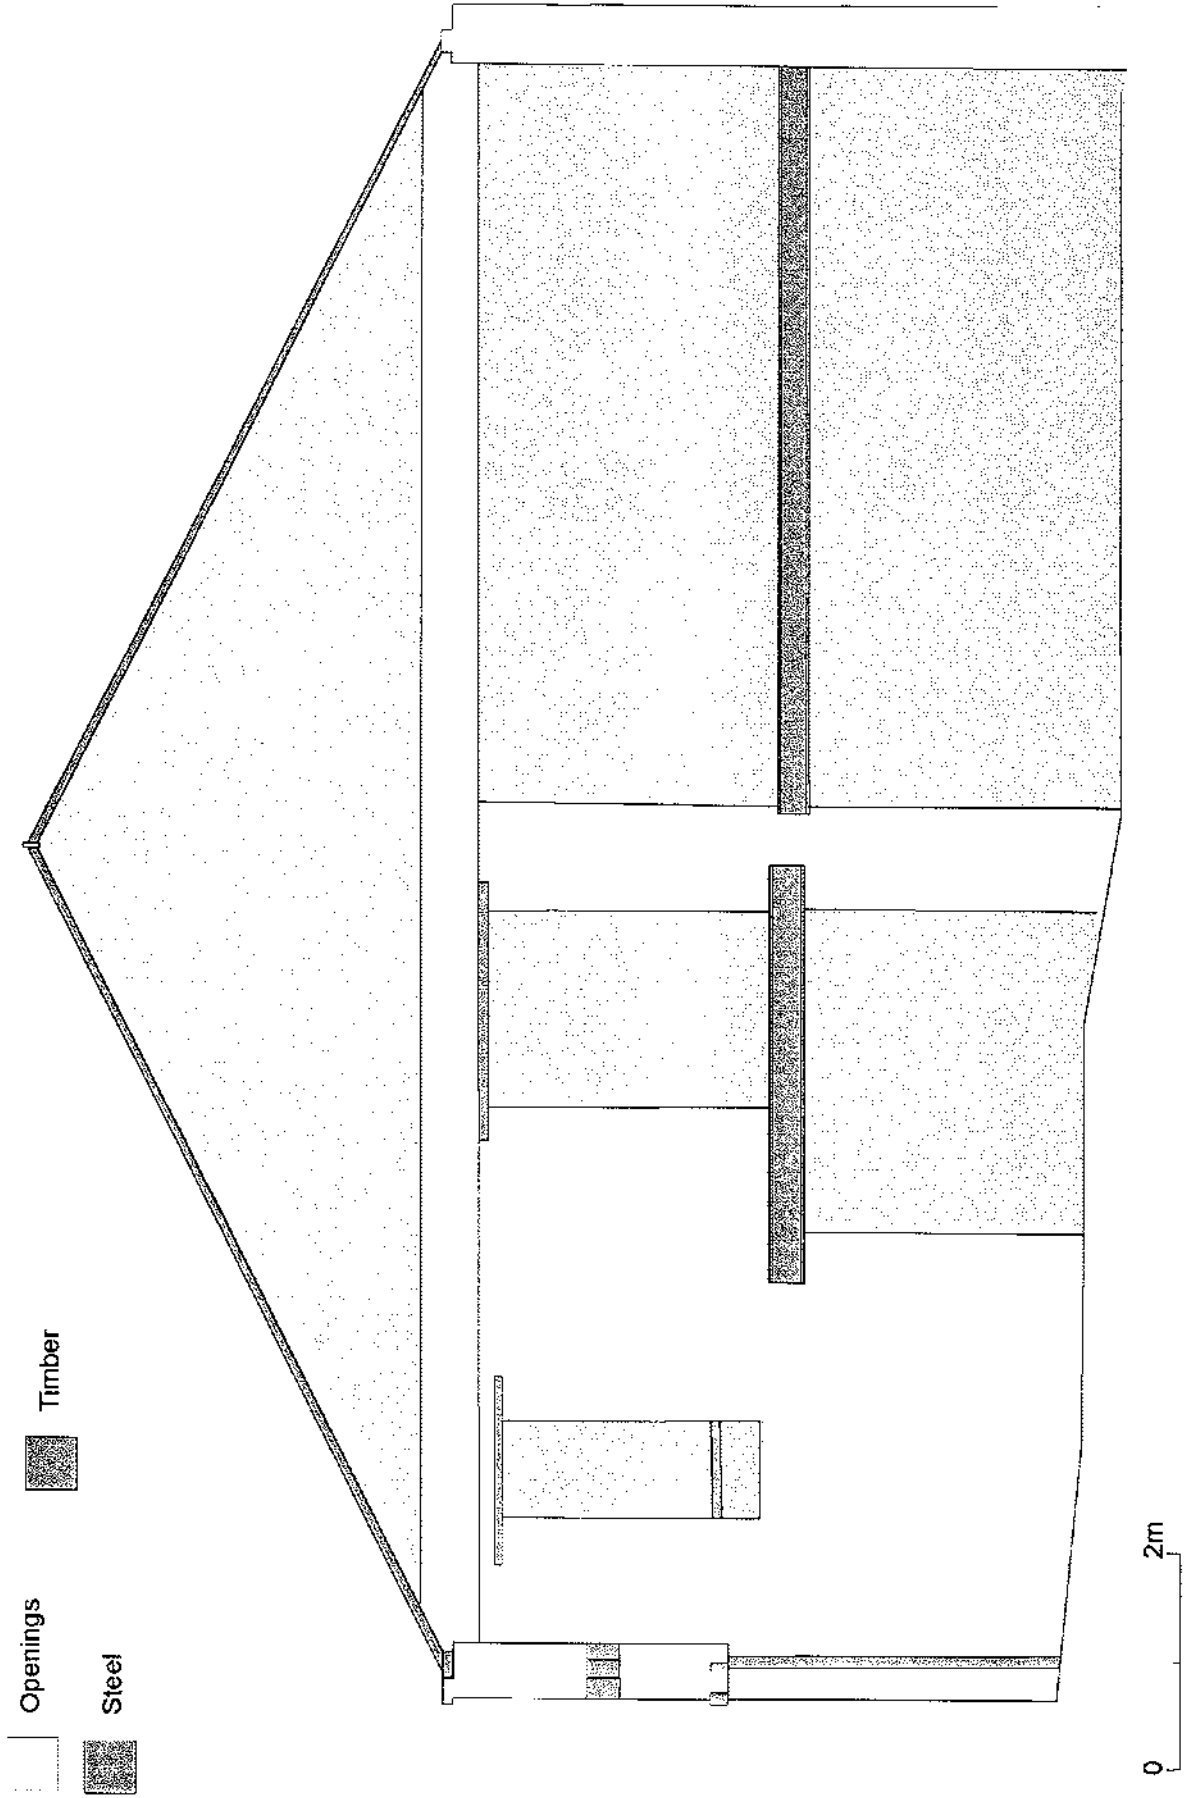
Fig.9 Building E, east facing elevation

The spine wall contained two large loading bays, both with timber sills and lintels, giving access to the canal basin (Fig. 9). The left-hand one was 6.46m wide and partially blocked, in at least three phases. The right-hand one was 6.82m wide and blocked in two phases. In the west wall of the northern room, which formerly contained the canal basin, was the blocked opening with rounded corner and high segmental arch (superseded by an I-beam) that allowed the barges ingress to the next building (Fig.10, Plate 3). It was evident that the canal basin area was originally open to the roof, as the first floor that was in existence at the time of the survey cut across the arch, proving that it was an insertion.

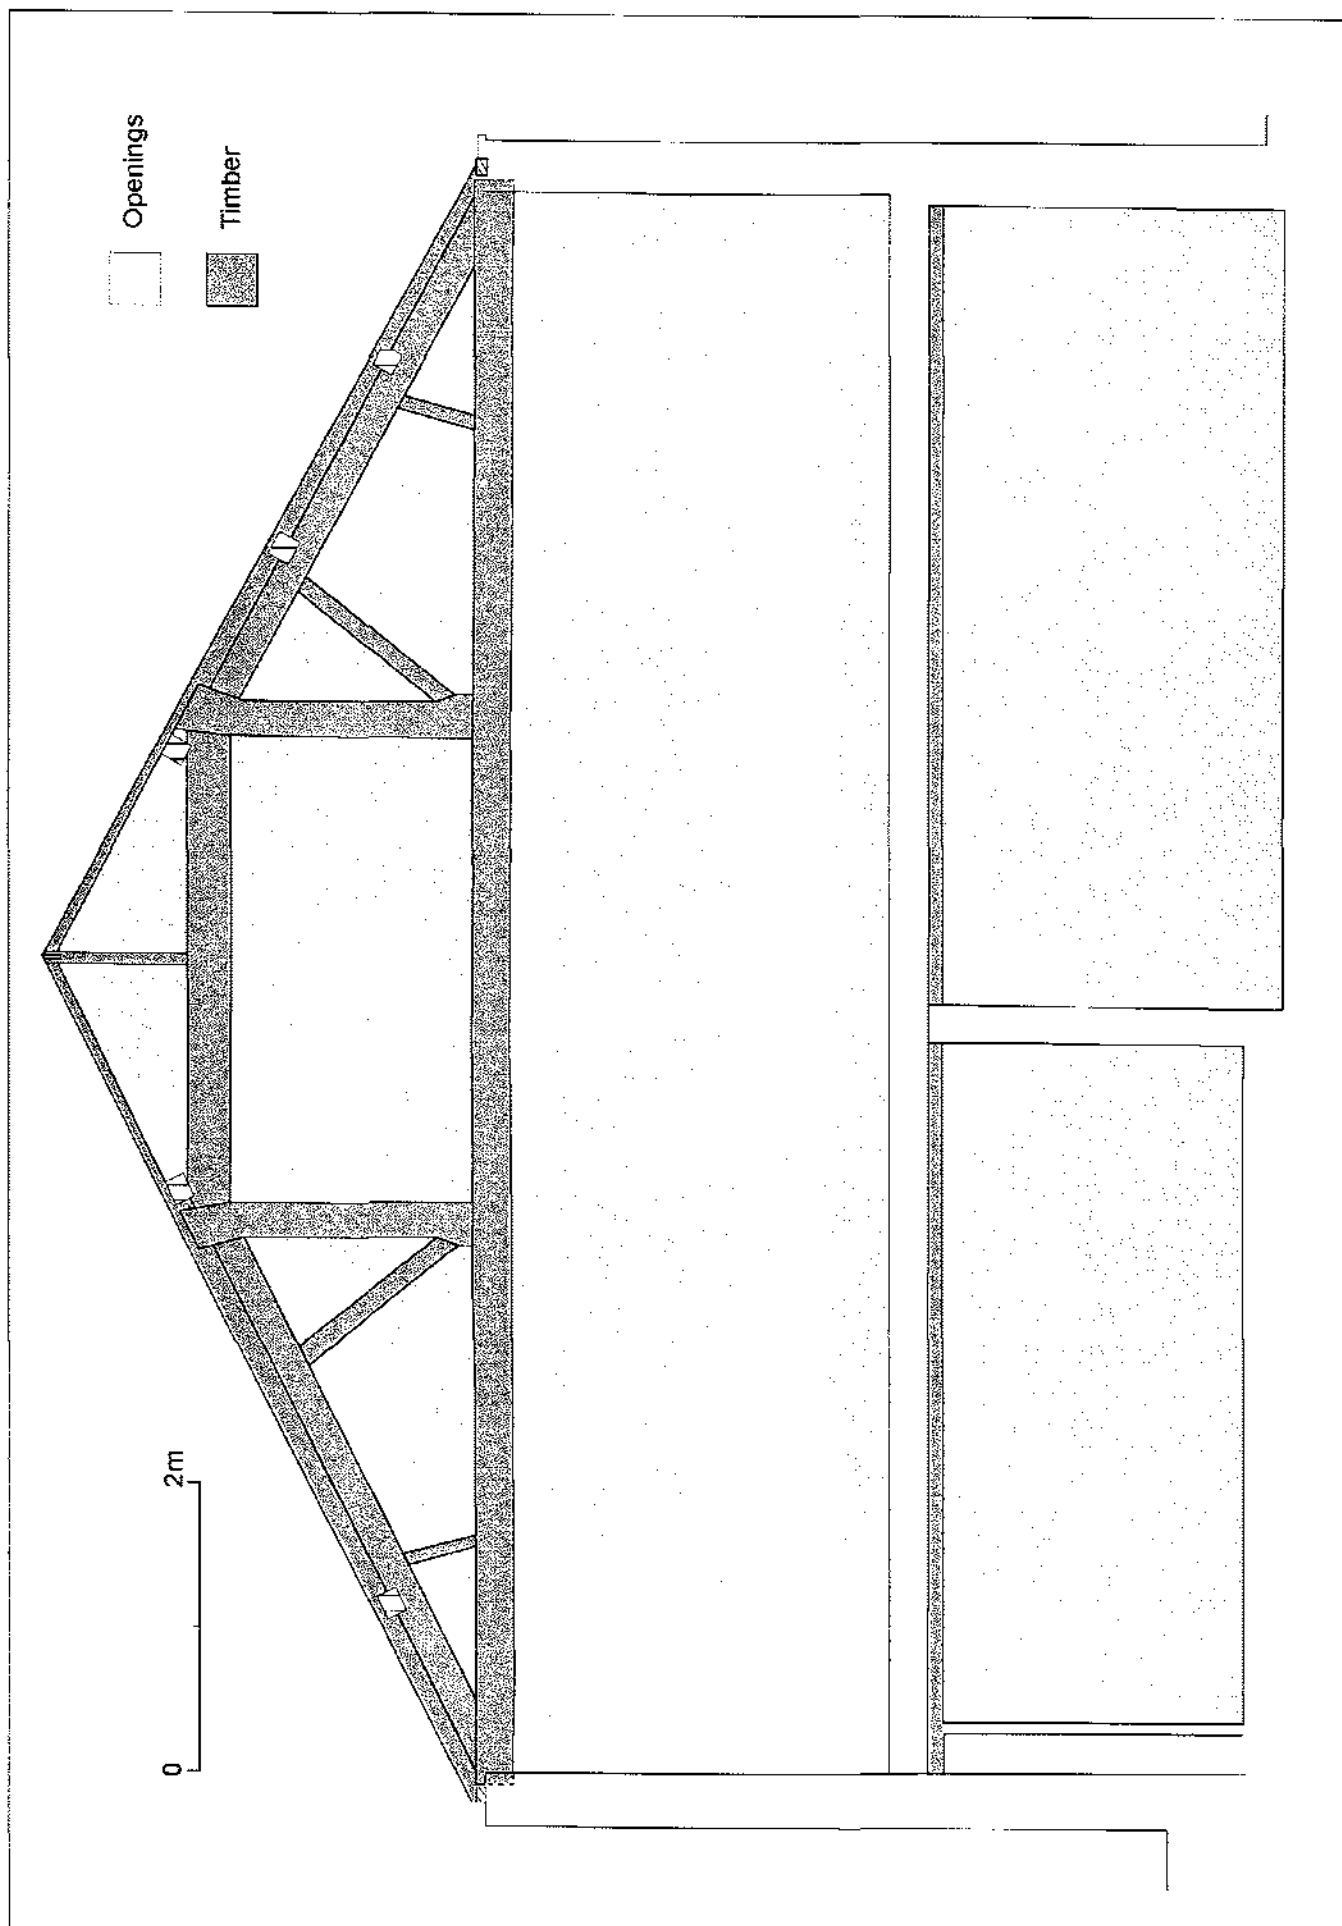
Fig.11 Building E, section C-C

The roof was supported by a series of queen post trusses with principals extending only as far as the queen posts carrying three pairs of purlins. A collar held between the queen posts supports a plank ridge (Fig. 11). On the north side of the building the tie beams carried a timber plate on top of which paired timbers was raised to create a continuous pattern or serrations of unknown purpose (Plate 5).

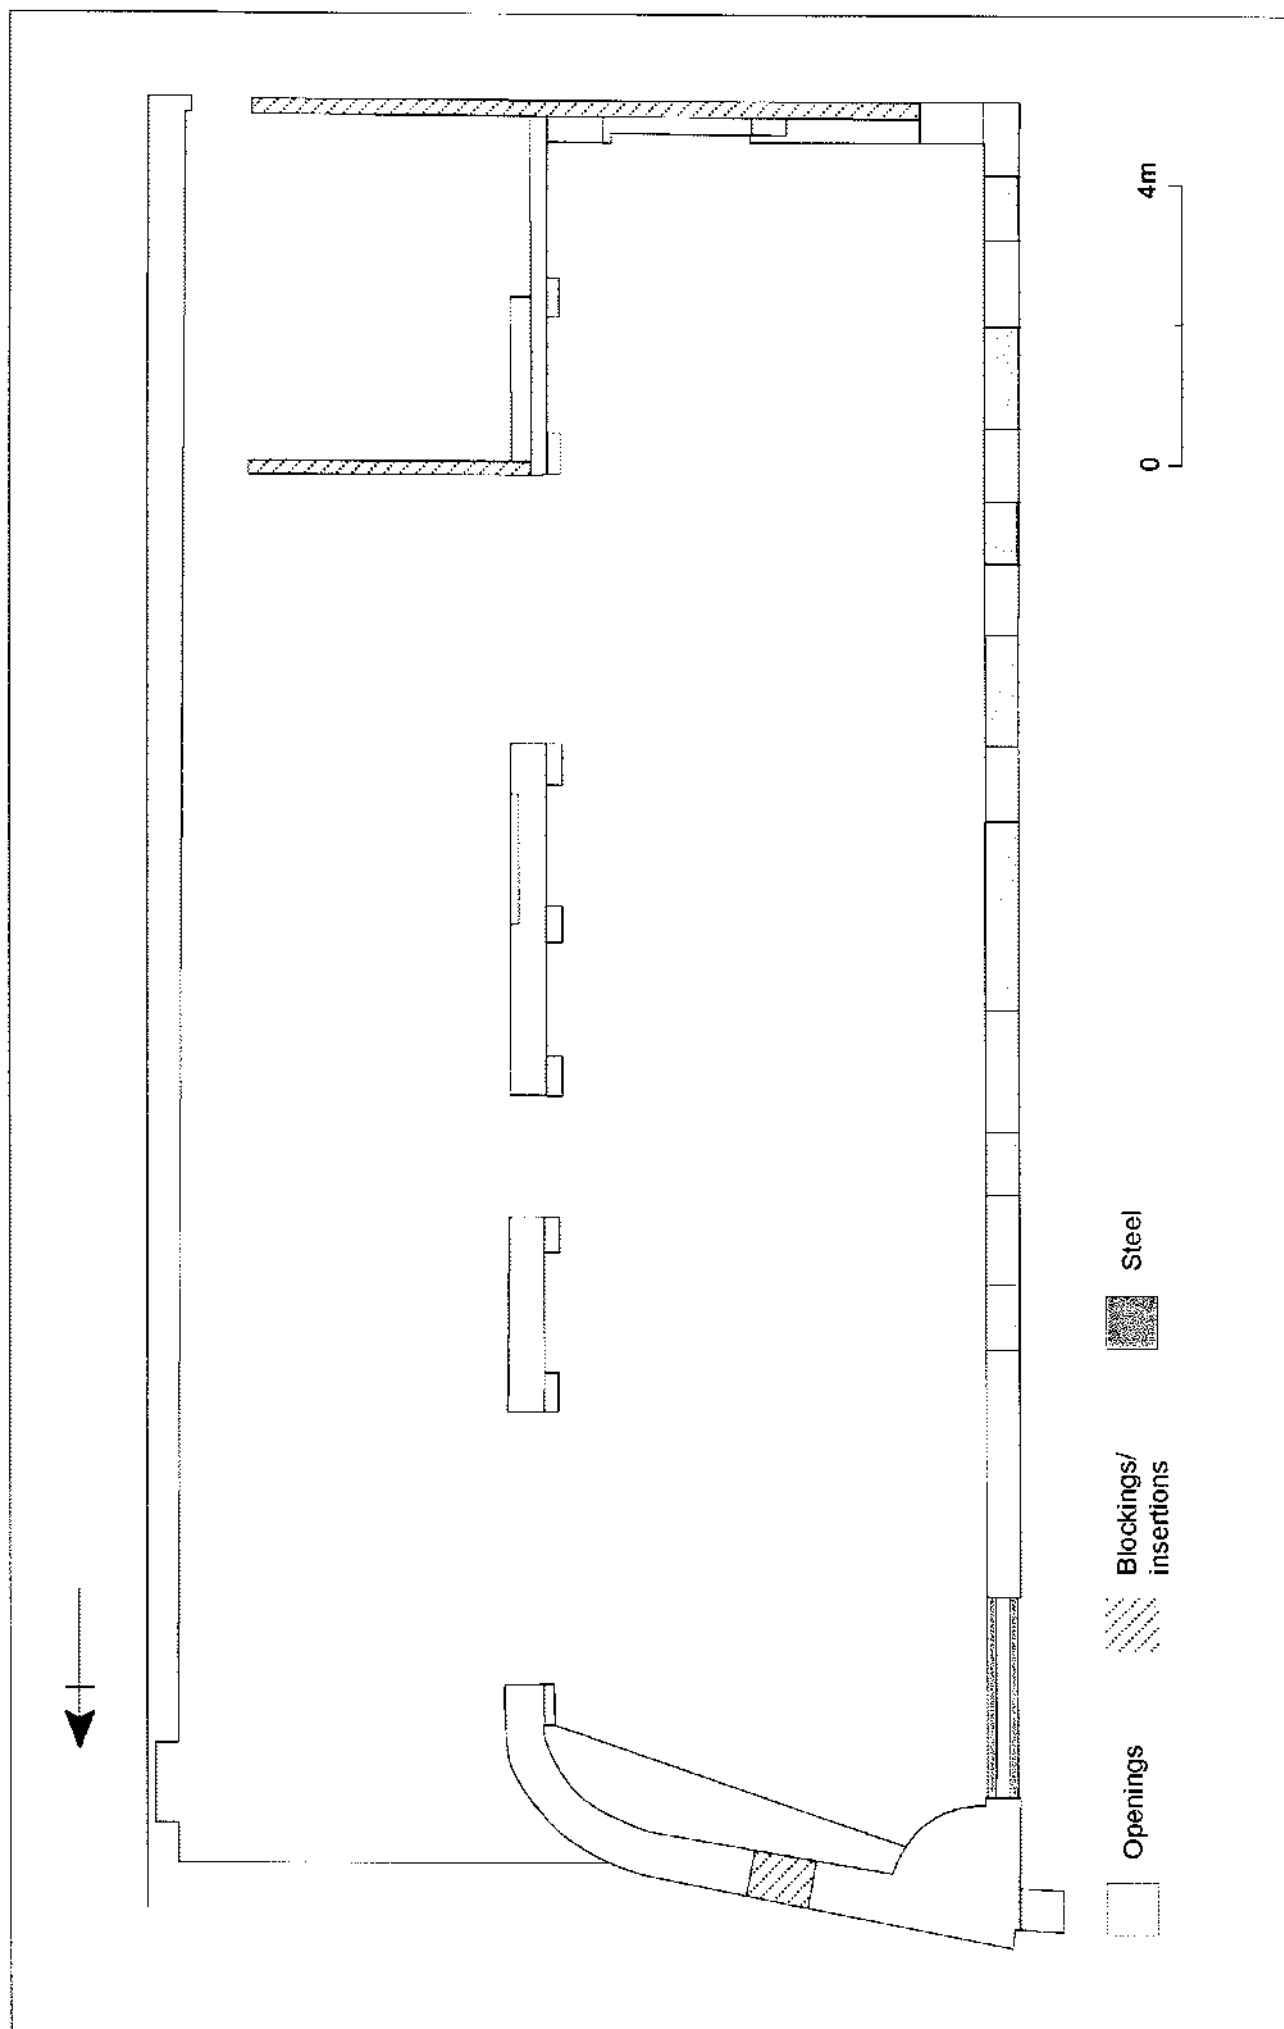
Fig.12 Building F, ground plan

Building F was constructed in 9¾" x 4¼" x 2¼" red brick laid in English bond, and had a hipped plain tile roof. It was a two-storey structure on the east side of the yard, aligned roughly north-south. Although essentially rectangular in plan the north end comprised two faces and was indented at the junction of the two (Figs. 12 and 13).

The concrete floor of the ground storey was 1.05m below the floor level outside the building to the south and west (Plate 7). There were two large rooms at this level, divided from one another by a spine wall, the loading platform or wharf to the west and the former canal basin to the east. This spine wall contained two large open loading bays approximately 4m wide, and two smaller openings to the left (north) of centre, and at the south end (blocked).

A number of alterations to the original fabric were evident. Firstly, a number of brick piers had been built along the west side of the spine wall, mostly butting against the wall though some had been bonded. In each of these piers was the embedded end of a truncated I-beam. There were corresponding features in the opposite (west) wall, suggesting that they supported an inserted floor (later removed). Approximately 0.2m above the tops of these I-beams was a 'dirt line', perhaps indicating the former floor level, 1.35m above the current one. This theory is supported by the character of the central opening, which had been lined with planks from the level of the 'dirt line' upwards. The brick piers also supported I-beams over each of the two large loading bays, and carried the beams for the upper floor.

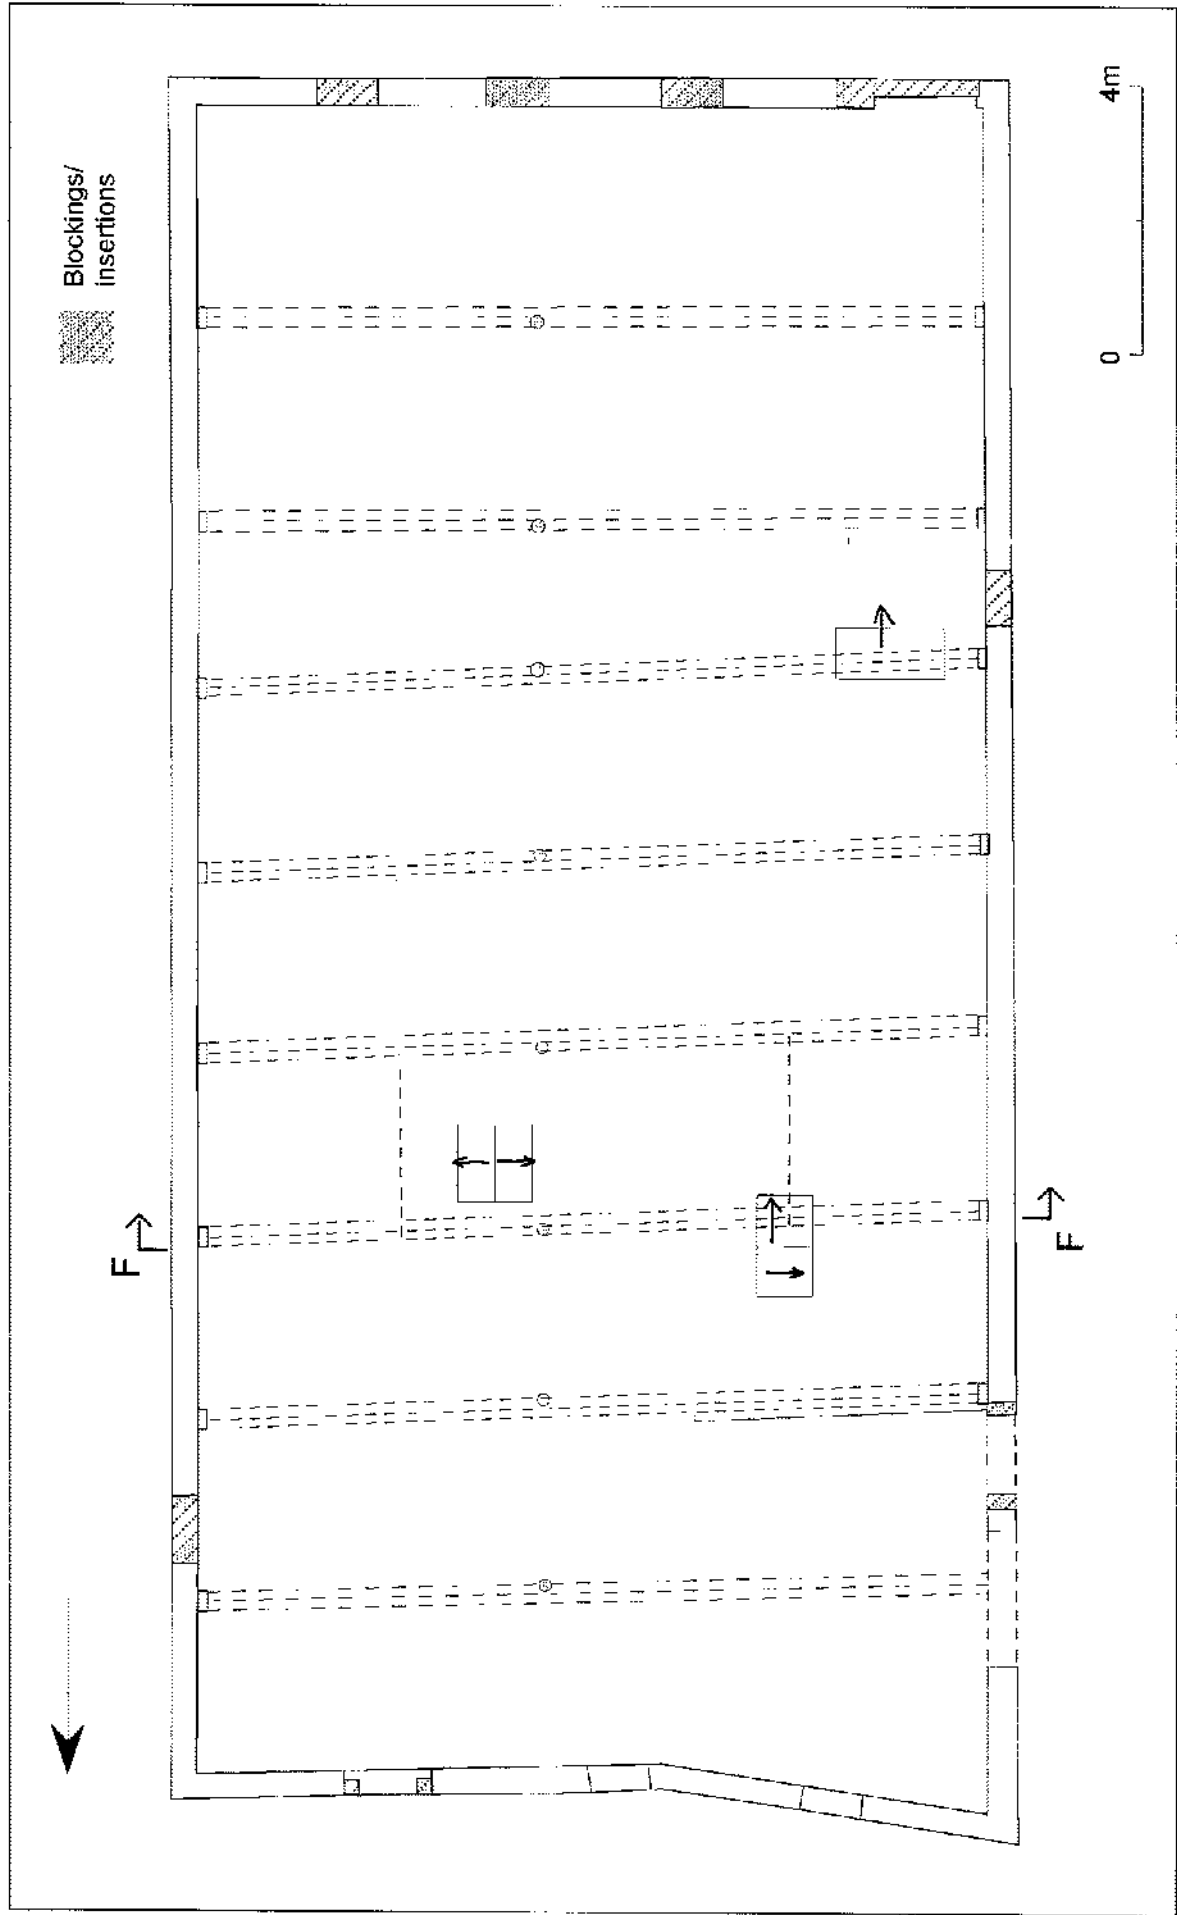
Fig. 13 Building F, first floor plan

The first floor cut across the loading doors at the north end of the west elevation, and was only 0.6m below the sills of the north and south windows, both indications that the floor had been raised. The upper storey comprised a single room. In addition to

the openings already mentioned in the north, south and west elevations, the east wall contained a blocked window and doorway, respectively 0.89m and 1.6m from its north end. The window suggests that these openings dated from a time when there was open land to the east side of Building F, and that the doorway was approached by an external flight of steps.

There were three trapdoors in the later floor, two on the west side and one on the east. The eastern trap was situated beneath a platform, raised on the tie beams of two of the roof trusses, containing a second trap over the one in the floor. The roof trusses themselves contained queen struts and, standing on the collars, king-posts that clasped a plank ridge (Fig. 18). The truss was transitional in that some of the members were secured with wooden pegs whilst iron stirrups and straps had also been used. Each roof truss had been strengthened at a later date by an I-beam and by an iron column a row of which extends down the centre of the room, immediately above the ground-floor spine wall.

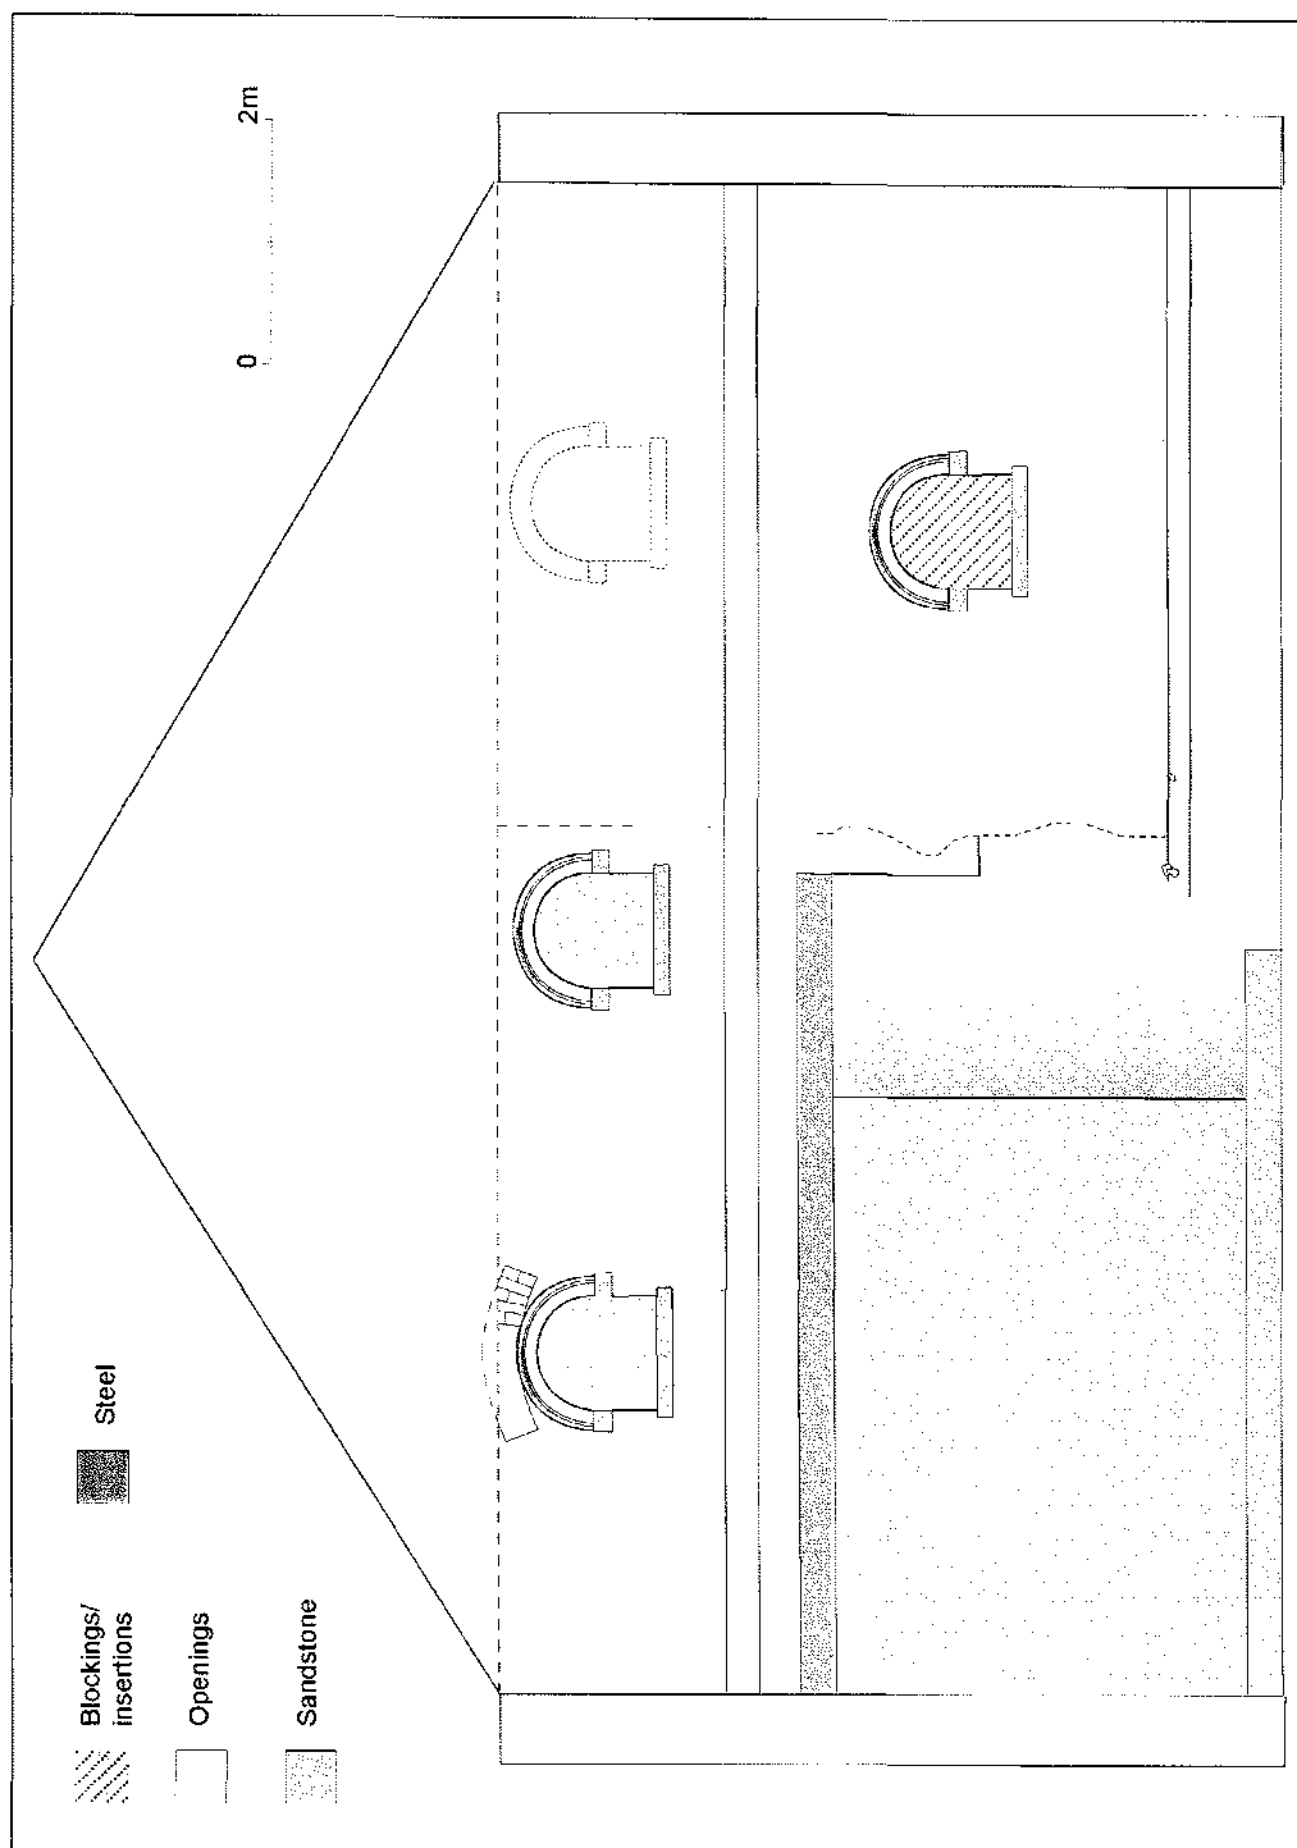
Fig.14 Building F, north facing elevation

The north elevation, towards the canal, formed the main front of the building. The right hand (west) side of the elevation had a projecting plinth, gradually diminishing in thickness towards the centre of the building where the wall curved back into the entrance to the former canal basin which occupied the entire eastern half of the front at the lower level. There was an I-beam over this opening, though presumably it was originally arched like the opening in Building E.

Building F had three bays of semi-circular arched windows with hood moulds springing from painted stone impost blocks (Plate 6). The first floor left hand window represents a conversion from a larger opening, possibly a doorway. Vertical breaks in the brickwork show that the jambs originally continued downwards. Below the window sill this earlier opening had been infilled with 9¾" x 4¼" x 2¾" bricks. Above the window arch was a segmental arch, latterly a relieving arch but possibly open originally.
