**Shipton's Wharf, Albion Street,
Wolverhampton:
An Archaeological Building
Record, 2003**

Project No. 1040
September 2003

By
Malcolm Hislop and Richard Cherrington

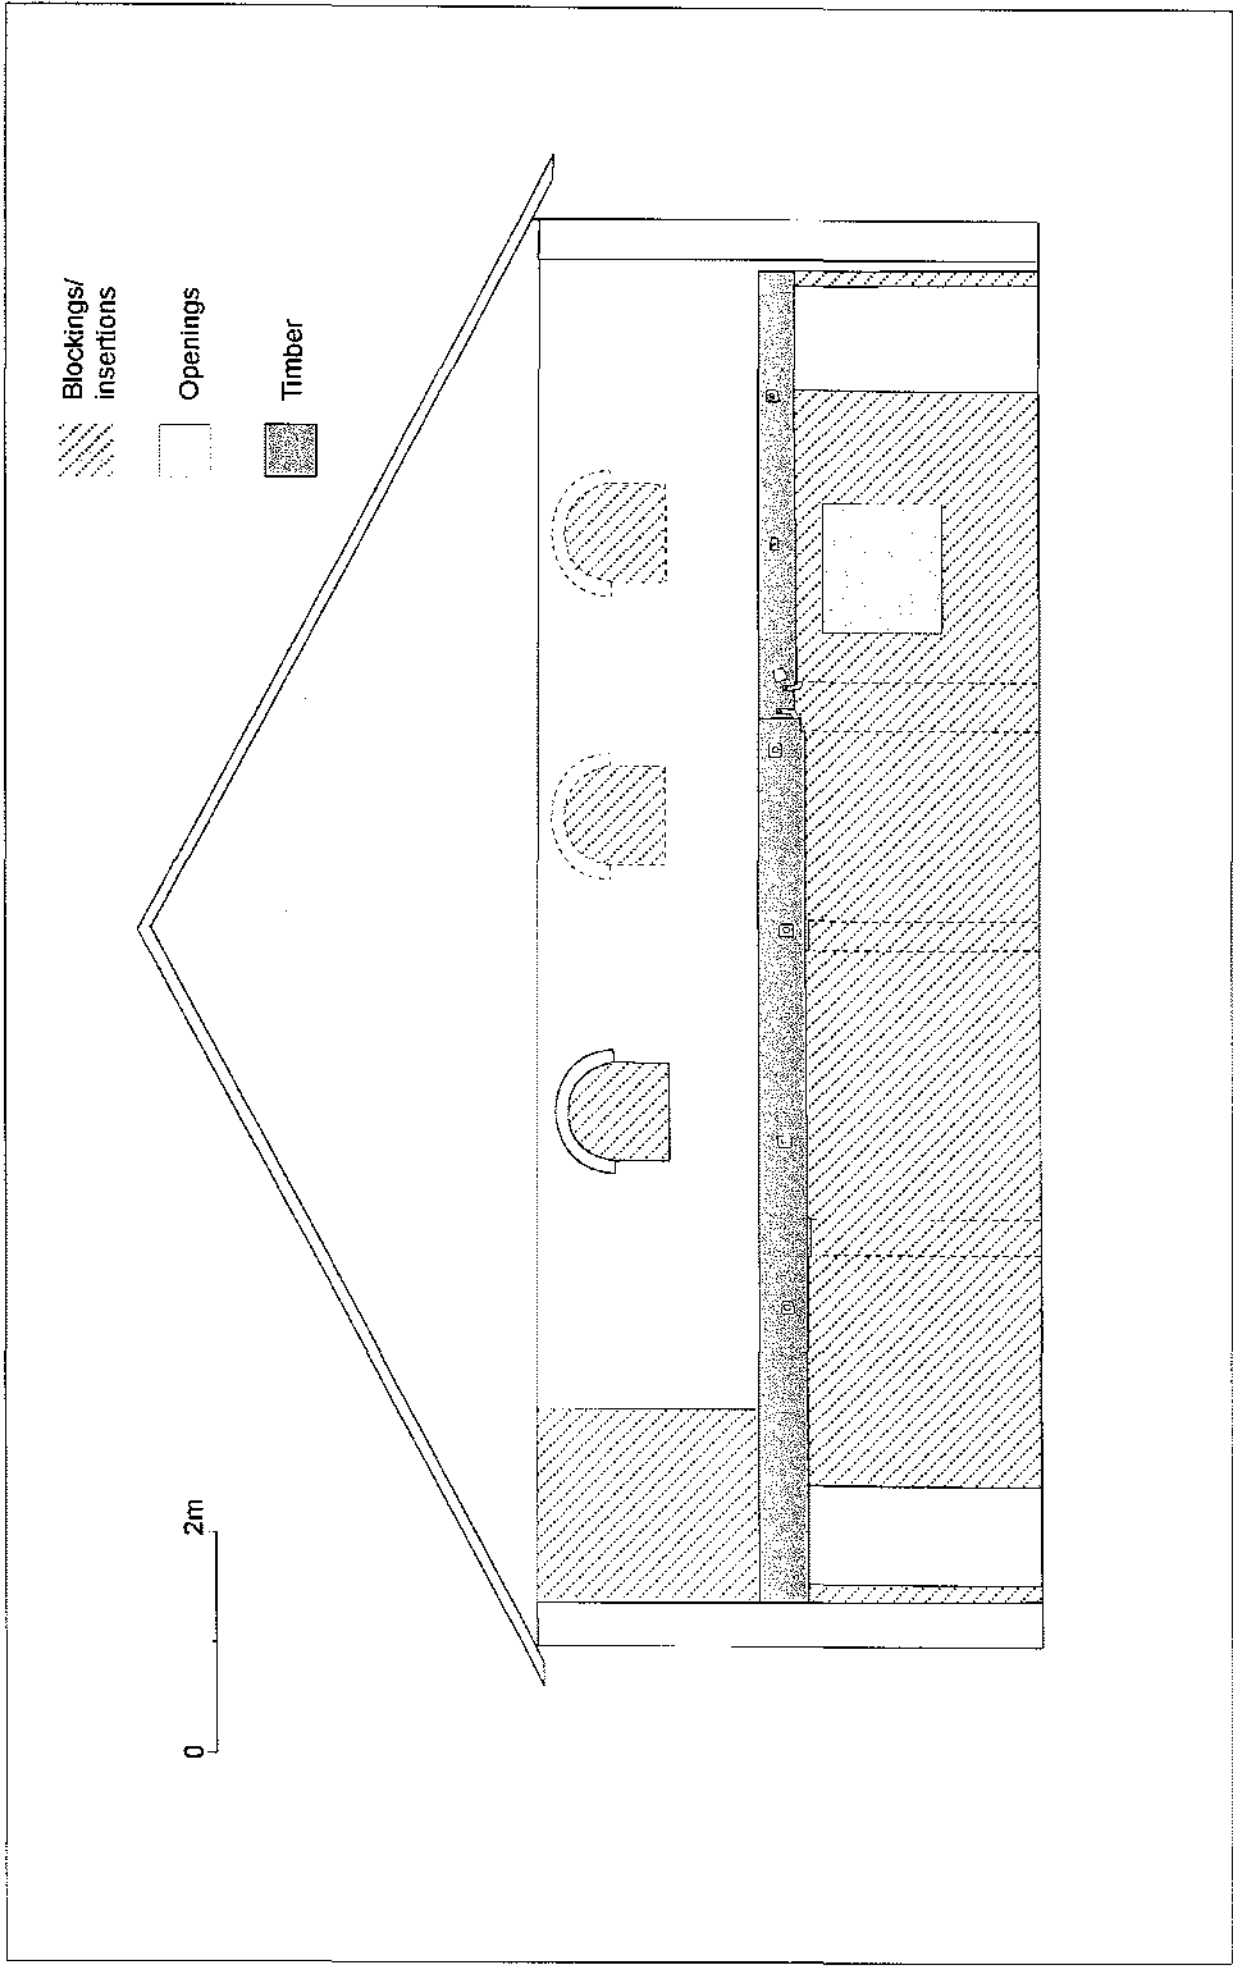
Fig.15 Building F, south facing elevation

First floor level was marked by two massive timber beams that extended across the entire width of the elevation. The truncated joints of three former timber supports survived in the soffit, suggesting that the ground storey was originally open. Latterly, probably during the 20th century, it was infilled with 8½" x 4" x 2½" bricks and provided with two doorways and a window. At first floor level were three blocked

semi-circular-arched windows, of similar proportions to those in the north front, and at the left-hand (west) end a large blocked opening, probably a doorway.

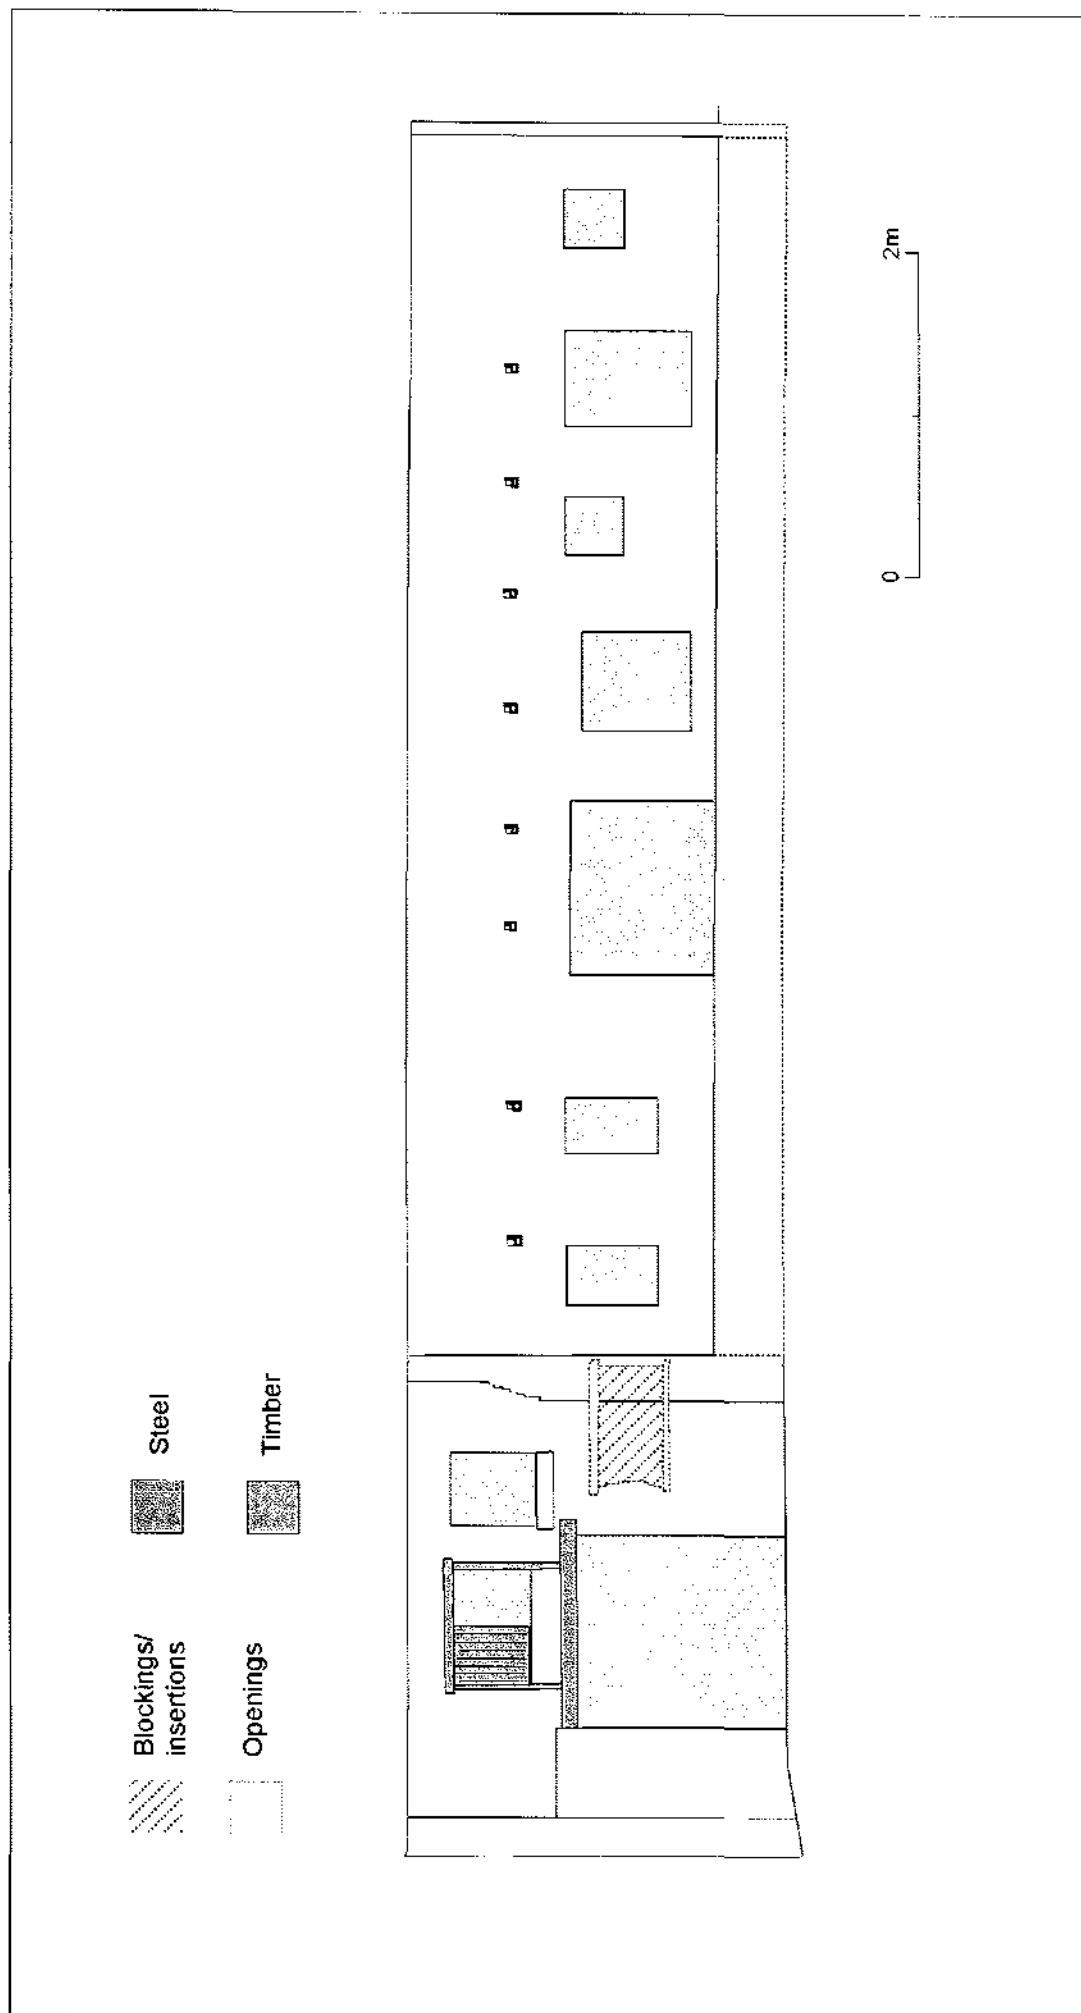
Fig. 16 Building F, west facing elevation

The west elevation, formerly open to the yard, was divided into two by the continuation of the south wall of Building E. To the left (north) of this wall is a large vehicular opening with I-beam over, evidently inserted or enlarged. To the right of it, and only visible from the interior was a blocked window with timber sill and lintel, partially obscured by the south wall of Building E. At first floor level, above the vehicular entrance, was an opening with double doors, probably a loading hatch, and, to the left of it an inserted doorway contemporary with a timber bridge linking the upper stories of buildings E and F.

The southern section of the elevation had seven bays of unequal sized openings at ground floor level, none original, containing large steel-framed windows of 1930s date. To the left (north) of centre was a wide opening, probably for loading. At first floor level there was only one small blocked window to right (south) of centre.

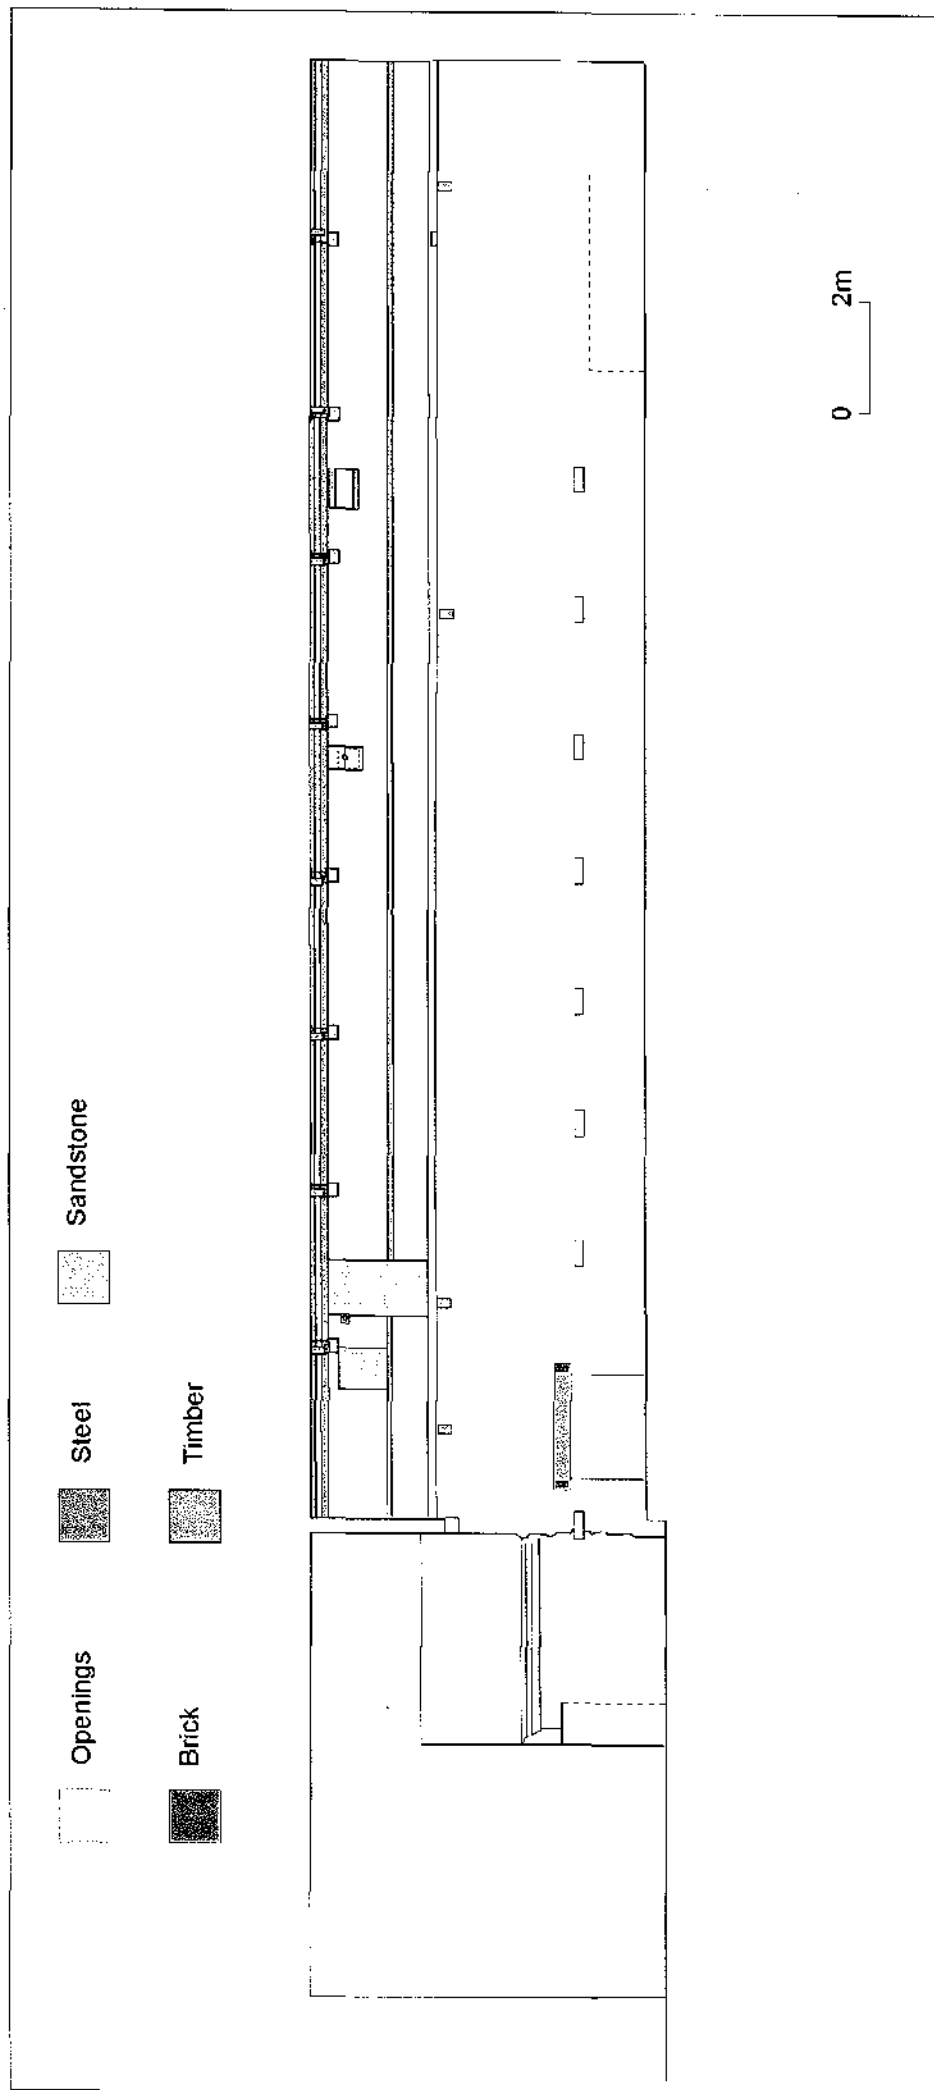
Fig.17 Building F, Section D-D

A floor had also been inserted in the eastern room. The east side of the spine wall also incorporated the remains of I-beams, and in the opposite (east) wall there were the corresponding remnants of concrete blocks (Fig. 17).

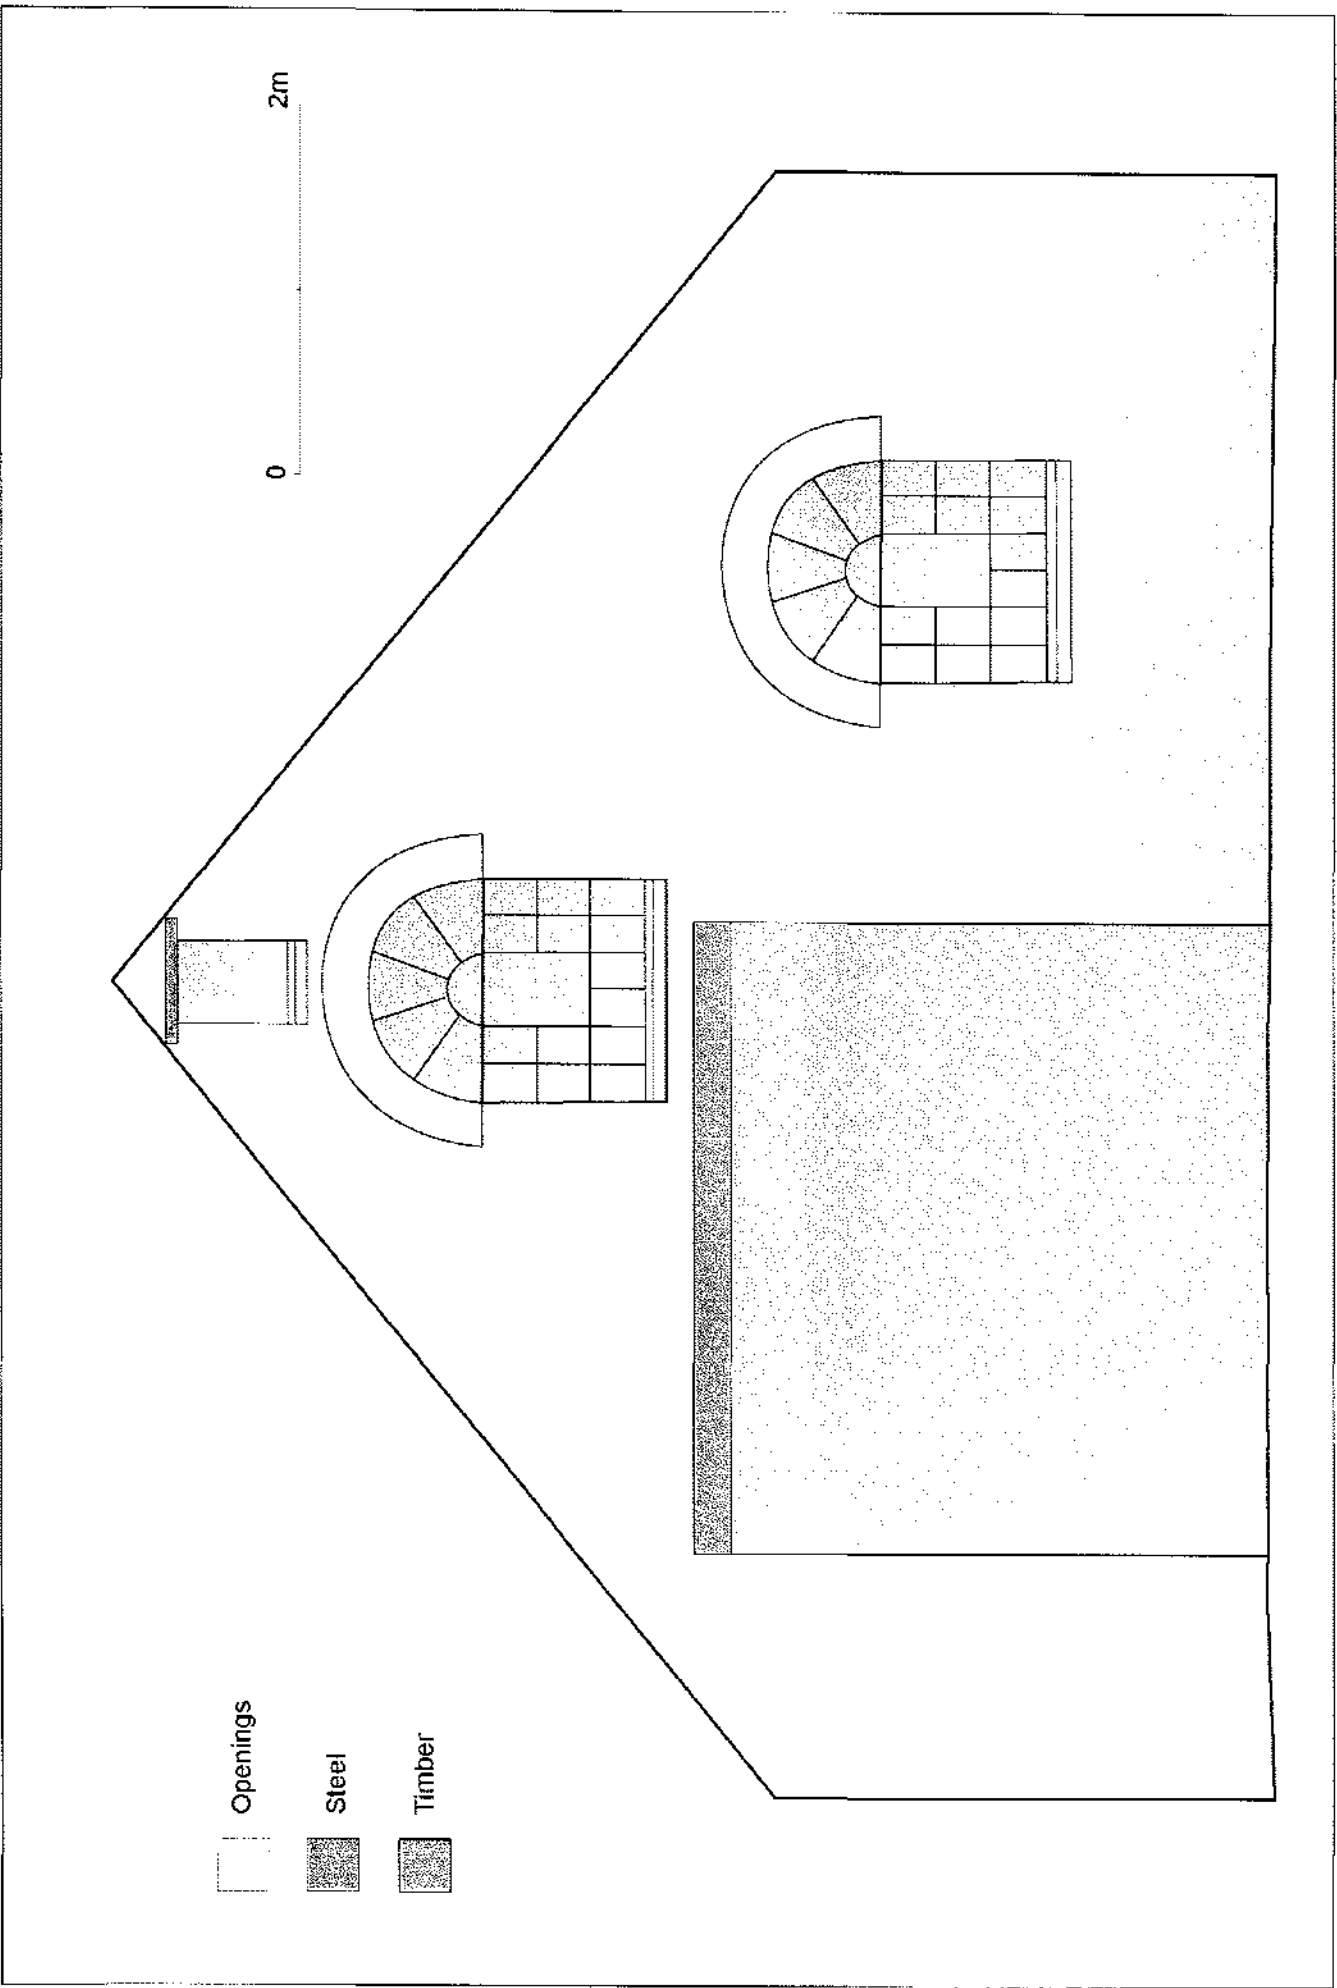
Fig.19 Building G, ground plan

Building G was a late 19th-century brick-built structure with corrugated iron roof. The bricks ranged in colour from red to yellow, and were laid in English garden wall bond. Aligned east-west facing east, the plan was that of an irregular rectangle, the east wall being built at an oblique angle to the side walls. This single-storey structure had a large sliding door to the left (south) beneath a steel girder, probably inserted, though the structural evidence was slight. There were two windows of identical design, one to the right and one in the gable. They had semi-circular heads with small-pane iron frames, and chamfered brick sills. Above the upper window was another small window opening with flat wooden lintel. Inside there were buttresses to each end, and in the centre of the side walls. Two square 20th-century openings had been inserted into the south wall. In the centre, extending from north to south was a single queen-post roof truss. The tie beam supported two longitudinal beams, the southernmost of which had had its western half removed.

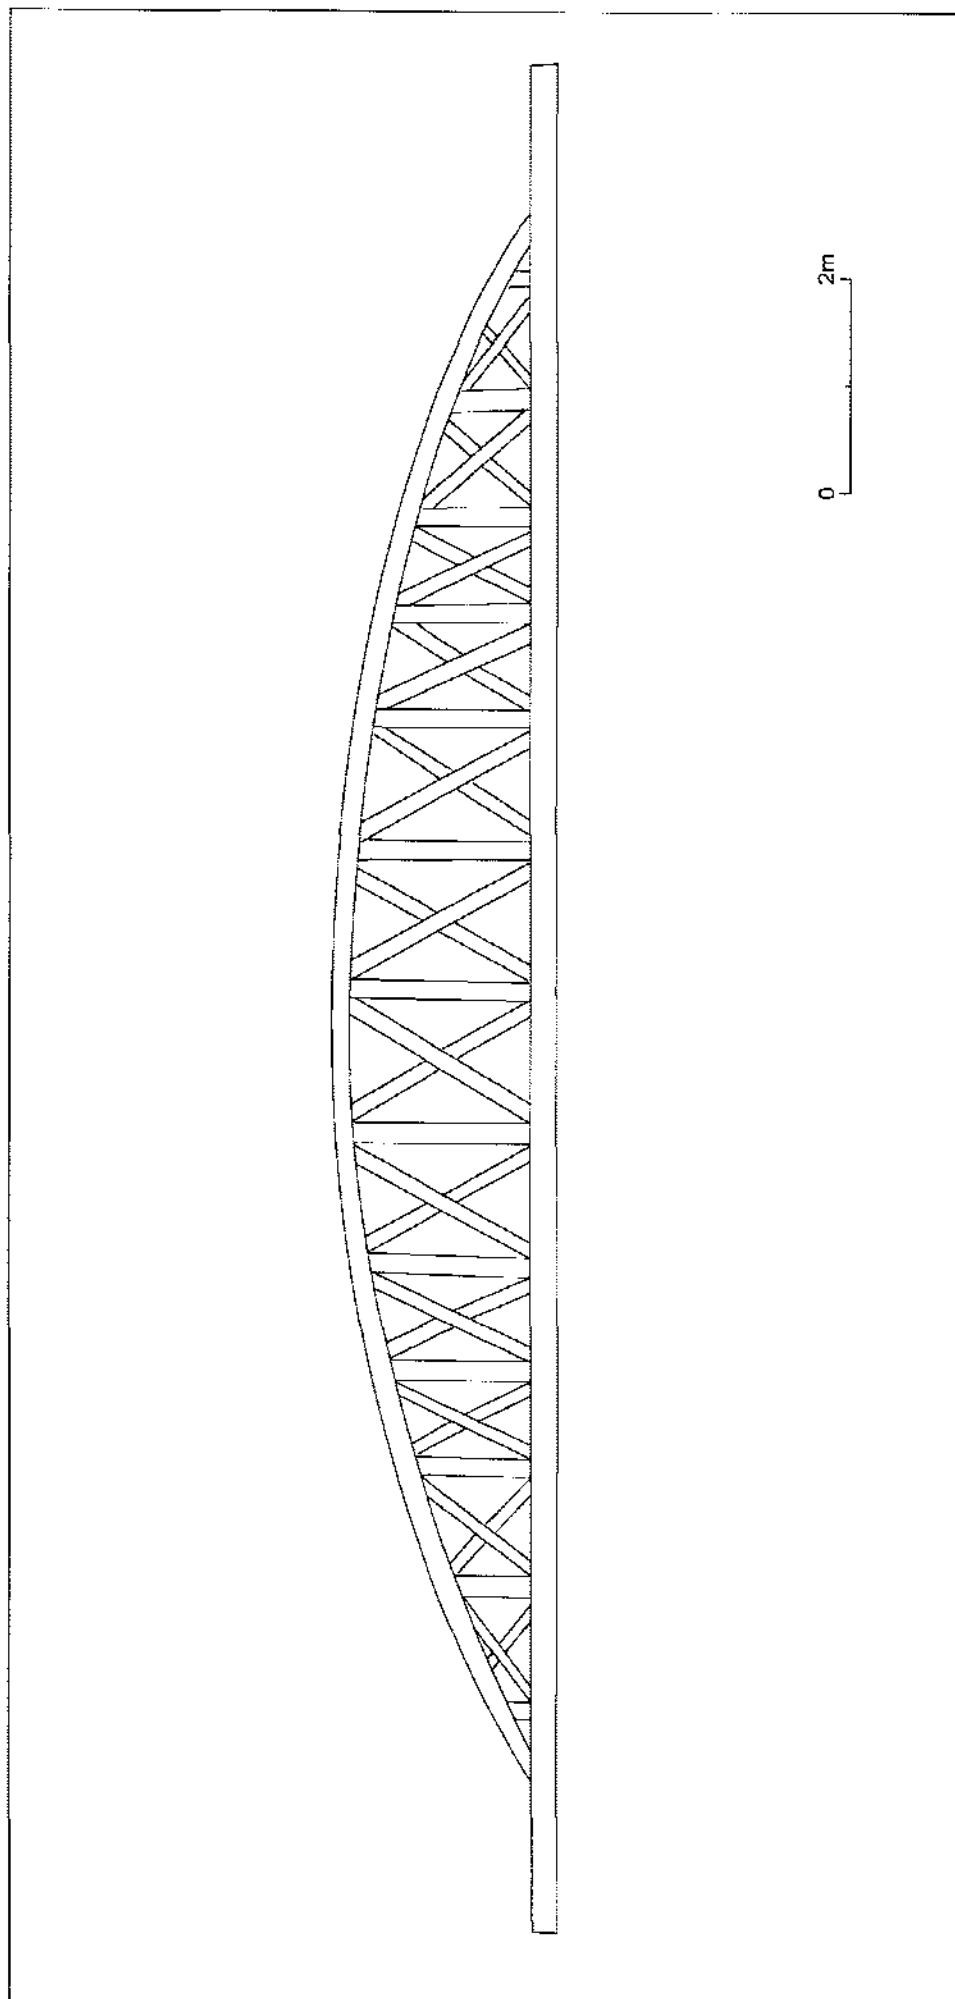
Fig.21 Building J, south facing elevation of roof truss

The roof trusses over Building J were a type of Belfast truss. Constructed of wood, they comprised twelve bays, each containing St Andrew's cross bracing. On the right-hand (east) side, the left-leaning braces crossed over the right-leaning braces. On the left-hand (west) side this pattern was reversed.

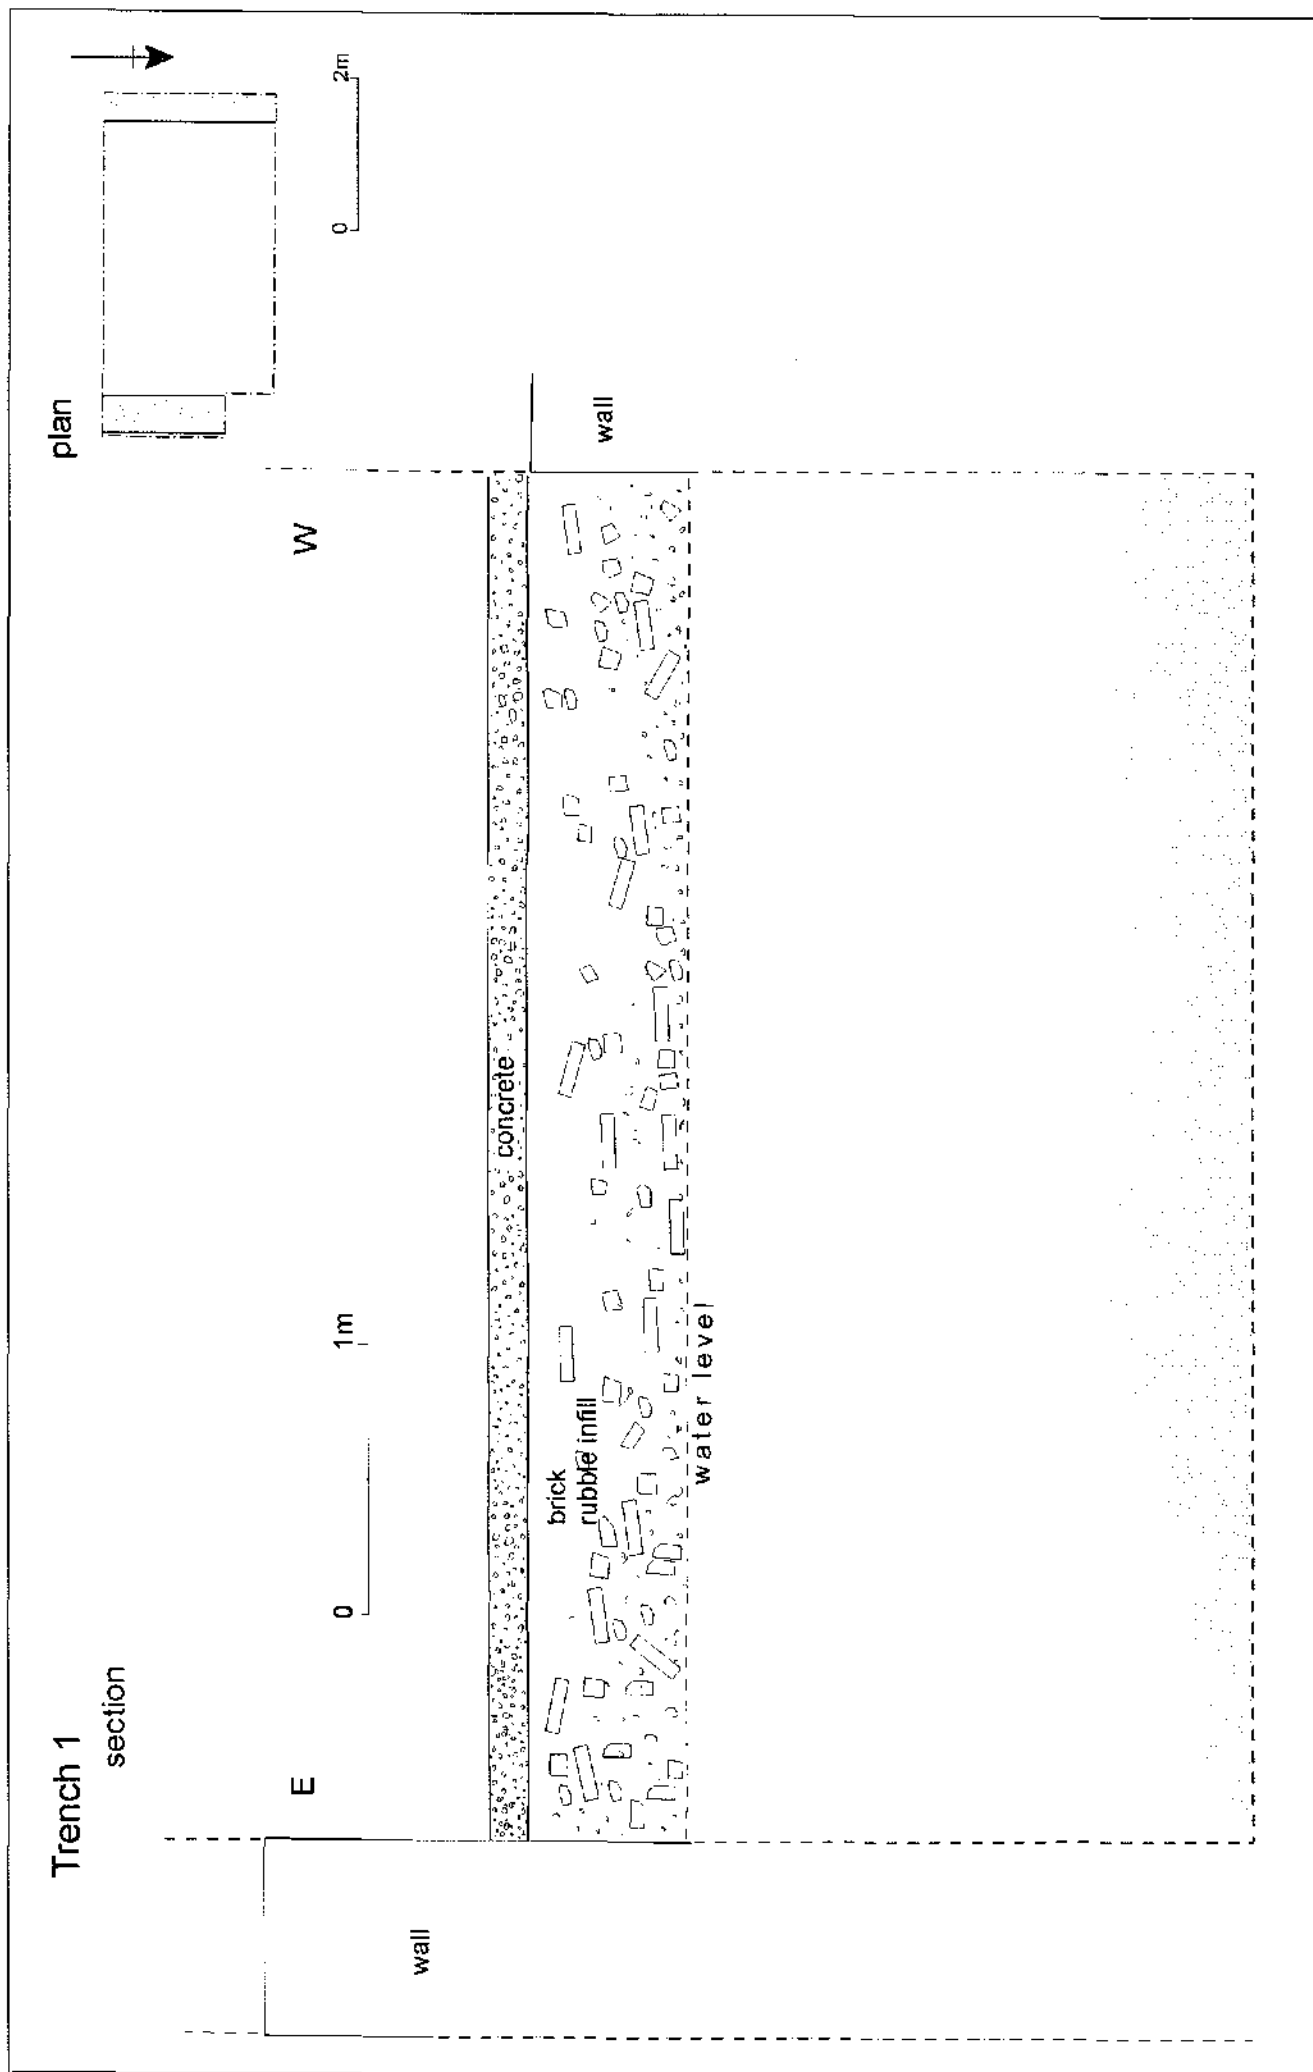
Fig.22 Trench 1, north facing section

Trench 1 was 6.5m long by 3m wide and aligned east west across Building F. The modern ground surface level was 145.63m AOD.

The canal basin was approximately 5m wide and ran north-south from the canal frontage into Building F. Its base (1003) comprised clay puddling (Plate 6) and was encountered at a depth of approximately 3.7m below the modern ground surface. The light brown clay of the puddling appeared to have been grogged with gravel and brick inclusions to increase workability. After it had become redundant the canal basin had been backfilled with loose demolition debris and other contaminants (1002). The water level occurred at approximately 1.6m from the modern ground surface. A Ferro-concrete raft with a damp-proof-membrane (1001) 0.15m in depth capped the canal basin, which was enclosed by two 0.7m thick walls (F100 and F101) constructed of hand-made red bricks measuring 9½" x 4½" x 3", laid in English bond and bonded with limed mortar. One of the walls (F100) had been partially whitewashed, this presumably marked the height of the original water-level. Brickwork below the water line had suffered damage from barge traffic (Plate 7). These features were sealed by a layer of modern demolition debris (1000) 0.8m in depth.

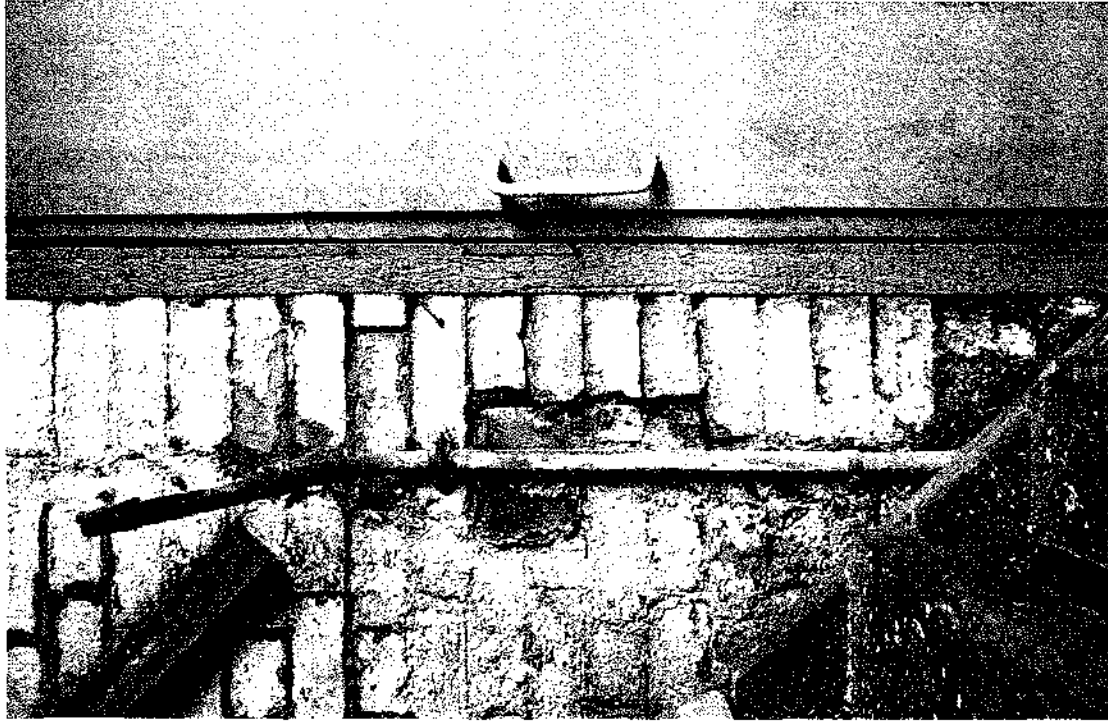
Plate 2

To the left (west) of the central recess, at ground level, was an inserted doorway giving access to the interior. To the left (west) of it was another sandstone impost and a curving break in the brickwork above it suggesting that there was formerly an arch in this position. (Plate 2). It seems probable that the existing doorway replaces an original opening of which this impost is the only surviving trace. To the far left (west) was a Gothic two-centred arch doorway and a window of similar character to the left of it, both openings having been blocked by the refacing of the inner elevation of the south wall. Between the two doorways, at first floor level, was another inserted doorway approached by a flight of wooden steps.

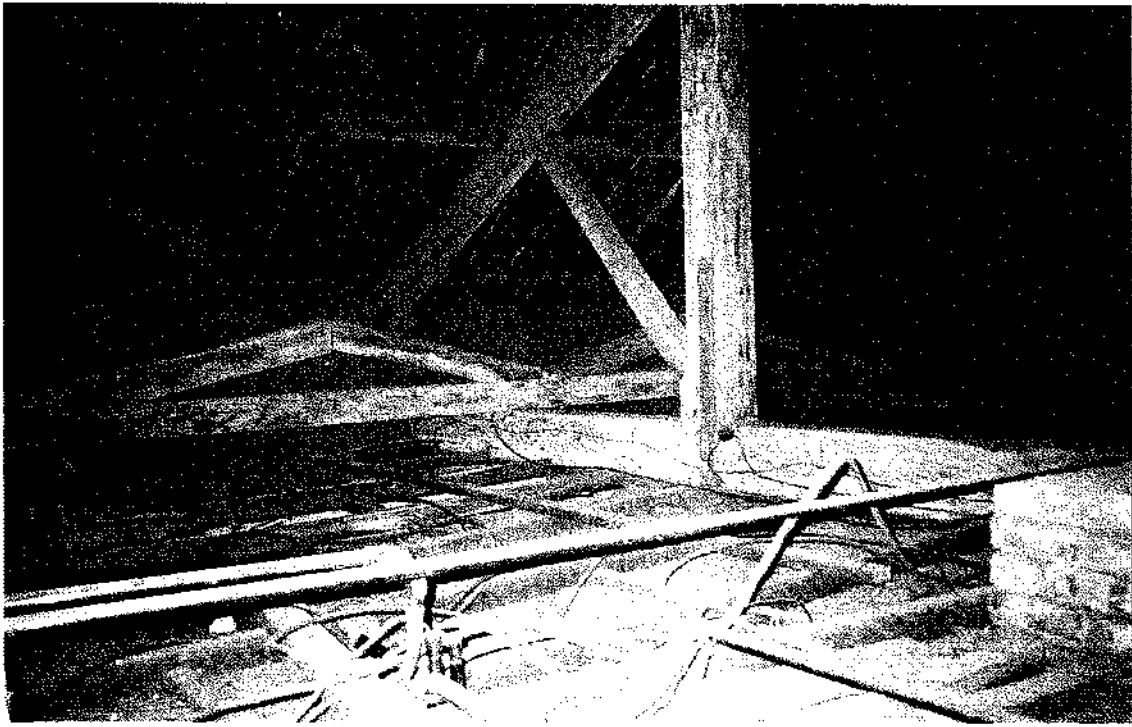
Plate 5

The roof was supported by a series of queen post trusses with principals extending only as far as the queen posts carrying three pairs of purlins. A collar held between the queen posts supports a plank ridge (Fig. 11). On the north side of the building the tie beams carried a timber plate on top of which paired timbers was raised to create a continuous pattern or serrations of unknown purpose (Plate 5).

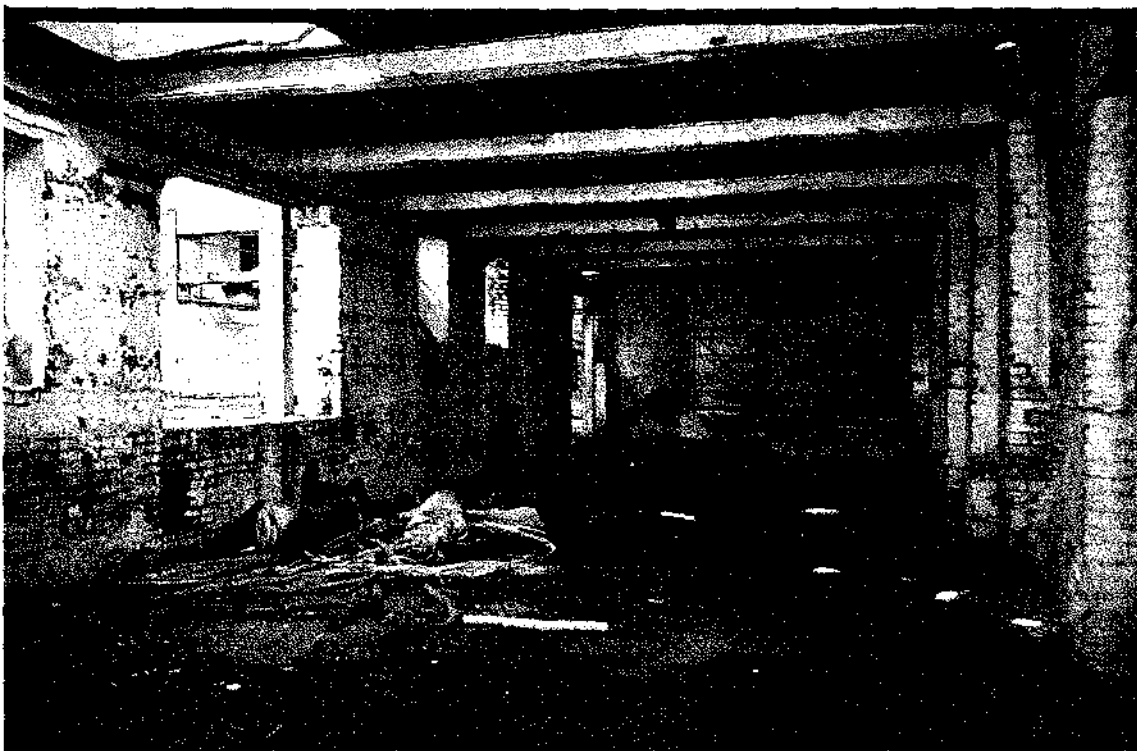
Plate 7

The concrete floor of the ground storey was 1.05m below the floor level outside the building to the south and west (Plate 7). There were two large rooms at this level, divided from one another by a spine wall, the loading platform or wharf to the west and the former canal basin to the east. This spine wall contained two large open loading bays approximately 4m wide, and two smaller openings to the left (north) of centre, and at the south end (blocked).
