**The Citroen Garage Site,
Merridale Lane,
Merridale,
Wolverhampton:
A Desk-Based Assessment**

Birmingham University Field Archaeology Unit

Birmingham University Field Archaeology Unit
Project No. 1068
May 2003

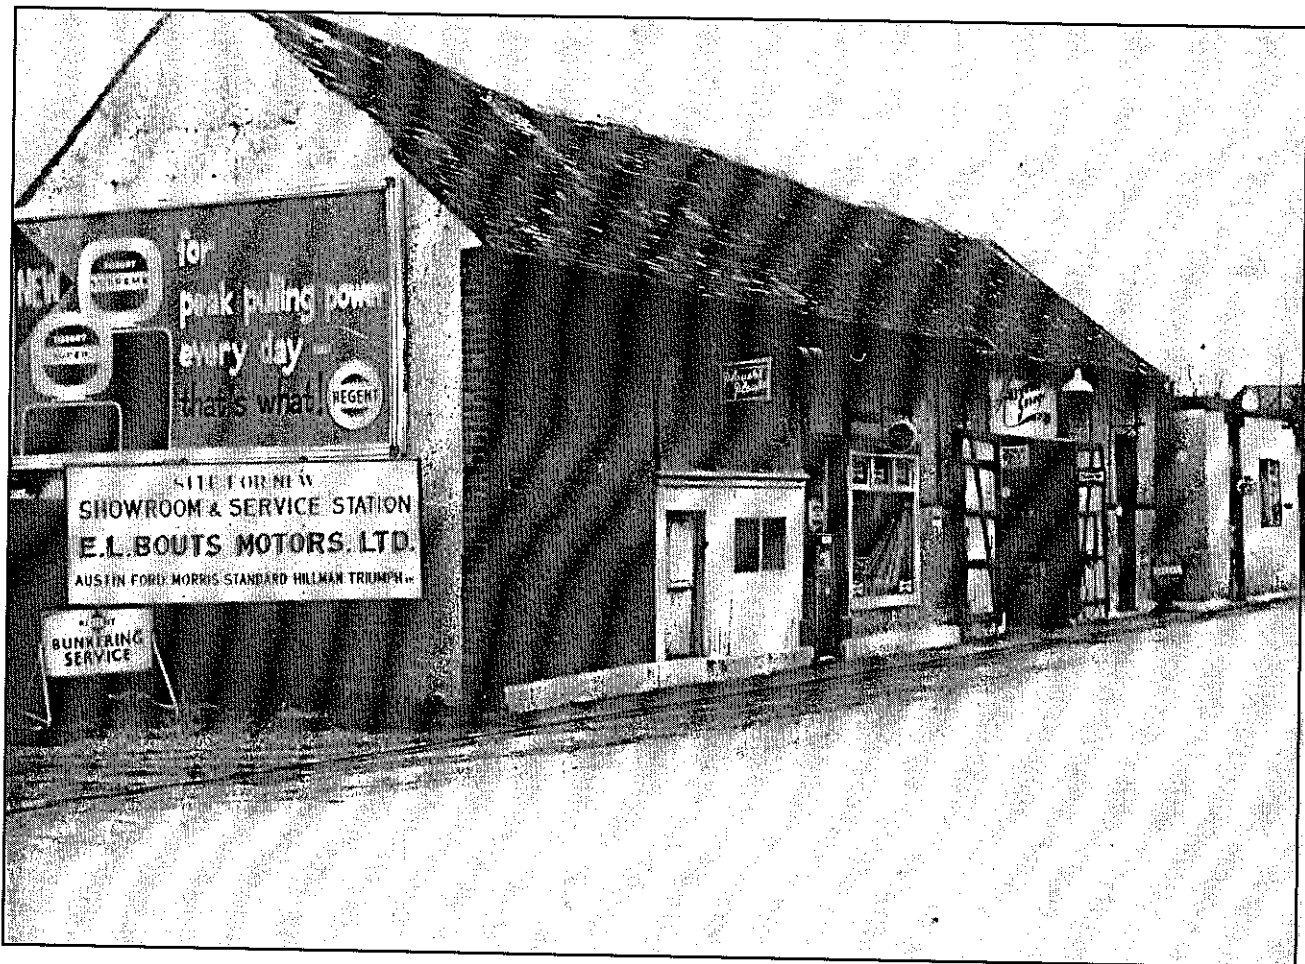
Plate 1

- 1. The farmbuildings from the southwest
- 2. The former cow house from the northwest
- 3. The former barn from the northwest
- 4. The possible slaughterhouse from the southeast

demolished, along with a house to the west. A set of photographs taken in 1961, some of which are reproduced here (Plates 1 - 4), shows the remaining farm buildings, ranged along Merridale Lane shortly before they were demolished. At the time they were in use as a garage, and there were two main components: a predominantly timber-framed range to the south with pebbledash-infill panels and a plain tile roof, and, to the north, breaking forward from this range, a flat-roofed building with pebbledash walls. These structures can be readily identified with those depicted on the map of 1871. The northern section was formerly the cow house, and the southern section the barn, and possible slaughter house and stable. The north and south wings both appear to have been demolished by this time. None of the original features of the cowhouse are visible in the photograph. The pitched roof had been taken down, and towards the road were two 20th-century windows and two recesses holding petrol pumps. Consequently, nothing can be said about its date.

The south range, however, is more easily made out. The timber-framing was of slight scantling and the roof was of king-post construction, both characteristics that suggest an 18th-century date. The barn lay to the north, the former entrance to the threshing floor being utilised as the vehicular entrance to the garage, having high paired doors, the upper part of the opening being occupied by a sign bearing the legend 'Merridale Garage Co. Ltd'. The threshing floor probably occupied the centre bay of a three-bay building, though the evidence of the exposed framing is not entirely clear. Other features of this front at the time the photographs were taken appear to have been 20th-century in date, and included two petrol pump recesses and a shop window. To the south was a timber shop front with a door to the left and a window to the right. Above it was a metal advertisement reading 'Player's Please'. To the rear, this part of the building had a 20th-century door and flanking windows beneath a long lintel, perhaps from an earlier entrance, or a remnant of former timber-framing.
