**48-50 High Street,  
Uttoxeter,  
Staffordshire**

**An Archaeological Building  
Record, 2004**

**Project No. 1171**

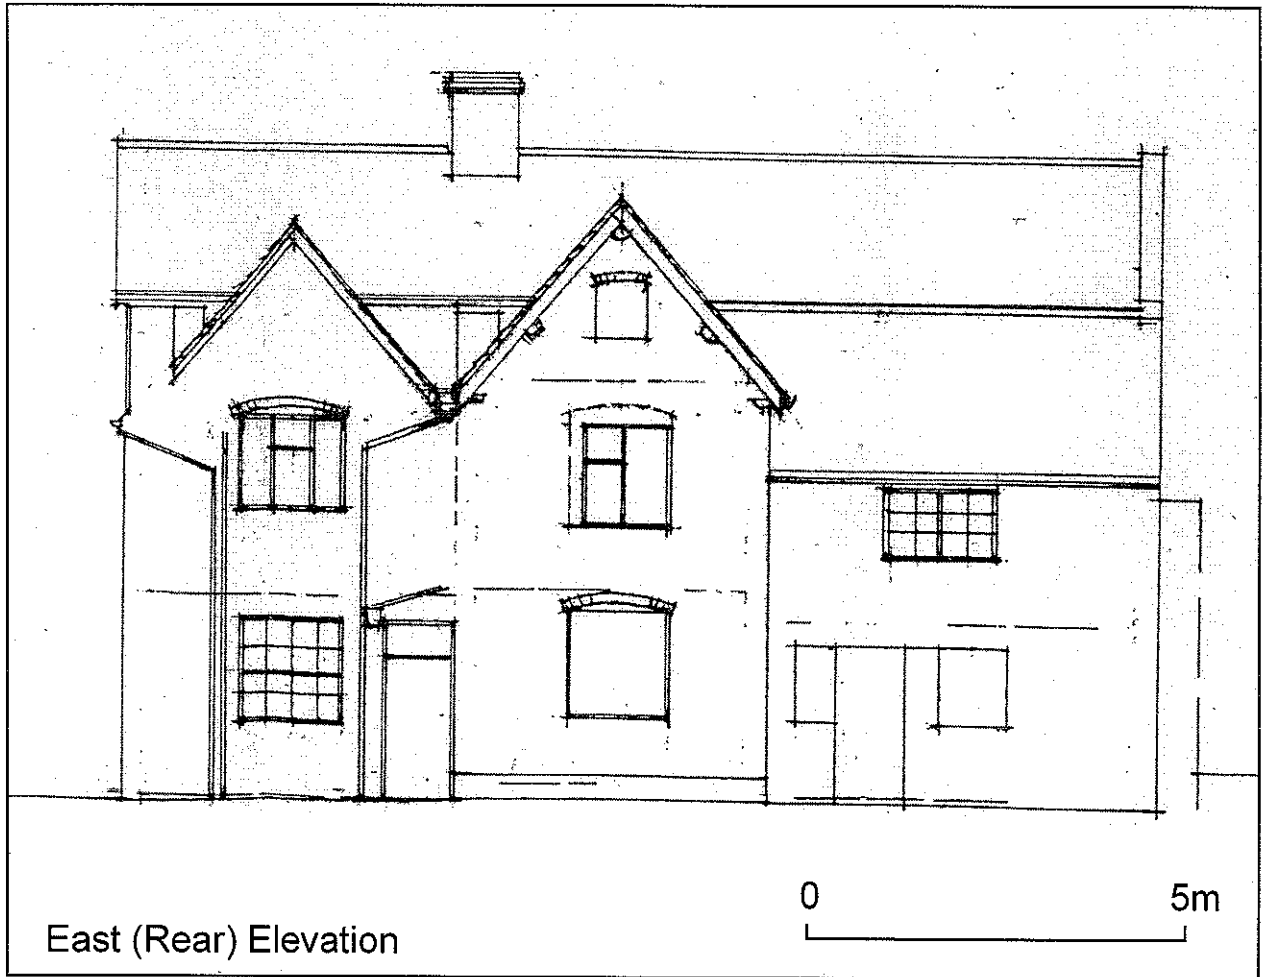
Fig.4

The gables were unadorned (Figs 5 & 6, Plate 2,). The northern gable, due for demolition, was rendered. Of the three ranges that extended to the rear (Plate 3, Fig. 4) the southern two were gabled with pitched roofs and the northern was lean-to. The southern corner was rounded to facilitate carriage access from the entrance immediately south of No.48.

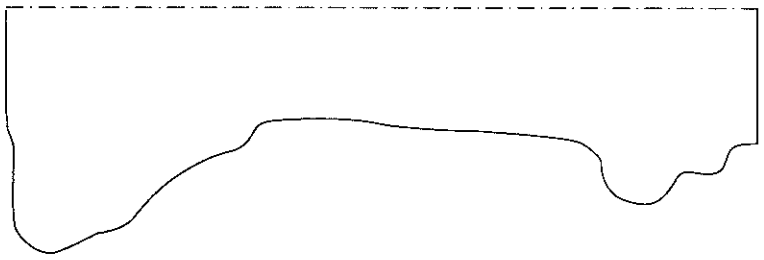
**Fig.13**

Two fixtures also appear to date from the early 18<sup>th</sup> century. One is the main staircase, which, between ground and first floors, has a closed string, straight handrail, square newel with flat cap, and column of vase balusters (Fig.13, Plate 8). The second is a cupboard situated at the top of the stairs at first-floor level on the east side of the chimneystack. It had paired doors, each with four tiers of panels, secured by butterfly hinges (Fig. 13). There are close parallels with a hinge of 1710 recorded by Alcock and Hall (Alcock and Hall 1994, 24).

**Butterfly Hinge  
of built-in cupboard (1:1)**

**Handrail profile  
(1:1)**

**Banister  
(Ground Floor)  
(1:5)**

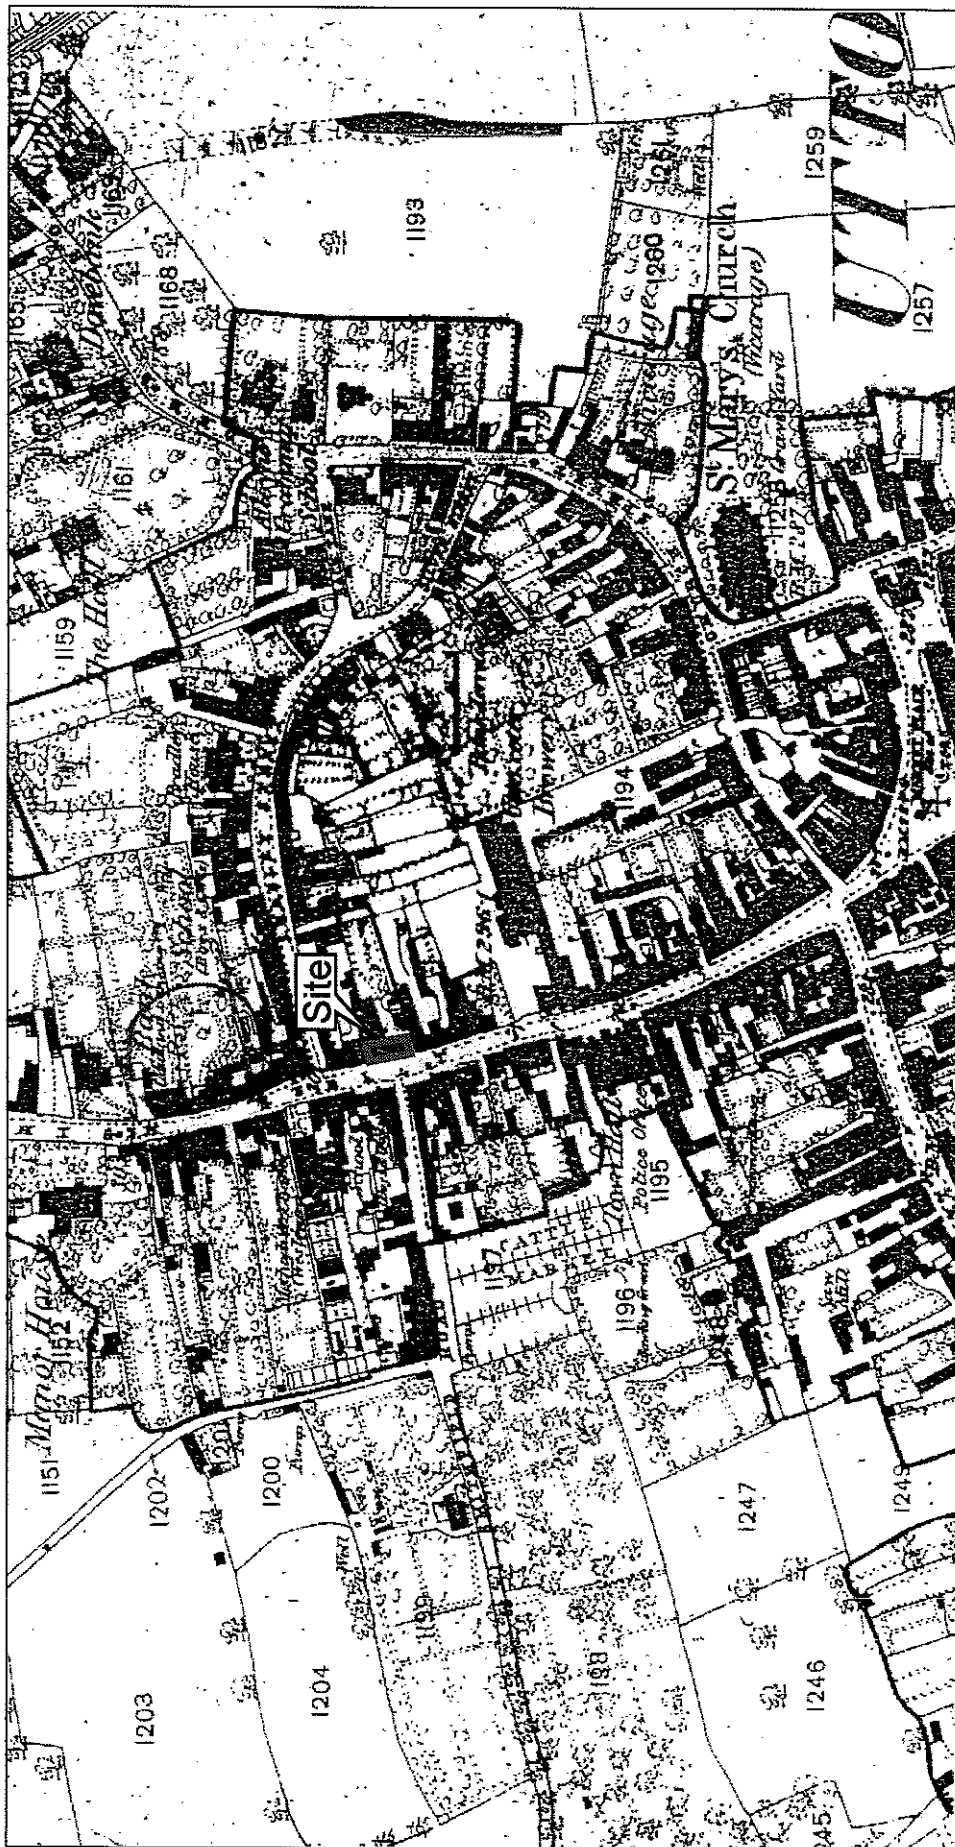
Fig. 15 (1882)

The 1<sup>st</sup> edition Ordnance Survey 1882 (Fig. 15) depicts the structure as one solid block and it would appear that the other two rear wings had been constructed at this period. The buildings adjacent and north of 50 High Street are still depicted on the 1964 Ordnance Survey Map and their demolition did not occur until after this period. The removal of these buildings is probably responsible for the subsequent instability of the northern gable and the necessity for its removal.
